## SUMMARY REPORT

**SUBJECT:** The Colony

A meeting was held on April 25, 2012 to discuss The Colony Beach & Tennis Resort/Club and previous reports and documents concerning the condition of the buildings. Representatives from the Fire, Police, Building, Public Works, Finance, and Zoning Departments as well as Town Administration (Town Manager and Attorney) were present.

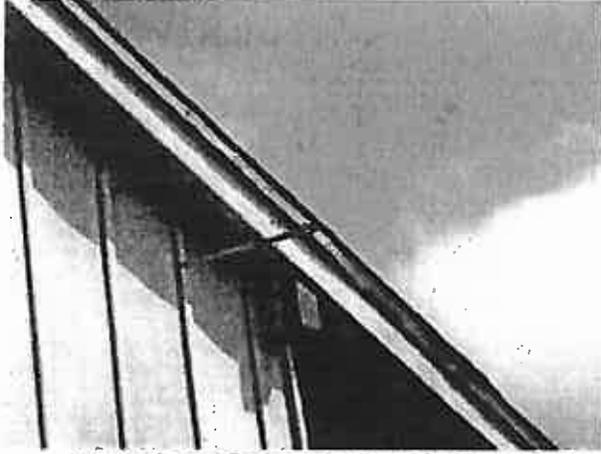
001 – Original roof flashing bent and mis-applied

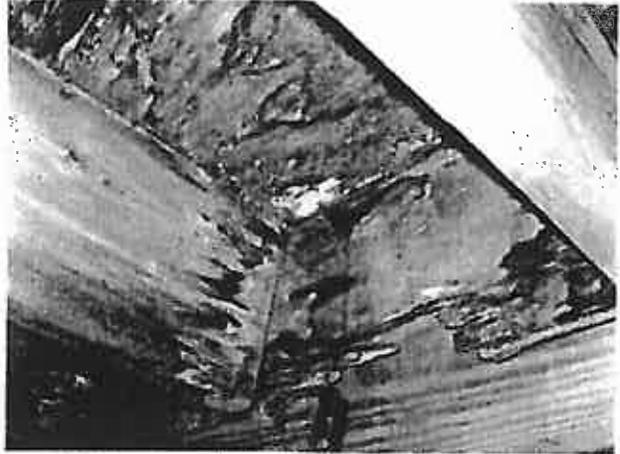
002 – Rotten wood sheathing and framing @ roof

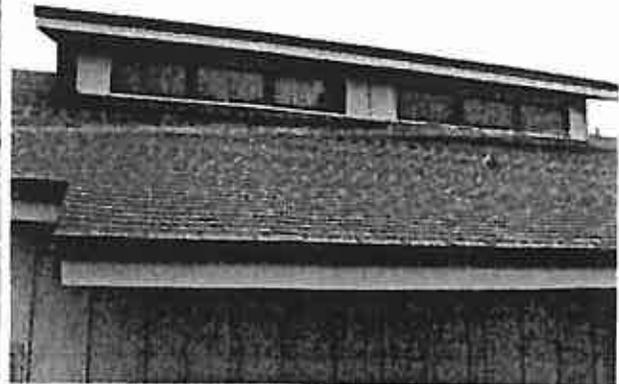
004 – Visible valleys in underlayment between joists @ roof

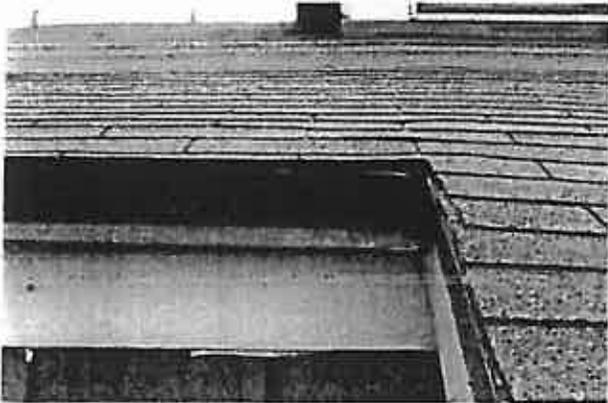
005 – Existing flashing, erratic cut-back @ shingles

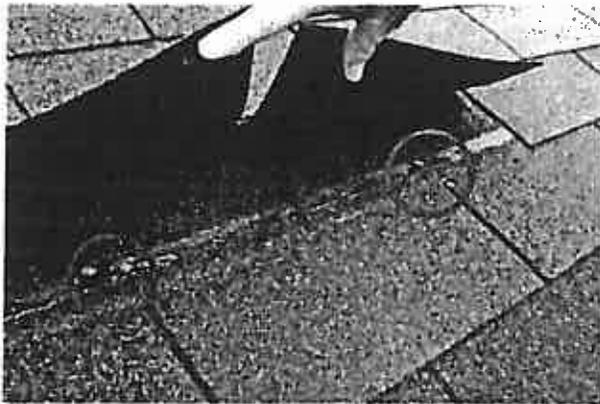
007 – Improper attachment of roof shingle

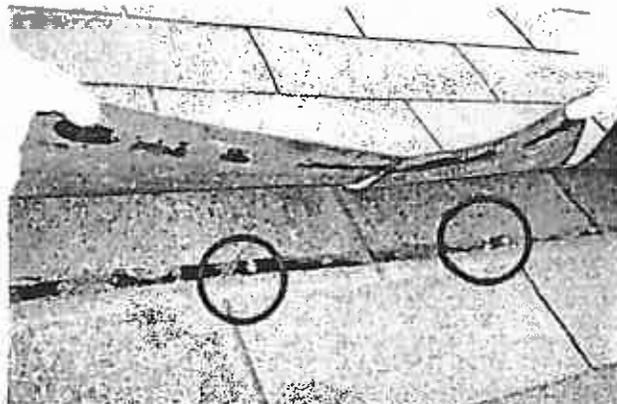
008 – Improper attachment of roof shingle

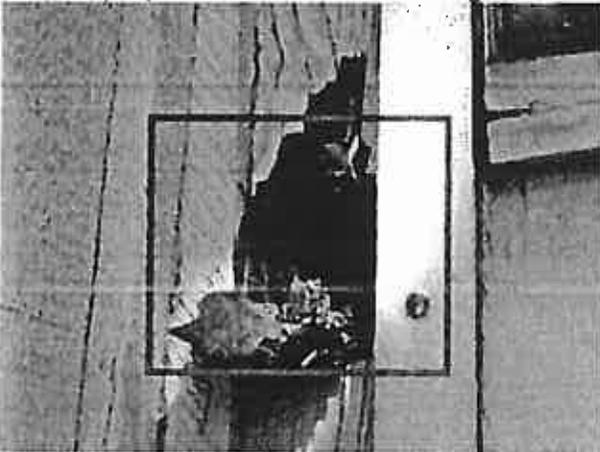
009 – Rotten wood and open hole in exterior siding

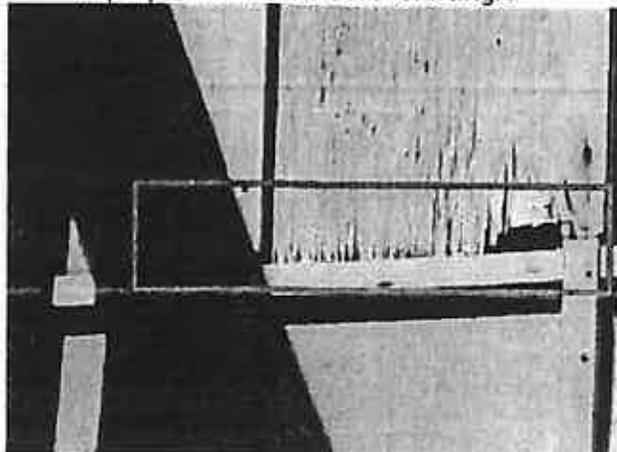
010 – Rotten wood and open hole in exterior siding

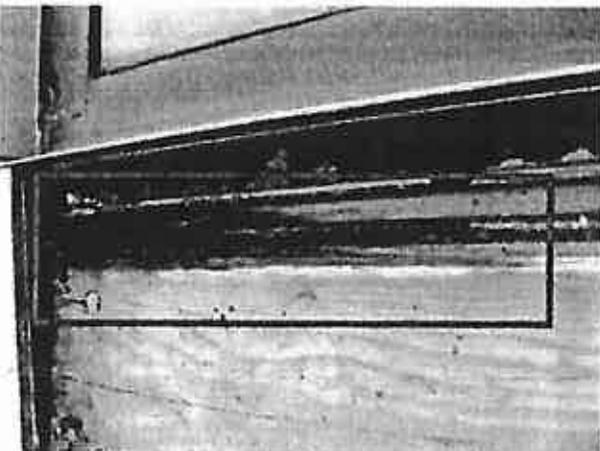
011 – Exposed rotten framing beneath window

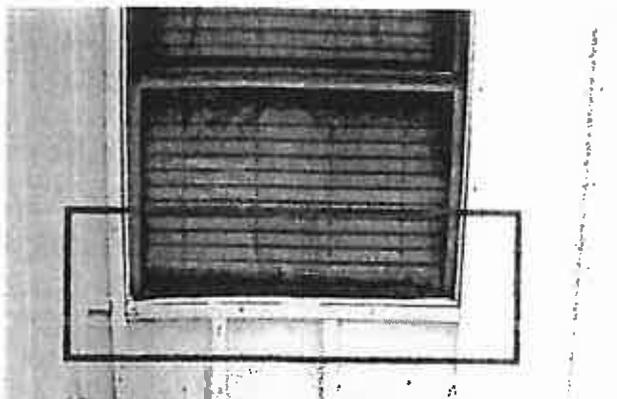
012 – Bowed framing and window caused by settling of framing members

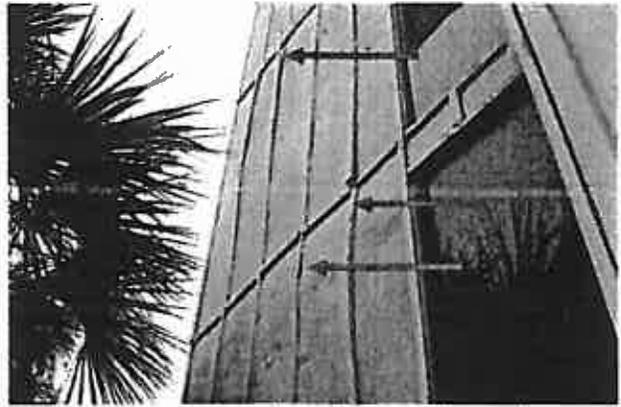
016 – Bowed exterior sheathing and loose battens

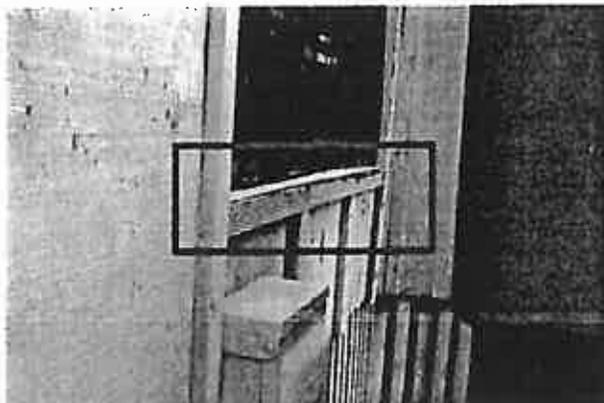
017 – Bowed window sill flashing, no sealant

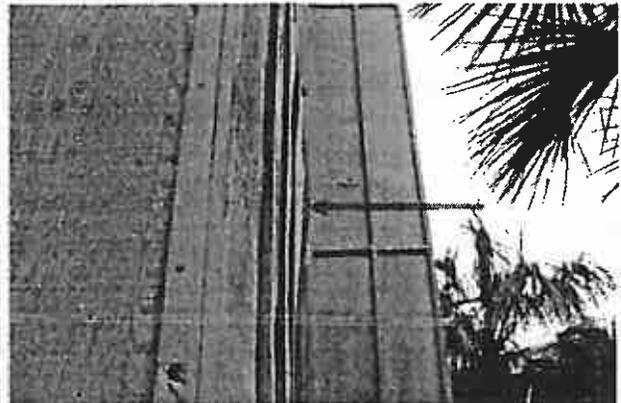
018 - Bowed exterior sheathing and loose battens

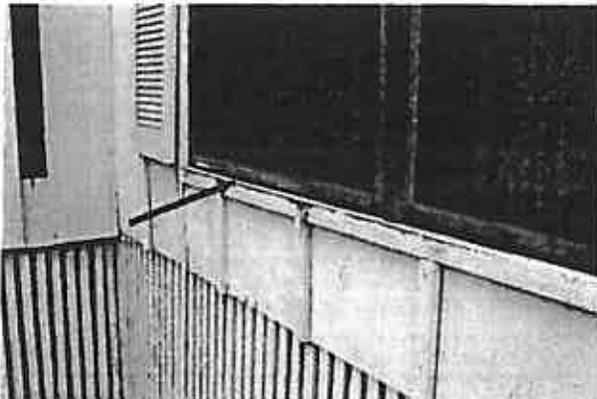
019 - Bowed window sill flashing, no sealant

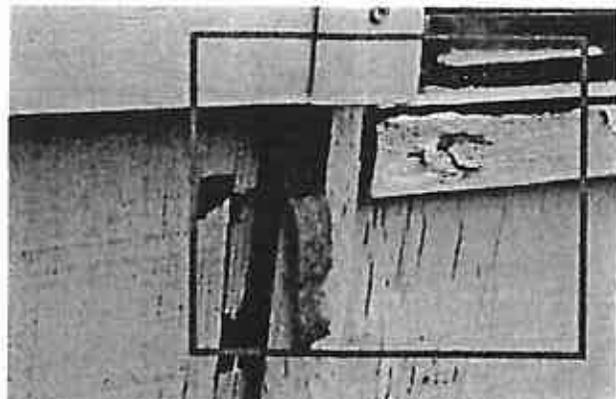
020 - Rotten wood siding beneath window

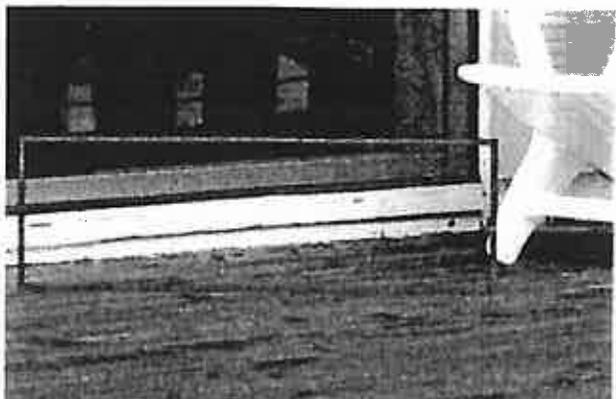
022 - Rusty fasteners and no sealant a sliding glass frame sill

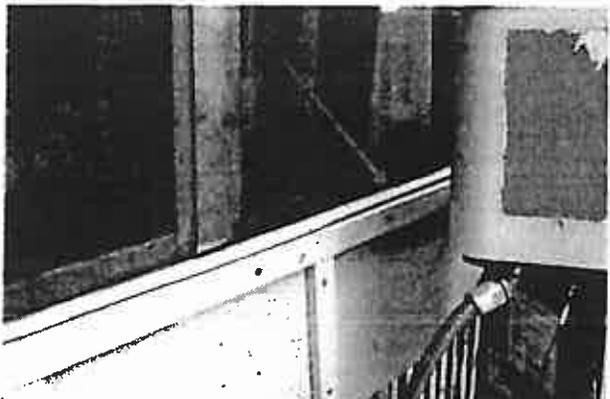
023 - Bowed window sill flashing, no sealant

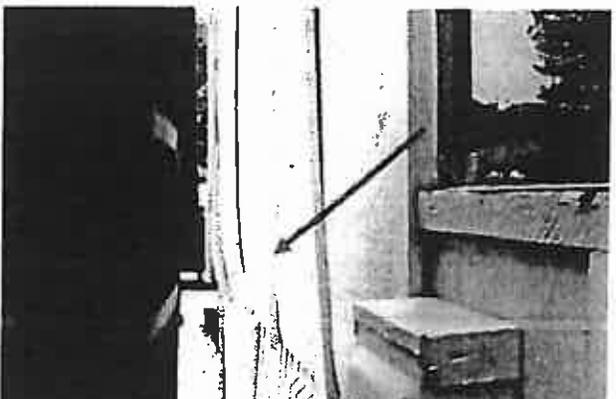
024 - Bowed exterior wall sheathing
