**PUBLIC NUISANCE HEARING
1620 GULF OF MEXICO DRIVE**

**HOUSEKEEPING/ACCOUNTING/FLOWER
SHOP/PURCHASING AND RECEIVING/
HUMAN RESOURCES BUILDING**

**TOWN COMMISSION SPECIAL MEETING
MAY 28, 2014
(CONTINUANCE)**

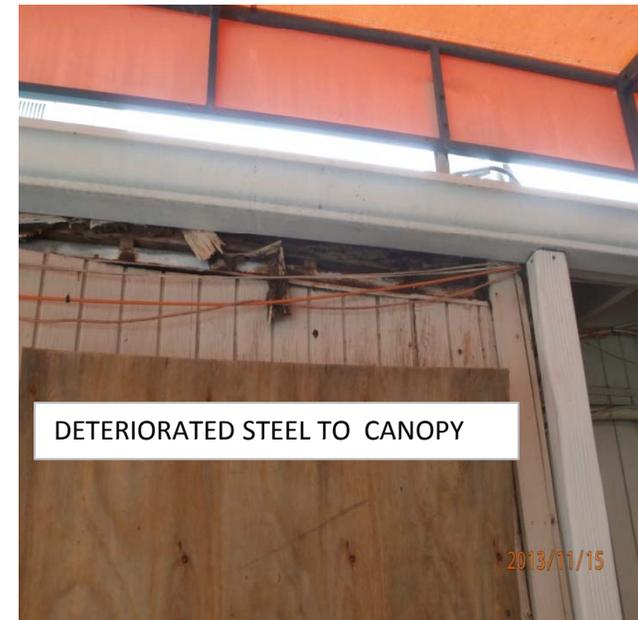
HOUSEKEEPING/ACCOUNTING/FLOWER SHOP/PURCHASING AND RECEIVING/ HUMAN RESOURCES BUILDING– STEEL

- Deterioration
- Metal fatigue

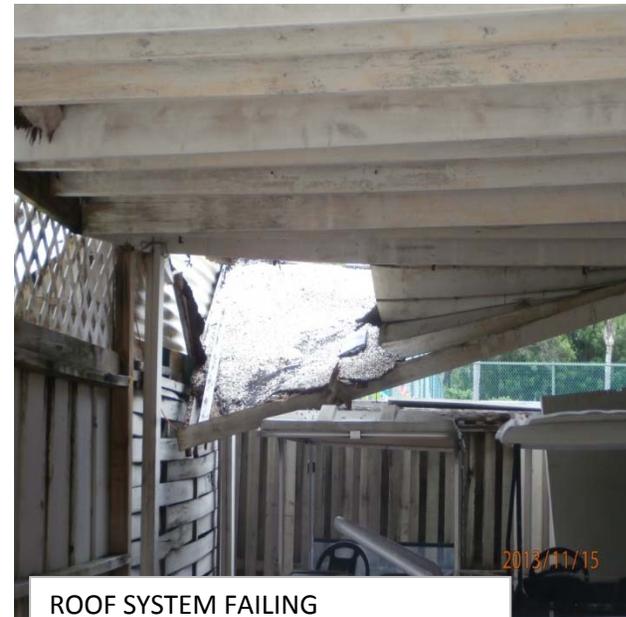
- Deterioration
- Damage from insects, rodents and other vermin
- Detached, dislodged, or failing connections

ROOF SYSTEM FAILING
