TOWN OF LONGBOAT KEY

**PUBLIC NUISANCE HEARING
1620 GULF OF MEXICO DRIVE**

VAGABOND/BEACHVIEW UNITS BUILDING

**TOWN COMMISSION SPECIAL MEETING
MAY 28, 2014
(CONTINUANCE)**

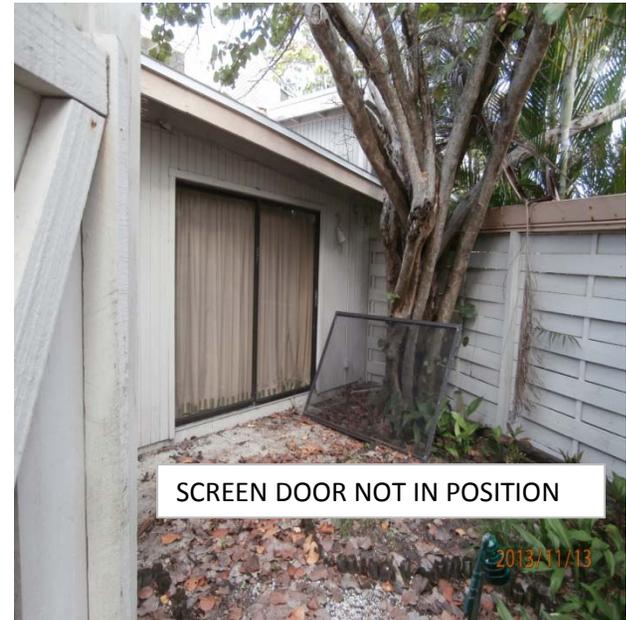
VAGABOND/BEACHVIEW UNITS BUILDING ALUMINUM

- **Detached, dislodged,
or failing connections**

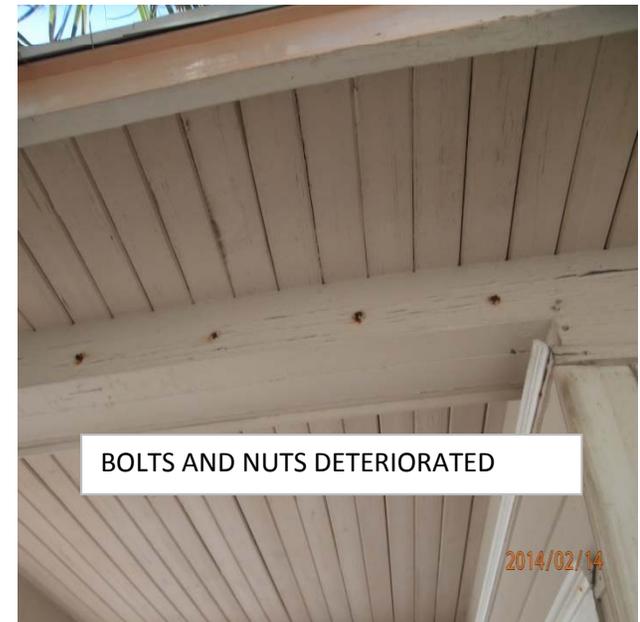
VAGABOND/BEACHVIEW UNITS BUILDING STEEL

- Deterioration
- Metal fatigue
- Detached, dislodged, or failing connections

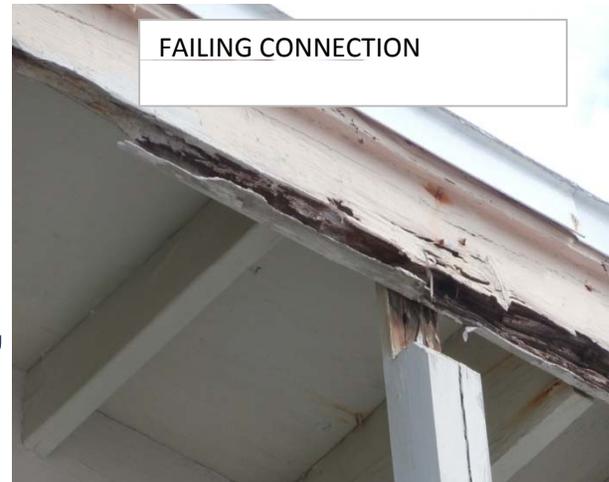
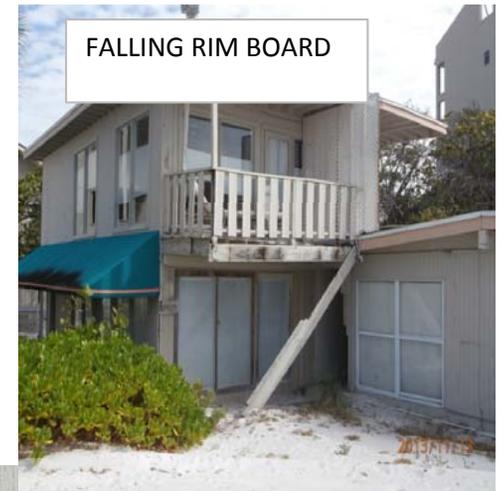
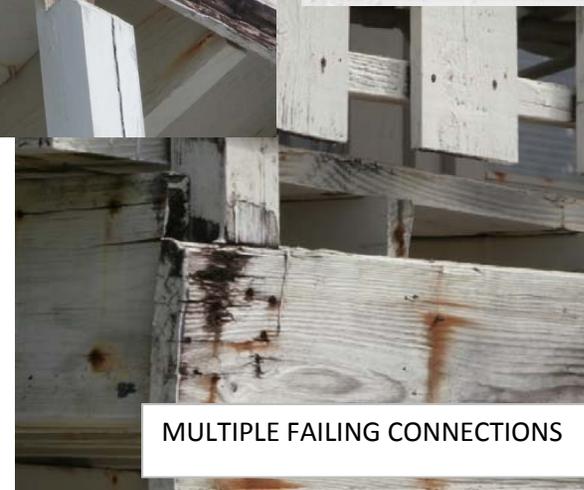
VAGABOND/BEACHVIEW UNITS BUILDING WOOD

- Ultimate deformation
- Deterioration
- Damage from insects, rodents and other vermin
- Detached , dislodged, or failing connections
