**PUBLIC NUISANCE HEARING
1620 GULF OF MEXICO DRIVE**

HI-RISE/MID-RISE BUILDING

**TOWN COMMISSION SPECIAL MEETING
MAY 28, 2014
(CONTINUANCE)**

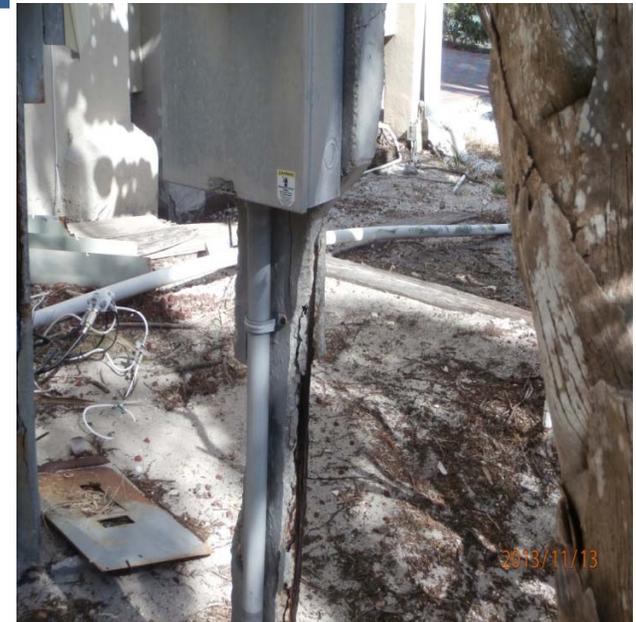
- Exposed Reinforcement
- Spalling

DETERIORATED CONCRETE POLE SUPPORTING
ELECTRICAL SERVICE. EQUIPMENT

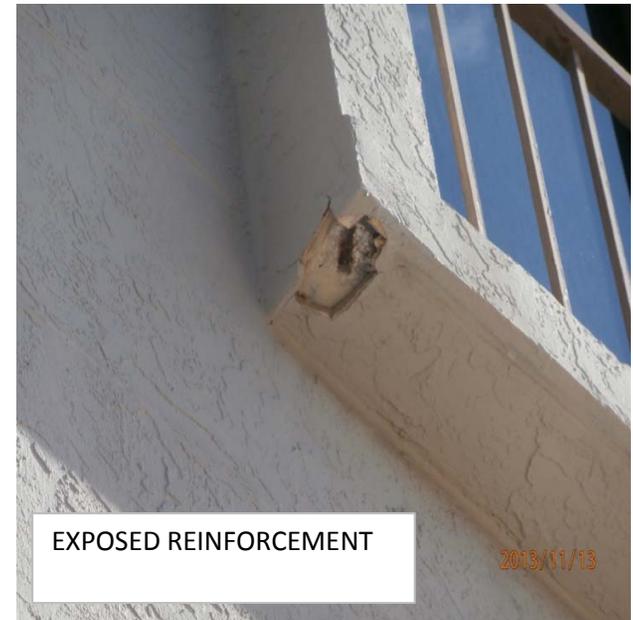
- **Fractures**
- **Fissures**
- **Spalling**
- **Exposed Reinforcement**

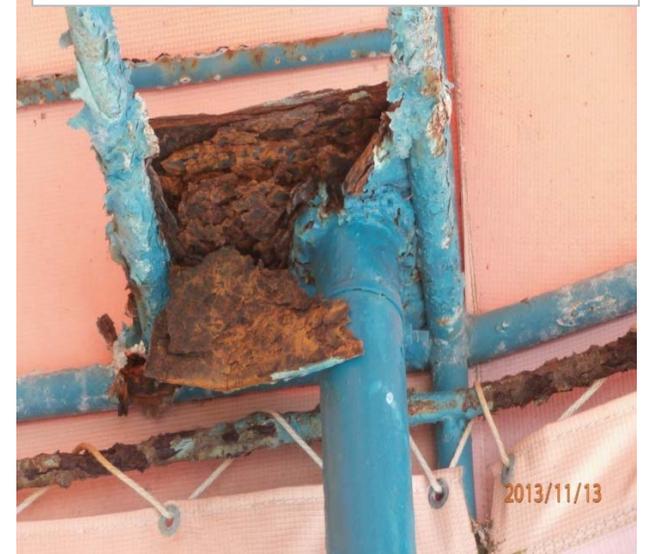
- **Deterioration**
- **Metal fatigue**
- **Detached, dislodged, or failing connections**

DETERIORATING STEEL AND FAILED CONNECTION

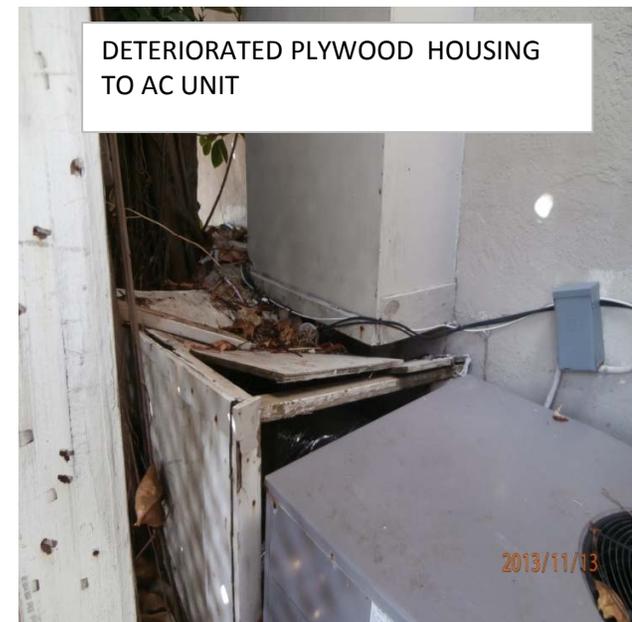
- **Deterioration**
- **Detached, dislodged, or failing connections**
