**PUBLIC NUISANCE HEARING  
1620 GULF OF MEXICO DRIVE**

**VILLA 1 BUILDING**

**TOWN COMMISSION SPECIAL MEETING  
MAY 28, 2014  
(CONTINUANCE)**

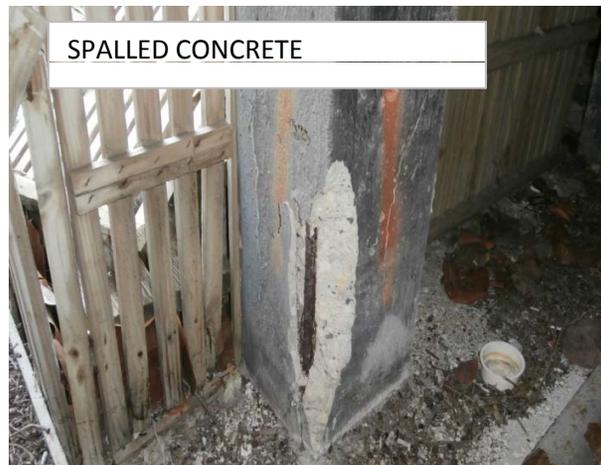
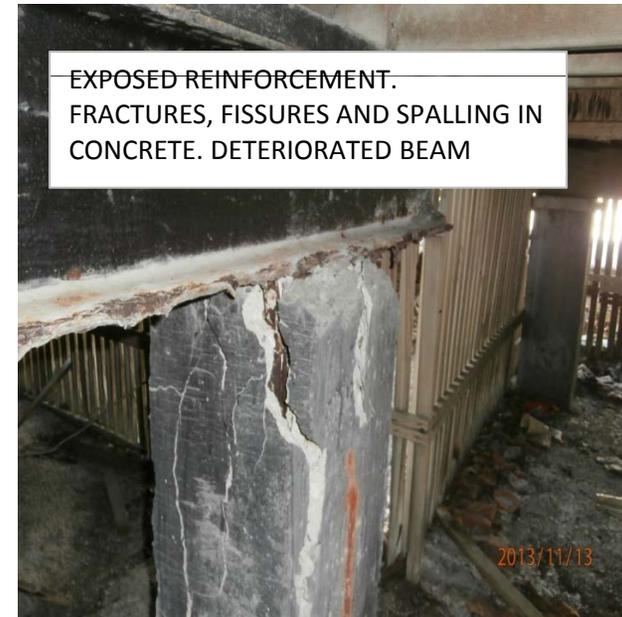
# VILLA 1 BUILDING – CONCRETE

- **Fractures**
- **Fissures**
- **Spalling**
- **Exposed Reinforcement**
- **Detached, Dislodged or Failing Connections**

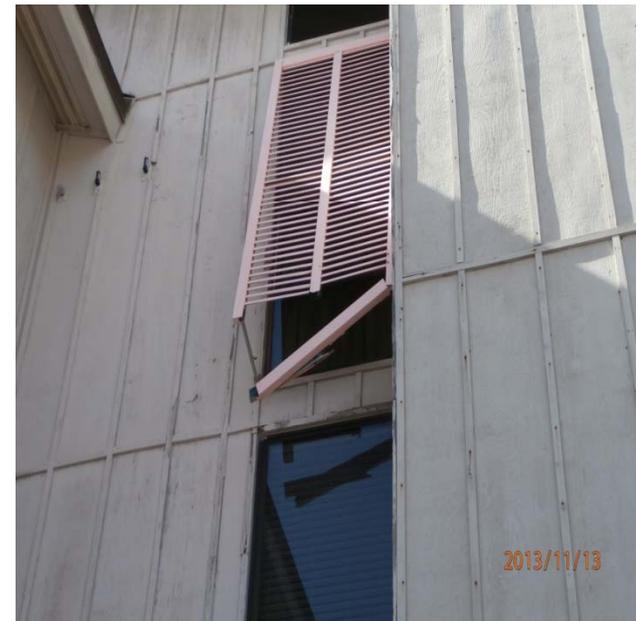
# VILLA 1 BUILDING – ALUMINUM

- **Detached, Dislodged or Failing Connections**

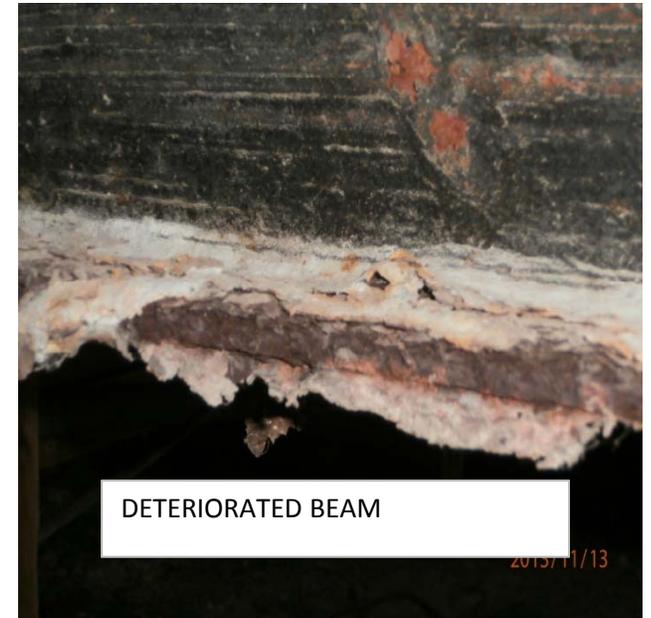
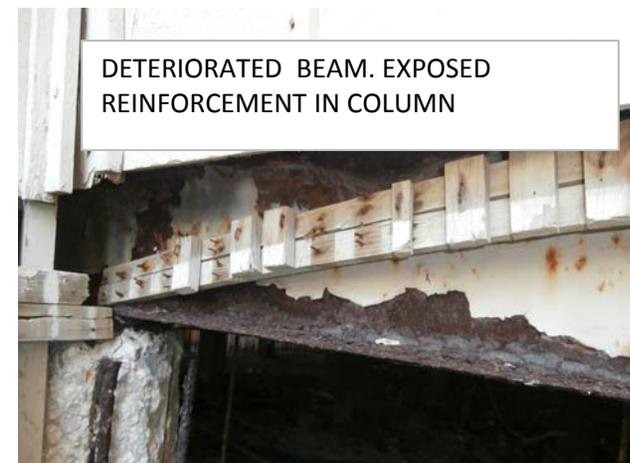
# VILLA 1 BUILDING STEEL

- Deterioration
- Metal fatigue
- Detached, dislodged, or failing connections

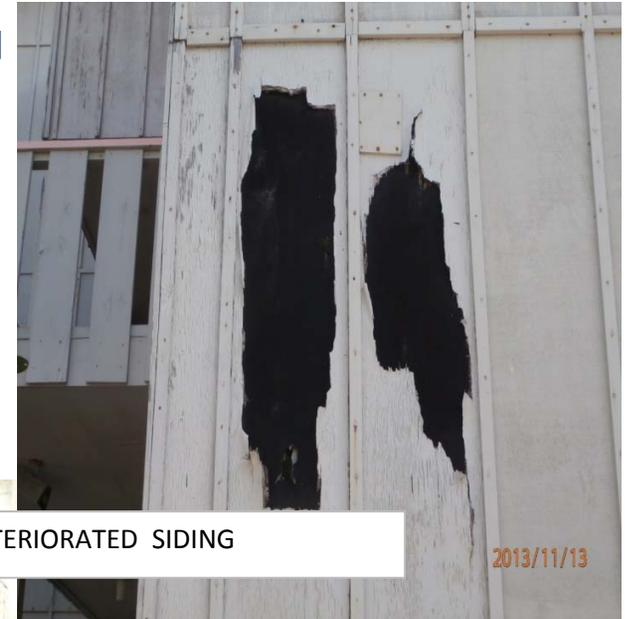
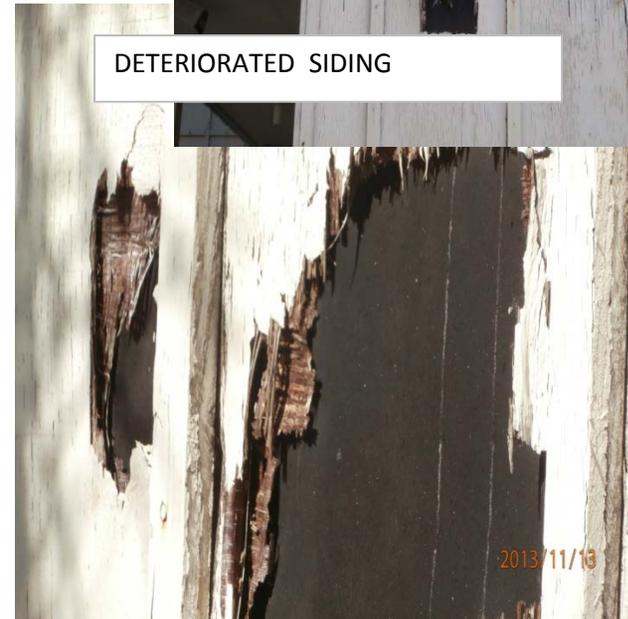
## VILLA 1 BUILDING WOOD

- Ultimate deformation
- Deterioration
- Damage from insects, rodents and other vermin
- Significant splits and checks
- Detached, dislodged, or failing connections
