**PUBLIC NUISANCE HEARING
1620 GULF OF MEXICO DRIVE**

VILLA 2 BUILDING

**TOWN COMMISSION SPECIAL MEETING
MAY 28, 2014
(CONTINUANCE)**

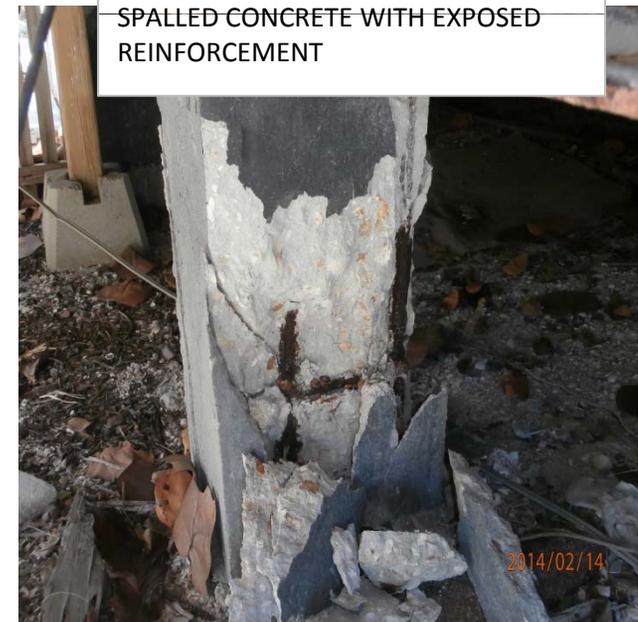
VILLA 2 BUILDING – CONCRETE

- **Fractures**
- **Fissures**
- **Spalling**
- **Exposed Reinforcement**
- **Detached, Dislodged or Failing Connections**

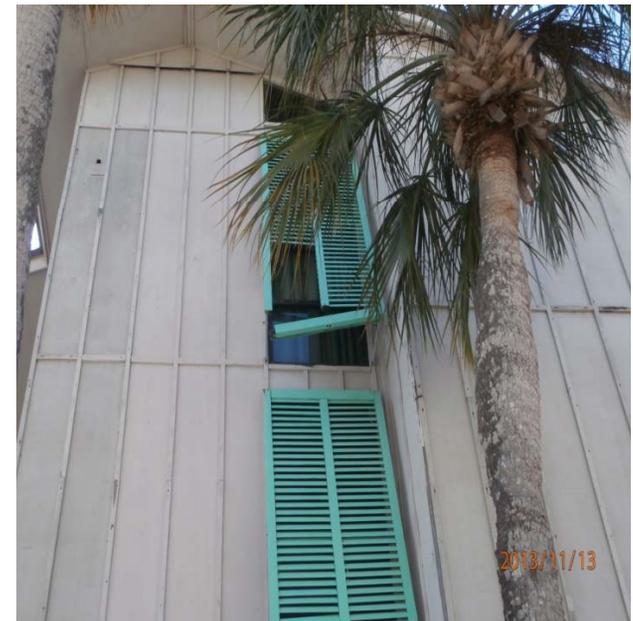
VILLA 2 BUILDING – ALUMINUM

- **Detached, Dislodged or Failing Connections**

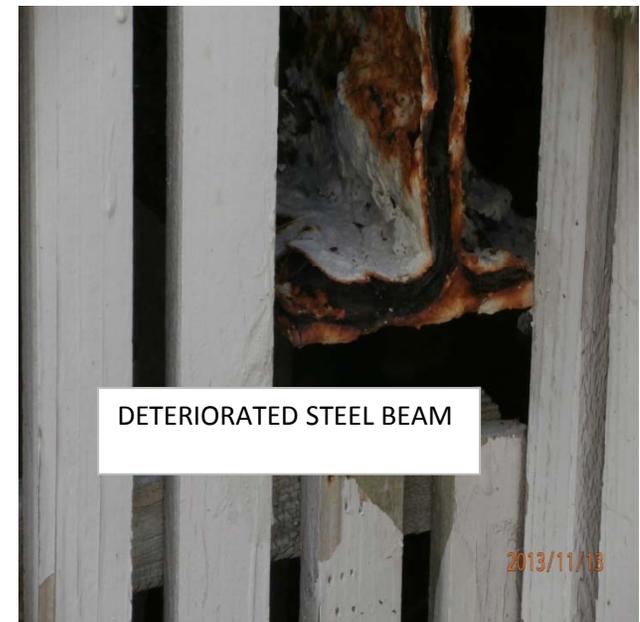
VILLA 2 BUILDING – STEEL

- Deterioration
- Metal fatigue
- Detached, dislodged, or failing connections

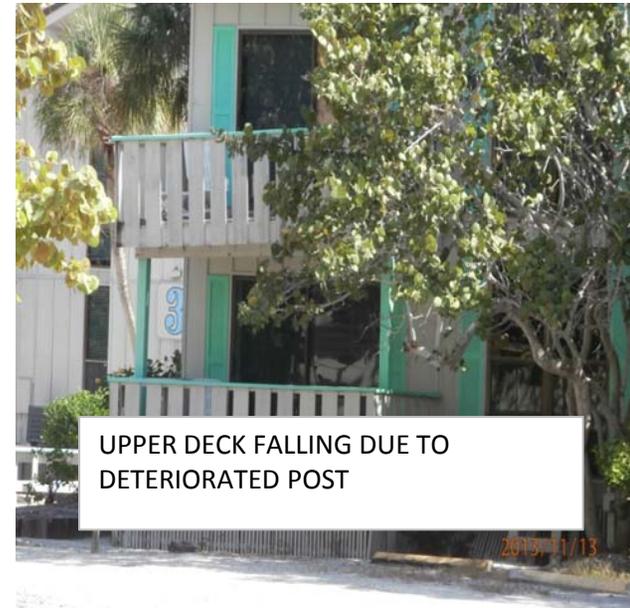
VILLA 2 BUILDING – WOOD

- Ultimate deformation
- Deterioration
- Damage from insects, rodents and other vermin
- Significant splits and checks
- Detached, dislodged, or failing connections
