**PUBLIC NUISANCE HEARING  
1620 GULF OF MEXICO DRIVE**

**VILLA 4 BUILDING**

**TOWN COMMISSION SPECIAL MEETING  
MAY 28, 2014  
(CONTINUANCE)**

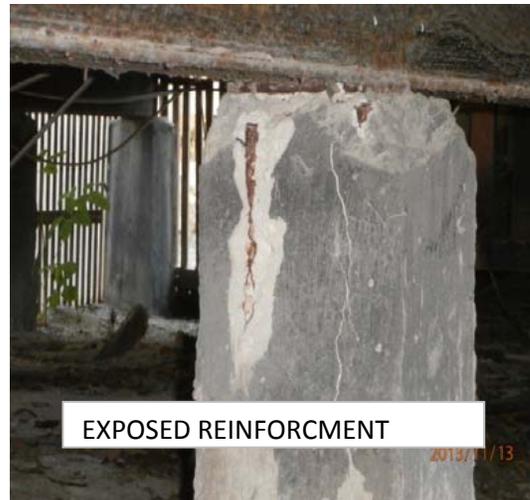
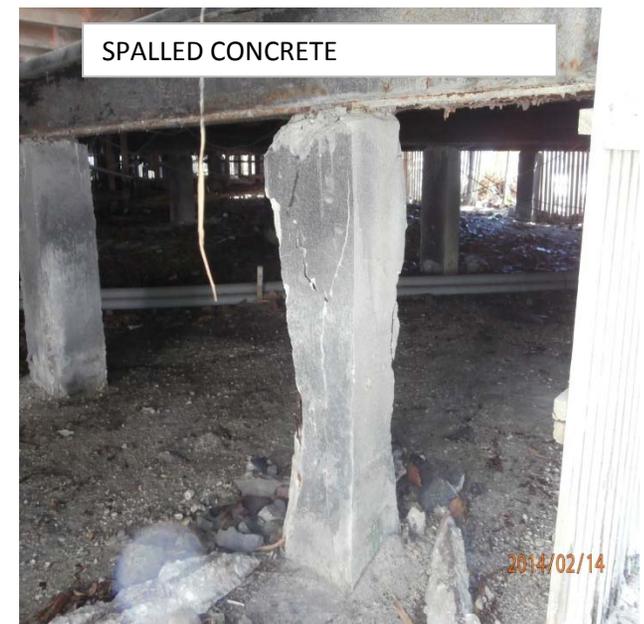
# VILLA 4 BUILDING – CONCRETE

- Fractures
- Fissures
- Spalling
- Exposed Reinforcement
- Detached, Dislodged or Failing Connections

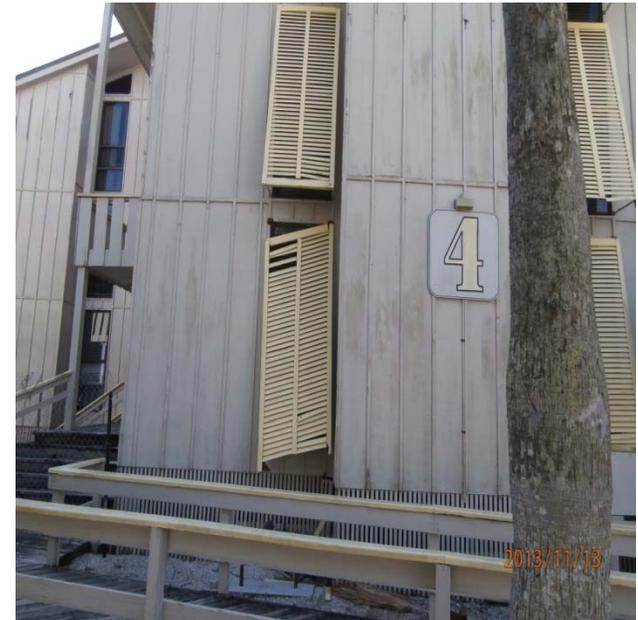
# VILLA 4 BUILDING – ALUMINUM

- **Detached, Dislodged or Failing Connections**

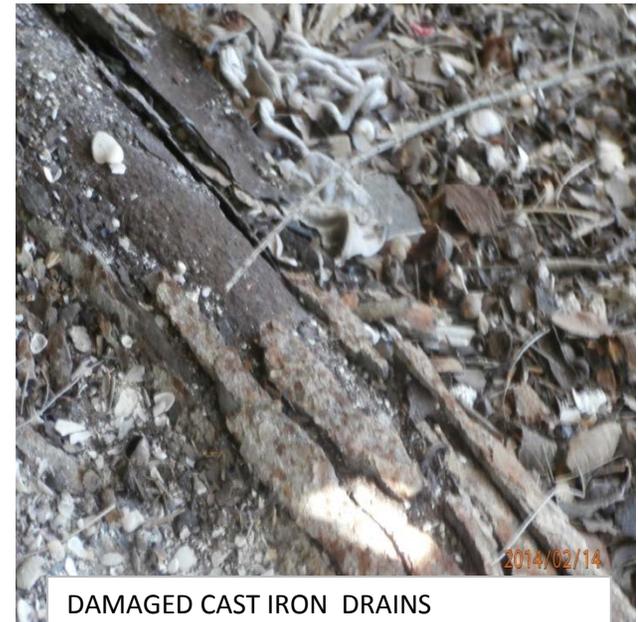
DAMAGED CAST IRON DRAINS

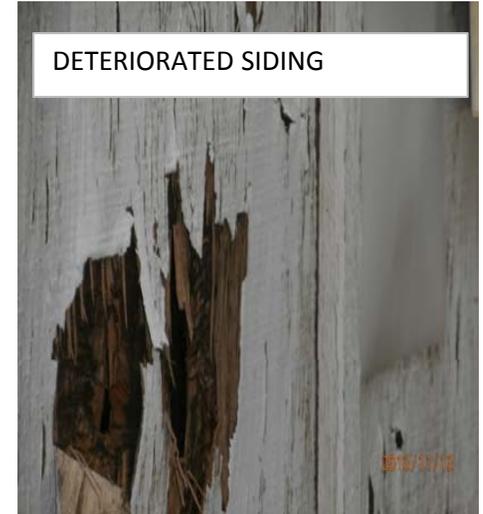
DETERIORATED SIDING

- Seal holes in siding on north and west elevations
- Secure and maintain the structure and property in compliance with Longboat Key Code of Ordinances, State, and Federal Regulations

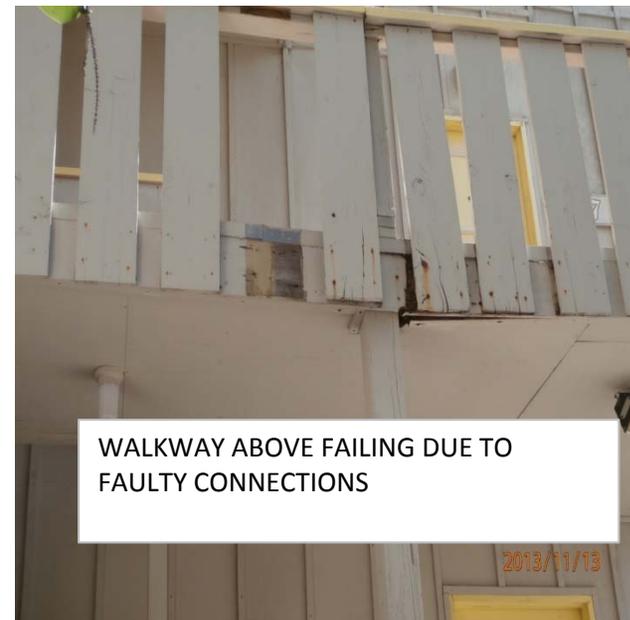
WALKWAY ABOVE FAILING DUE TO  
FAULTY CONNECTIONS

- **Maintain existing building entrance and perimeter security fencing**
- **Disconnect and cap off sewer connection**
- **Provide additional support to upper walkway at post at south entrance**
