**PUBLIC NUISANCE HEARING
1620 GULF OF MEXICO DRIVE**

VILLA 5 BUILDING

**TOWN COMMISSION SPECIAL MEETING
MAY 28, 2014
(CONTINUANCE)**

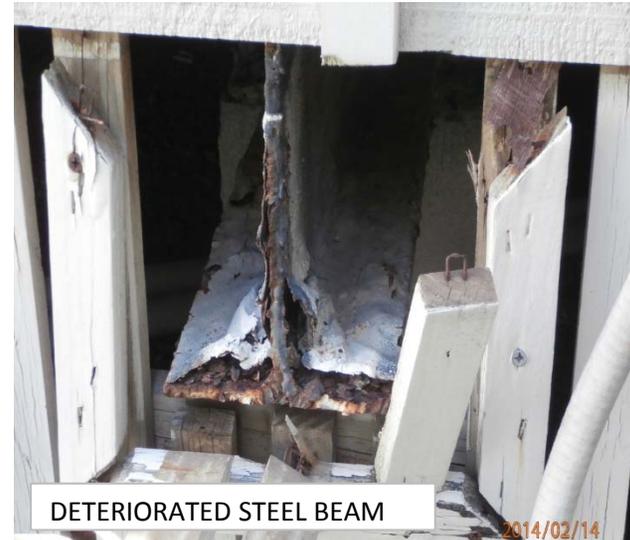
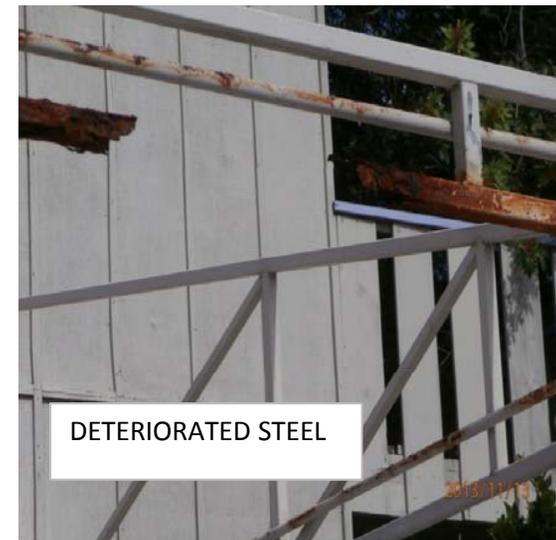
VILLA 5 BUILDING – STEEL

- Deterioration
- Metal fatigue
- Detached, dislodged, or failing connections

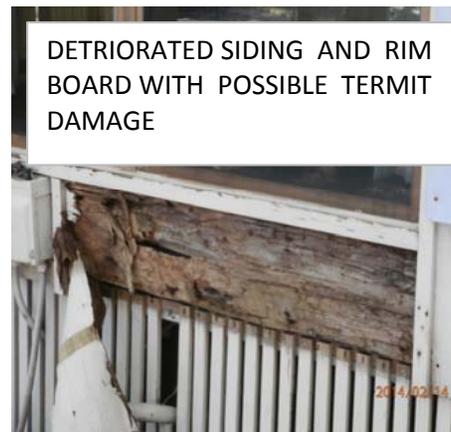
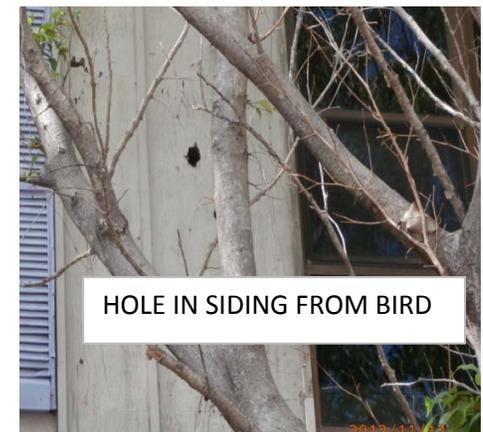
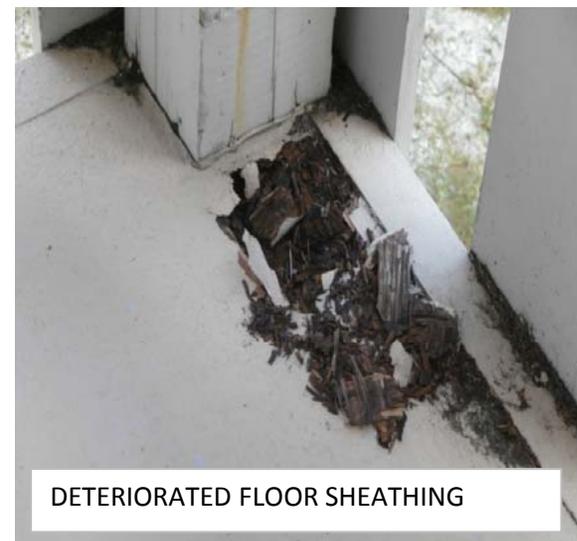
VILLA 5 BUILDING – WOOD

- **Ultimate deformation**
- **Deterioration**
- **Damage from insects, rodents and other vermin**
- **Significant splits and checks**
- **Detached, dislodged, or failing connections**
