**PUBLIC NUISANCE HEARING  
1620 GULF OF MEXICO DRIVE**

**VILLA 6 BUILDING**

**TOWN COMMISSION SPECIAL MEETING  
MAY 28, 2014  
(CONTINUANCE)**

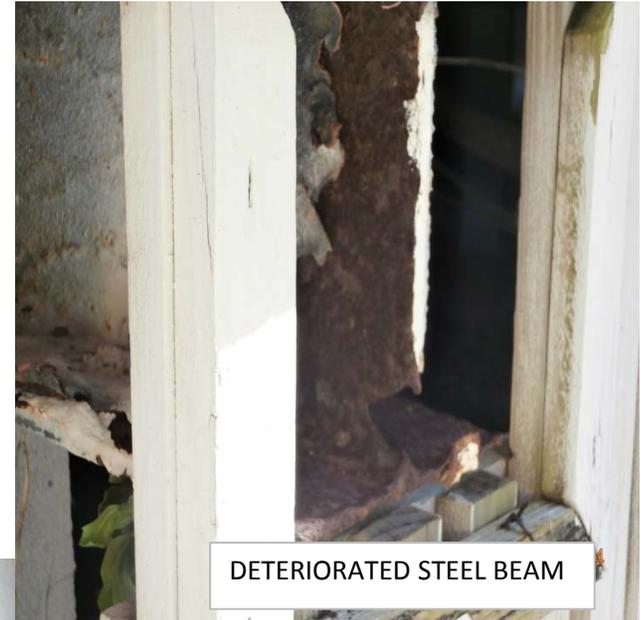
DETERIORATED STEEL BEAM

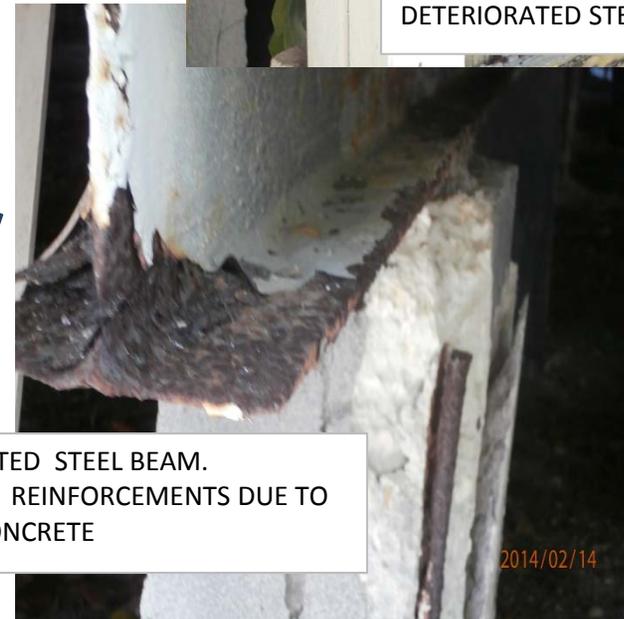
DETERIORATED STEEL BEAM.  
DISLODGED REINFORCEMENTS DUE TO  
SPALLED CONCRETE

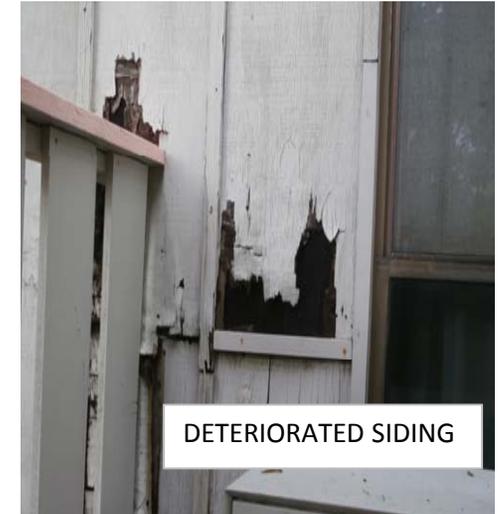
DETERIORATED SIDING

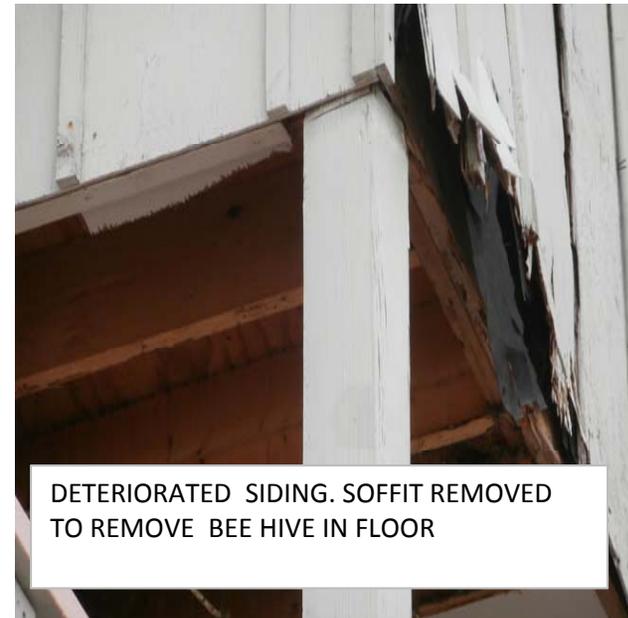
DETERIORATED SIDING. SOFFIT REMOVED  
TO REMOVE BEE HIVE IN FLOOR

- **Seal/cover holes made from bee hive remediation on east elevation**
- **Evacuate refrigerant from two AC unit on east side of building**
- **Remove patio furniture from all decks**
