**PUBLIC NUISANCE HEARING  
1620 GULF OF MEXICO DRIVE**

**VILLA 8 BUILDING**

**TOWN COMMISSION SPECIAL MEETING  
MAY 28, 2014  
(CONTINUANCE)**

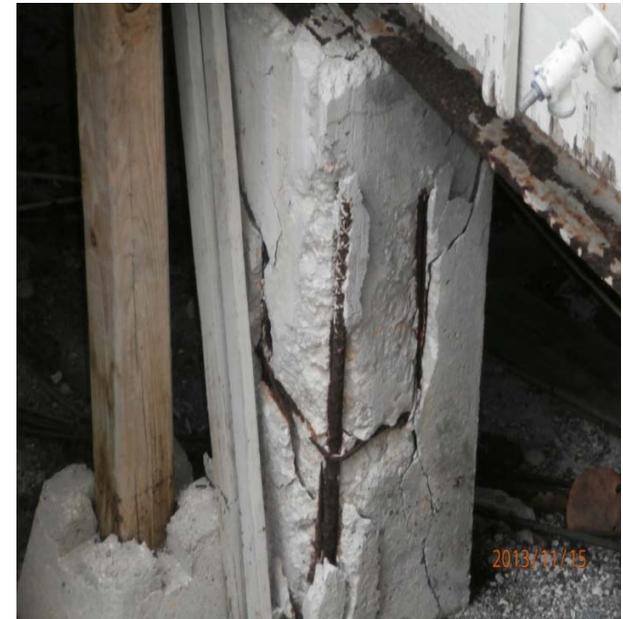
SPALLED CONCRETE WITH EXPOSED REINFORCEMENT .

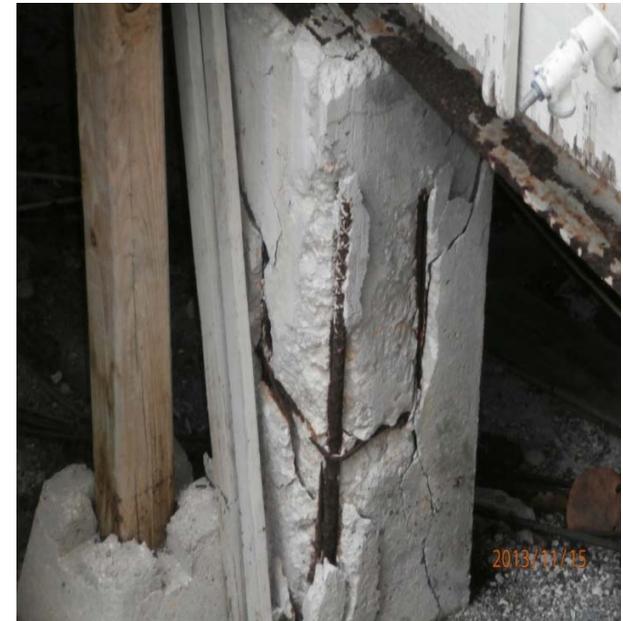
Deteriorated Steel beam

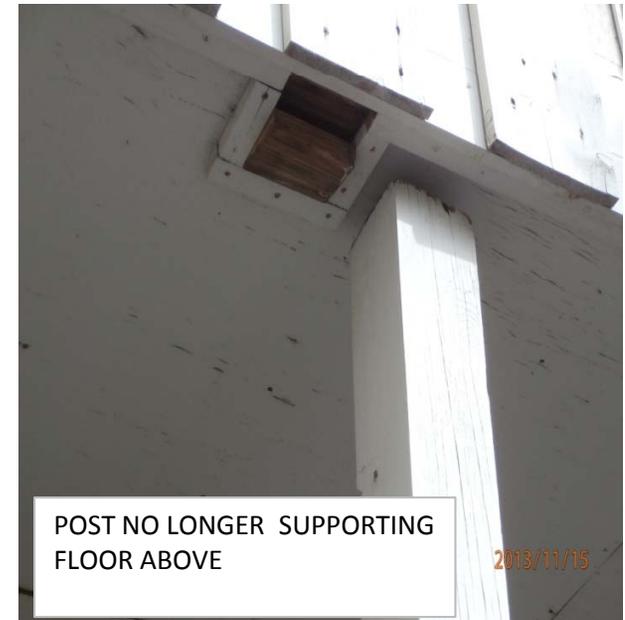
- Ultimate deformation
- Deterioration
- Damage from insects, rodents and other vermin
- Significant splits and checks
- Detached, dislodged, or failing connections
