**PUBLIC NUISANCE HEARING
1620 GULF OF MEXICO DRIVE**

VILLA 9 BUILDING

**TOWN COMMISSION SPECIAL MEETING
MAY 28, 2014
(CONTINUANCE)**

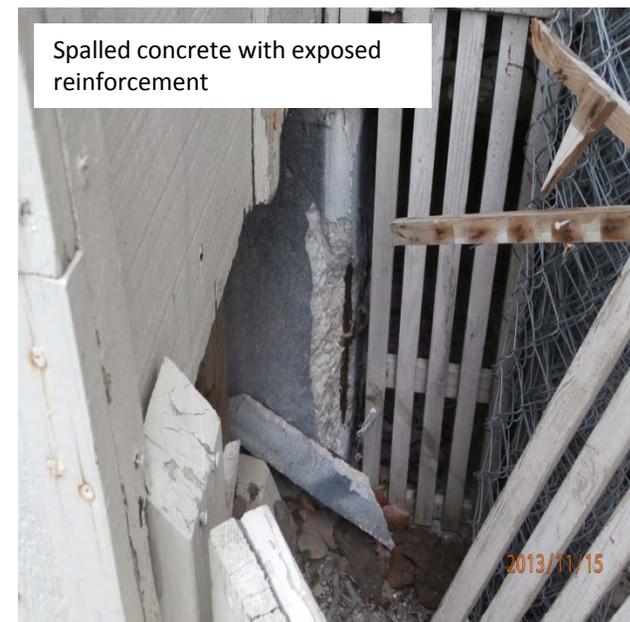
VILLA 9 BUILDING – CONCRETE

- Fractures
- Fissures
- Spalling
- Exposed Reinforcement
- Detached, Dislodged or Failing Connections

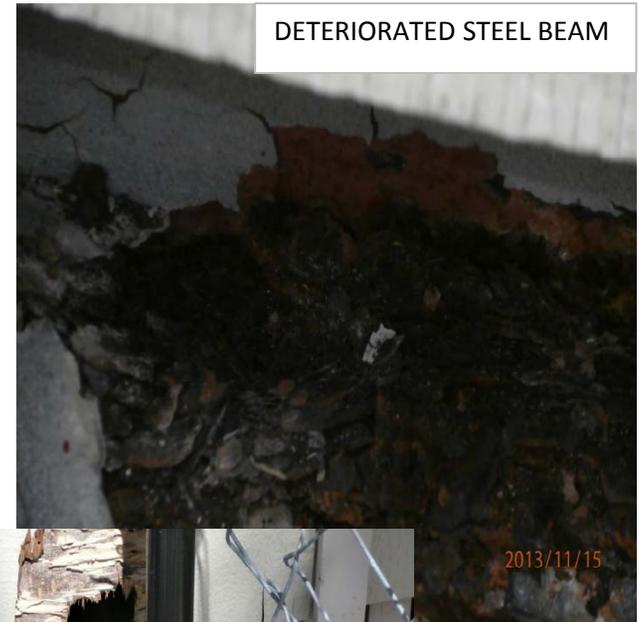
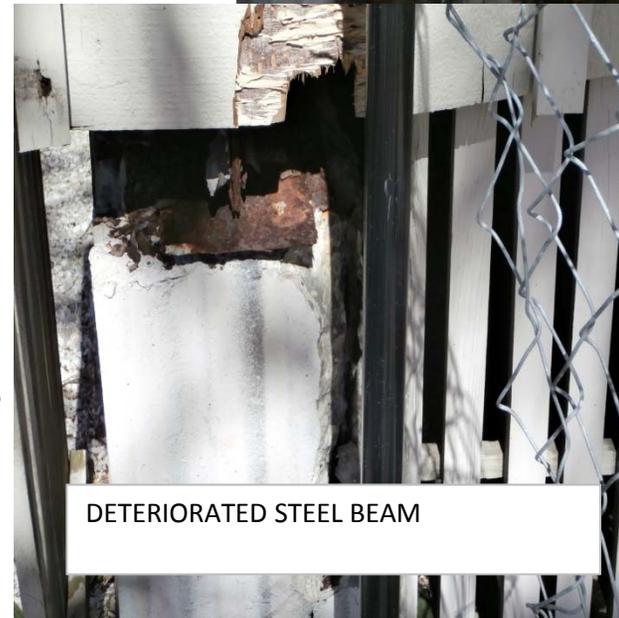
VILLA 9 BUILDING – STEEL

- Deterioration
- Metal fatigue
- Detached, dislodged,
or failing connections

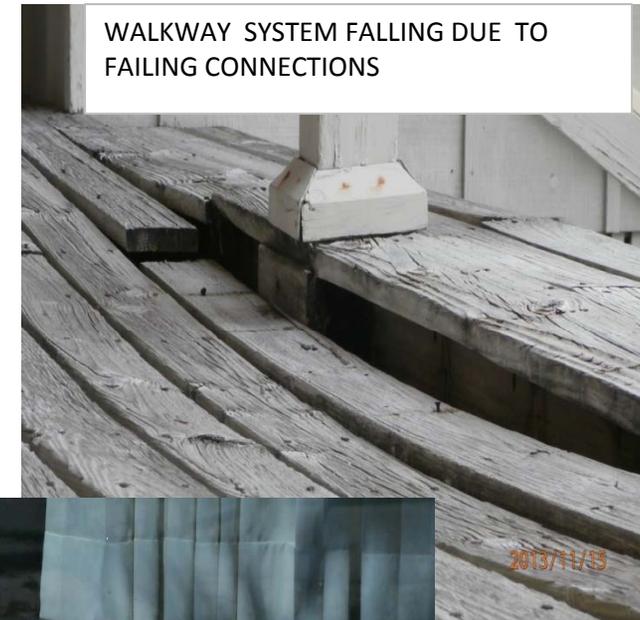
VILLA 9 BUILDING – WOOD

- Ultimate deformation
- Deterioration
- Damage from insects, rodents and other vermin
- Significant splits and checks
- Detached, dislodged, or failing connections

WALKWAY SYSTEM FALLING DUE TO FAILING CONNECTIONS

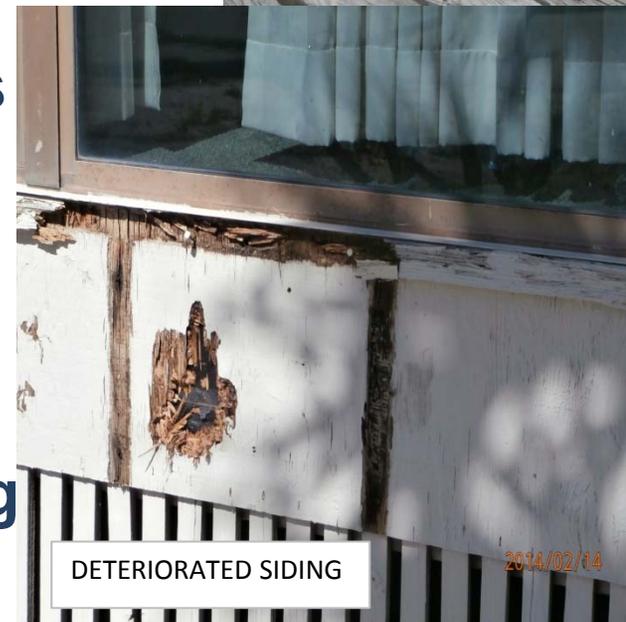
DETERIORATED SIDING
