**PUBLIC NUISANCE HEARING
1620 GULF OF MEXICO DRIVE**

VILLA 11 BUILDING

**TOWN COMMISSION SPECIAL MEETING
MAY 28, 2014
(CONTINUANCE)**

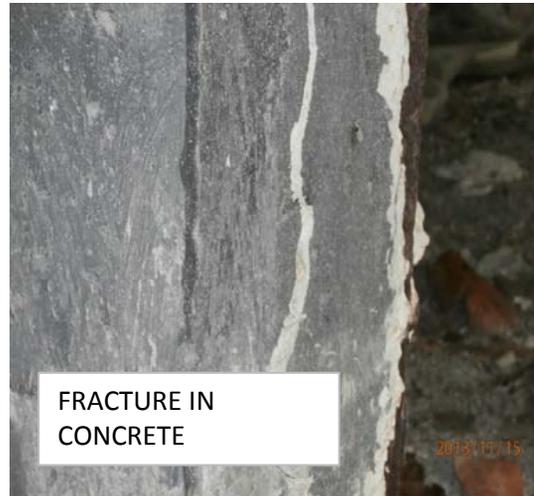
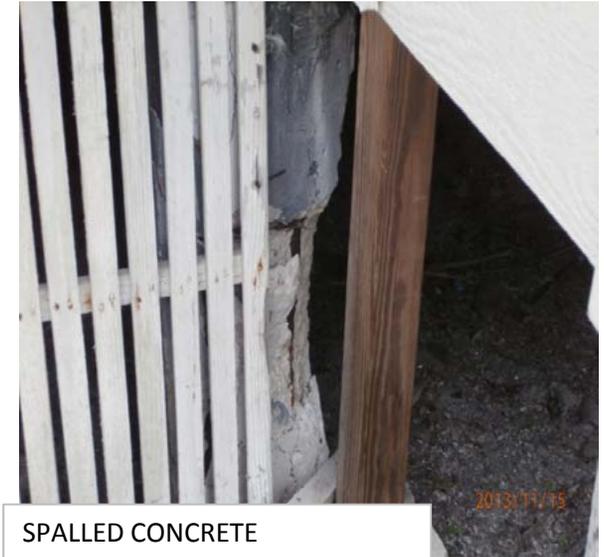
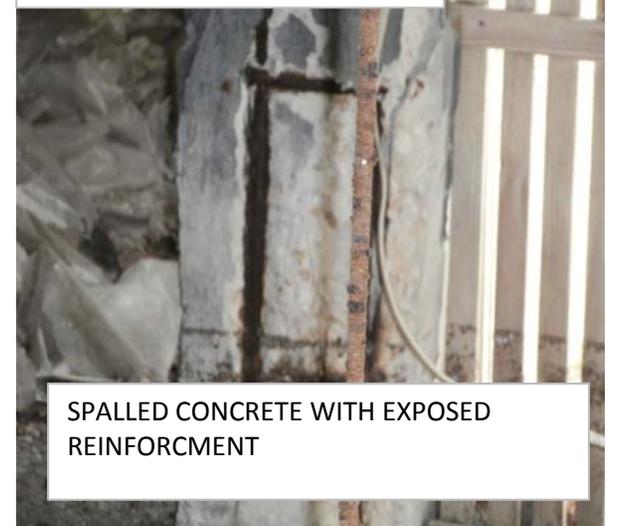
VILLA 11 BUILDING – CONCRETE

- Fractures
- Fissures
- Spalling
- Exposed Reinforcement
- Detached, Dislodged or Failing Connections

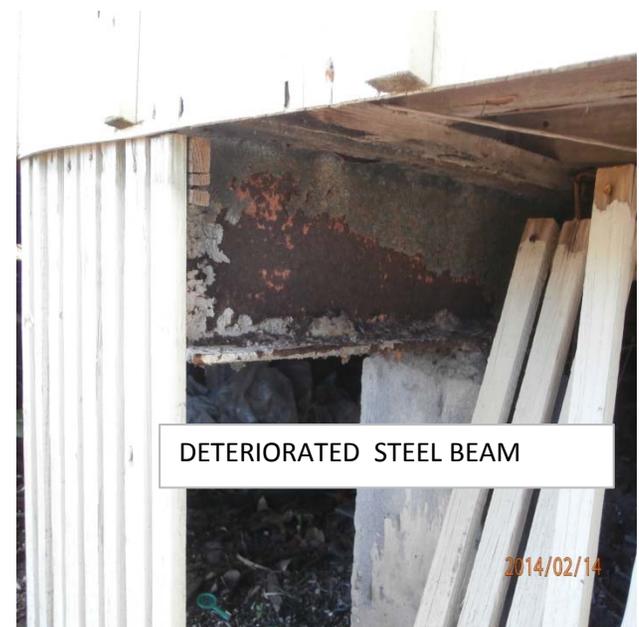
VILLA 11 BUILDING – STEEL

- Deterioration
- Metal fatigue
- Detached, dislodged, or failing connections

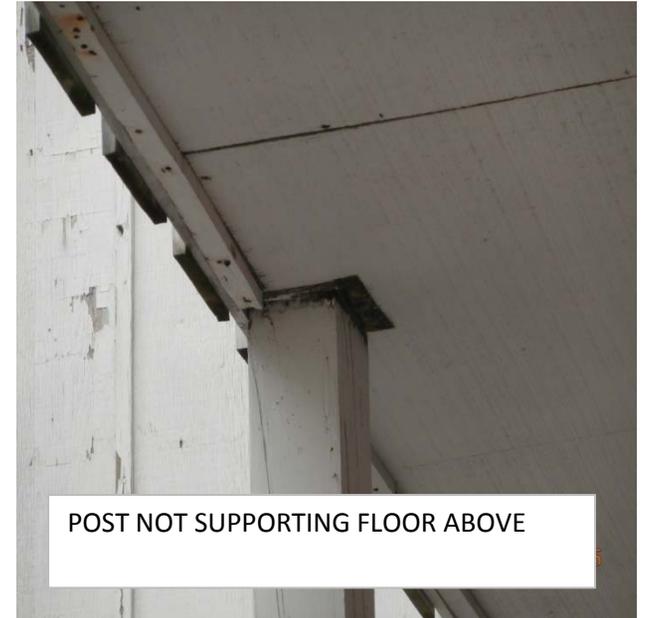
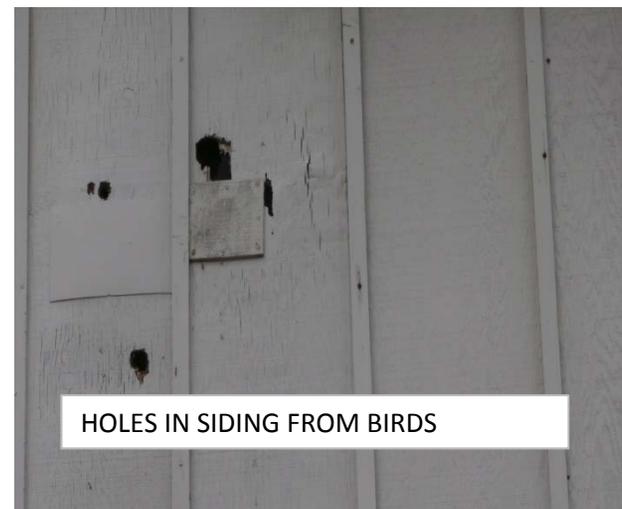
VILLA 11 BUILDING – WOOD

- Ultimate deformation
- Deterioration
- Damage from insects, rodents and other vermin
- Significant splits and checks
- Detached, dislodged, or failing connections
