**PUBLIC NUISANCE HEARING  
1620 GULF OF MEXICO DRIVE**

**VILLA 12 BUILDING**

**TOWN COMMISSION SPECIAL MEETING  
MAY 28, 2014  
(CONTINUANCE)**

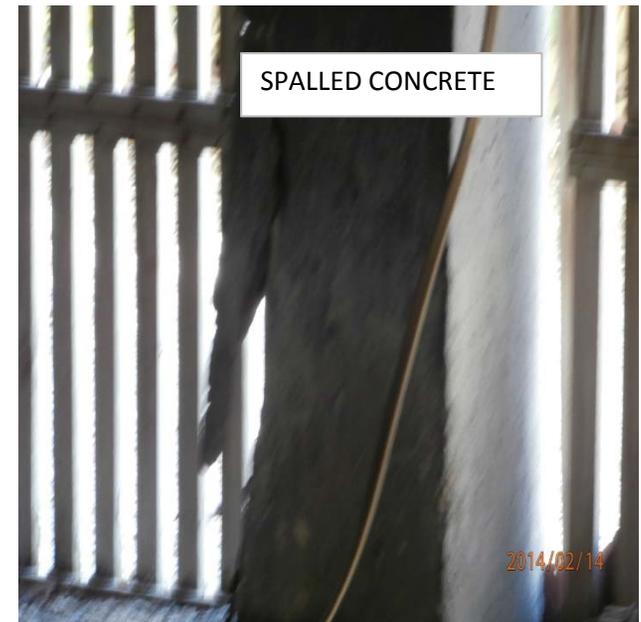
# VILLA 12 BUILDING – CONCRETE

- Fractures
- Fissures
- Spalling
- Exposed Reinforcement
- Detached, Dislodged or Failing Connections

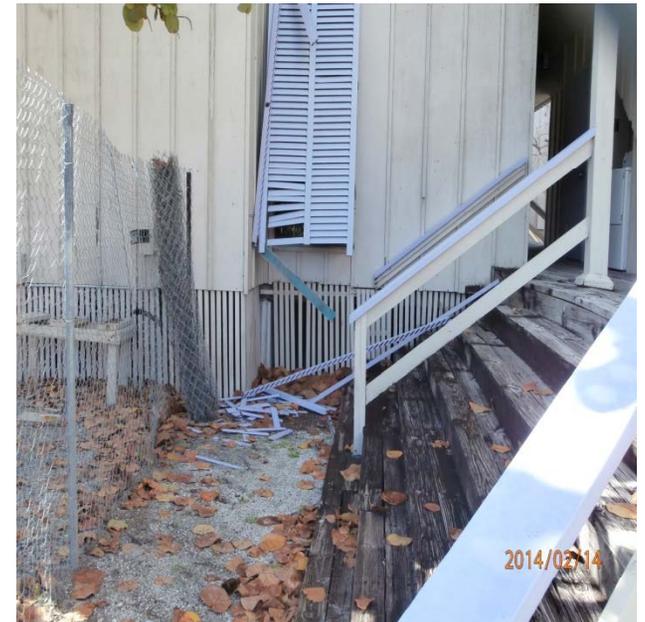
# VILLA 12 BUILDING – ALUMINUM

- **Detached, Dislodged or Failing Connections**

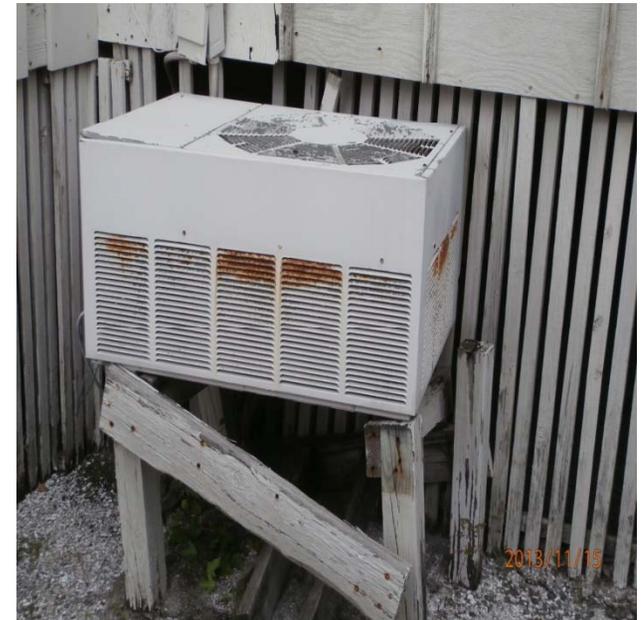
## VILLA 12 BUILDING – STEEL

- Deterioration
- Metal fatigue
- Detached, dislodged, or failing connections

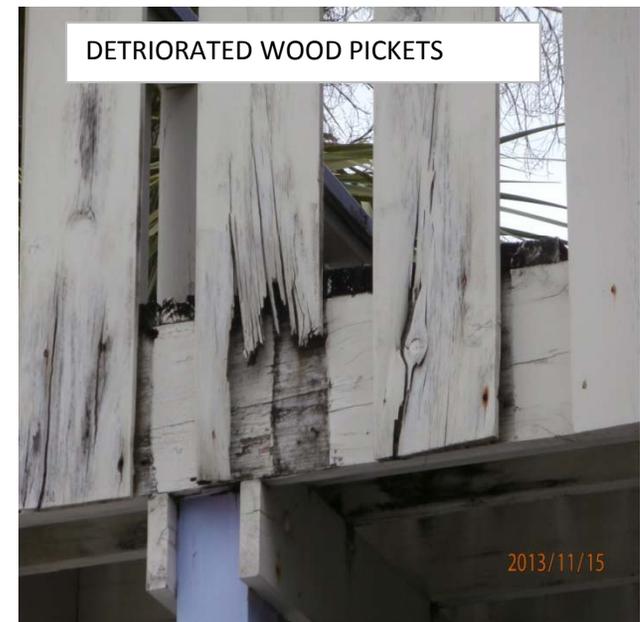
## VILLA 12 BUILDING – WOOD

- Ultimate deformation
- Deterioration
- Damage from insects, rodents and other vermin
- Significant splits and checks
- Detached, dislodged, or failing connections
