**PUBLIC NUISANCE HEARING  
1620 GULF OF MEXICO DRIVE**

**VILLA 13 BUILDING**

**TOWN COMMISSION SPECIAL MEETING  
MAY 28, 2014  
(CONTINUANCE)**

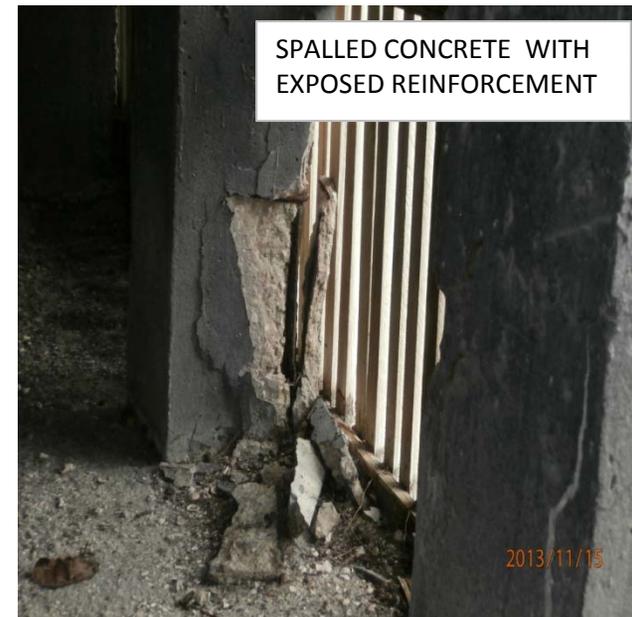
# VILLA 13 BUILDING – CONCRETE

- Fractures
- Fissures
- Spalling
- Exposed Reinforcement
- Detached, Dislodged or Failing Connections

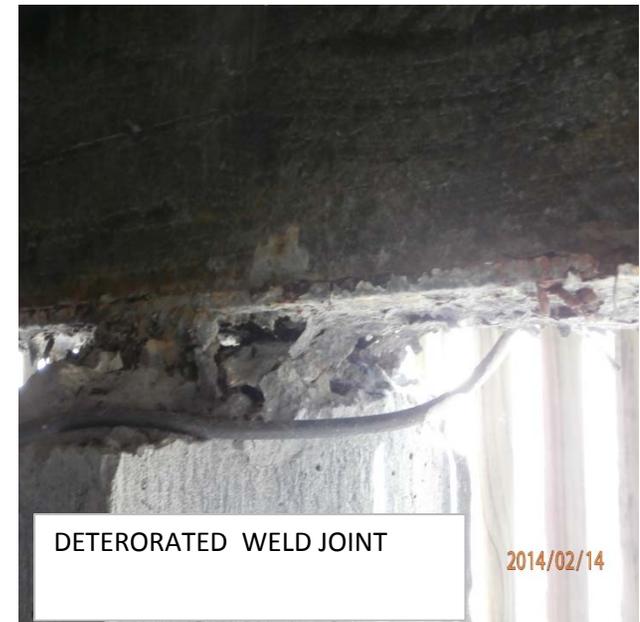
# VILLA 13 BUILDING – STEEL

- Deterioration
- Metal fatigue
- Detached, dislodged, or failing connections

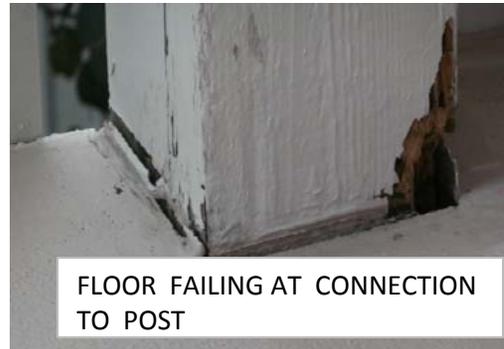
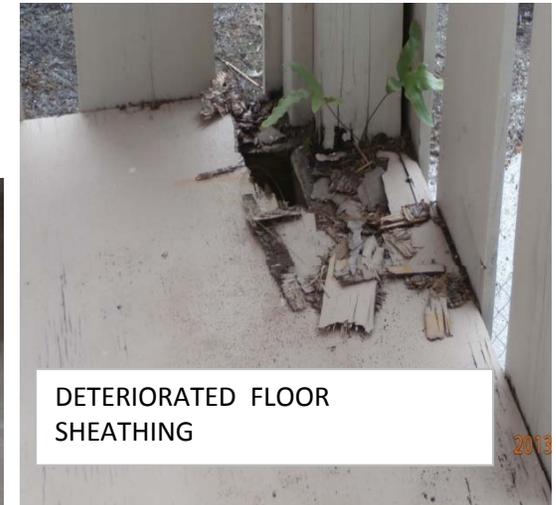
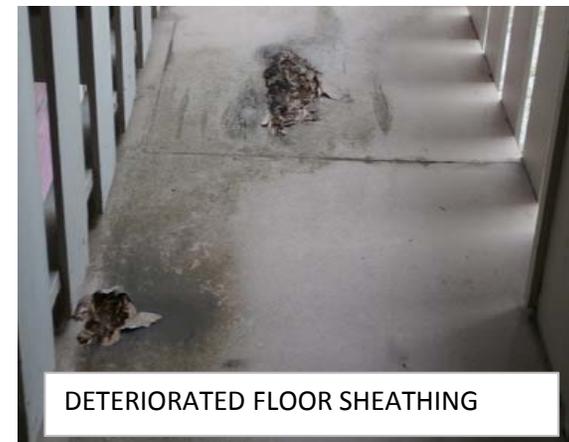
# VILLA 13 BUILDING – WOOD

- Ultimate deformation
- Deterioration
- Damage from insects, rodents and other vermin
- Significant splits and checks
- Detached, dislodged, or failing connections
