**PUBLIC NUISANCE HEARING
1620 GULF OF MEXICO DRIVE**

VILLA 14 BUILDING

**TOWN COMMISSION SPECIAL MEETING
MAY 28, 2014
(CONTINUANCE)**

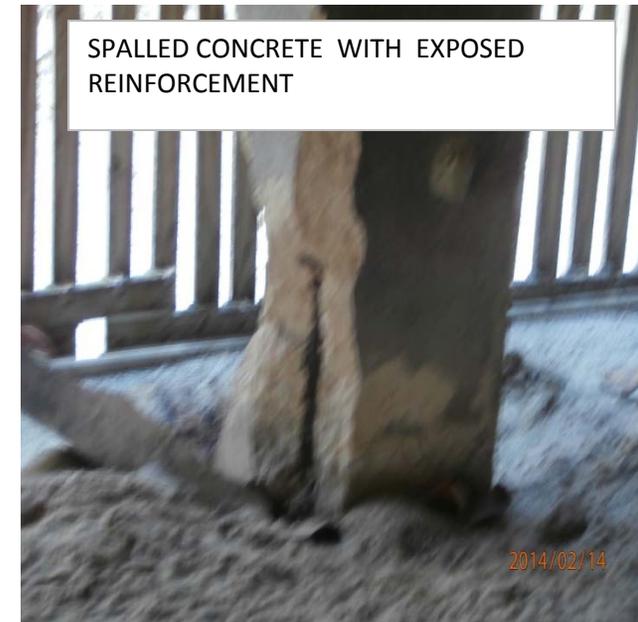
VILLA 14 BUILDING – CONCRETE

- **Fractures**
- **Fissures**
- **Spalling**
- **Exposed Reinforcement**
- **Detached, Dislodged or Failing Connections**

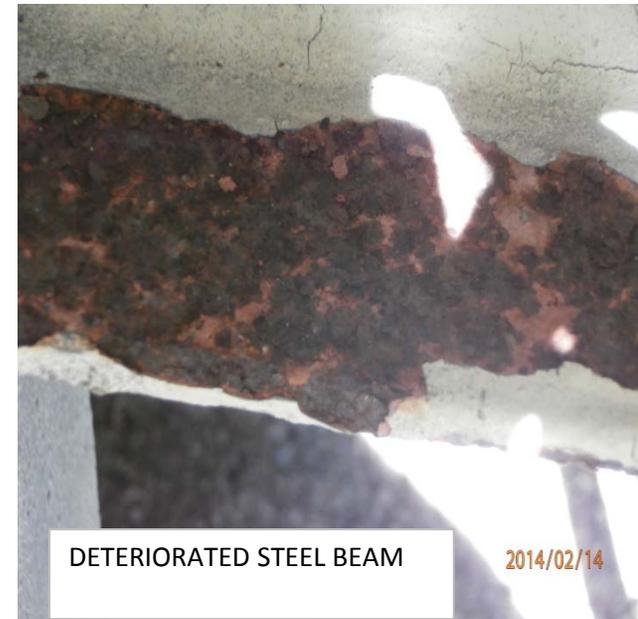
VILLA 14 BUILDING – STEEL

- Deterioration
- Metal fatigue
- Detached, dislodged, or failing connections

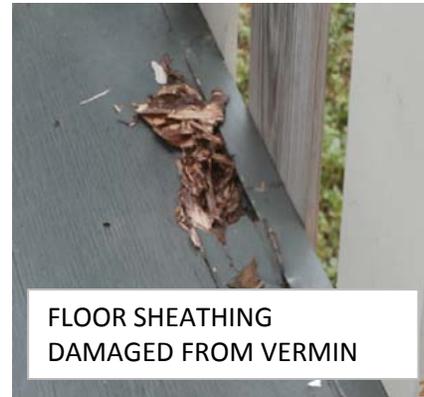
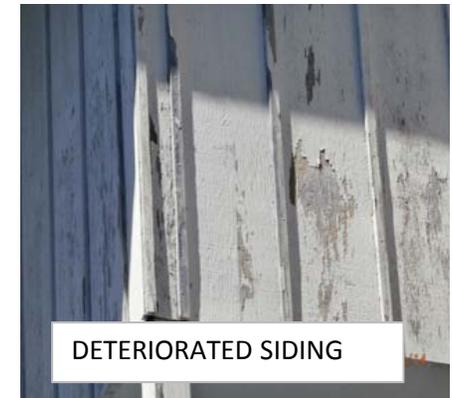
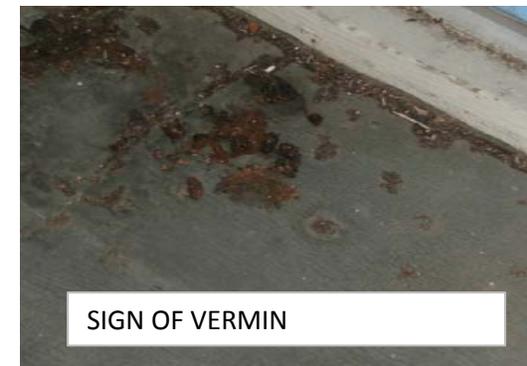
VILLA 14 BUILDING – WOOD

- Ultimate deformation
- Deterioration
- Damage from insects, rodents and other vermin
- Significant splits and checks
- Detached, dislodged, or failing connections
