**PUBLIC NUISANCE HEARING
1620 GULF OF MEXICO DRIVE**

VILLA 17 BUILDING

**TOWN COMMISSION SPECIAL MEETING
MAY 28, 2014
(CONTINUANCE)**

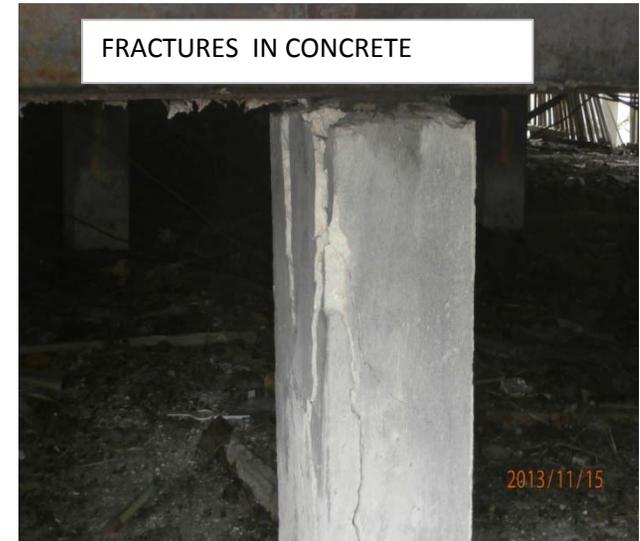
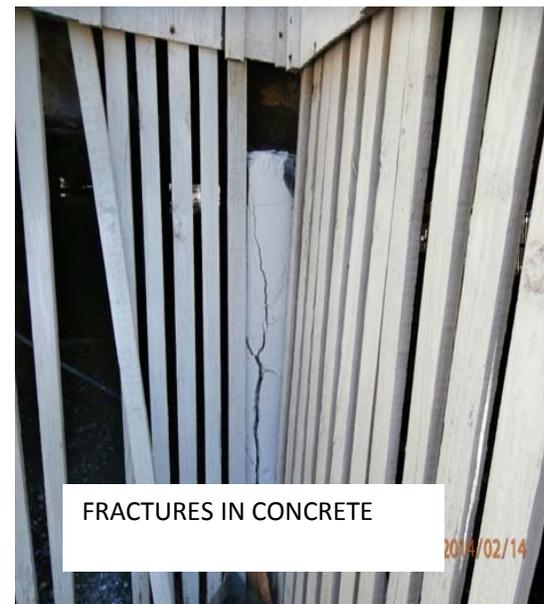
VILLA 17 BUILDING – CONCRETE

- Fractures
- Fissures
- Spalling
- Exposed Reinforcement
- Detached, Dislodged or Failing Connections

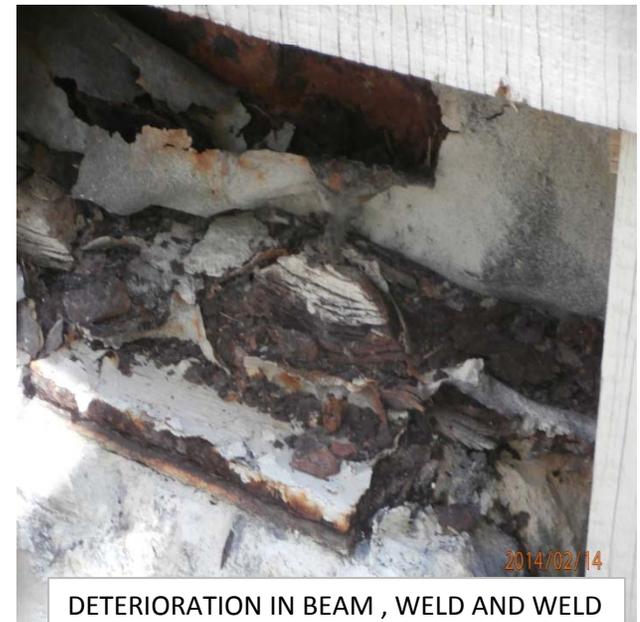
VILLA 17 BUILDING – STEEL

- Deterioration
- Metal fatigue
- Detached, dislodged, or failing connections

DETERIORATION IN BEAM , WELD AND WELD PLATE

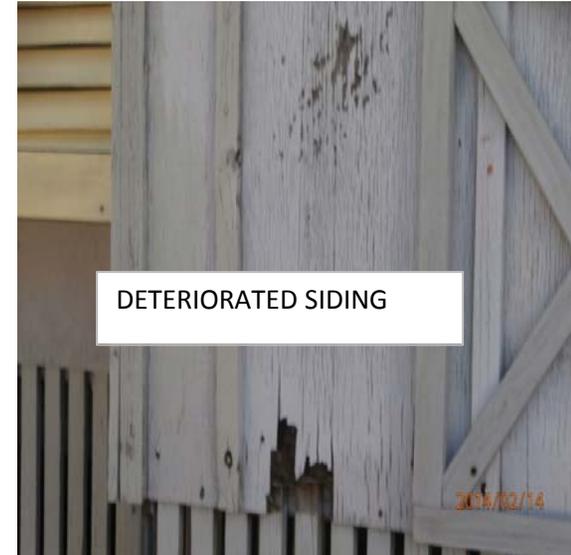
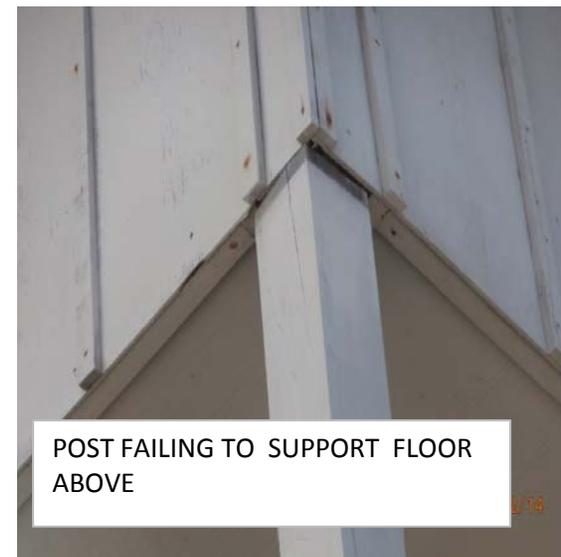
VILLA 17 BUILDING – WOOD

- Ultimate deformation
- Deterioration
- Damage from insects, rodents and other vermin
- Significant splits and checks
- Detached, dislodged, or failing connections
