**Building Official Inspection Report
February 26, 2014
1620 Gulf of Mexico Drive
The Colony**

Building Official Report

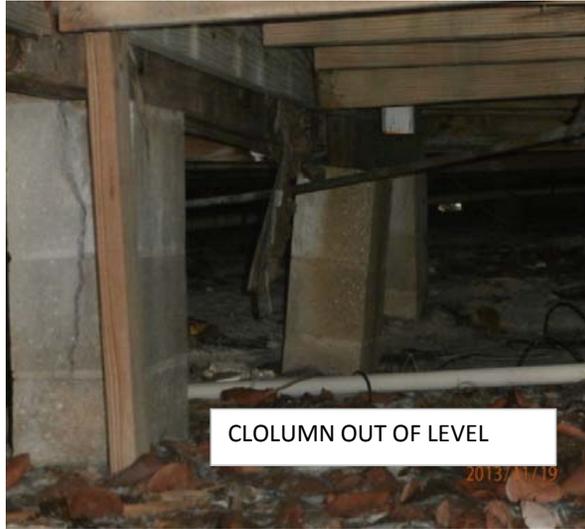
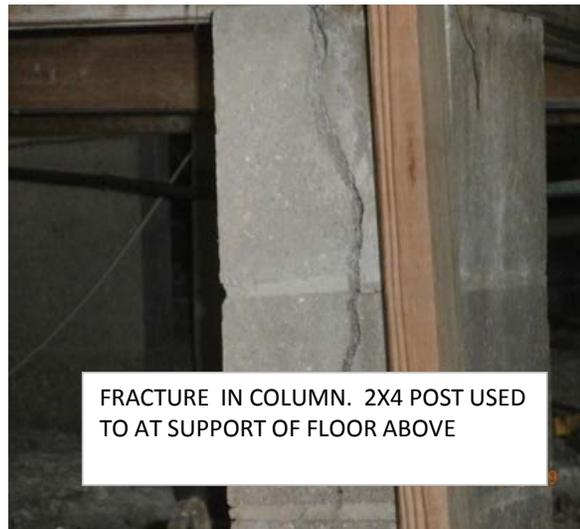
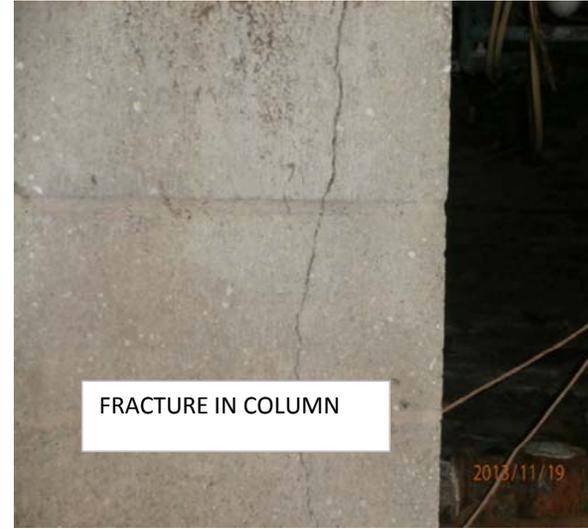
Some of cracking in joints to foundation columns

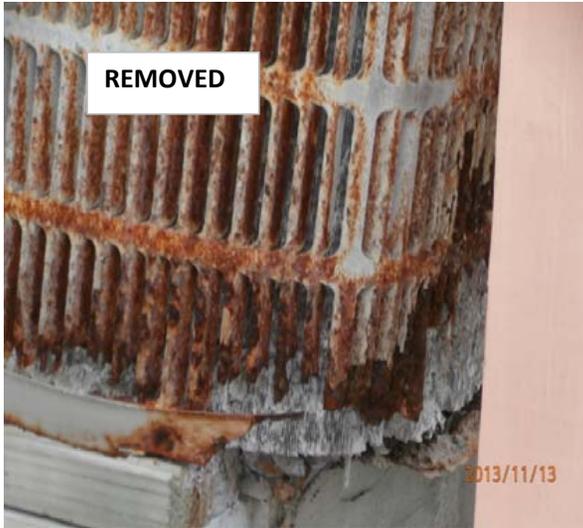
AC units to a point that they no longer function

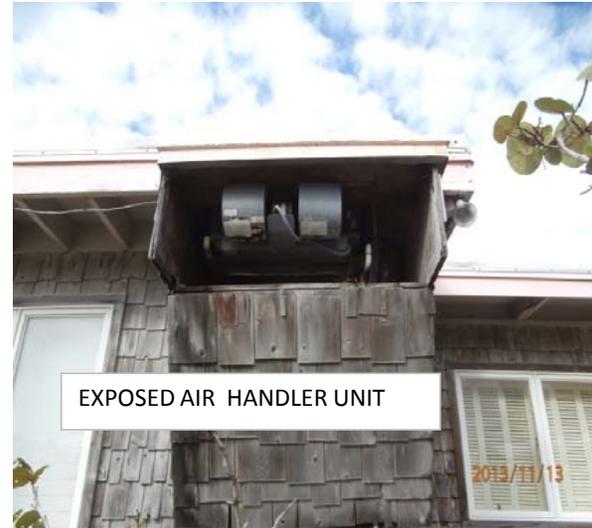
AC units to a point that they no longer function

Awnings have fallen from failed connections

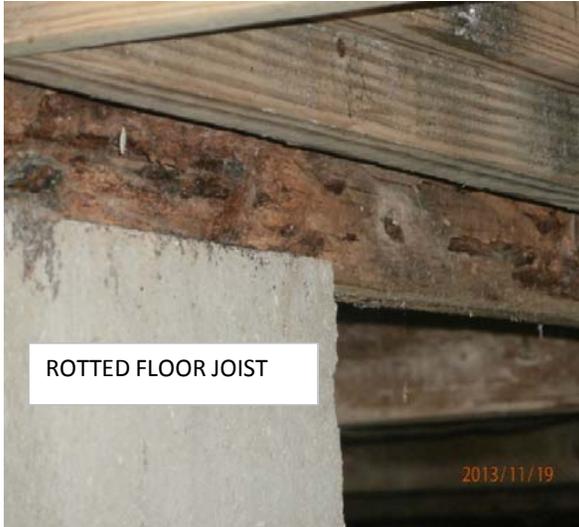
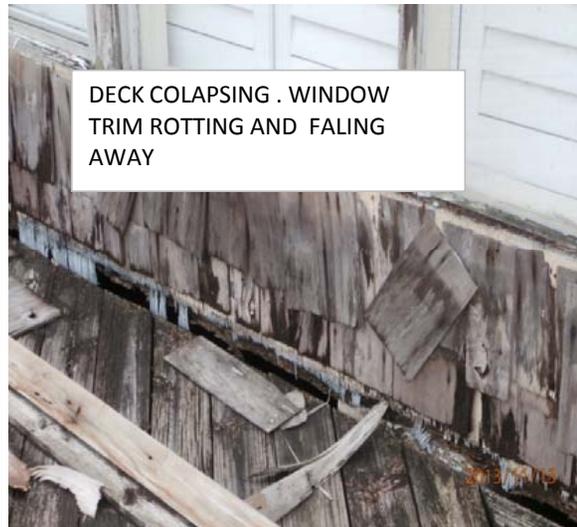
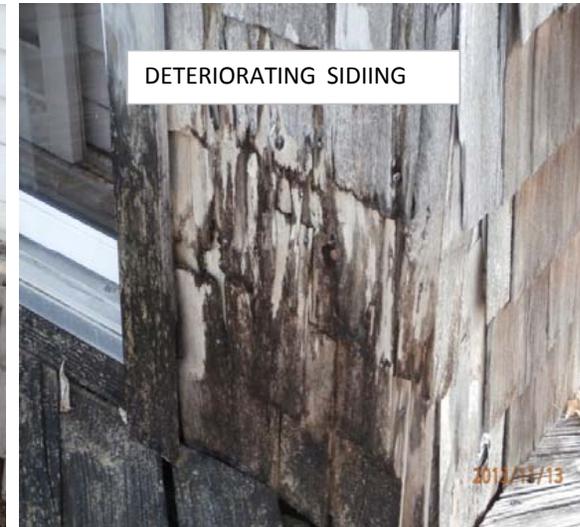
Fascia, soffits, siding, windows, doors, trims, roof sheathing
Signs of Possible damage due to termites

Joists and supports appear to be failing through out deck systems.
Through out deck systems, joists, decking surface, guard and hand railing. Window planter boxes falling from walls, lattice skirting.

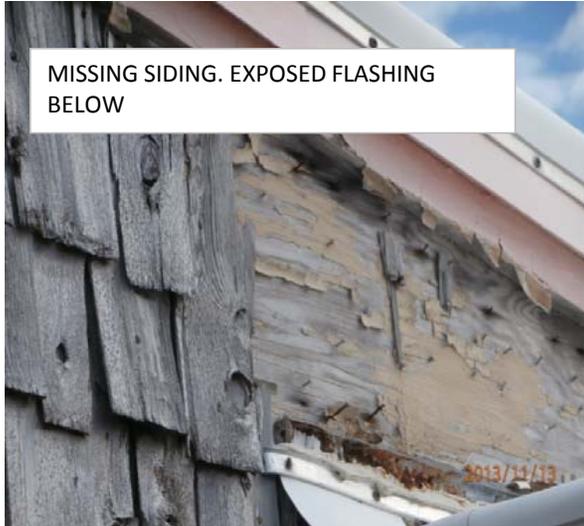
MISSING SIDING. EXPOSED FLASHING BELOW

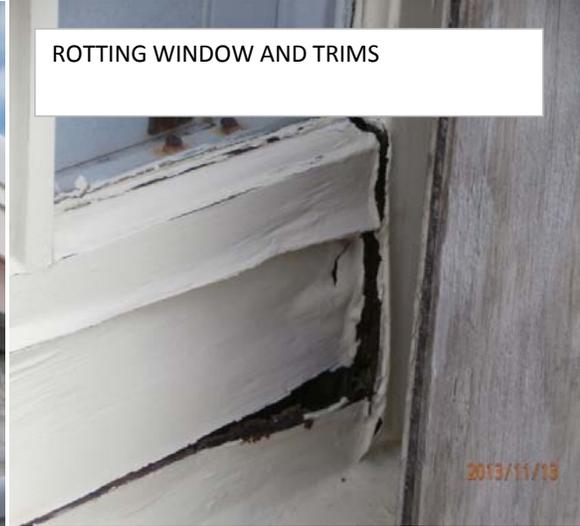
ROTTING WINDOW AND TRIMS

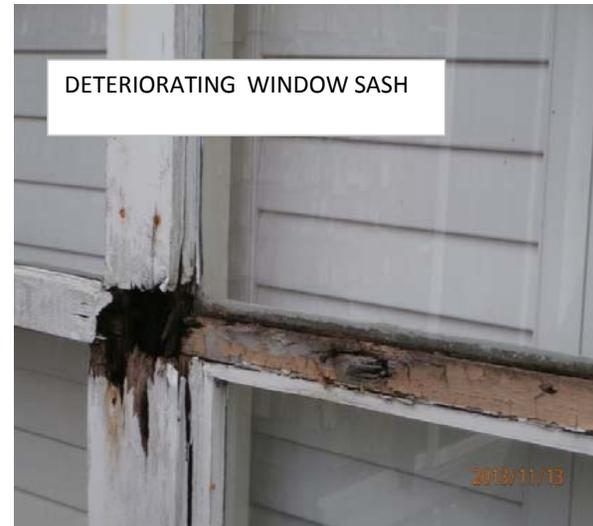
DETERIORATING WINDOW SASH

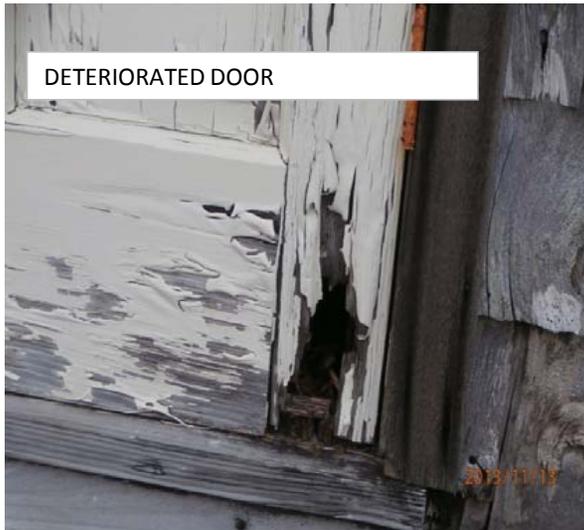
DETERIORATED DOOR

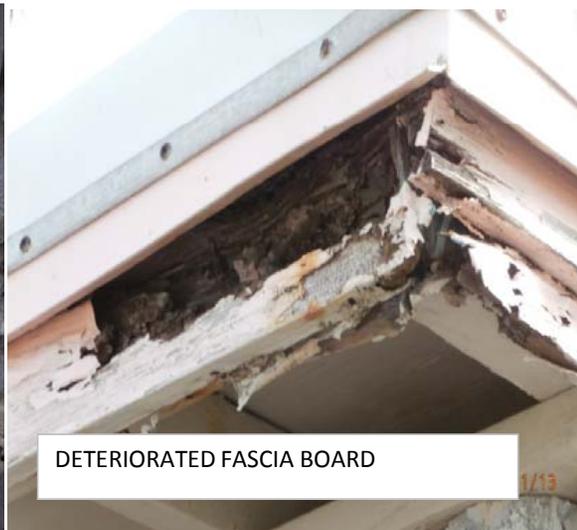
DETERIORATED FASCIA BOARD

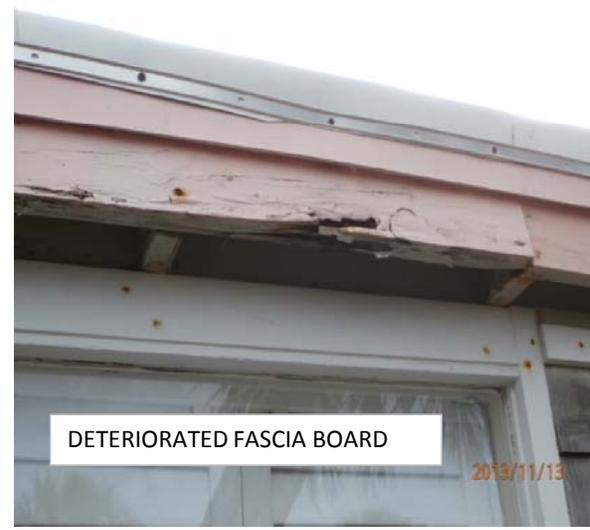
DETERIORATED FASCIA BOARD

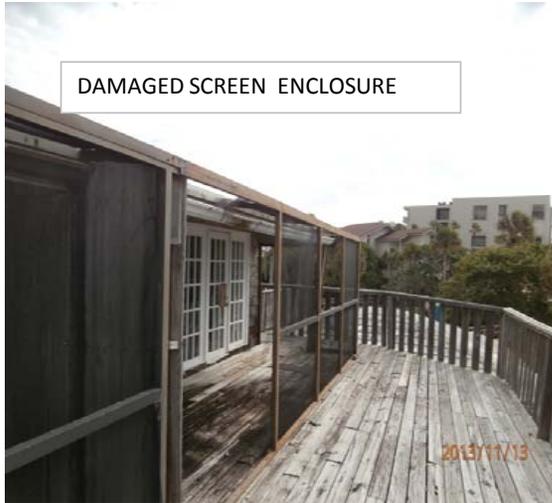
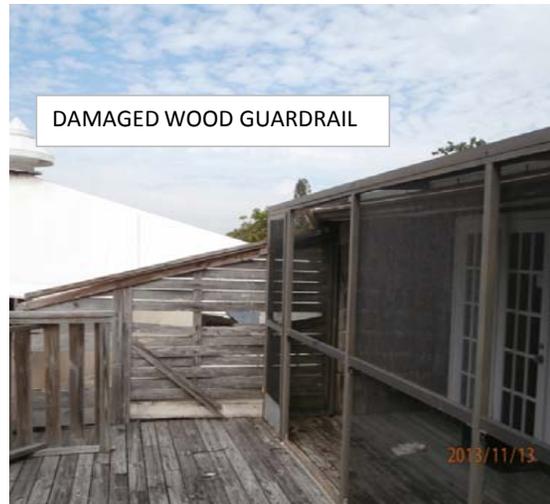
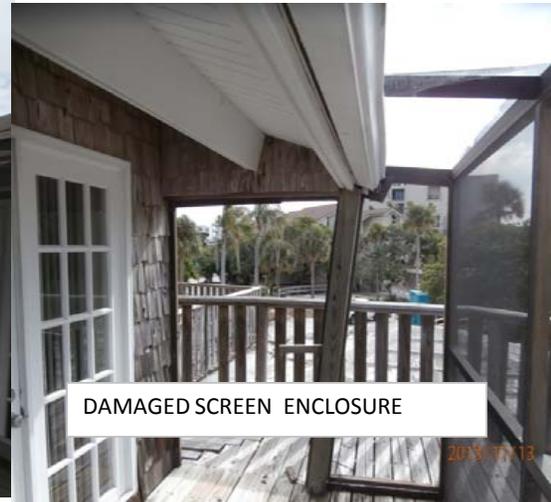
Screen enclosures to presidential suites
Screen enclosures to presidential suites

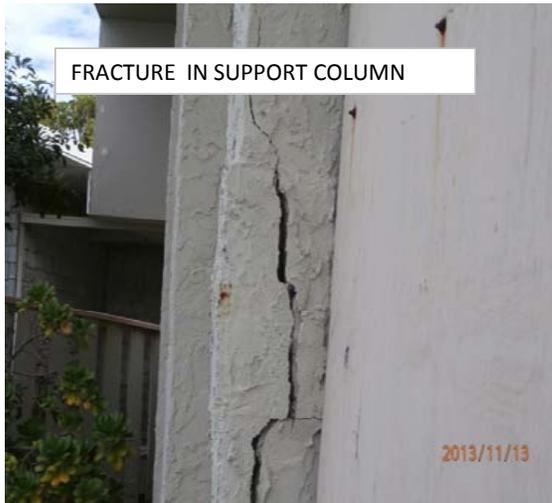
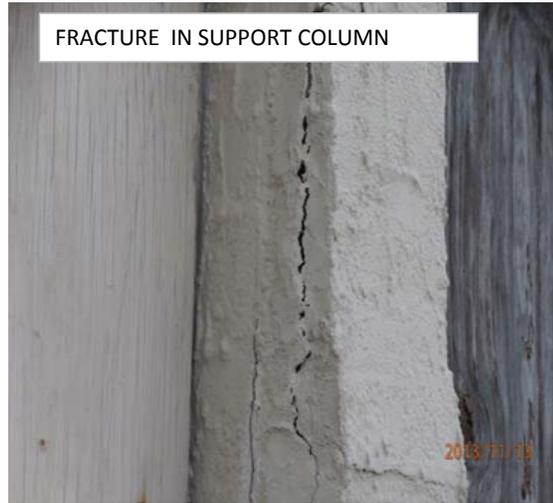
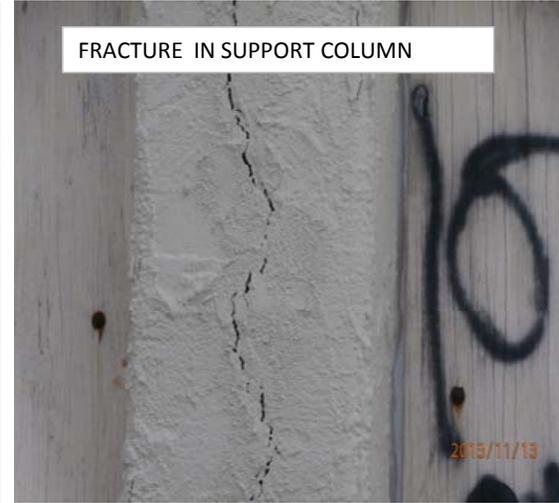
Critical on northwest side. Also found throughout the building
Many locations mainly associated to settlement and some at Northwest especially
At bulged location on northwest side columns of windows

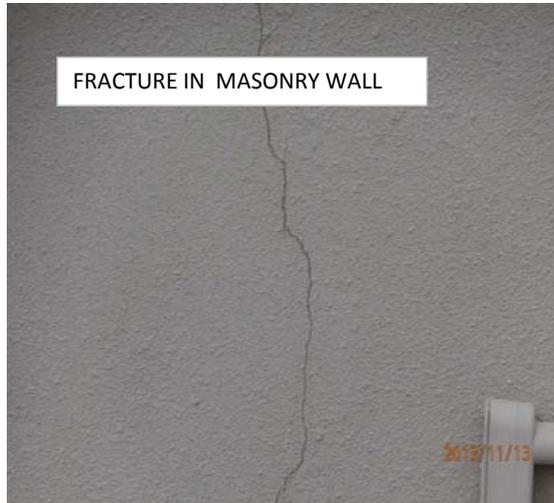
FRACTURE IN MASONRY WALL

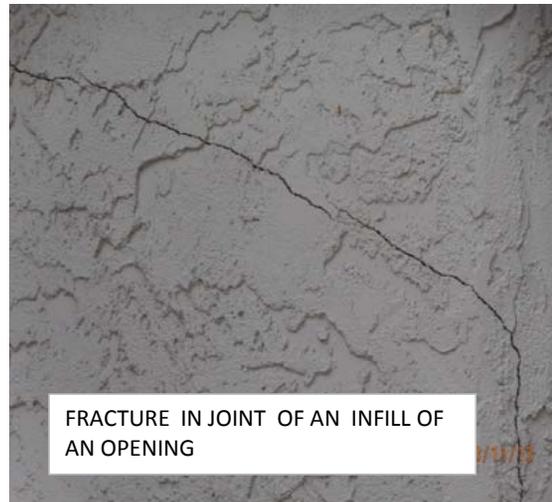
FRACTURE IN JOINT OF AN INFILL OF AN OPENING

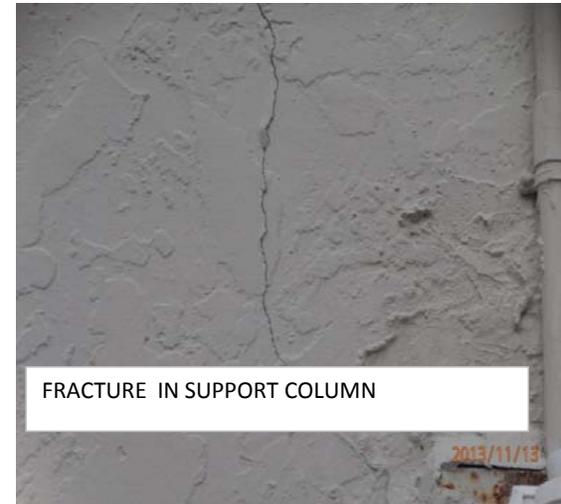
FRACTURE IN SUPPORT COLUMN

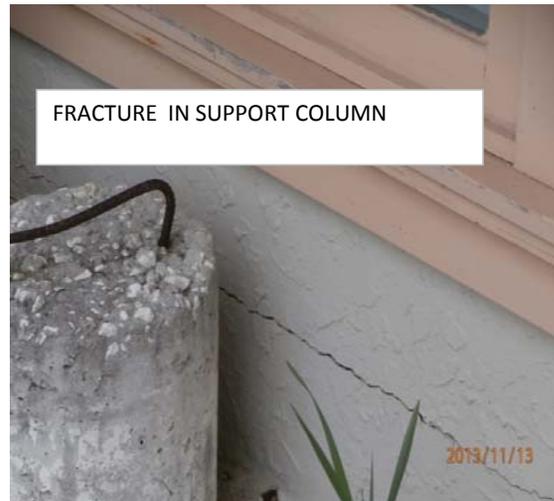
FRACTURE IN SUPPORT COLUMN

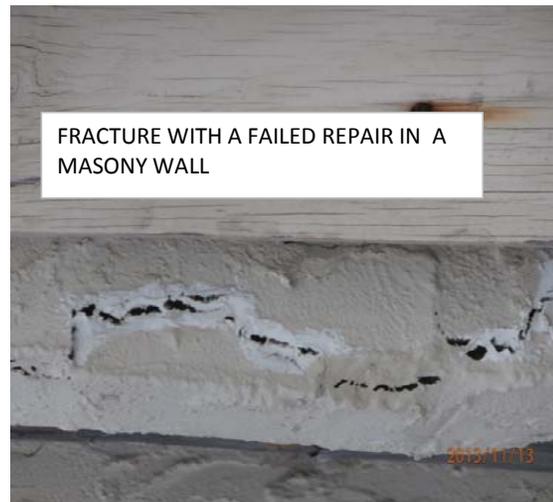
FRACTURE WITH A FAILED REPAIR IN A MASONRY WALL

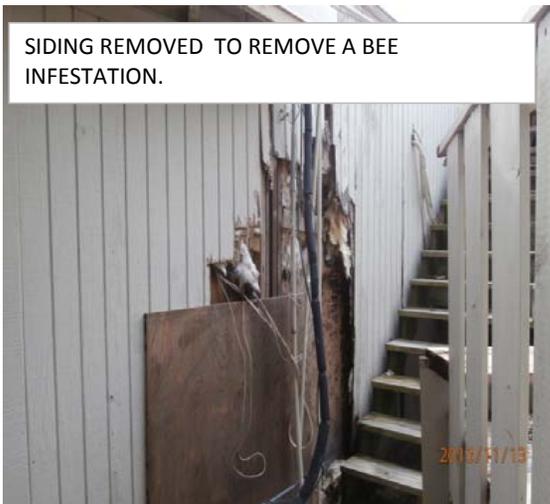
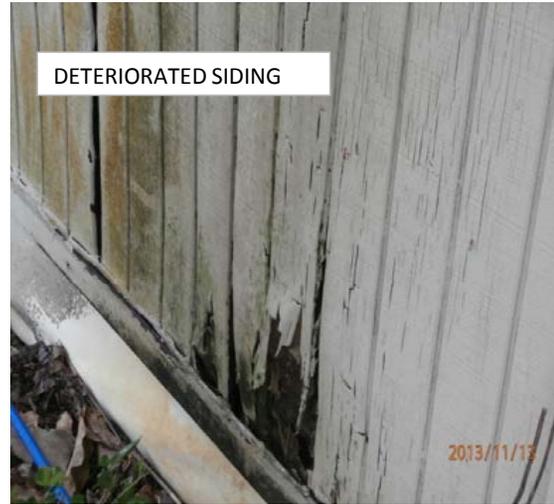
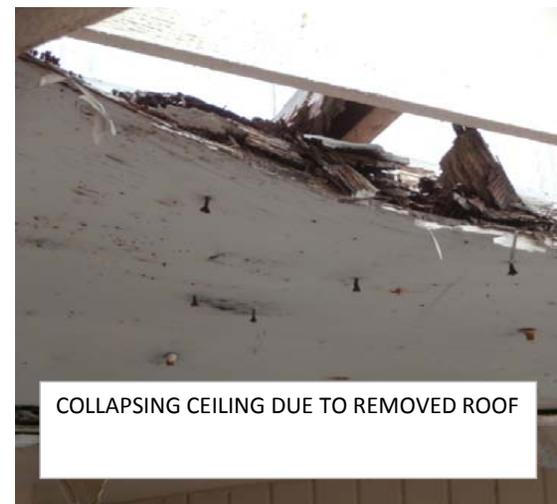
Bee infestation at the rear caused removal of siding

Found vertical separation at on window of realtors office.

Roof over Monkey entry, guard rails, handrails, decking.

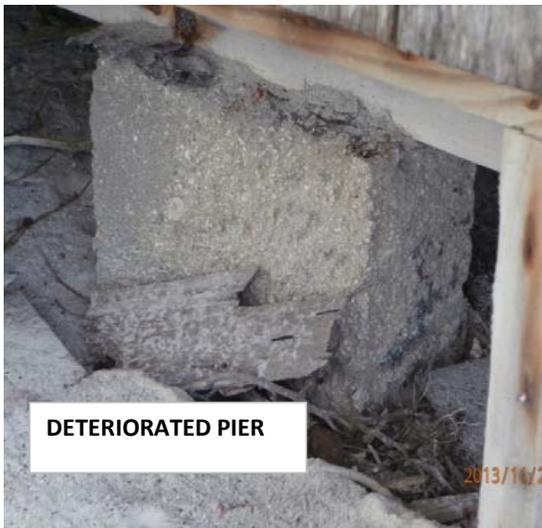
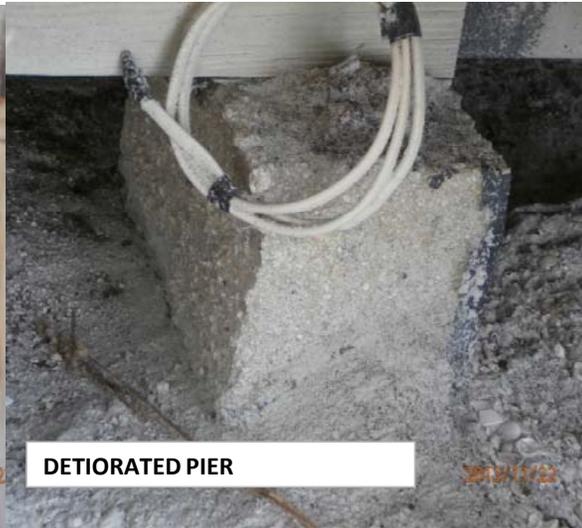
This building is seaward of the coastal construction control line.
Code limitation associated to working on the foundation.
Columns on the north end

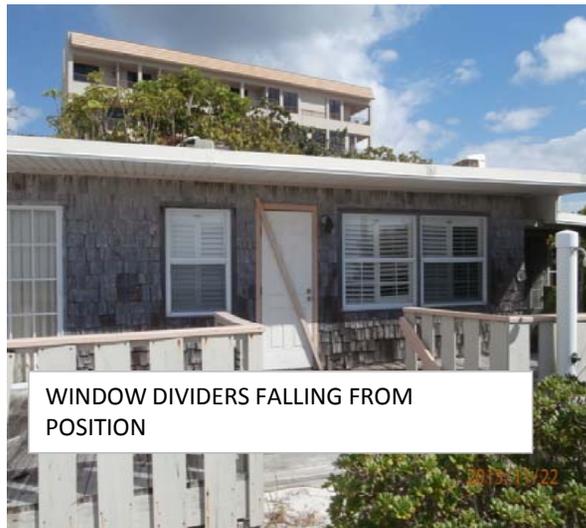
Window and door divider grids breaking away

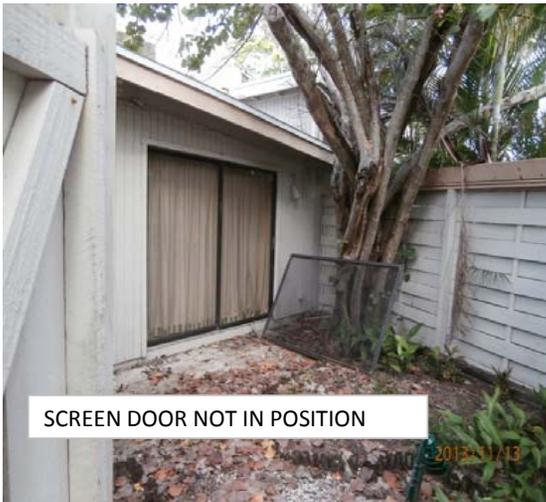
SCREEN DOOR NOT IN POSITION

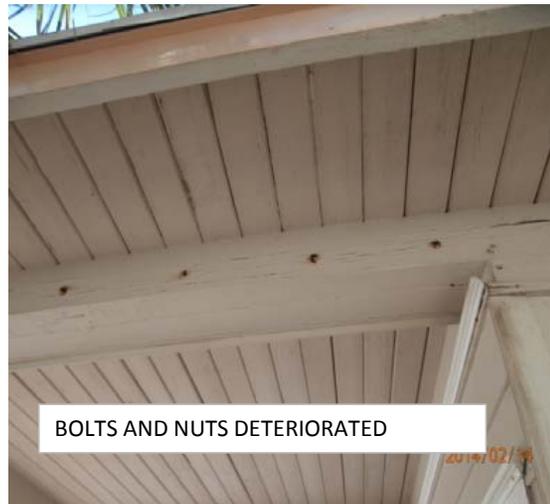
Awnings at all units, air conditioning units

Bottom of air conditioning units
Corroded joints to awnings.

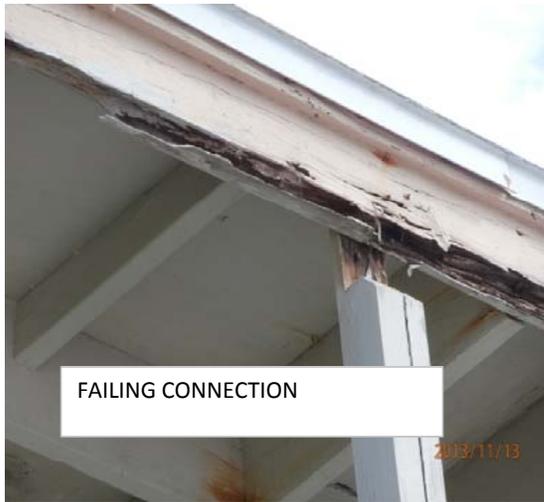
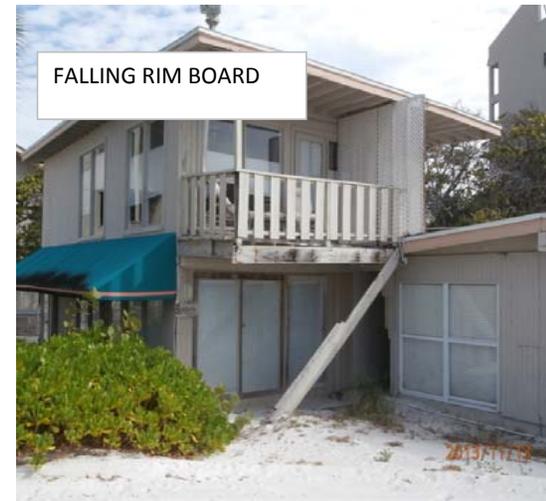
Deck surface warping up
Siding, trims, fascia boards, doors, windows, air conditioning stands, deck joists.

Signs of damage from termite at trims, holes in siding may be from birds and insects. Hole at vagabond a/c once had a dead animal .

Air conditioning stands. Cantilevered balcony to beachview units

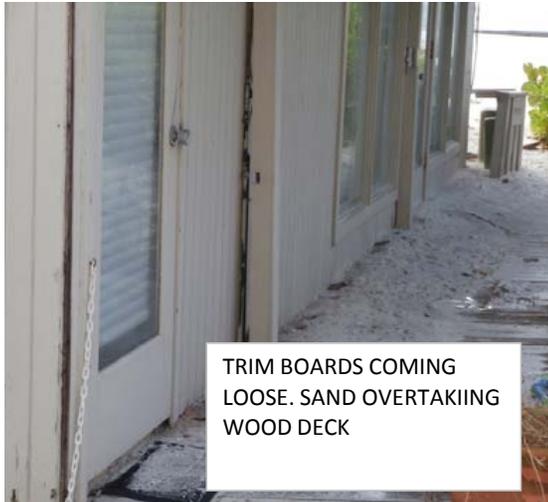
TRIM BOARDS COMING
LOOSE. SAND OVERTAKIING
WOOD DECK

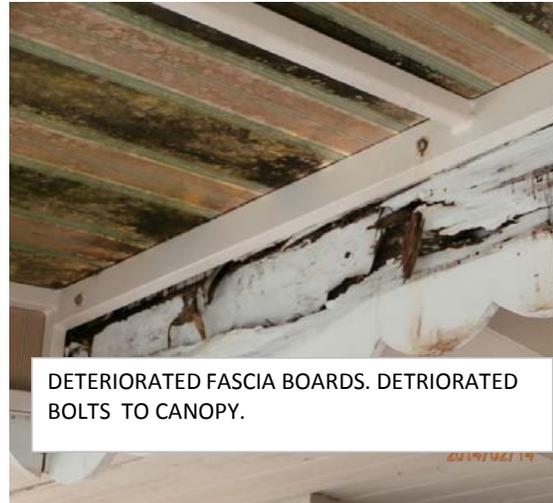
DETERIORATED FASCIA BOARDS. DETRIORATED
BOLTS TO CANOPY.

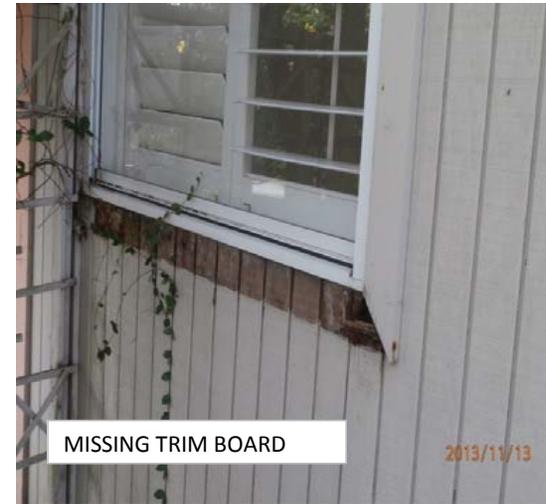
MISSING TRIM BOARD

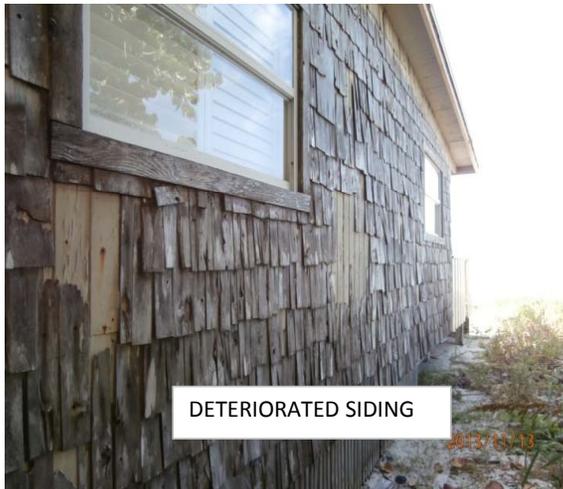
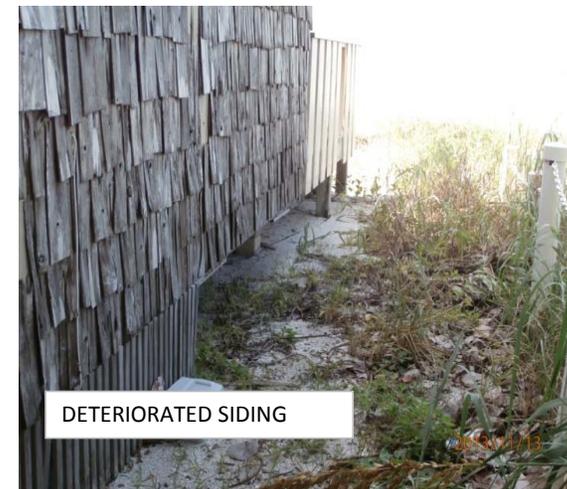
Deck waling surface, sidings, trims, doors, windows, fascia boards, railings.
Signs of insect damage to sheathing behind wood siding.

Fencing falling down, joists have fallen, railing pulling down. Air conditioning stands.

Joists, decking, siding, railings. Lattice skirting falling from structure

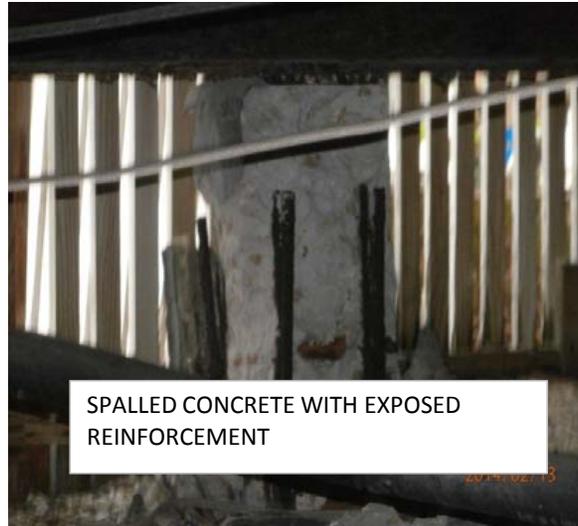
SPALLED CONCRETE WITH EXPOSED REINFORCEMENT

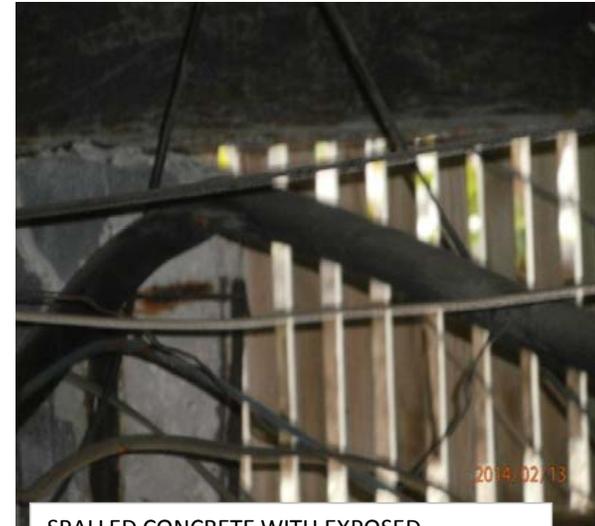
SPALLED CONCRETE WITH EXPOSED REINFORCEMENT

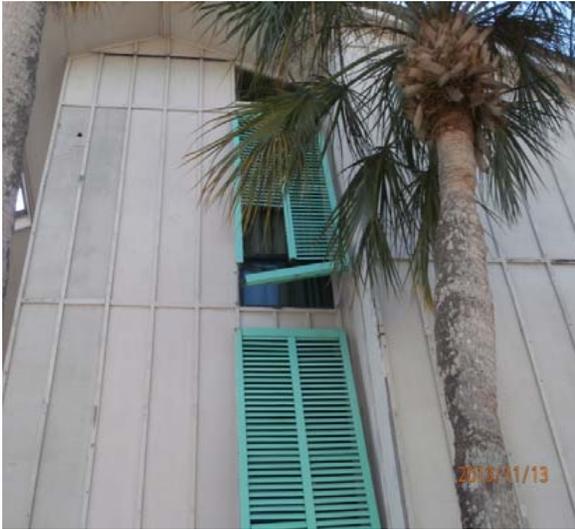
Connection poles to shutters.

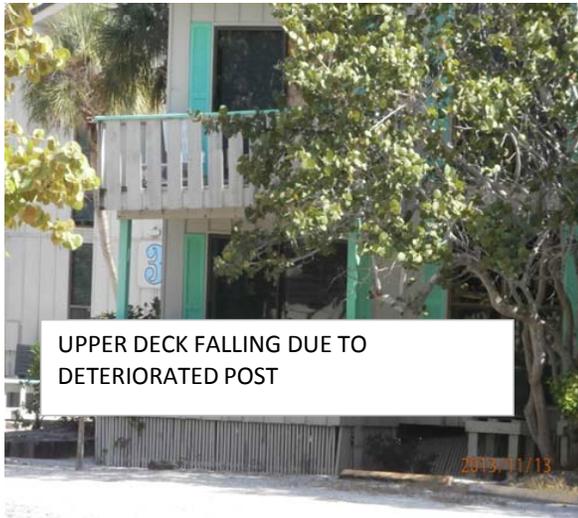
One upper level deck has rotted post and has dropped approximately 4 inches. A/C unit stands.

UPPER DECK FALLING DUE TO
DETERIORATED POST

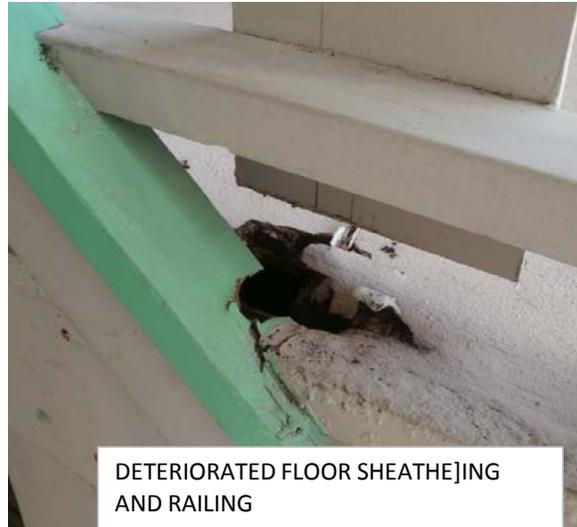
DETERIORATED FLOOR SHEATHING
AND RAILING

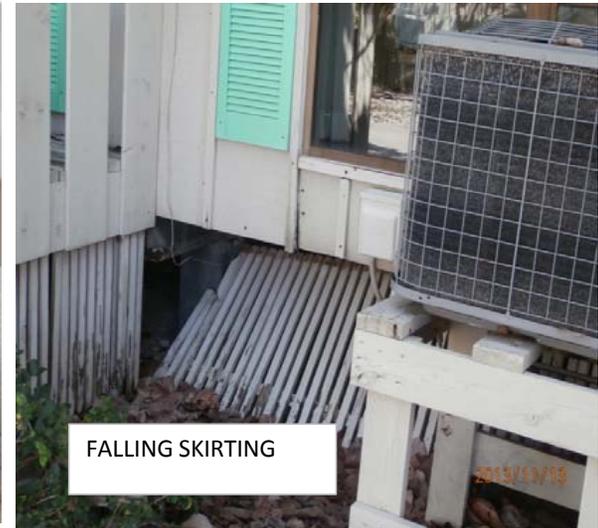
FALLING SKIRTING

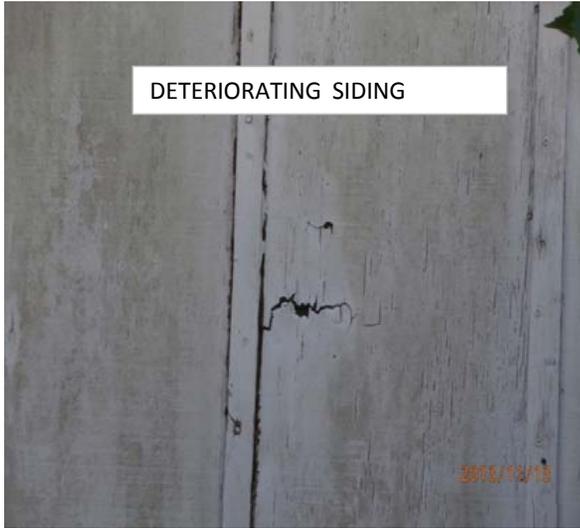
DETERIORATING SIDING

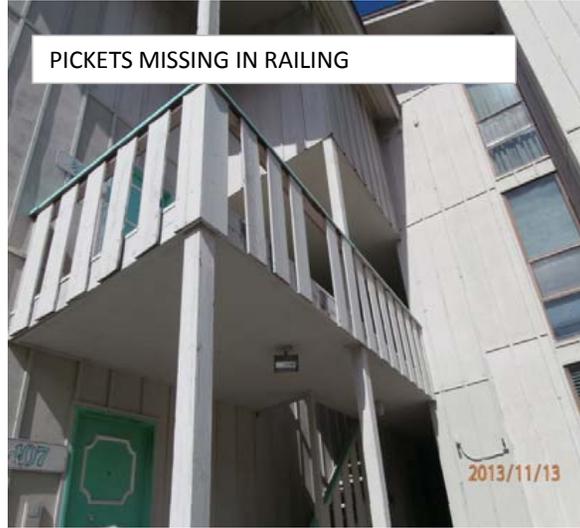
PICKETS MISSING IN RAILING

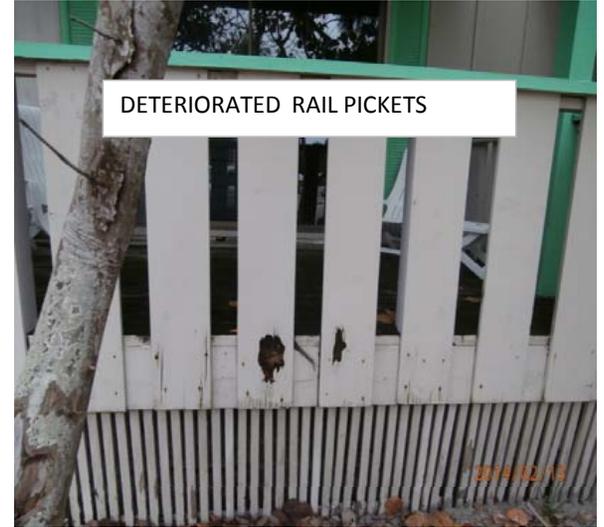
DETERIORATED RAIL PICKETS

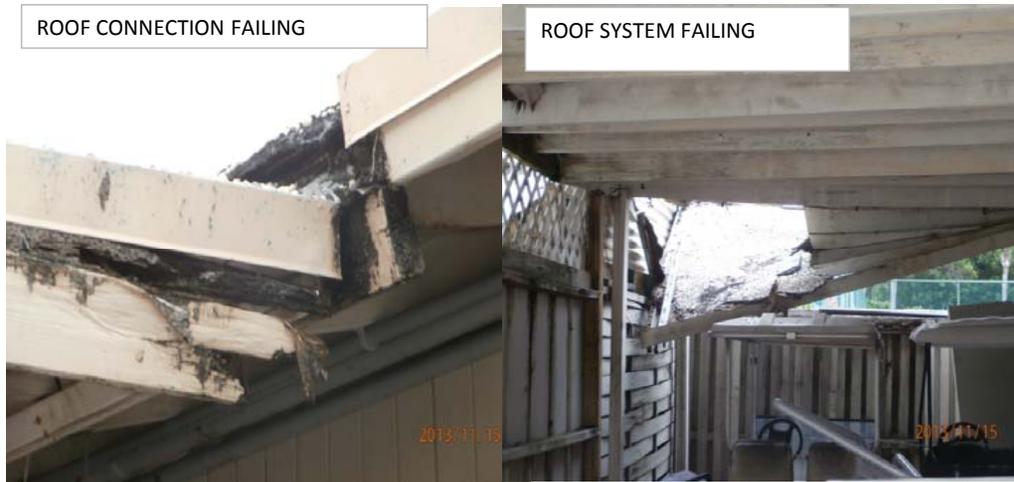
Signs of termite damage.

One shed roof is collapsing. Siding damage due to vandalizing.
