ENGINEERING INSPECTION REPORT

THE COLONY BEACH and TENNIS RESORT

Longboat Key, Florida

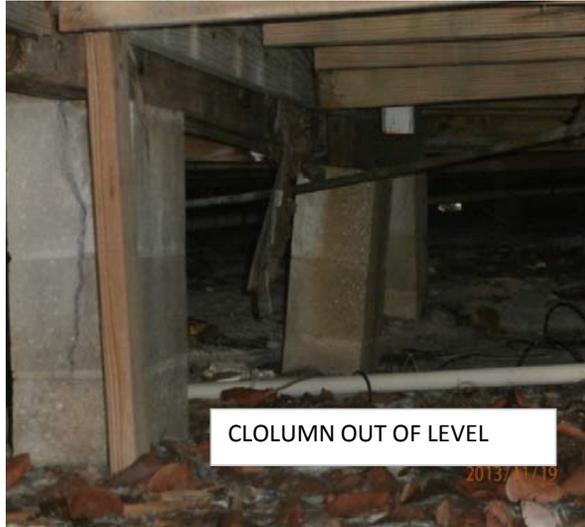
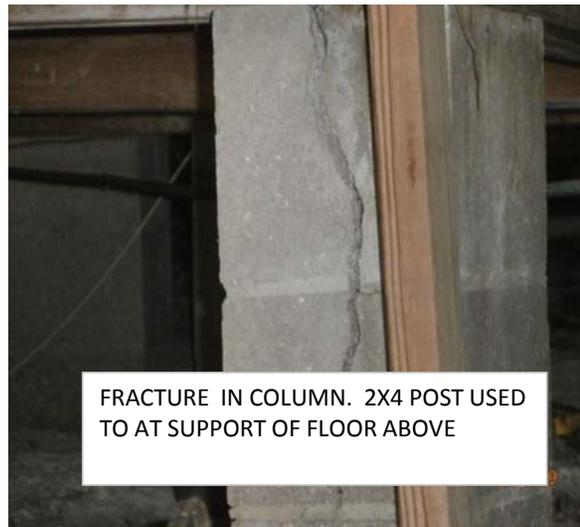
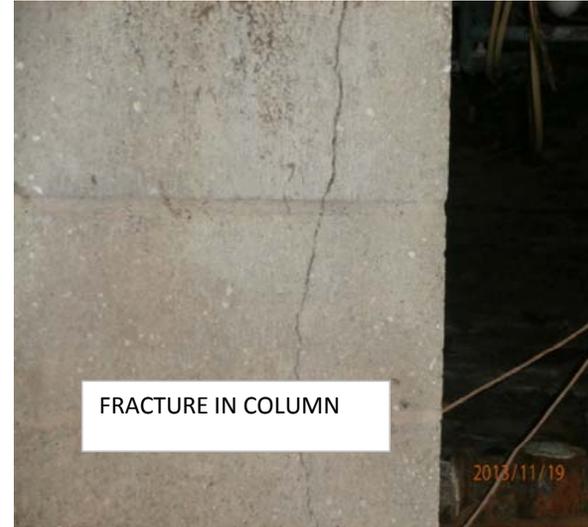
Some of cracking in joints to foundation columns

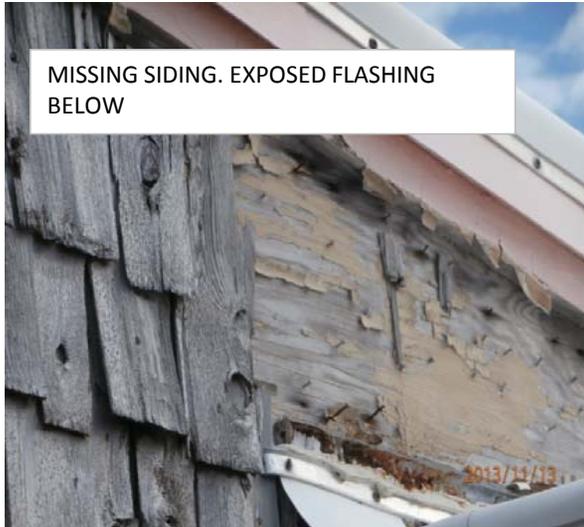
MISSING SIDING. EXPOSED FLASHING BELOW

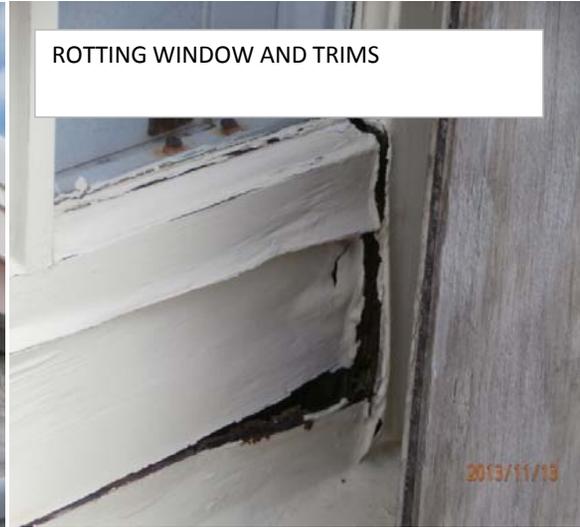
ROTTING WINDOW AND TRIMS

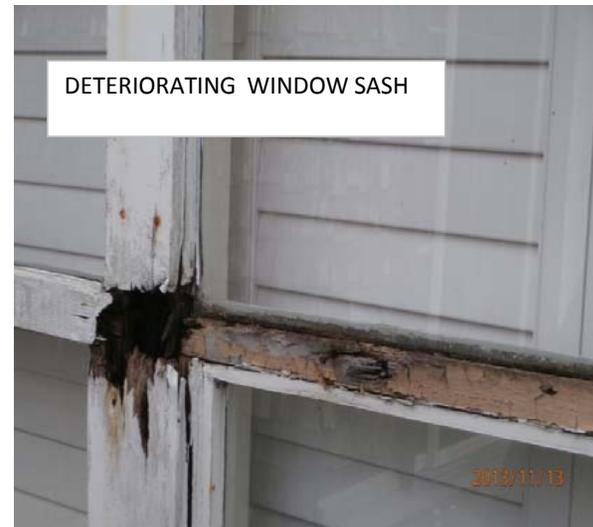
DETERIORATING WINDOW SASH

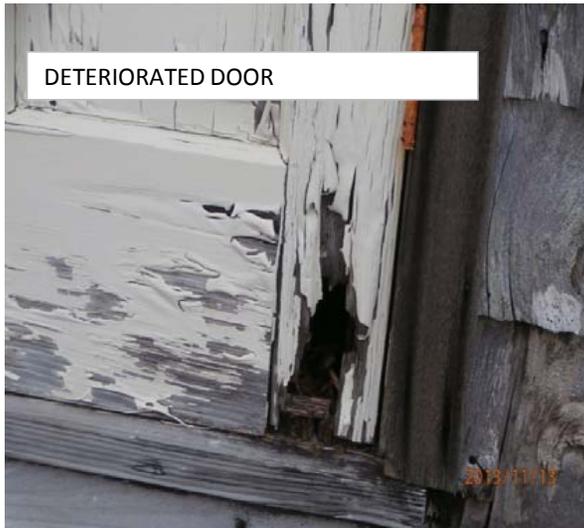
DETERIORATED DOOR

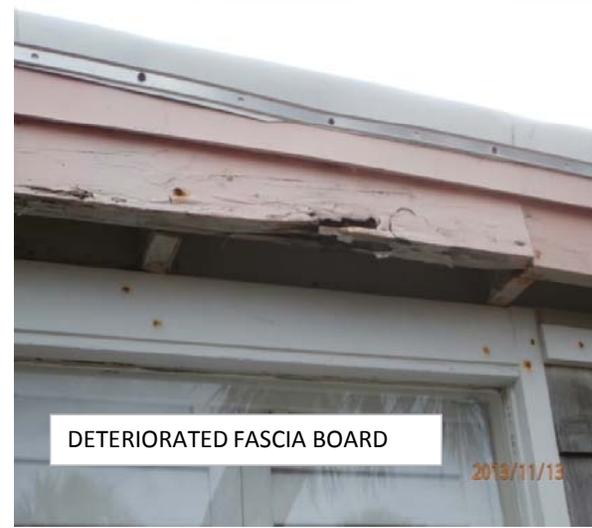
DETERIORATED FASCIA BOARD

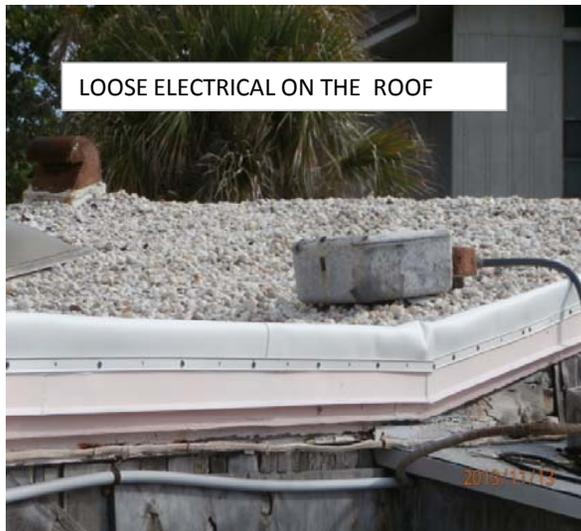
LOOSE ELECTRICAL ON THE ROOF

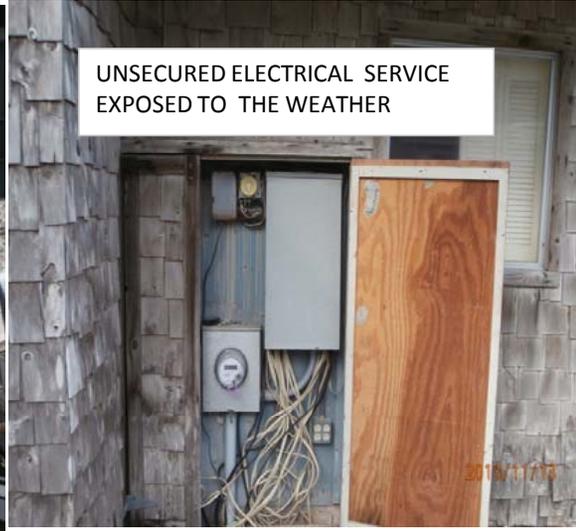
UNSECURED ELECTRICAL SERVICE EXPOSED TO THE WEATHER

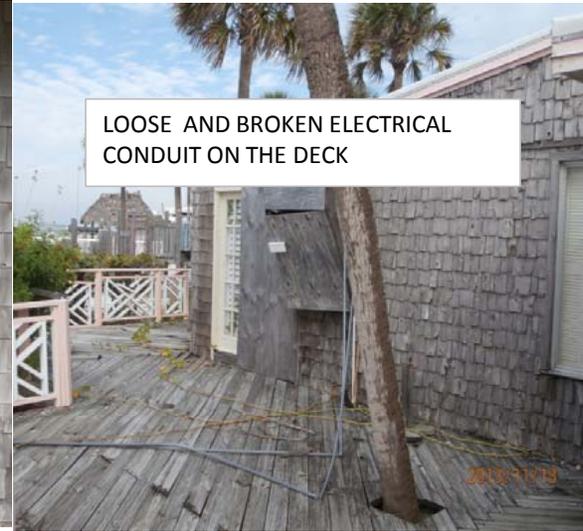
LOOSE AND BROKEN ELECTRICAL CONDUIT ON THE DECK

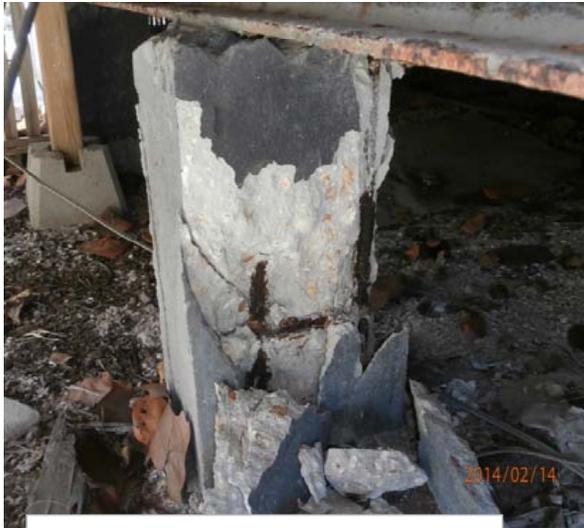
SPALLED CONCRETE WITH EXPOSED REINFORCEMENT

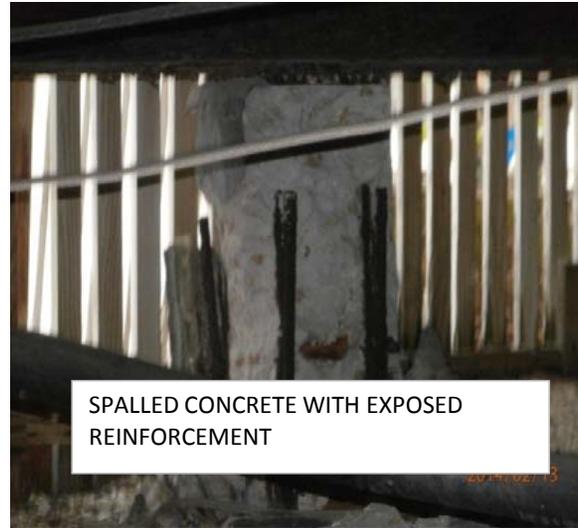
SPALLED CONCRETE WITH EXPOSED REINFORCEMENT

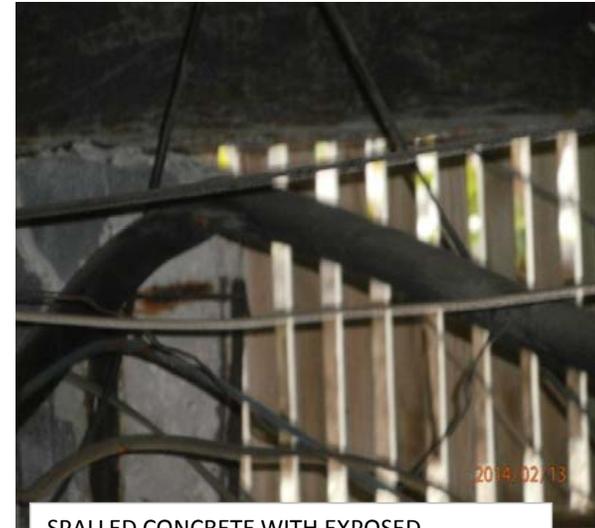
SPALLED CONCRETE WITH EXPOSED REINFORCEMENT

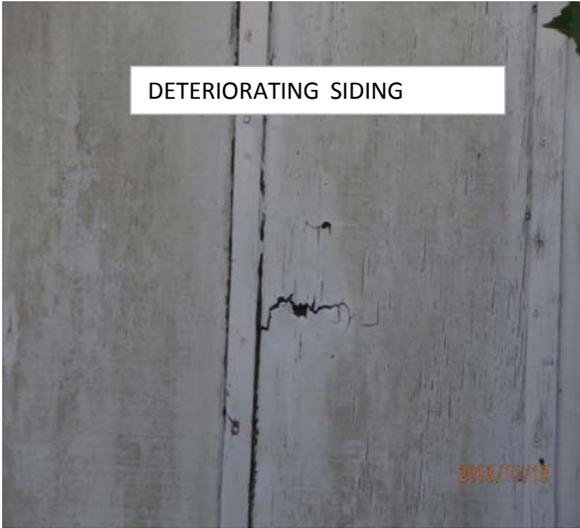
DETERIORATING SIDING

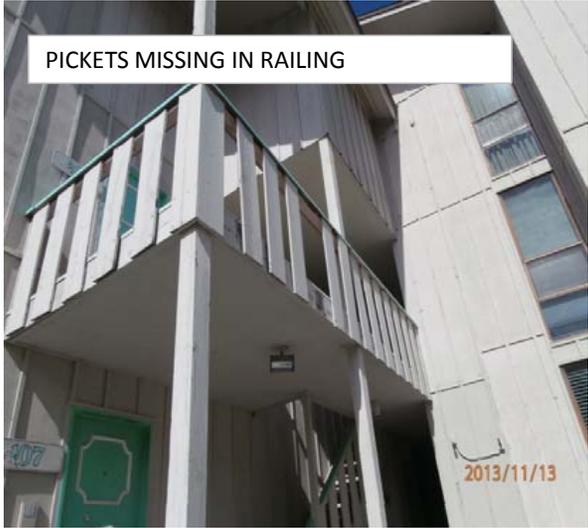
PICKETS MISSING IN RAILING

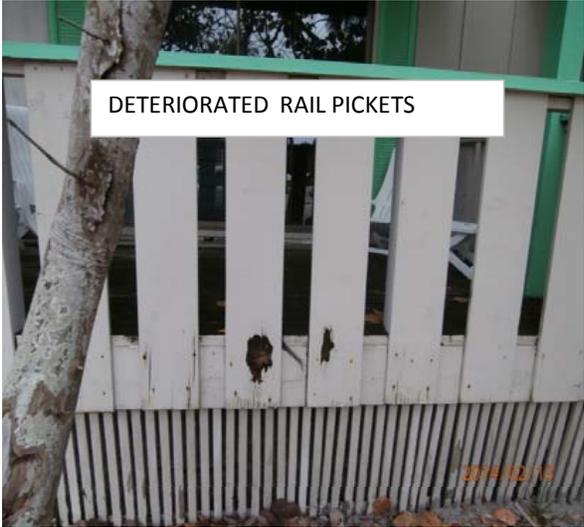
DETERIORATED RAIL PICKETS

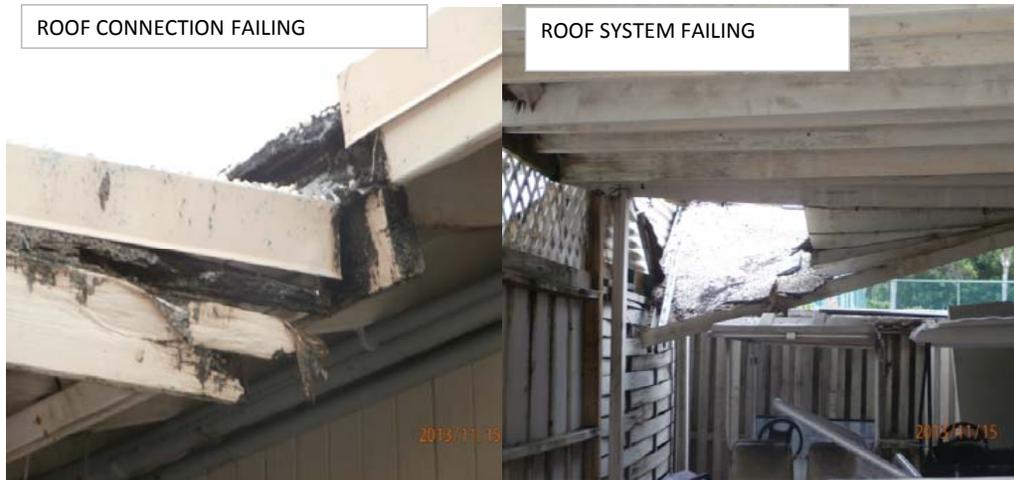
One shed roof is collapsing. Siding damage due to vandalizing.
