**PUBLIC NUISANCE HEARING
1620 GULF OF MEXICO DRIVE
RESTAURANT/BAR COMPLEX**

**TOWN COMMISSION SPECIAL MEETING
MARCH 4, 2014**

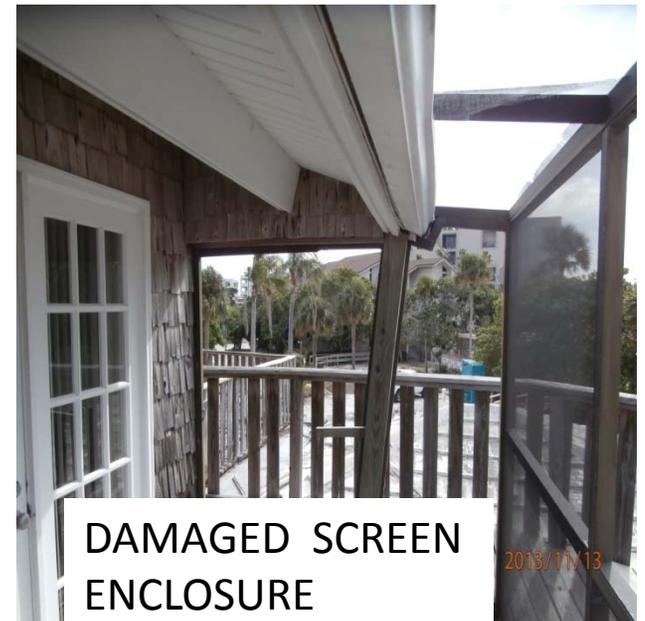
RESTAURANT/BAR COMPLEX— ALUMINUM

- Joint fatigue
- Detached, Dislodged or Failing Connections

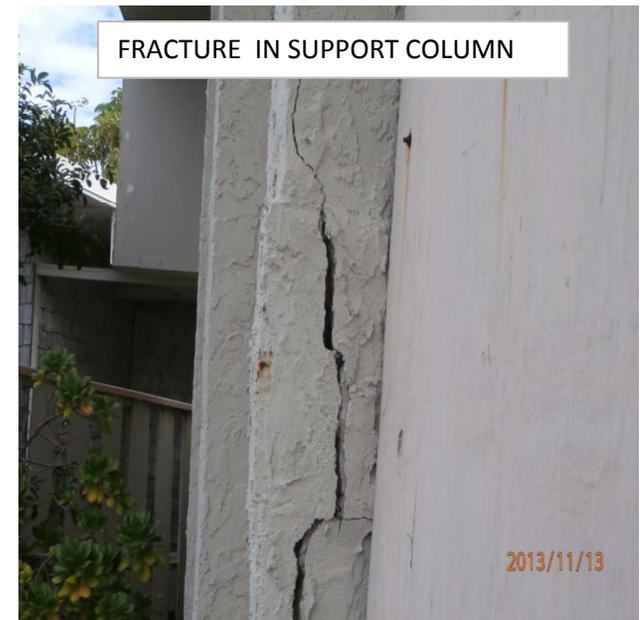
RESTAURANT/BAR COMPLEX – MASONRY

- **Fractures**
- **Fissures**
- **Spalling**
- **Detached, dislodged, or failing connections**

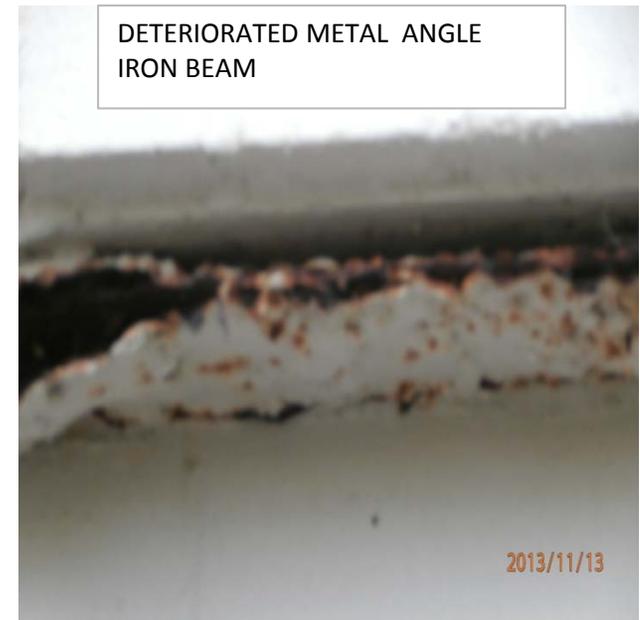
RESTAURANT/BAR COMPLEX— STEEL

- **Deterioration**
- **Detached, dislodged, or failing connections**

DETERIORATED METAL ANGLE
IRON BEAM

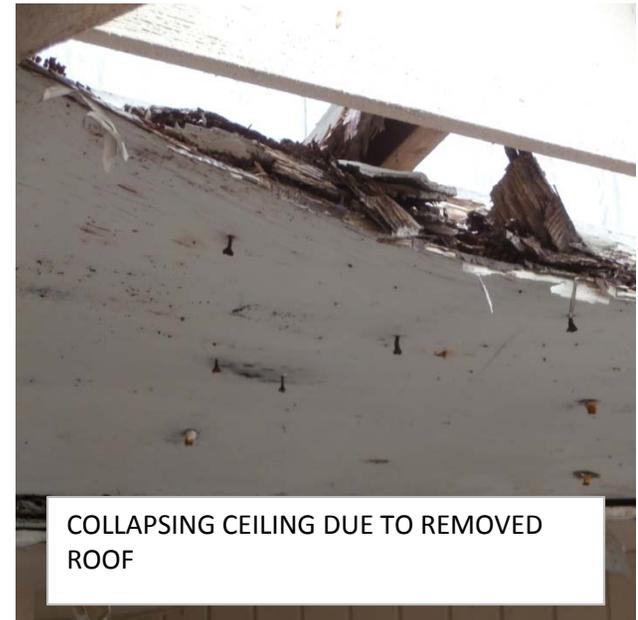
RESTAURANT/BAR COMPLEX – WOOD

- Deterioration
- Damage from insects, rodents, or other vermin
- Significant splits and cracks
- Detached, dislodged, or failing connections

COLLAPSING CEILING DUE TO REMOVED ROOF

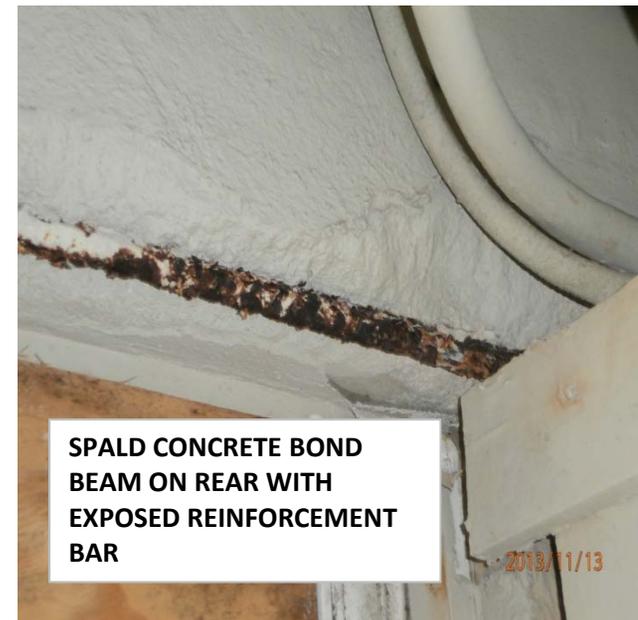
BEACH UNITS BUILDING – CONCRETE

- Exposed Reinforcement
- Spalling
- Detached, Dislodged or Failing Connections

SPALD CONCRETE BOND
BEAM ON REAR WITH
EXPOSED REINFORCEMENT
BAR

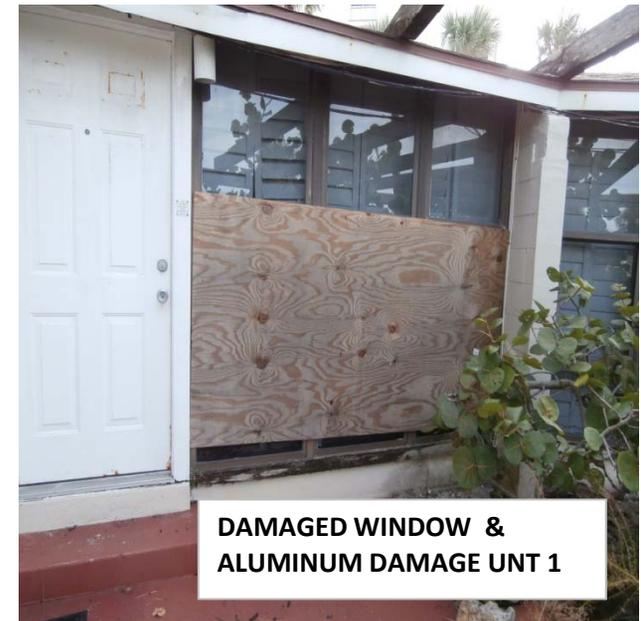
BEACH UNITS BUILDING – ALUMINUM

- **Detached, Dislodged or Failing Connections**

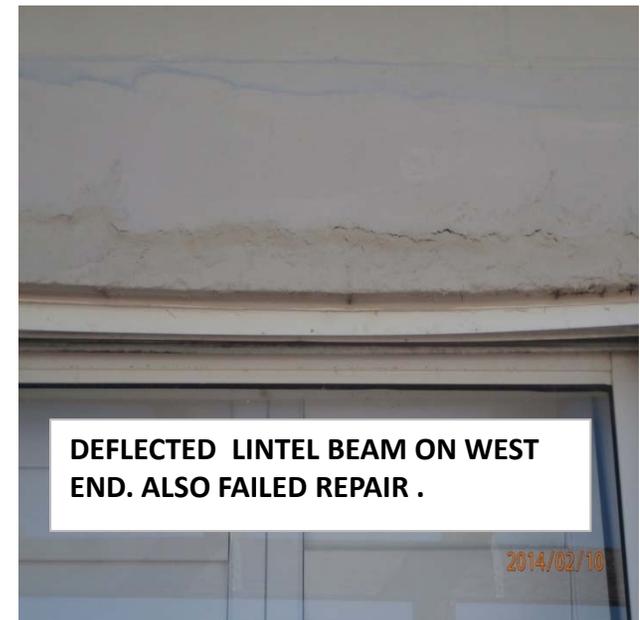
BEACH UNITS BUILDING – MASONRY

- Fractures
- Fissures
- Detached, dislodged,
or failing connections

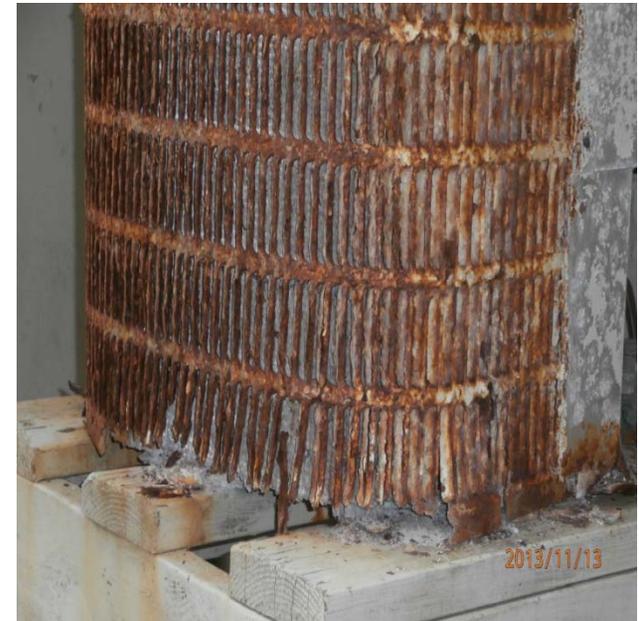
BEACH UNITS BUILDING – STEEL

- **Deterioration**

DETERIORATED STEEL AT AIR
CONDITIONING UNIT. COULD ALSO
BE CLASSIFIED AS METAL FATIGUE.

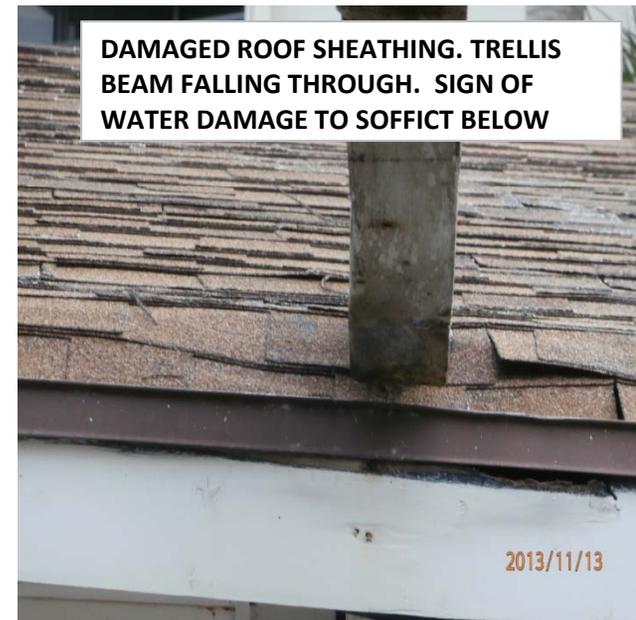
BEACH UNITS BUILDING – WOOD

- Ultimate deformation
- Deterioration
- Inadequate support
- Detached, dislodged, or failing connections

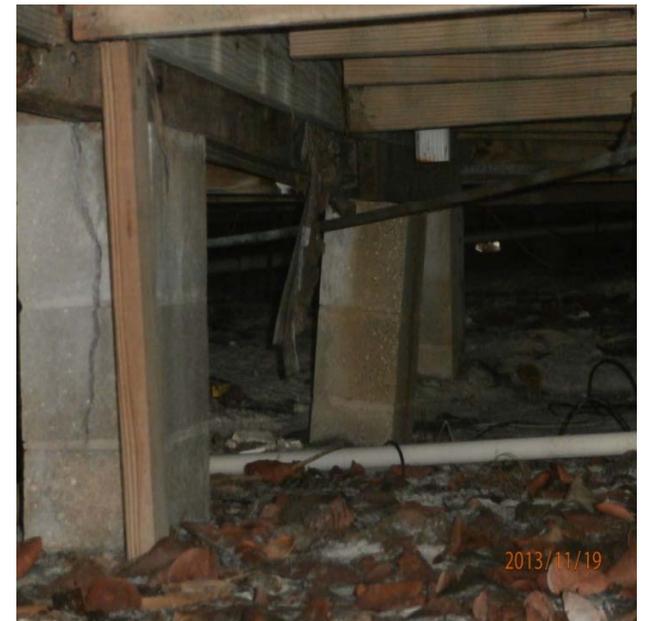
LANAI UNITS BUILDING – MASONRY

- **Fractures**
- **Fissures**
- **Spalling**
- **Exposed reinforcements**

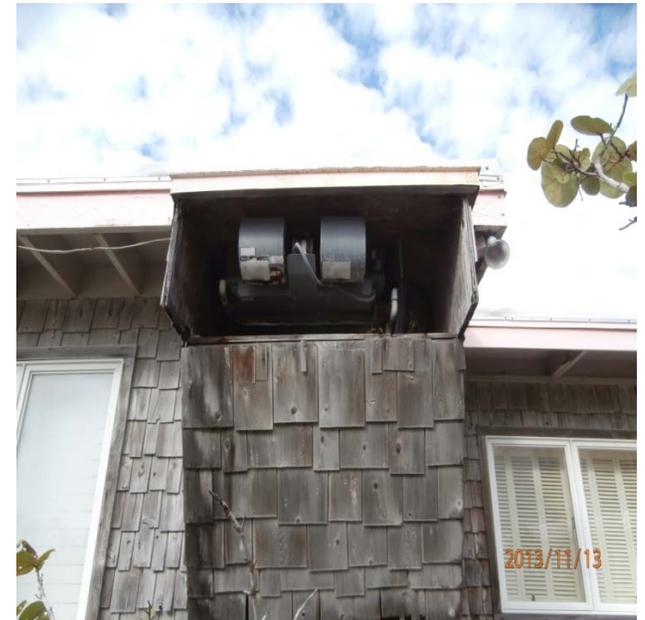
LANAI UNITS BUILDING – STEEL

- Deterioration
- Metal fatigue
- Detached, dislodged, or failing connections

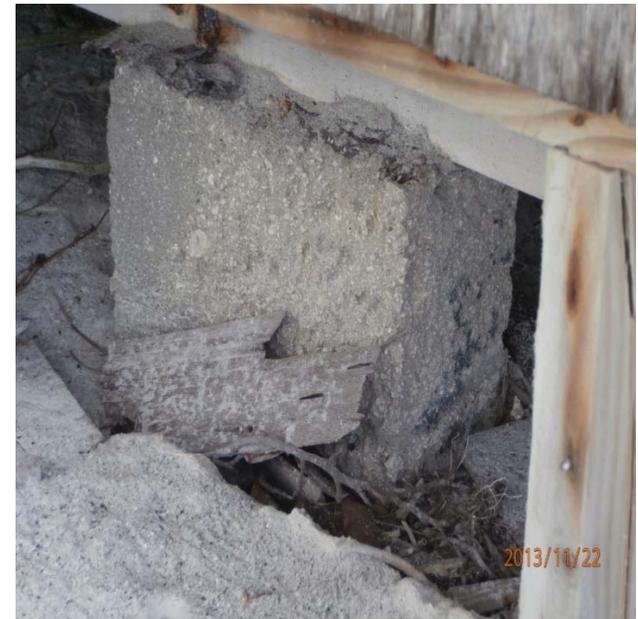
BEACHCOMBER UNIT BUILDING – CONCRETE

- Deterioration of
columns

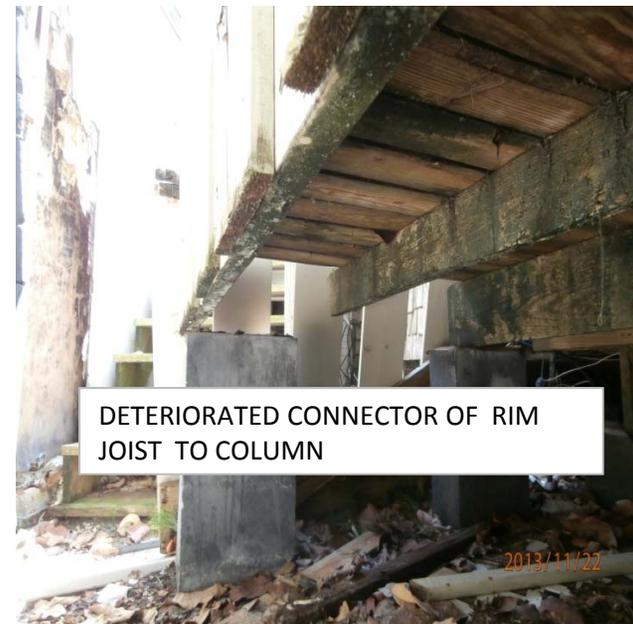
BEACHCOMBER UNIT BUILDING – STEEL

- Deterioration
- Detached, dislodged,
or failing connections

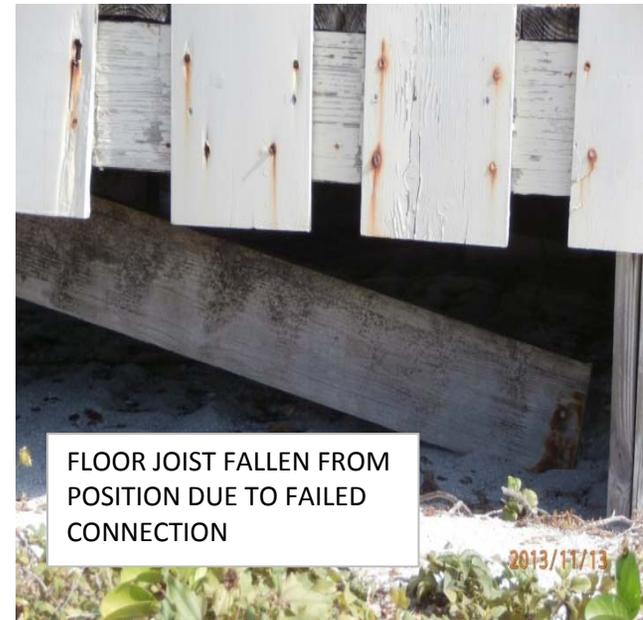
CASTAWAYS UNIT BUILDING STEEL

- Metal fatigue
- Detached, dislodged, or failing connections

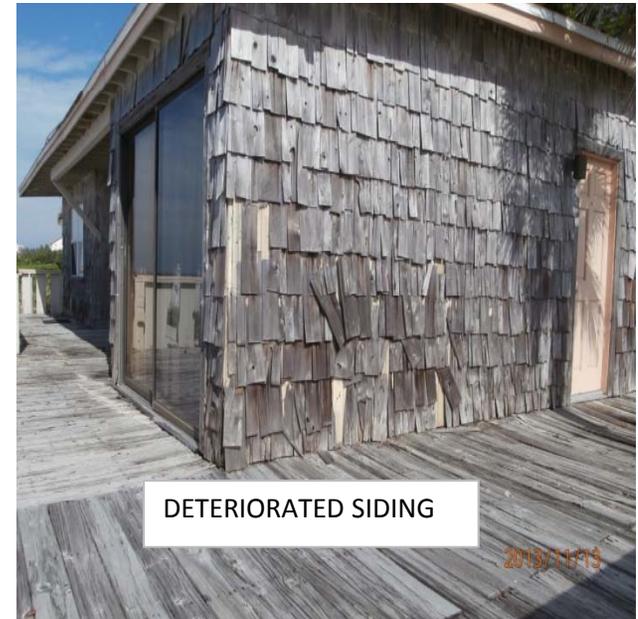
CASTAWAYS UNIT BUILDING WOOD

- Deterioration
- Damage from insects, rodents and other vermin
- Inadequate support
- Detached, dislodged, or failing connections

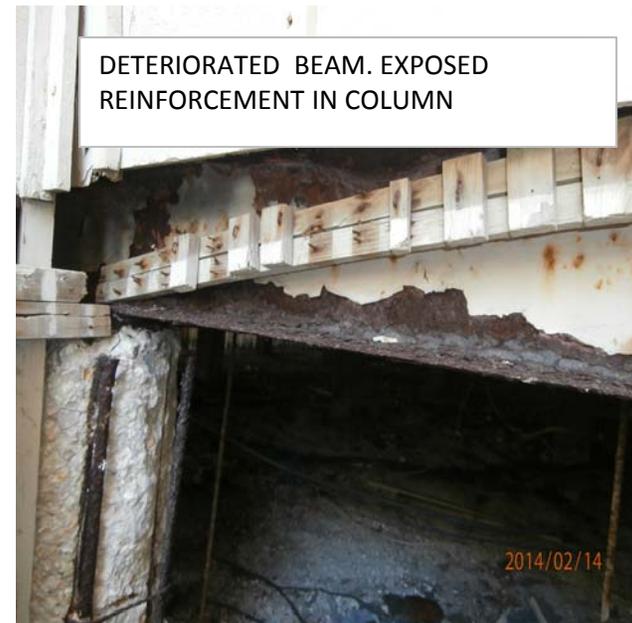
VILLA 1 BUILDING – STEEL

- **Deterioration**
- **Metal fatigue**
- **Detached, dislodged, or failing connections**

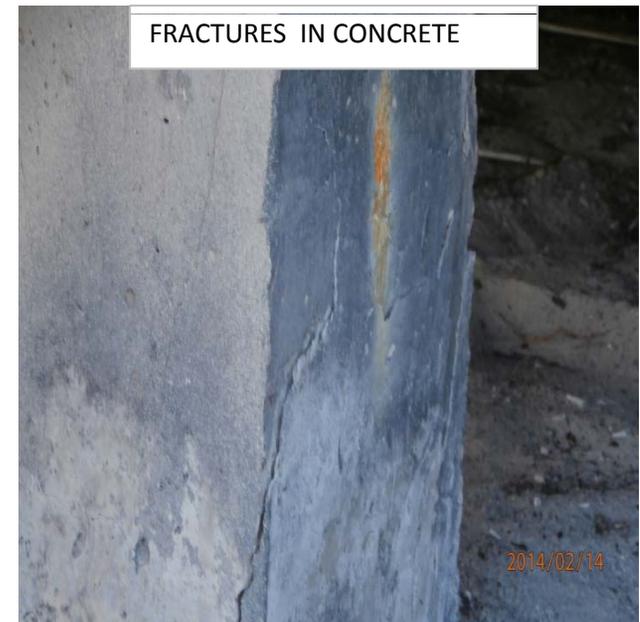
VILLA 18 BUILDING – CONCRETE

- Fractures
- Fissures
- Spalling
- Exposed Reinforcement
- Detached, Dislodged or Failing Connections

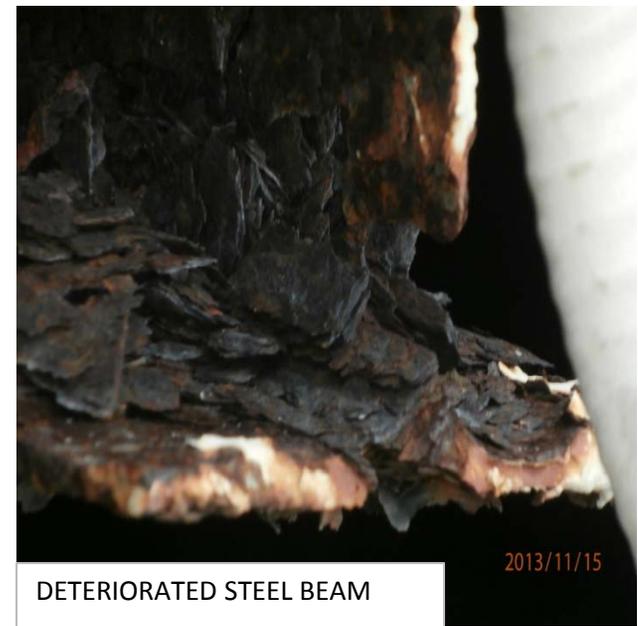
VILLA 18 BUILDING – STEEL

- Deterioration
- Metal fatigue
- Detached, dislodged, or failing connections

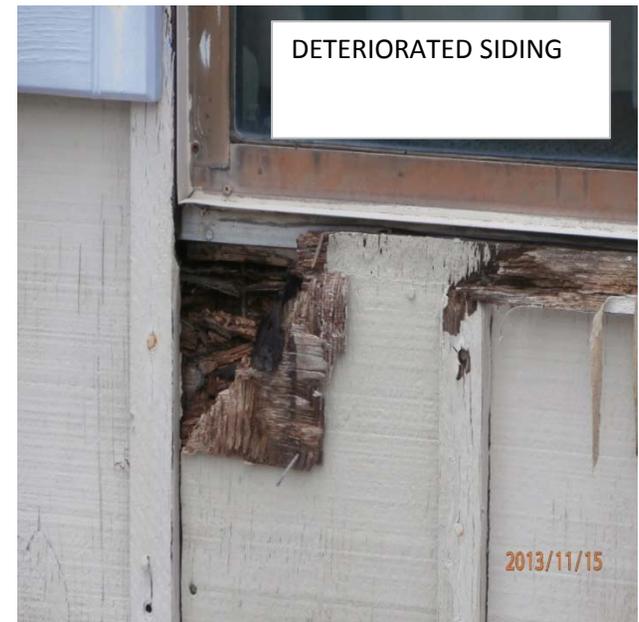
VILLA 18 BUILDING – WOOD

- **Ultimate deformation**
- **Deterioration**
- **Damage from insects, rodents and other vermin**
- **Significant splits and checks**
- **Detached, dislodged, or failing connections**

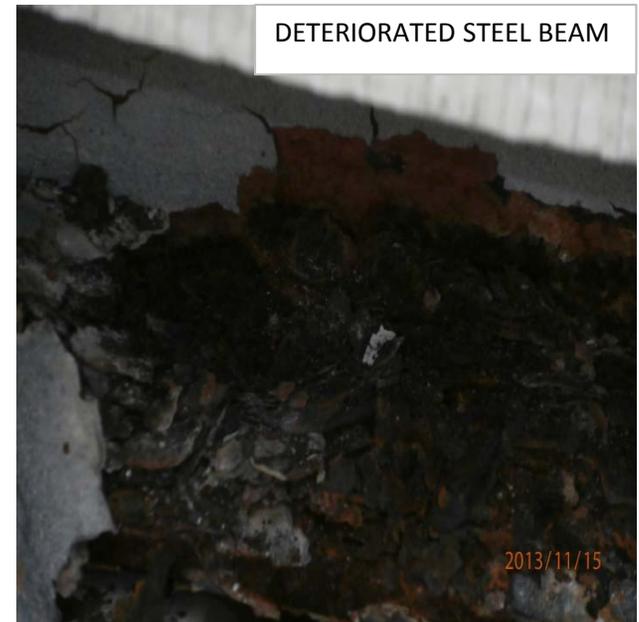
VILLA 9 BUILDING – STEEL

- Deterioration
- Metal fatigue
- Detached, dislodged, or failing connections

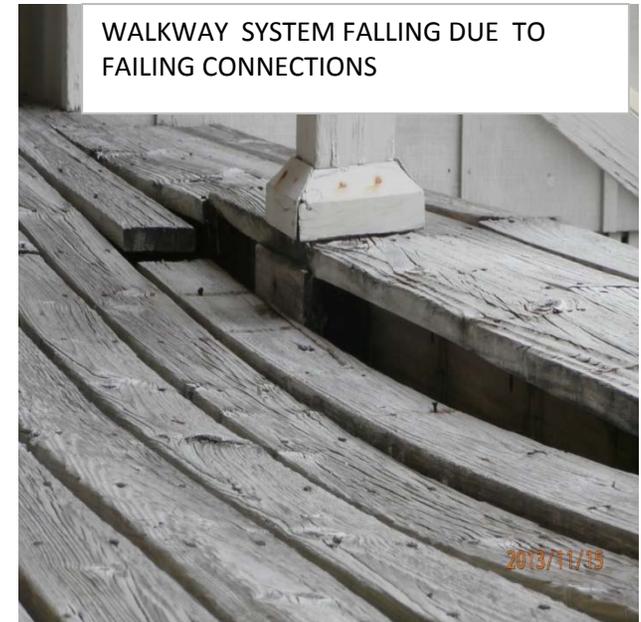
VILLA 9 BUILDING – WOOD

- **Ultimate deformation**
- **Deterioration**
- **Damage from insects, rodents and other vermin**
- **Significant splits and checks**
- **Detached, dislodged, or failing connections**

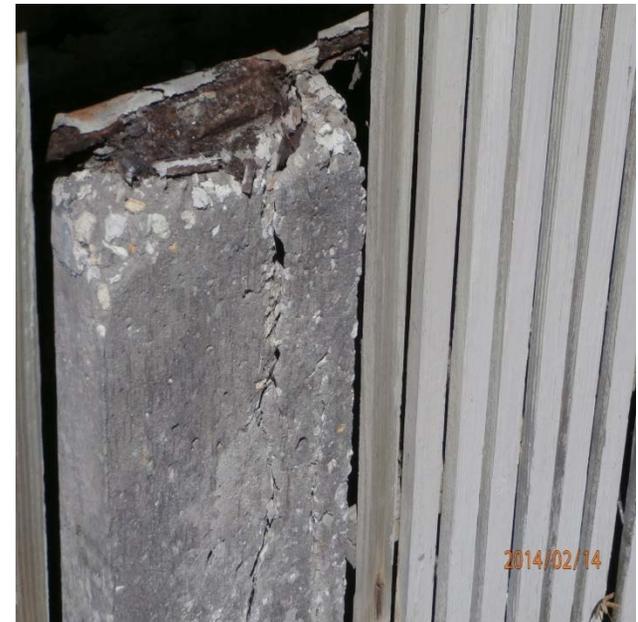
VILLA 10 BUILDING – CONCRETE

- Fractures
- Fissures
- Spalling
- Exposed Reinforcement
- Detached, Dislodged or Failing Connections

FRACTURE IN CONCRETE COLUMN

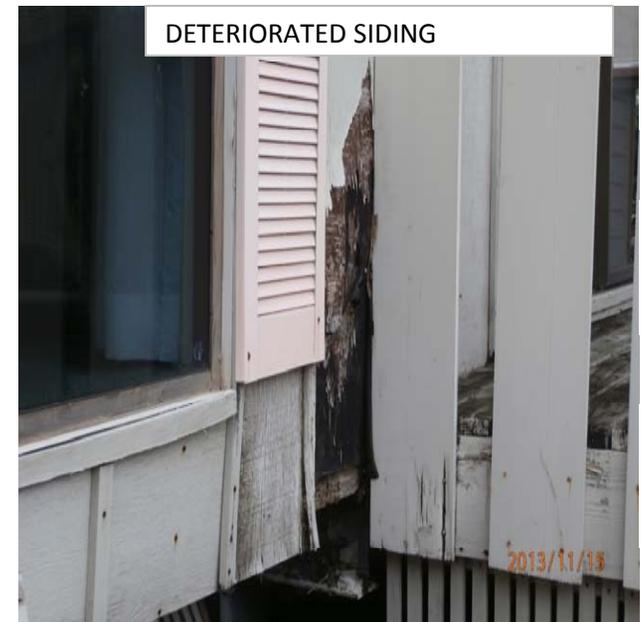
VILLA 10 BUILDING – WOOD

- Ultimate deformation
- Deterioration
- Damage from insects, rodents and other vermin
- Significant splits and checks
- Detached, dislodged, or failing connections

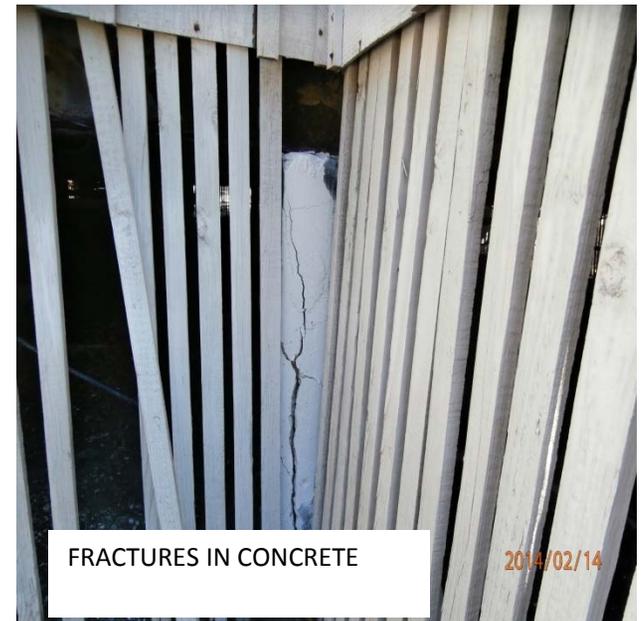
VILLA 17 BUILDING – CONCRETE

- Fractures
- Fissures
- Spalling
- Exposed Reinforcement
- Detached, Dislodged or Failing Connections

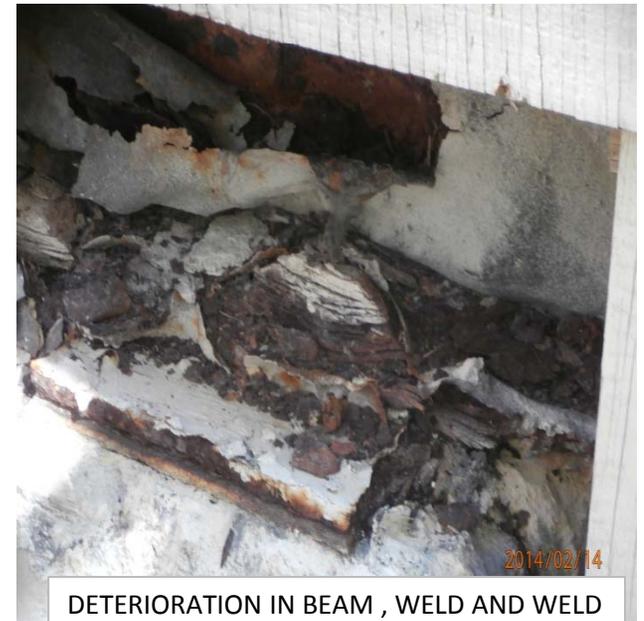
VILLA 17 BUILDING – ALUMINUM

- **Detached, Dislodged or Failing Connections**

DETERIORATION IN BEAM , WELD AND WELD PLATE

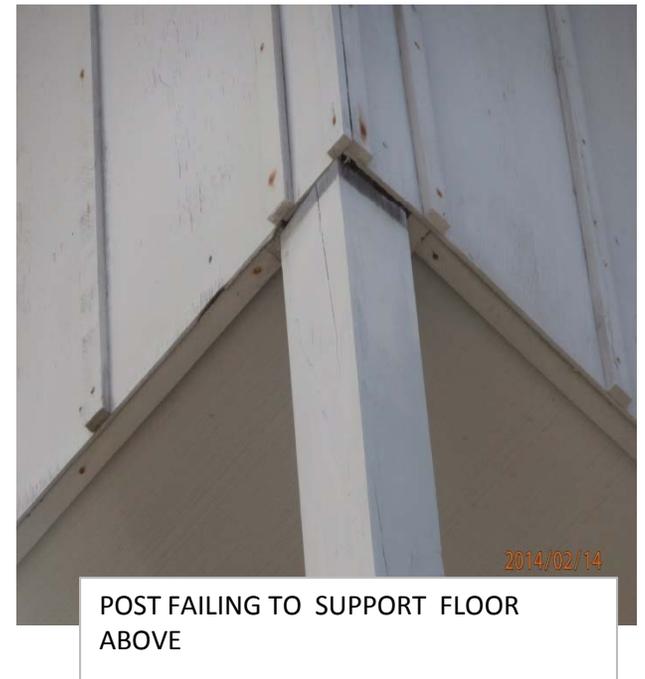
VILLA 17 BUILDING – WOOD

- Ultimate deformation
- Deterioration
- Damage from insects, rodents and other vermin
- Significant splits and checks
- Detached, dislodged, or failing connections

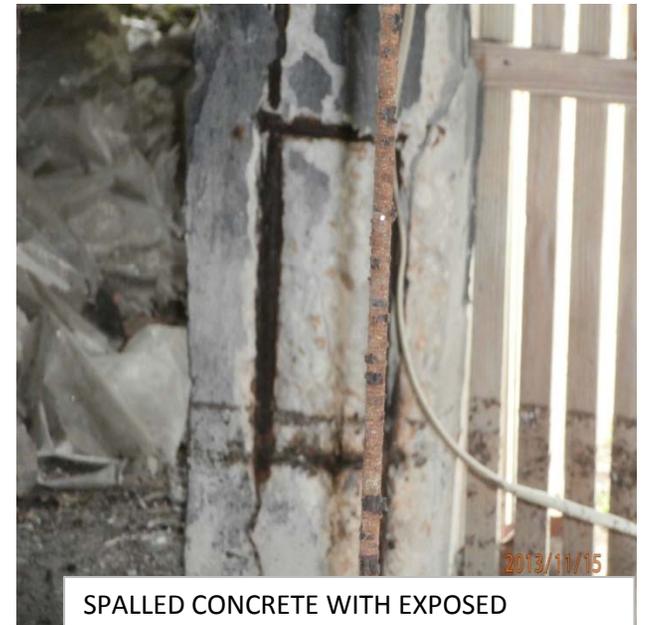
VILLA 11 BUILDING – CONCRETE

- Fractures
- Fissures
- Spalling
- Exposed Reinforcement
- Detached, Dislodged or Failing Connections

SPALLED CONCRETE WITH EXPOSED REINFORCEMENT

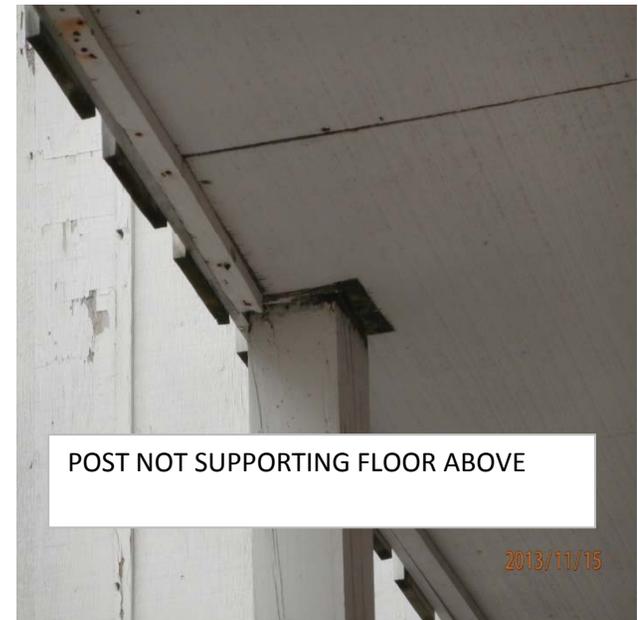
VILLA 11 BUILDING – WOOD

- Ultimate deformation
- Deterioration
- Damage from insects, rodents and other vermin
- Significant splits and checks
- Detached, dislodged, or failing connections

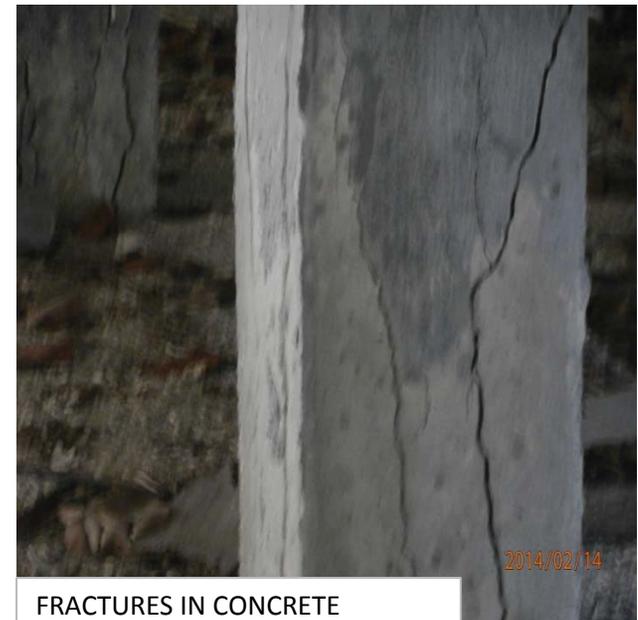
VILLA 16 BUILDING – CONCRETE

- Fractures
- Fissures
- Spalling
- Exposed Reinforcement
- Detached, Dislodged or Failing Connections

FRACTURES IN CONCRETE

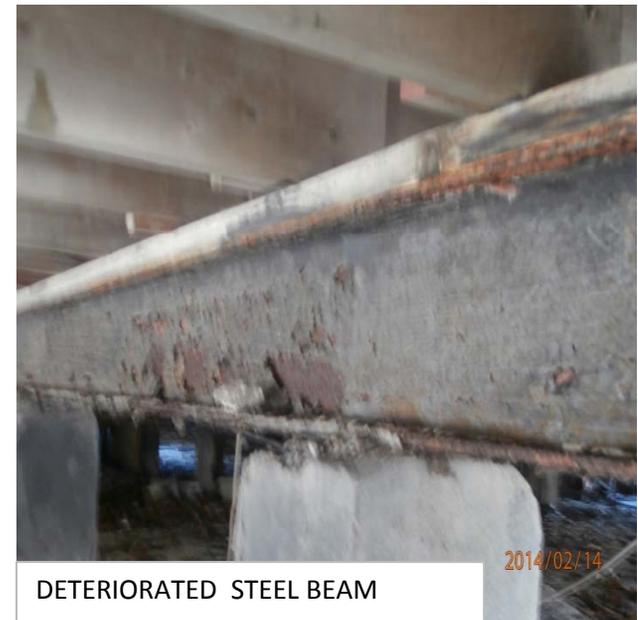
VILLA 16 BUILDING – STEEL

- Deterioration
- Metal fatigue
- Detached, dislodged, or failing connections

DETERIORATED STEEL BEAM

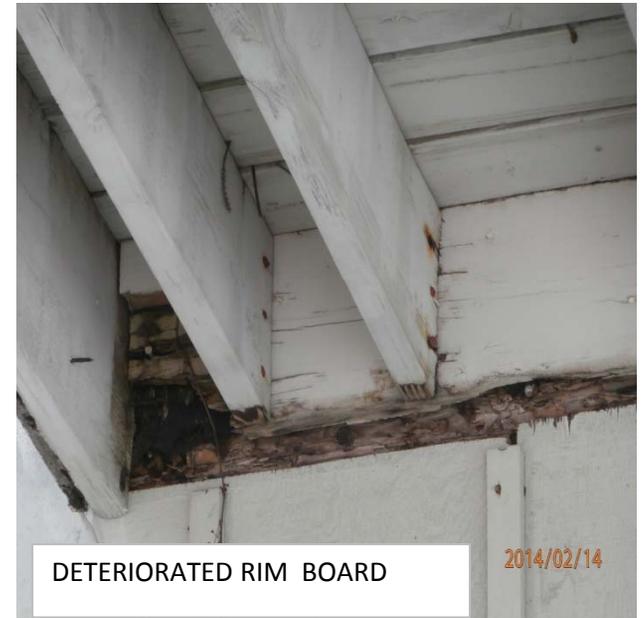
VILLA 16 BUILDING – WOOD

- Ultimate deformation
- Deterioration
- Damage from insects, rodents and other vermin
- Significant splits and checks
- Detached, dislodged, or failing connections

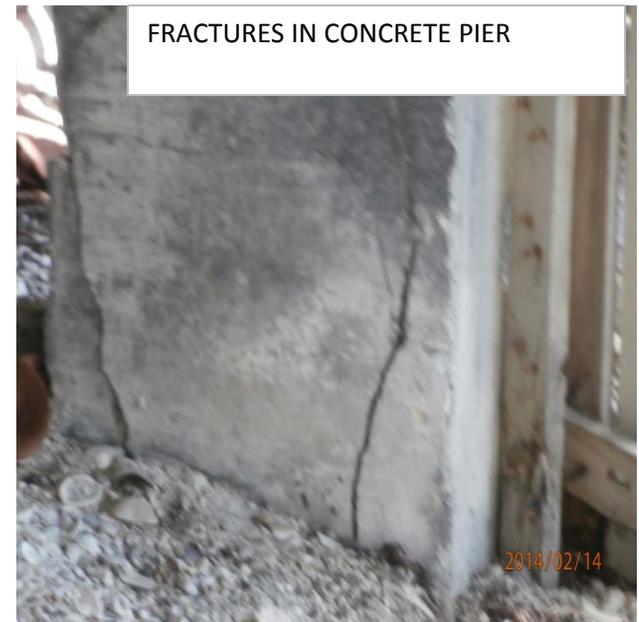
VILLA 3 BUILDING – CONCRETE

- **Fractures**
- **Fissures**
- **Spalling**
- **Exposed Reinforcement**
- **Detached, Dislodged or Failing Connections**

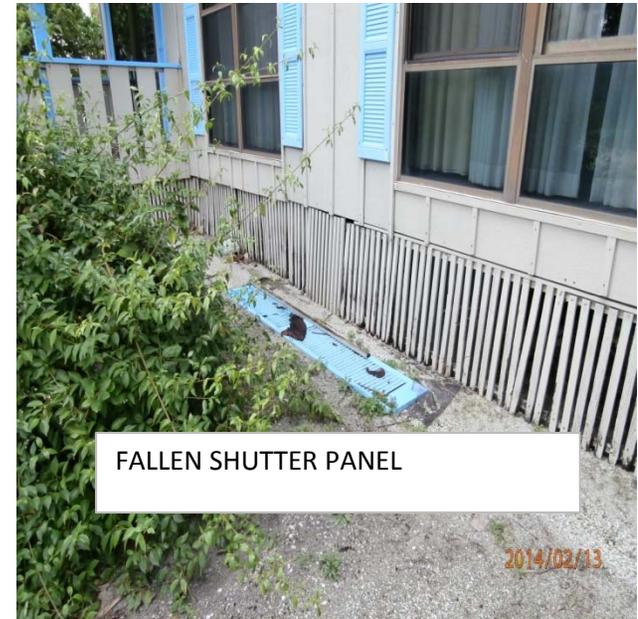
VILLA 2 BUILDING – ALUMINUM

- **Detached, Dislodged or Failing Connections**

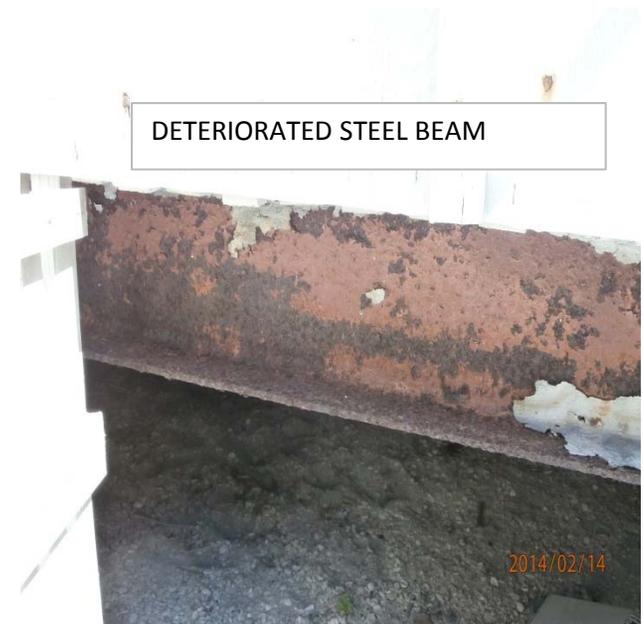
VILLA 3 BUILDING – STEEL

- Deterioration
- Metal fatigue
- Detached, dislodged, or failing connections

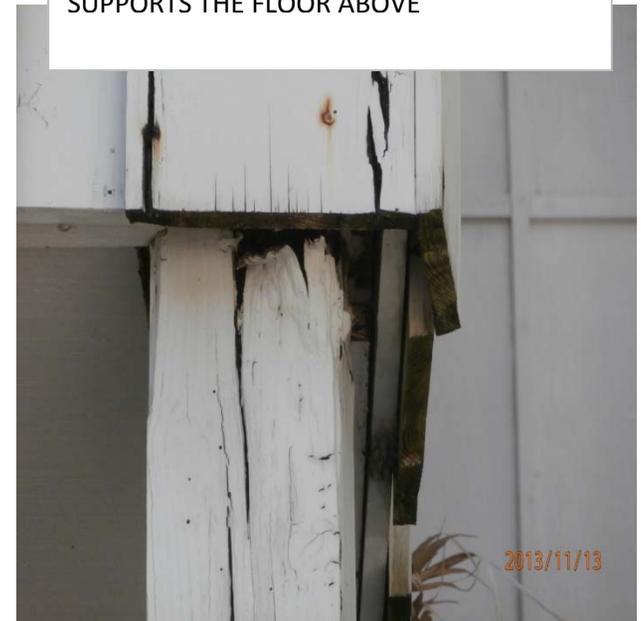
VILLA 3 BUILDING – WOOD

- **Ultimate deformation**
- **Deterioration**
- **Damage from insects, rodents and other vermin**
- **Significant splits and checks**
- **Detached, dislodged, or failing connections**

DETERIORATED WOOD.. POST NO LONGER SUPPORTS THE FLOOR ABOVE

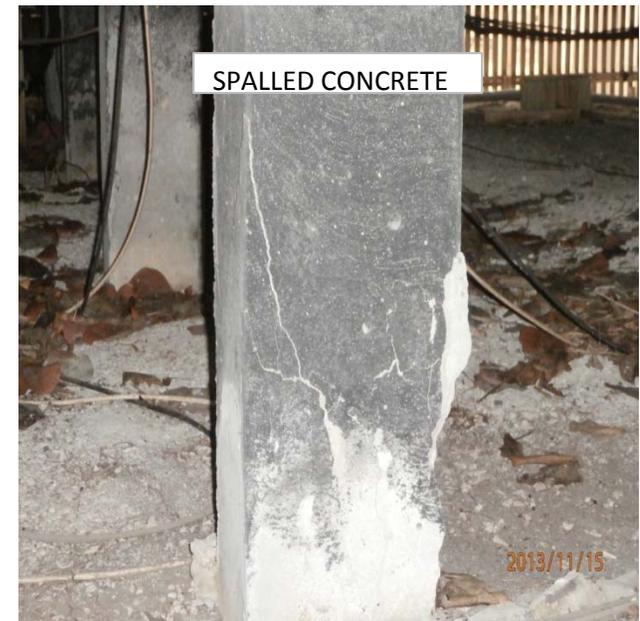
VILLA 7 BUILDING – CONCRETE

- Fractures
- Fissures
- Spalling
- Exposed Reinforcement
- Detached, Dislodged or Failing Connections

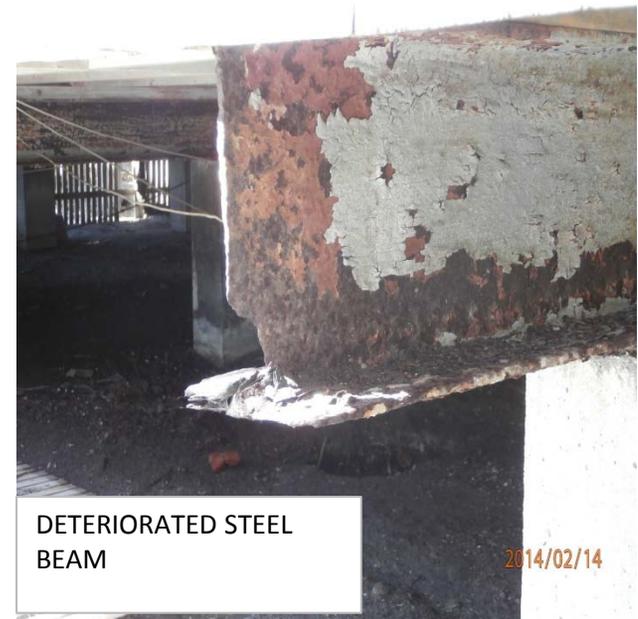
VILLA 7 BUILDING – STEEL

- Deterioration
- Metal fatigue
- Detached, dislodged, or failing connections

DETERIORATED STEEL
BEAM

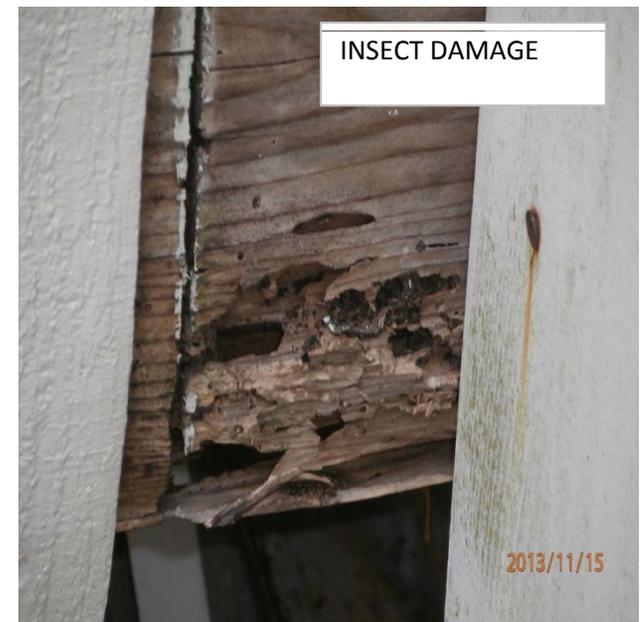
VILLA 7 BUILDING – WOOD

- Ultimate deformation
- Deterioration
- Damage from insects, rodents and other vermin
- Significant splits and checks
- Detached, dislodged, or failing connections

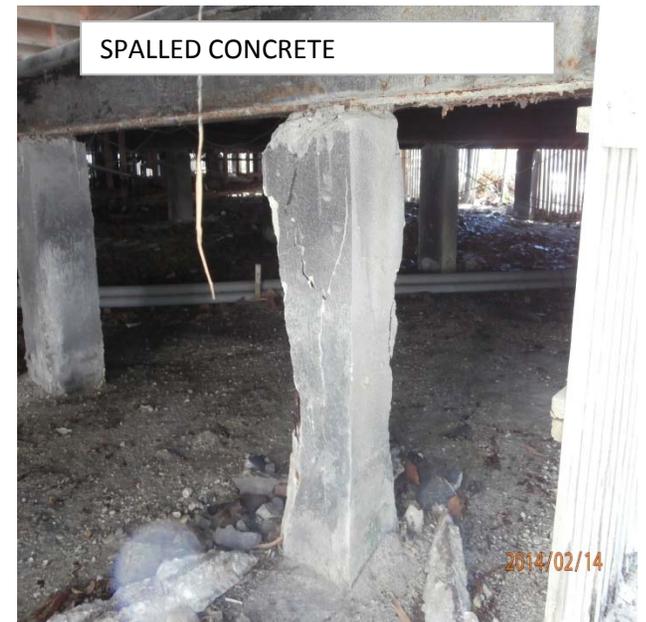
VILLA 4 BUILDING – CONCRETE

- Fractures
- Fissures
- Spalling
- Exposed Reinforcement
- Detached, Dislodged or Failing Connections

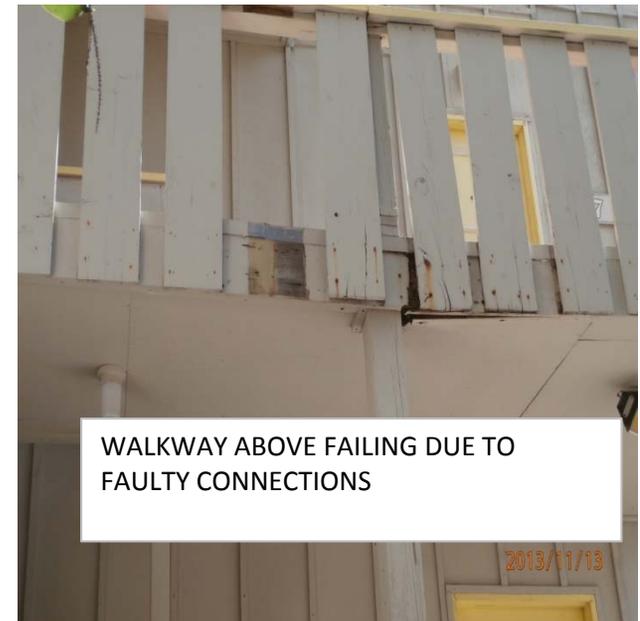
VILLA 4 BUILDING – WOOD

- Ultimate deformation
- Deterioration
- Damage from insects, rodents and other vermin
- Significant splits and checks
- Detached, dislodged, or failing connections

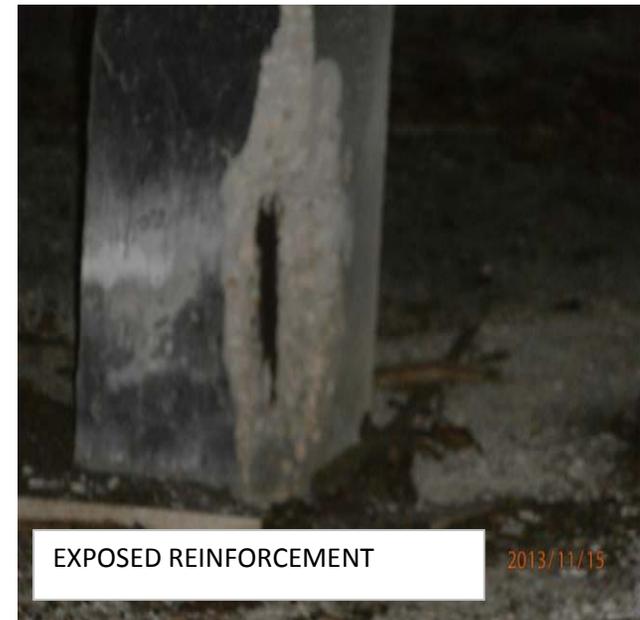
VILLA 6 BUILDING – CONCRETE

- Fractures
- Fissures
- Spalling
- Exposed Reinforcement
- Detached, Dislodged or Failing Connections

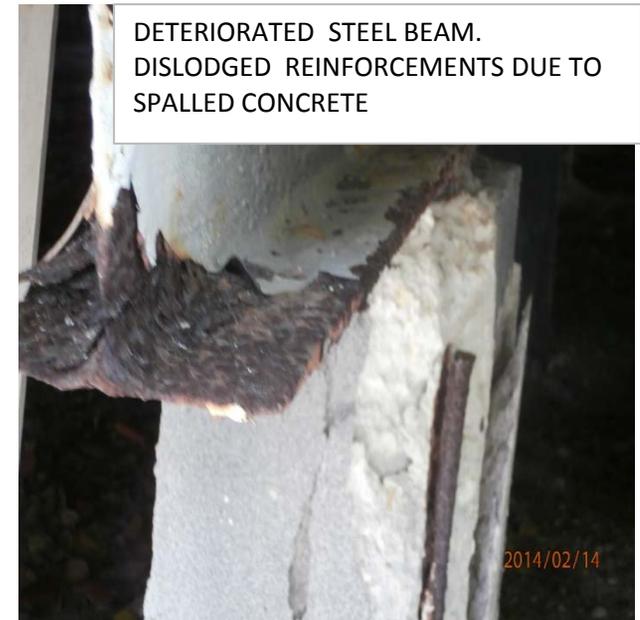
VILLA 6 BUILDING – STEEL

- **Deterioration**
- **Metal fatigue**
- **Detached, dislodged, or failing connections**

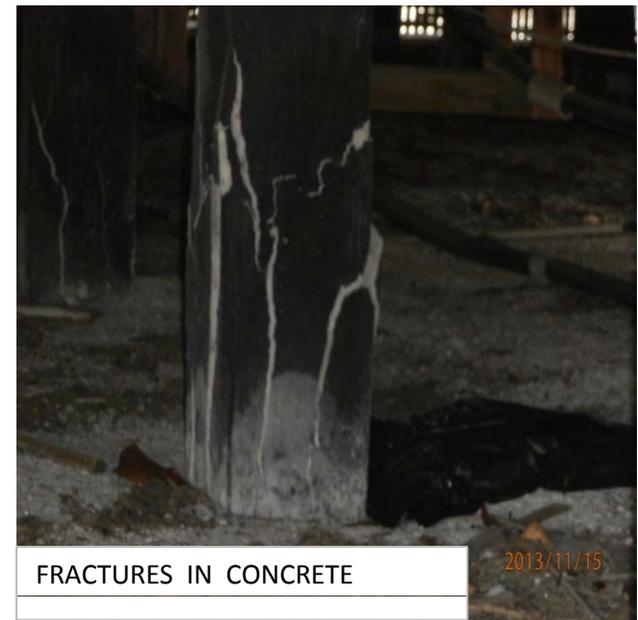
VILLA 15 BUILDING – CONCRETE

- Fractures
- Fissures
- Spalling
- Exposed Reinforcement
- Detached, Dislodged or Failing Connections

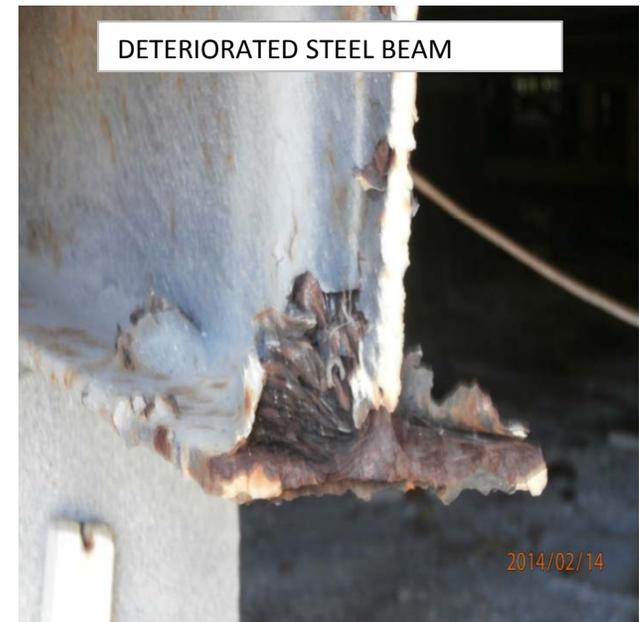
VILLA 15 BUILDING – STEEL

- **Deterioration**
- **Metal fatigue**
- **Detached, dislodged, or failing connections**

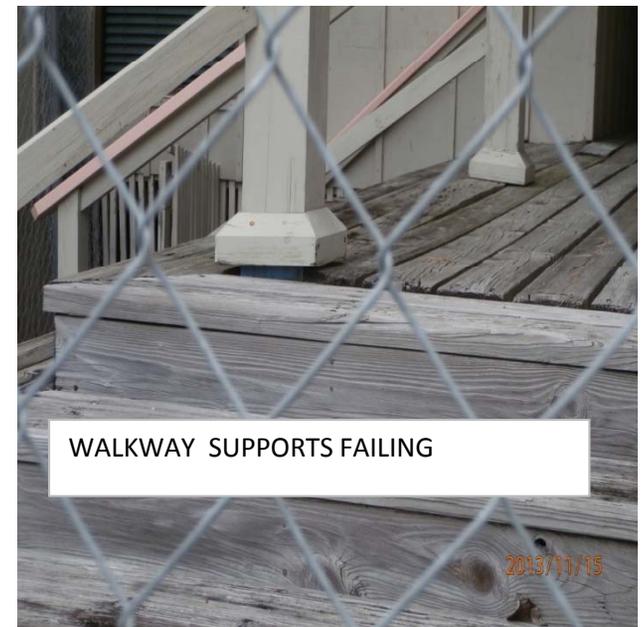
VILLA 15 BUILDING – WOOD

- Ultimate deformation
- Deterioration
- Damage from insects, rodents and other vermin
- Significant splits and checks
- Detached, dislodged, or failing connections

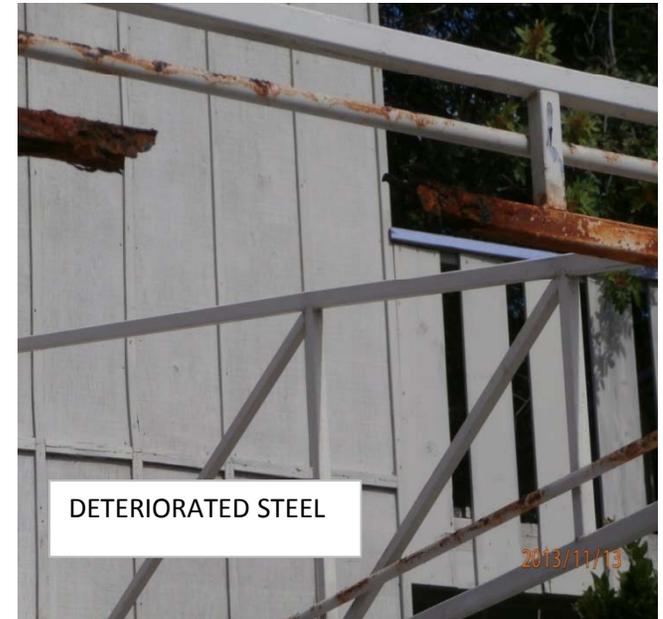
VILLA 5 BUILDING – STEEL

- Deterioration
- Metal fatigue
- Detached, dislodged, or failing connections

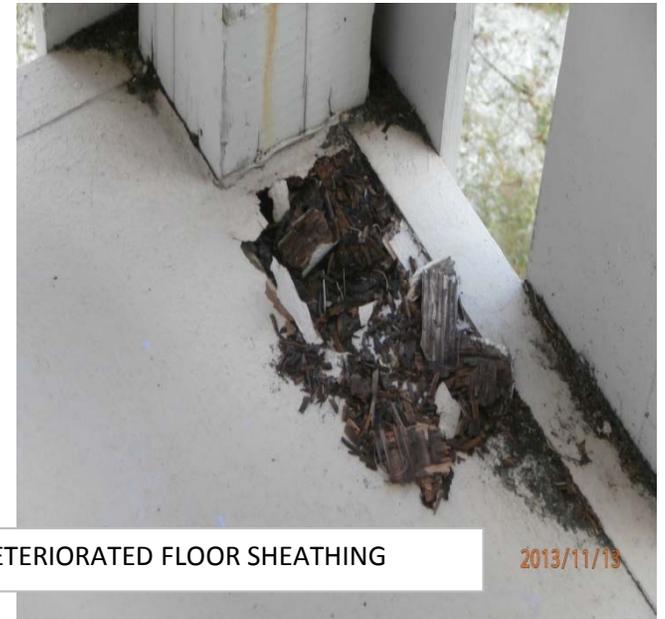
VILLA 5 BUILDING – WOOD

- Ultimate deformation
- Deterioration
- Damage from insects, rodents and other vermin
- Significant splits and checks
- Detached, dislodged, or failing connections

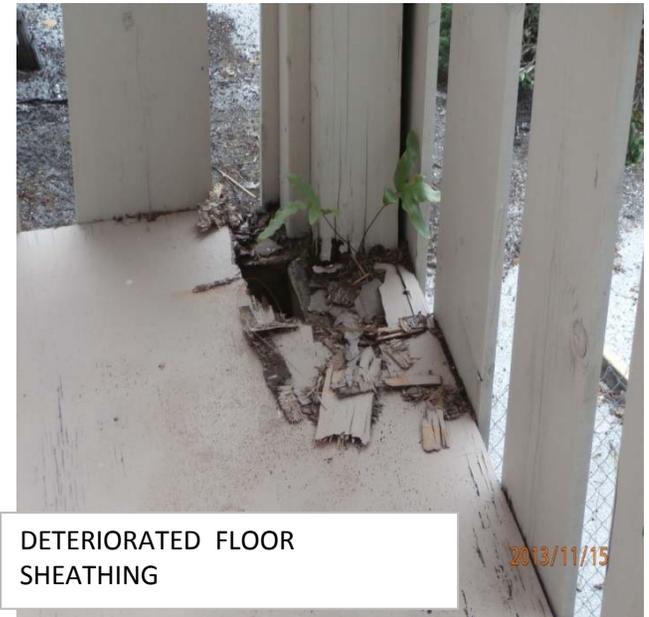
VILLA 13 BUILDING – WOOD

- Ultimate deformation
- Deterioration
- Damage from insects, rodents and other vermin
- Significant splits and checks
- Detached, dislodged, or failing connections

DETERIORATED FLOOR
SHEATHING

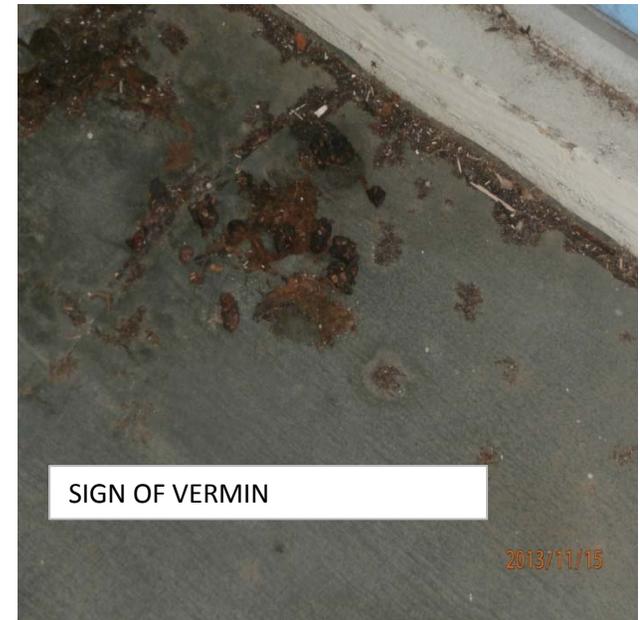
VILLA 14 BUILDING – WOOD

- Ultimate deformation
- Deterioration
- Damage from insects, rodents and other vermin
- Significant splits and checks
- Detached, dislodged, or failing connections

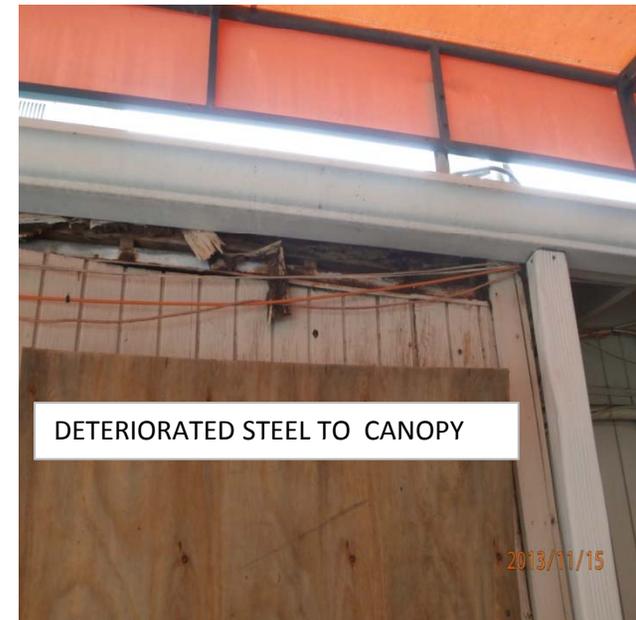
HOUSEKEEPING/ACCOUNTING/FLOWER SHOP/PURCHASING AND RECEIVING/ HUMAN RESOURCES BUILDING– STEEL

- Deterioration
- Metal fatigue

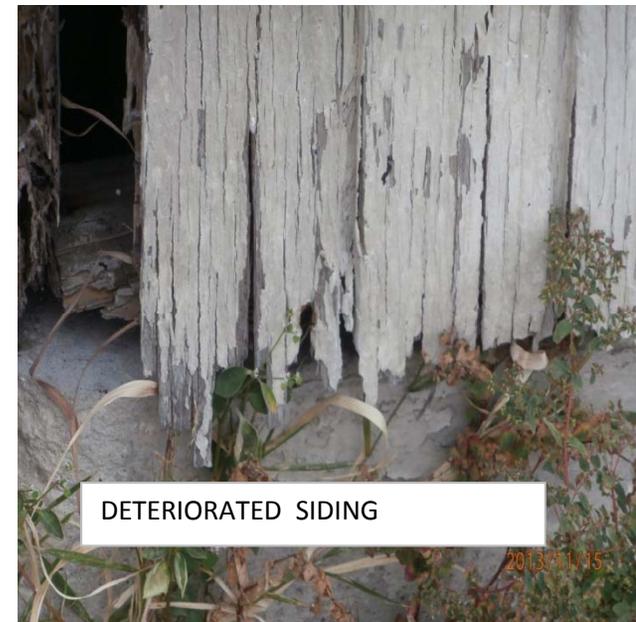
MAINTENANCE BUILDING – WOOD

- Deterioration
- Damage from insects, rodents and other vermin
- Detached, dislodged, or failing connections

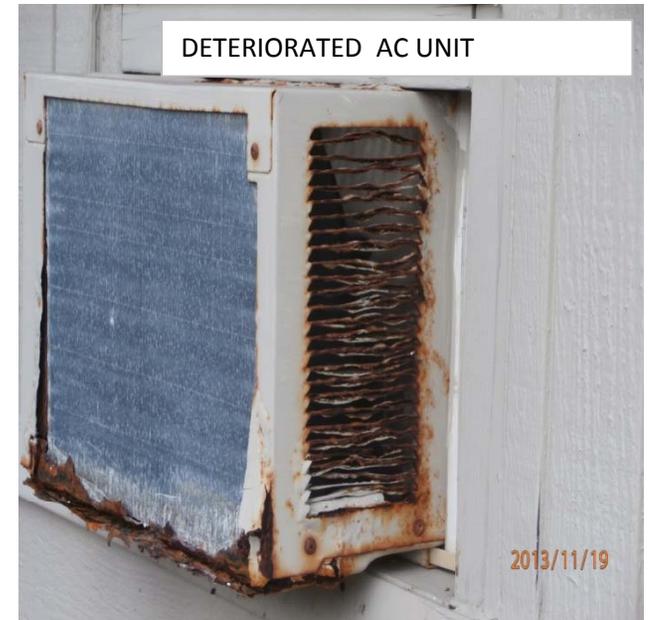
GUARDHOUSE BUILDING – STEEL

- **Deterioration**
