**PUBLIC NUISANCE HEARING
1620 GULF OF MEXICO DRIVE
RESTAURANT/BAR COMPLEX**

**TOWN COMMISSION SPECIAL MEETING
MARCH 4, 2014**

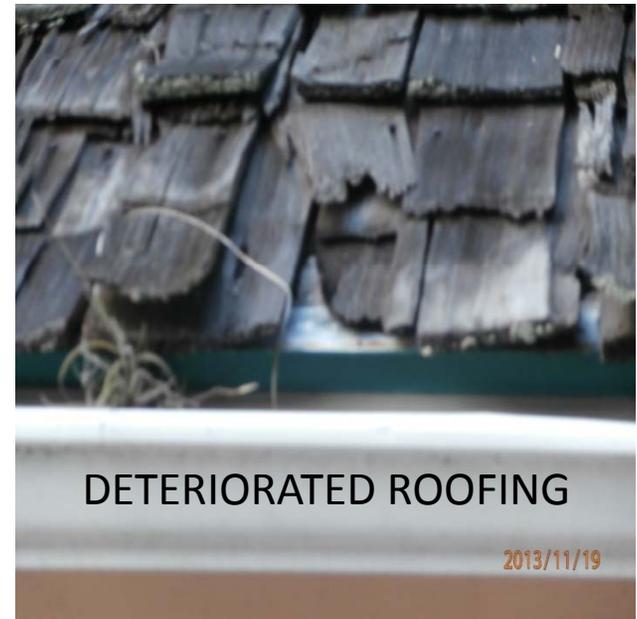
GUARDHOUSE BUILDING – WOOD

- Deterioration
- Damage from insects, rodents and other vermin

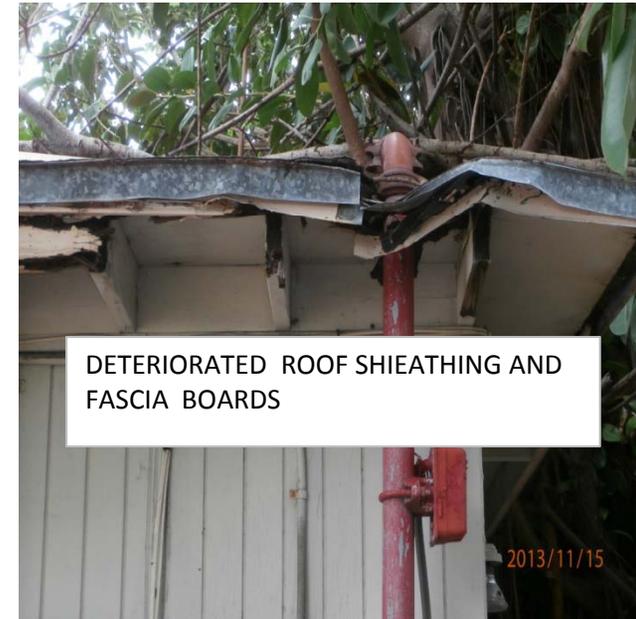
CONFERENCE CENTER/AEROBICS CENTER BUILDING WOOD

- **Deterioration**

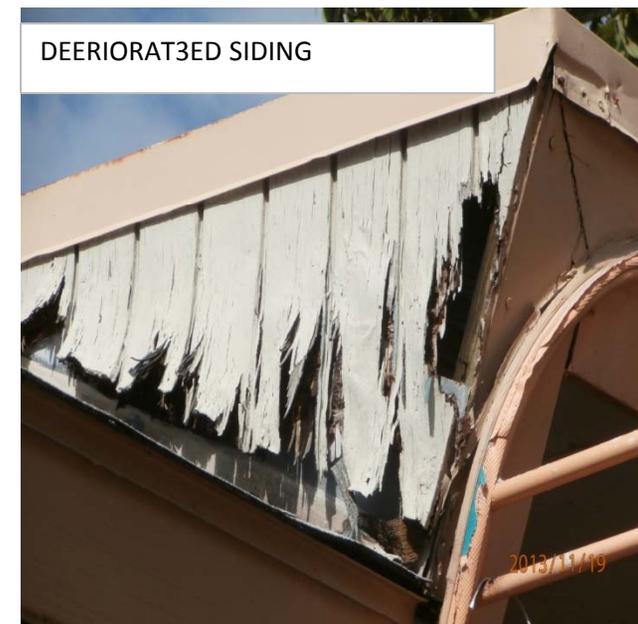
SALES AND MARKETING/EXECUTIVE OFFICE BUILDING – WOOD

- Deterioration
- Damage from insects, rodents and other vermin
- Detached, dislodged, or failing connections
