ENGINEERING INSPECTION REPORT

THE COLONY BEACH and TENNIS RESORT

Longboat Key, Florida

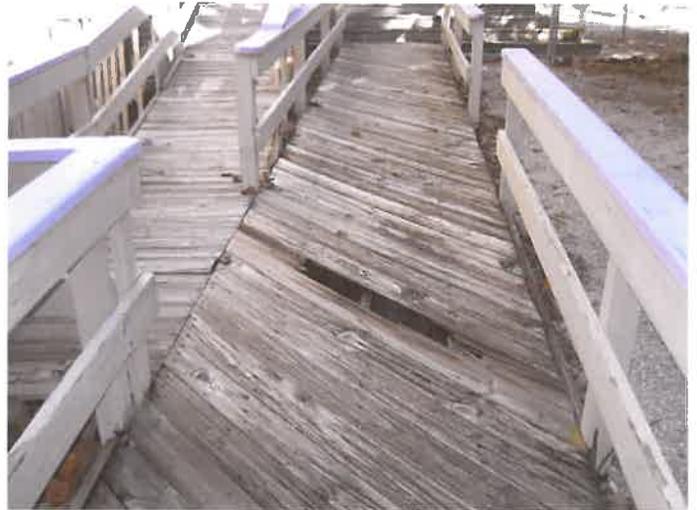
| 78 | Villa – Deteriorated walkway | 1582 | Villa 5 |
