Agenda Item: North End Structures Update

**NORTH END EROSION CONTROL STRUCTURE  
DISCUSSION - SEPTEMBER 24, 2012**

## EROSION CONTROL STRUCTURES NORTH LONGBOAT KEY AND GREER ISLAND

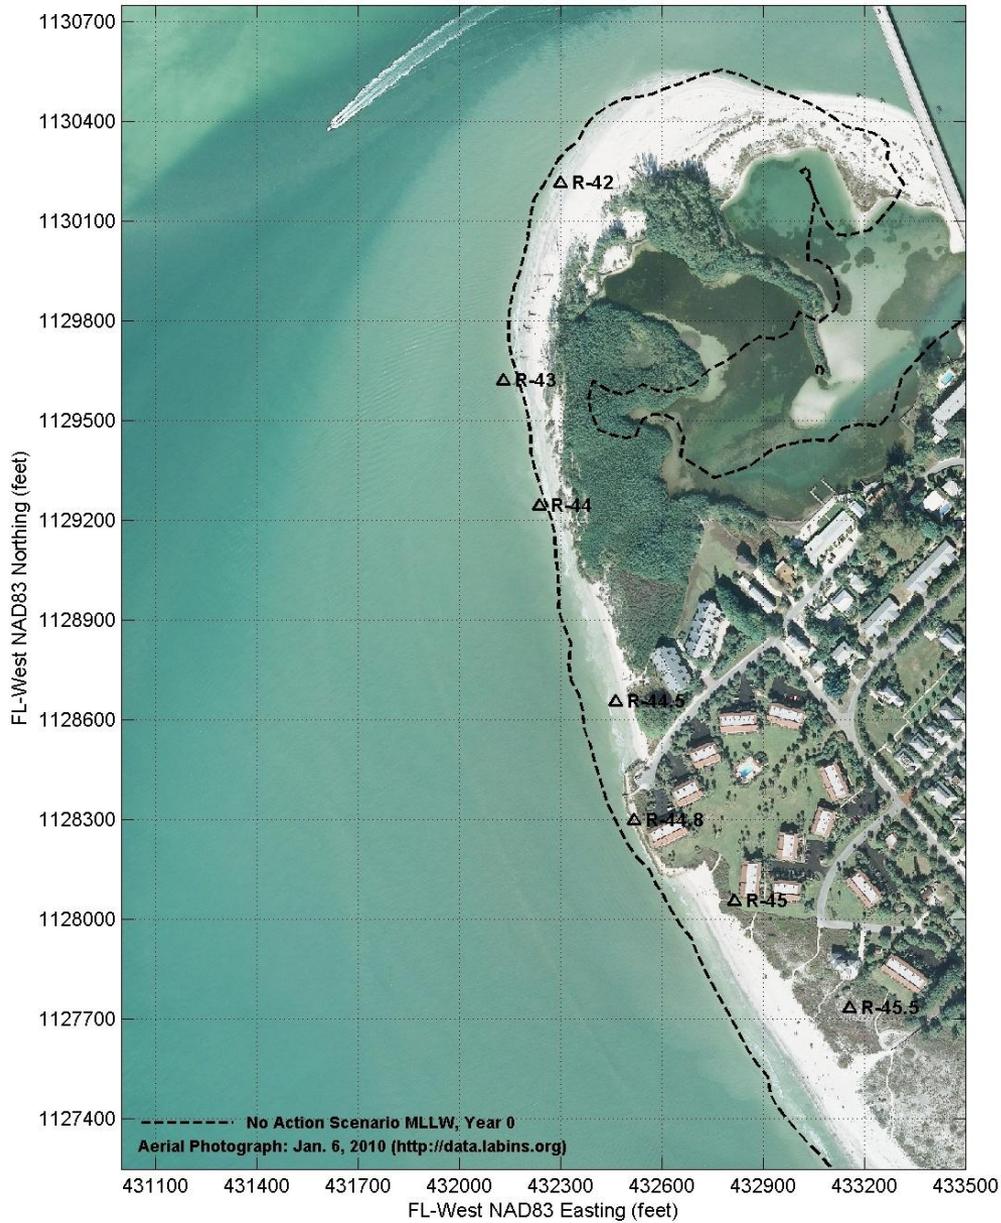
# No Action Scenario Year 0

**No beach fills, navigational dredging,  
nor new erosion control structures**

No Action Scenario (Alt. A) Simulated MLLW (-1.57 feet NAVD) Shoreline, Year 0

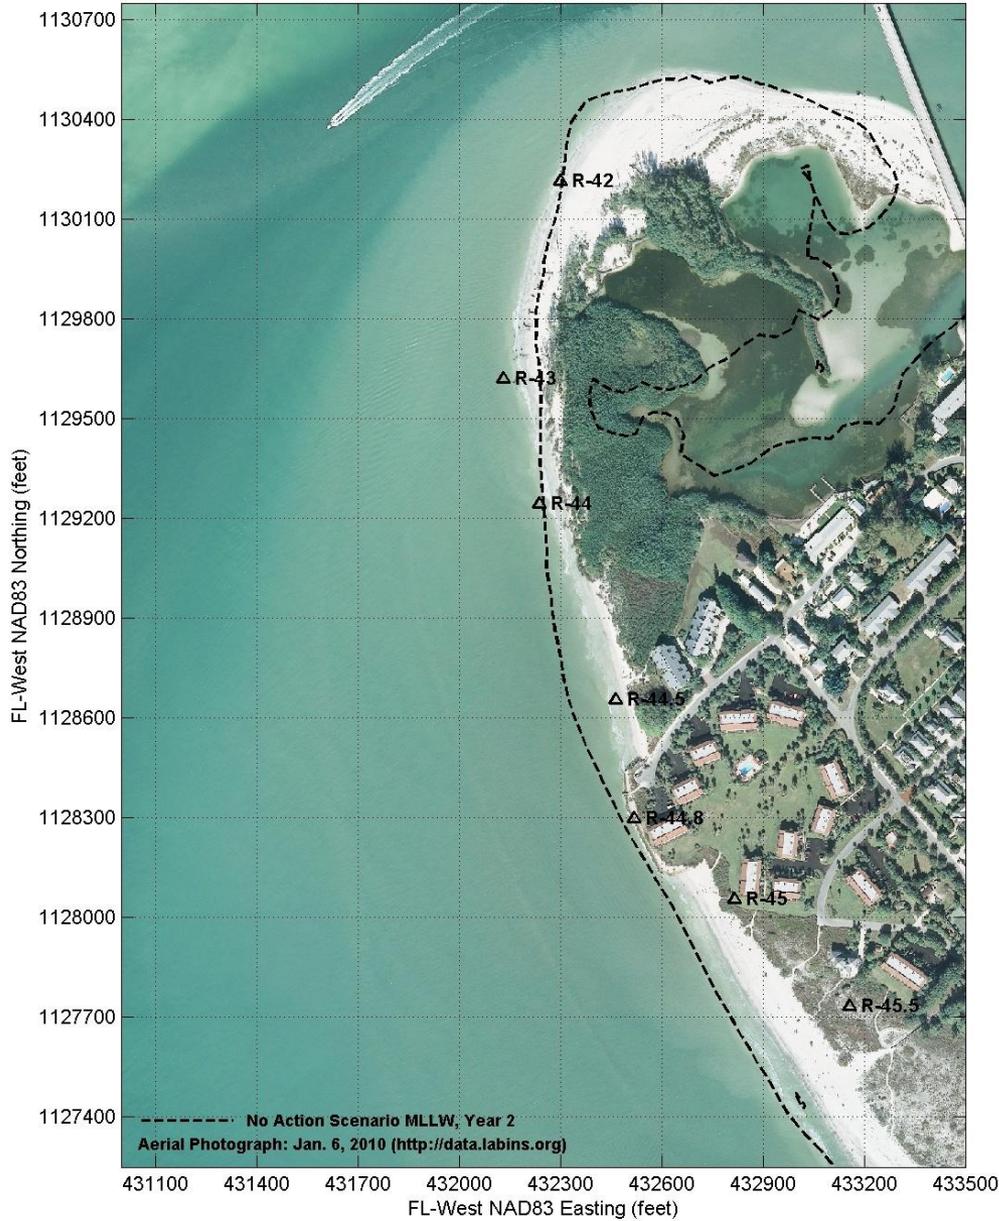
# No Action Scenario Year 2

No Action Scenario (Alt. A) Simulated MLLW (-1.57 feet NAVD) Shoreline, Year 2

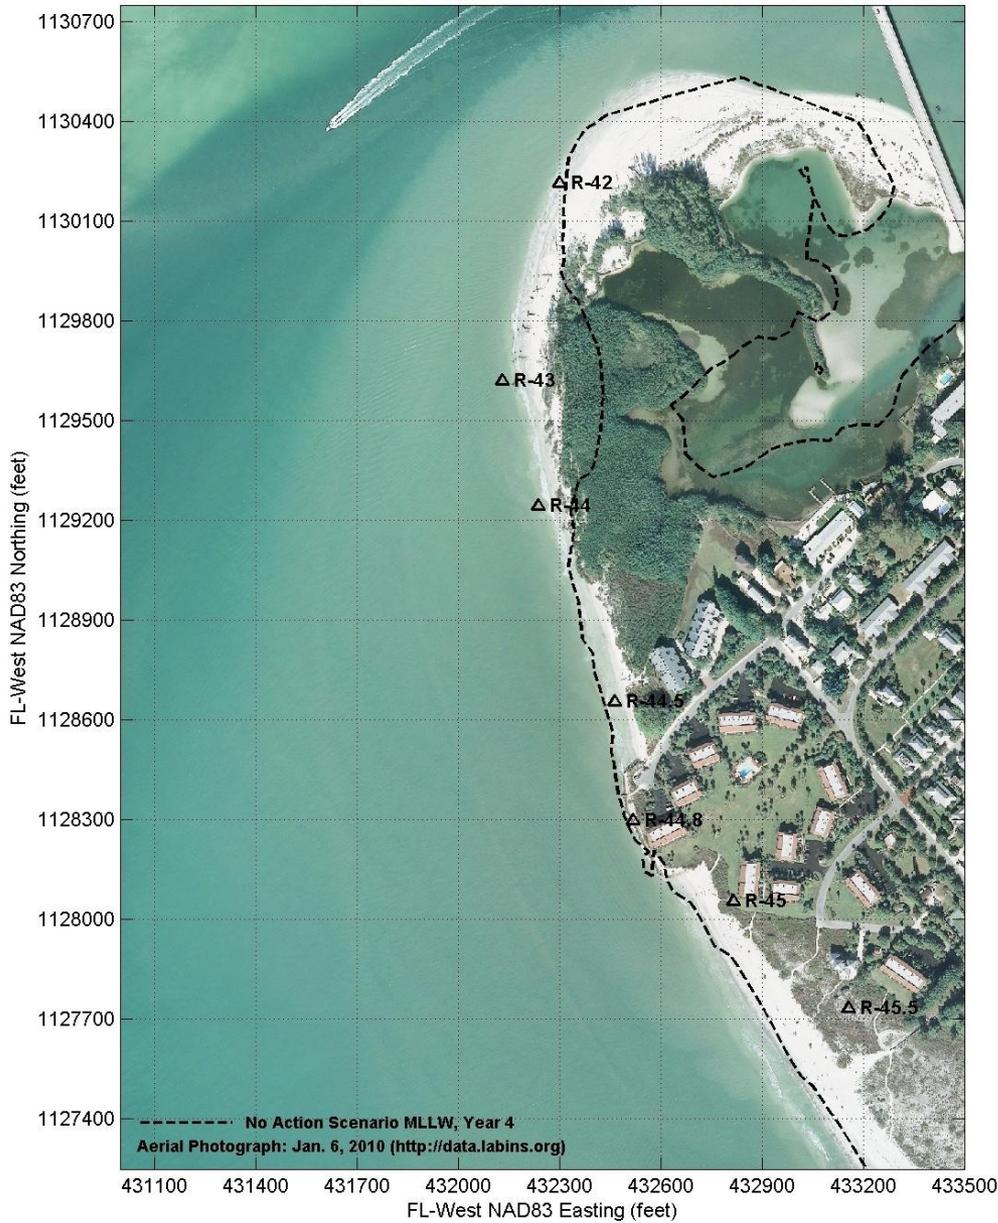
# No Action Scenario Year 4

No Action Scenario (Alt. A) Simulated MLLW (-1.57 feet NAVD) Shoreline, Year 4

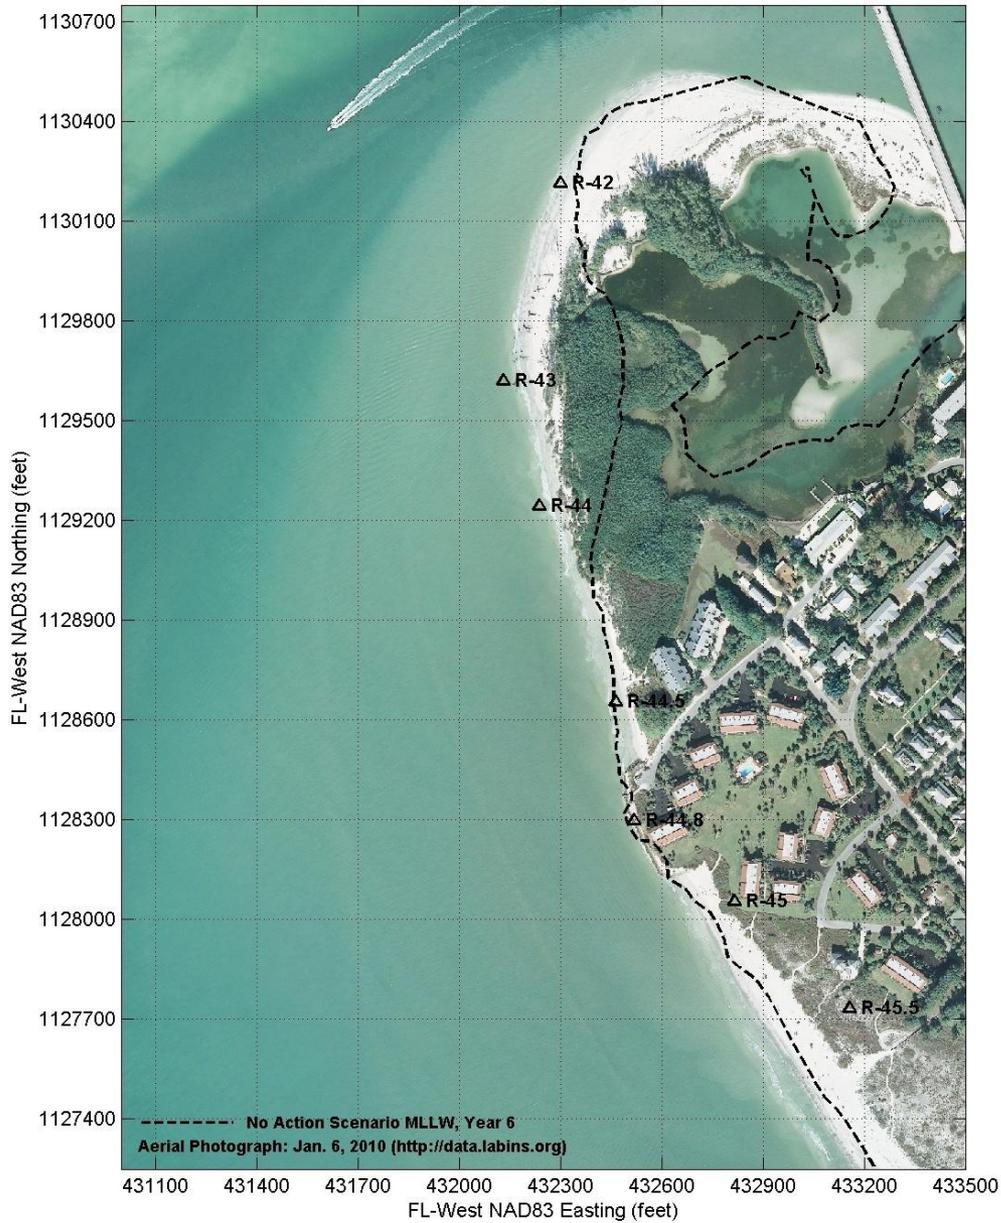
# No Action Scenario Year 6

No Action Scenario (Alt. A) Simulated MLLW (-1.57 feet NAVD) Shoreline, Year 6

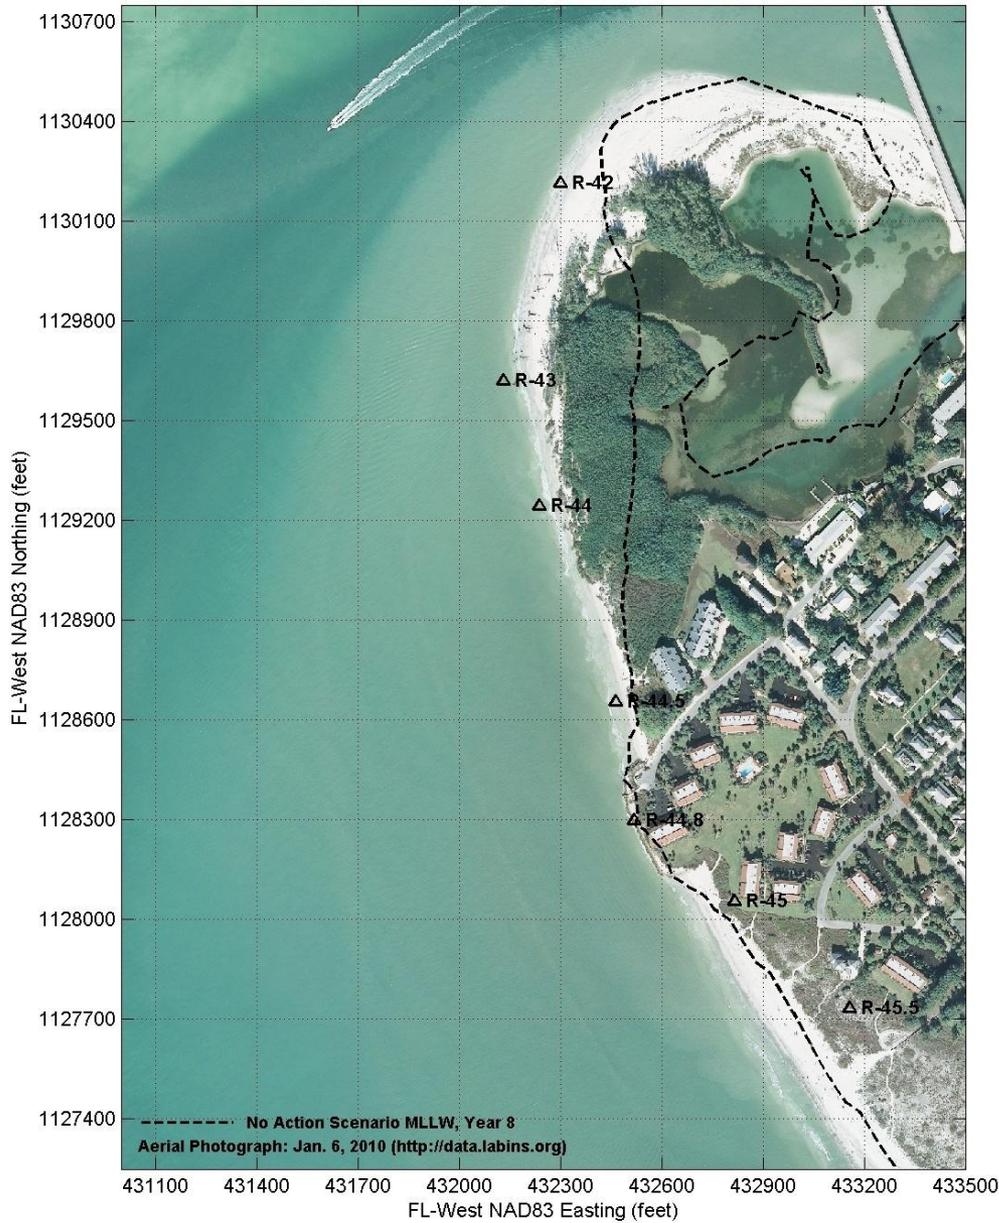
# No Action Scenario Year 8

No Action Scenario (Alt. A) Simulated MLLW (-1.57 feet NAVD) Shoreline, Year 8

- Building no erosion control structure will result in eventual narrowing of the beach from the North Shore sea wall to the north end of Greer (Beer Can) Island.
- 360 North Condominiums will continue to see over-wash and/or wave action during storms.
- Erosion if left unaddressed will eventually overtake all or part of the Australian Pines and mangrove areas of Greer Island.

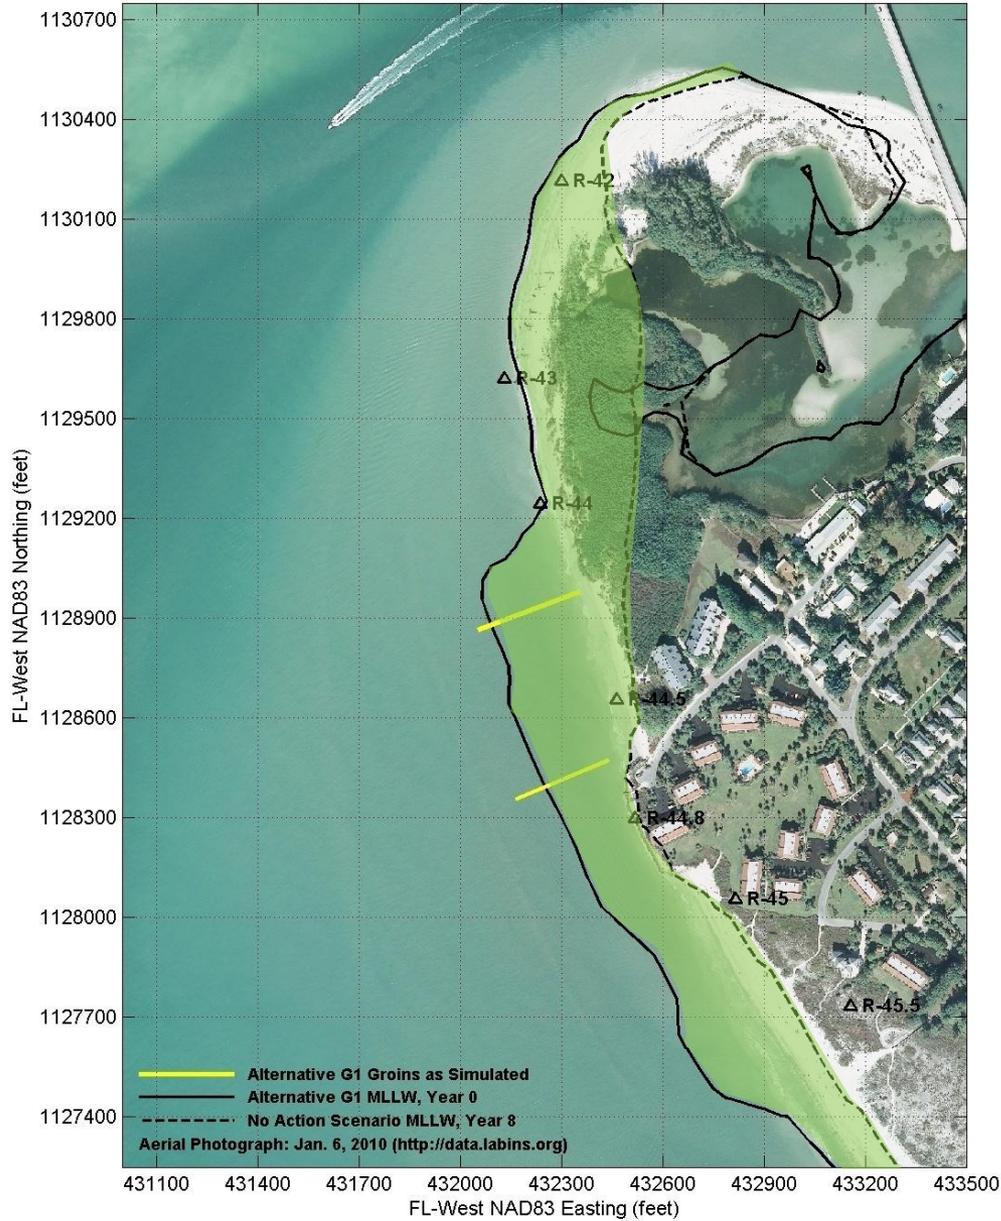
# Two PAG's with Beach Fill Year 0

**Northern groin located up coast from 360 North condominium**

**Southern groin located near north end of  
North Shore Road seawall**

**Beach fill from navigation dredging**

Alternative G1 Simulated MLLW (-1.57 feet NAVD) Shoreline, Year 0

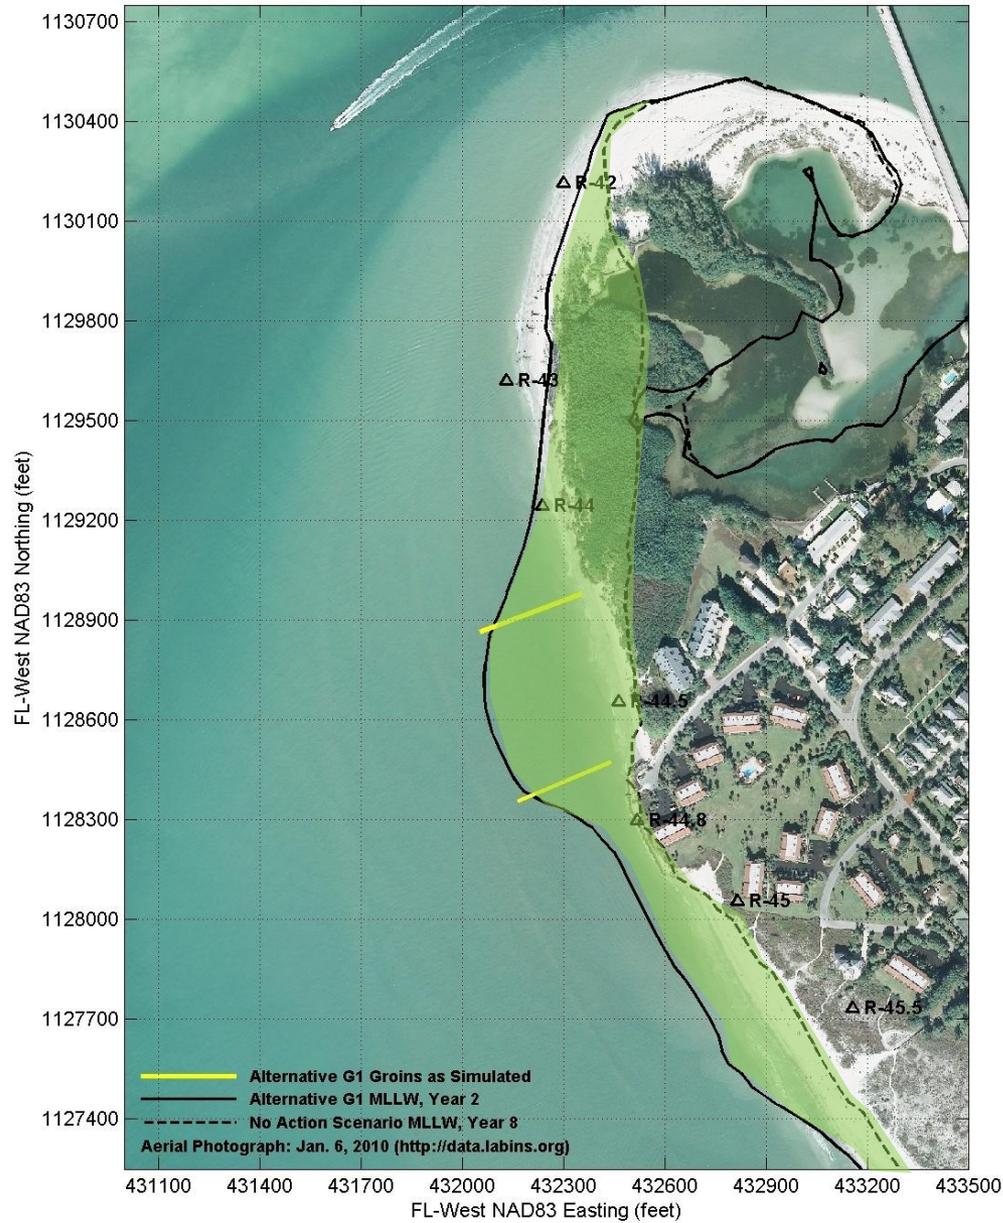
# Two PAG's with Beach Fill Year 2

Alternative G1 Simulated MLLW (-1.57 feet NAVD) Shoreline, Year 2

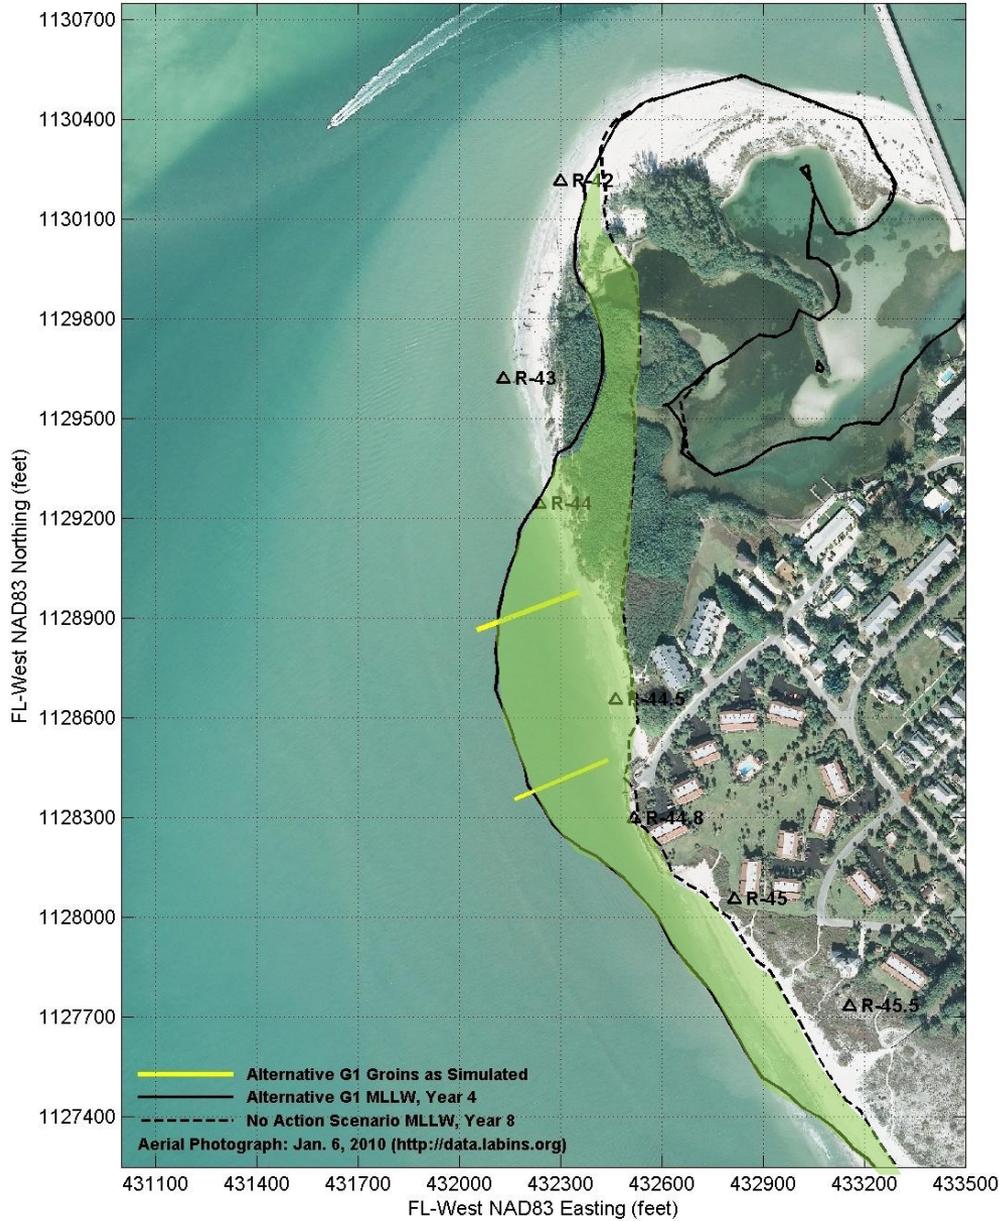
# Two PAG's with Beach Fill Year 4

Alternative G1 Simulated MLLW (-1.57 feet NAVD) Shoreline, Year 4

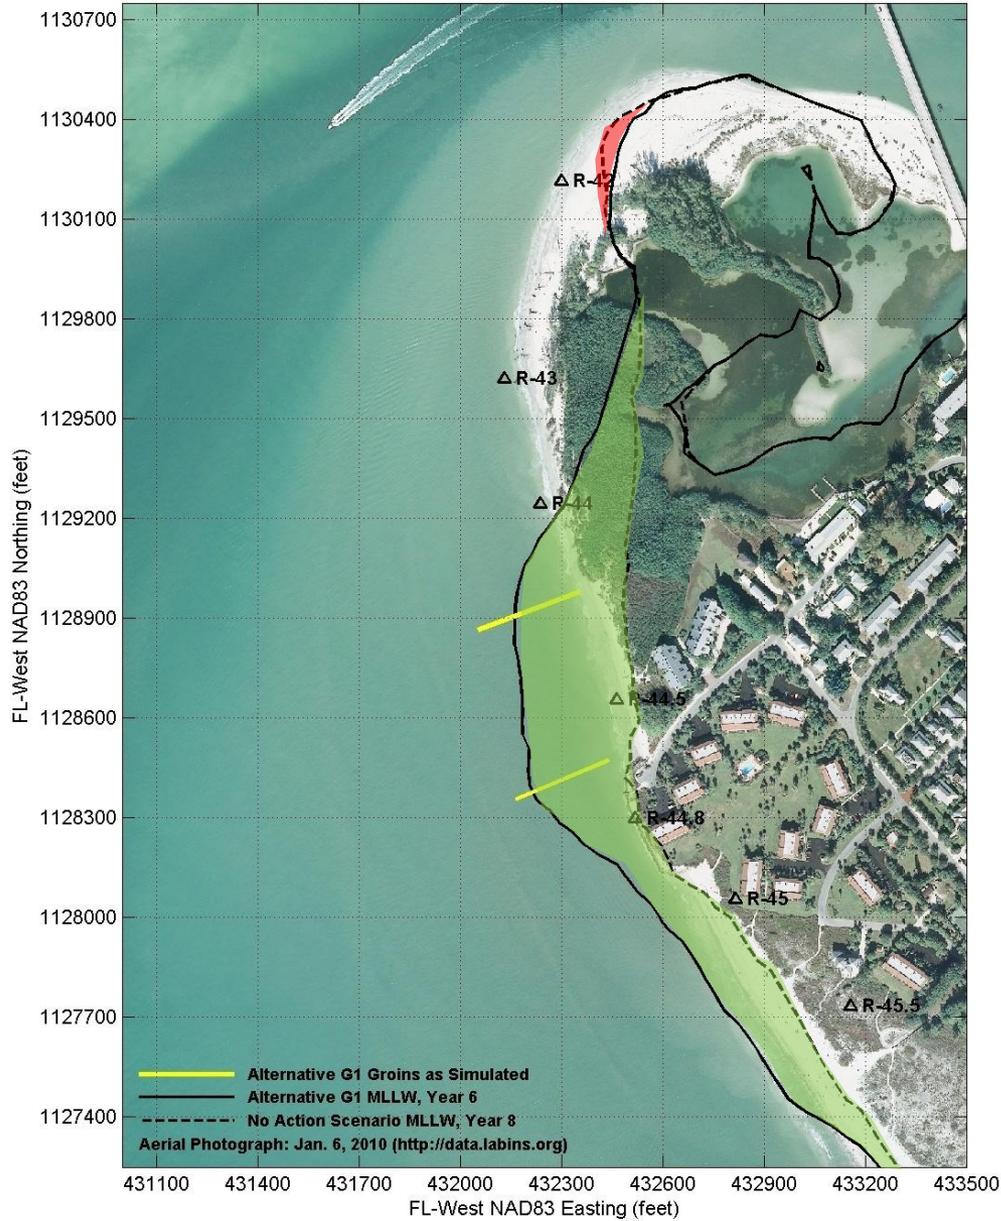
# Two PAG's with Beach Fill Year 6

Alternative G1 Simulated MLLW (-1.57 feet NAVD) Shoreline, Year 6

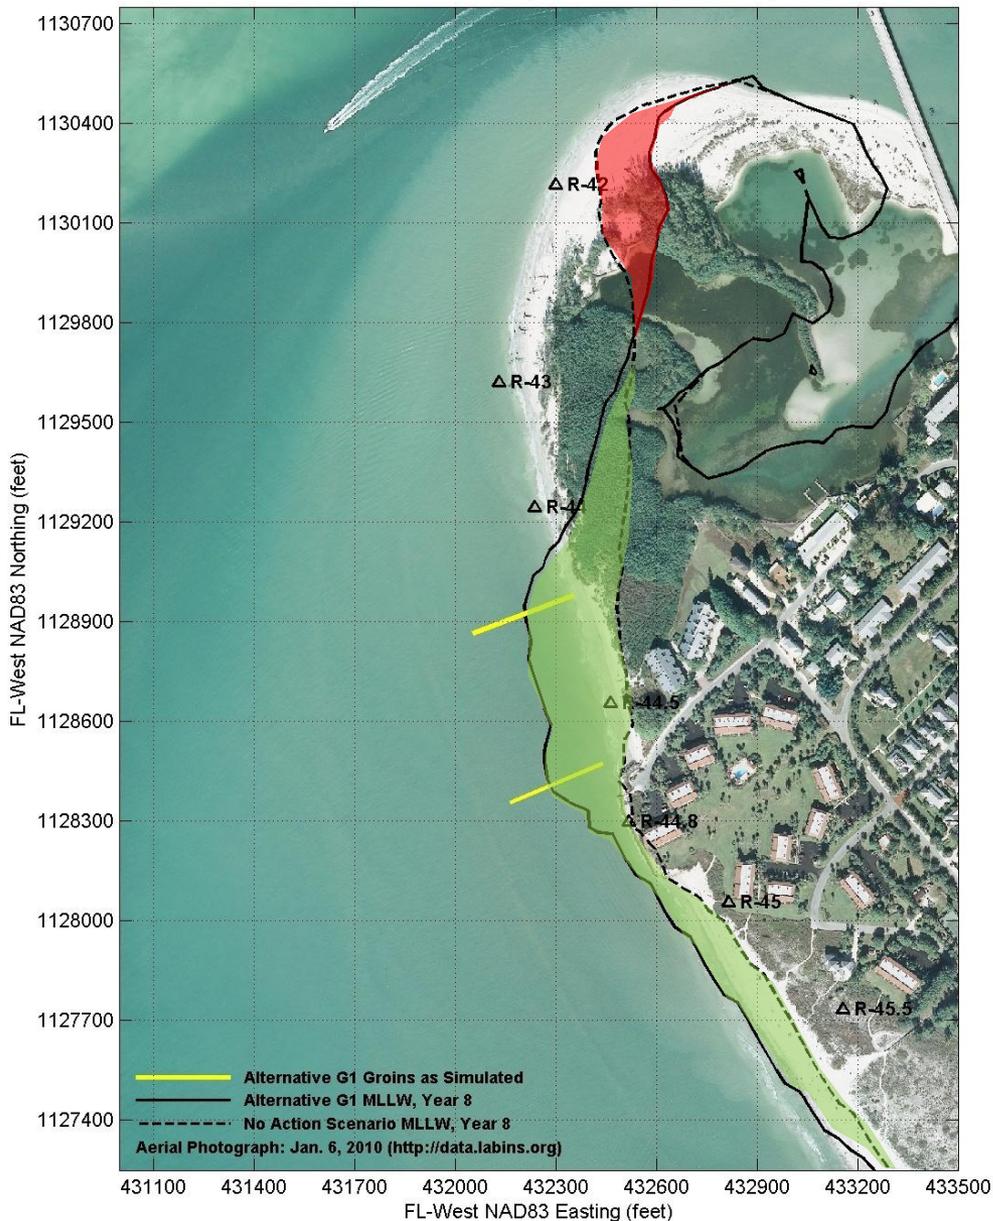
# Two PAG's with Beach Fill Year 8

Alternative G1 Simulated MLLW (-1.57 feet NAVD) Shoreline, Year 8

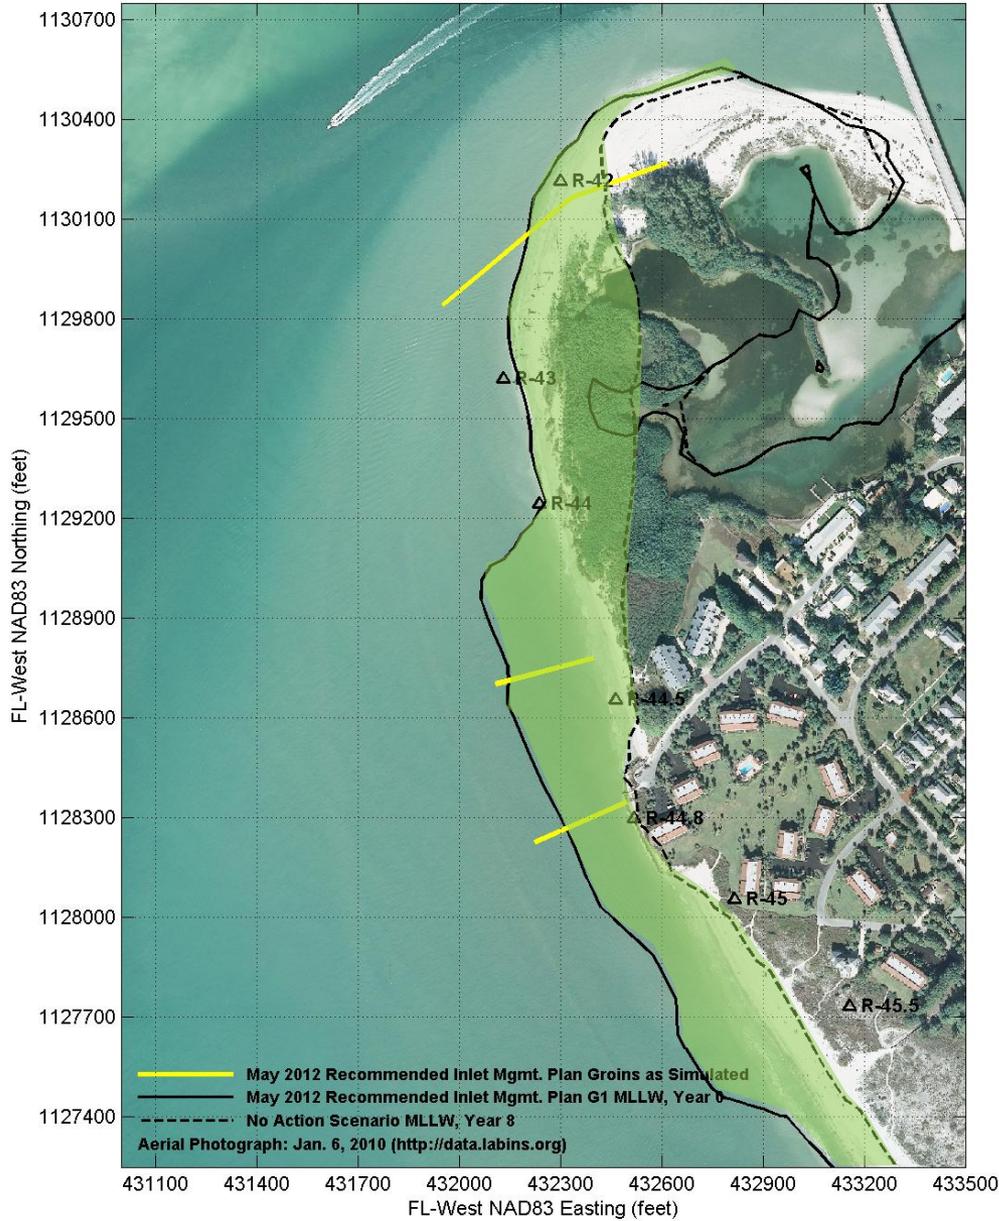
# Two PAG's One Terminal Groin Year 0

**Northern groin located opposite northwest corner of  
360 North Condominium**

**Southern groin located near North Shore Road  
dune/seawall walkover**

**New terminal groin at Longboat Pass**

May 2012 Recommended Inlet Mgmt. Plan (Alt. B1) Simulated MLLW (-1.57 feet NAVD) Shoreline, Year 0

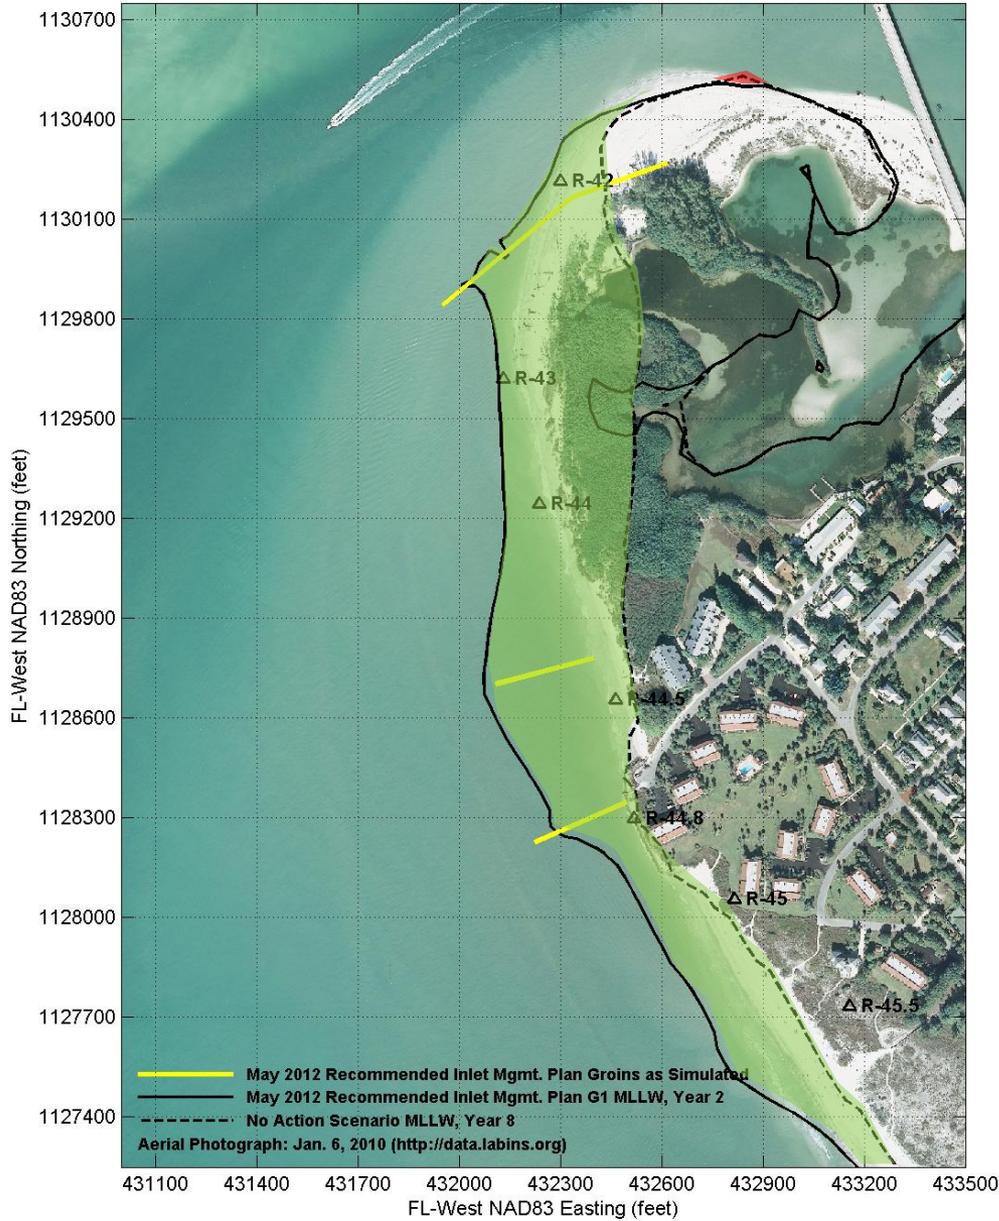
# Two PAG's One Terminal Groin Year 2

May 2012 Recommended Inlet Mgmt. Plan (Alt. B1) Simulated MLLW (-1.57 feet NAVD) Shoreline, Year 2

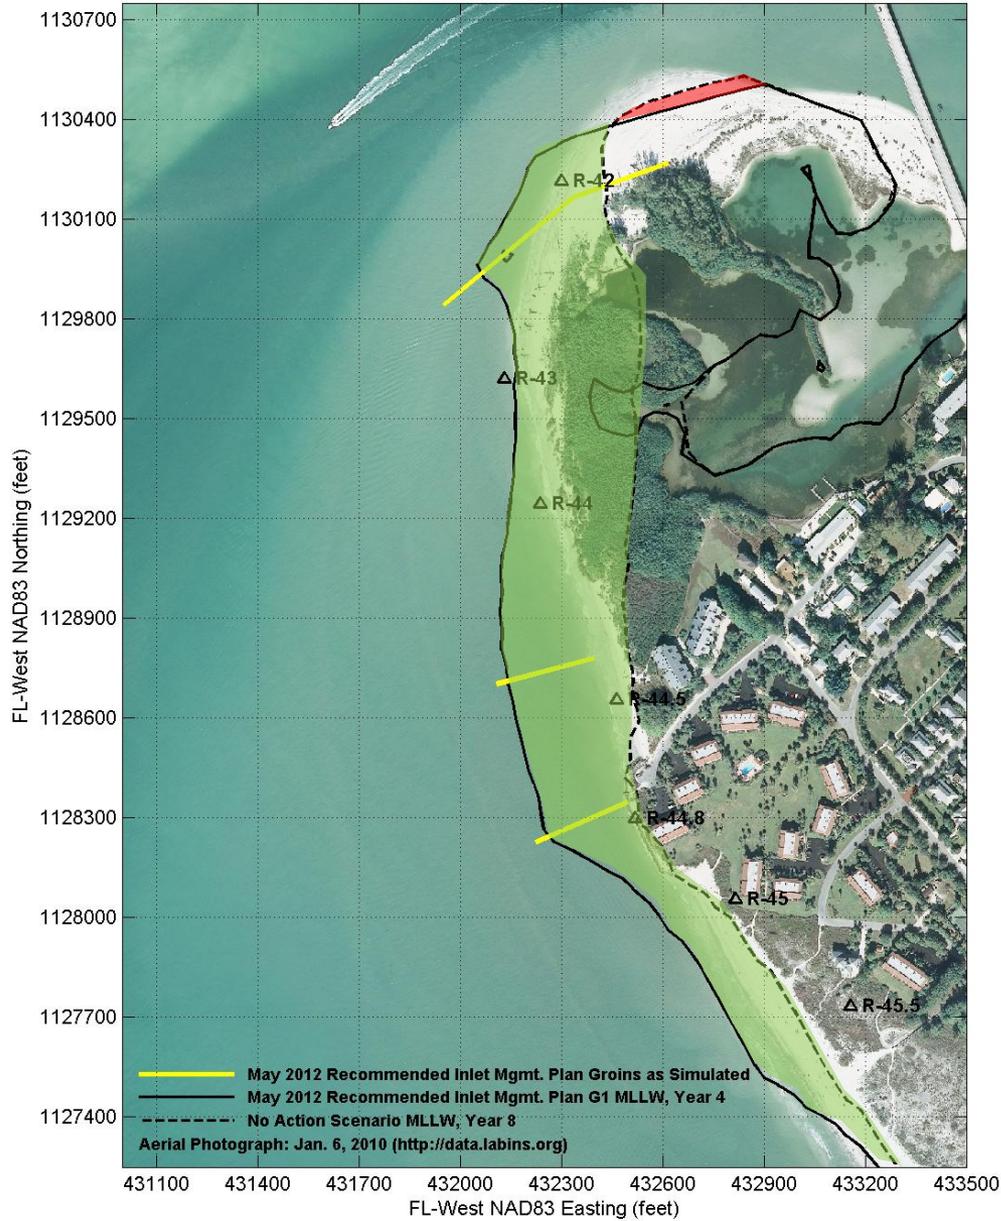
# Two PAG's One Terminal Groin Year 4

May 2012 Recommended Inlet Mgmt. Plan (Alt. B1) Simulated MLLW (-1.57 feet NAVD) Shoreline, Year 4

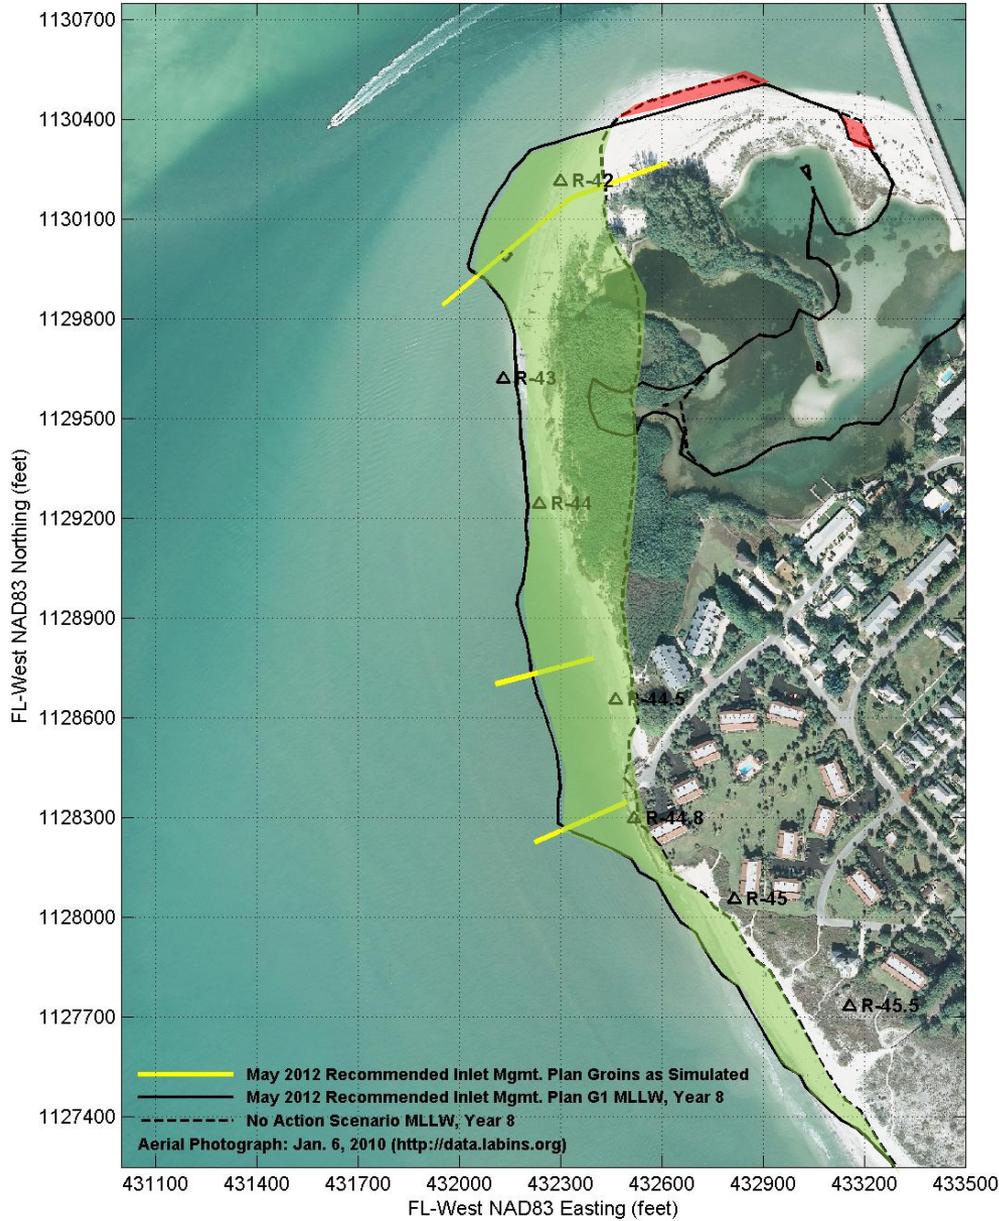
# Two PAG's One Terminal Groin Year 8

May 2012 Recommended Inlet Mgmt. Plan (Alt. B1) Simulated MLLW (-1.57 feet NAVD) Shoreline, Year 8

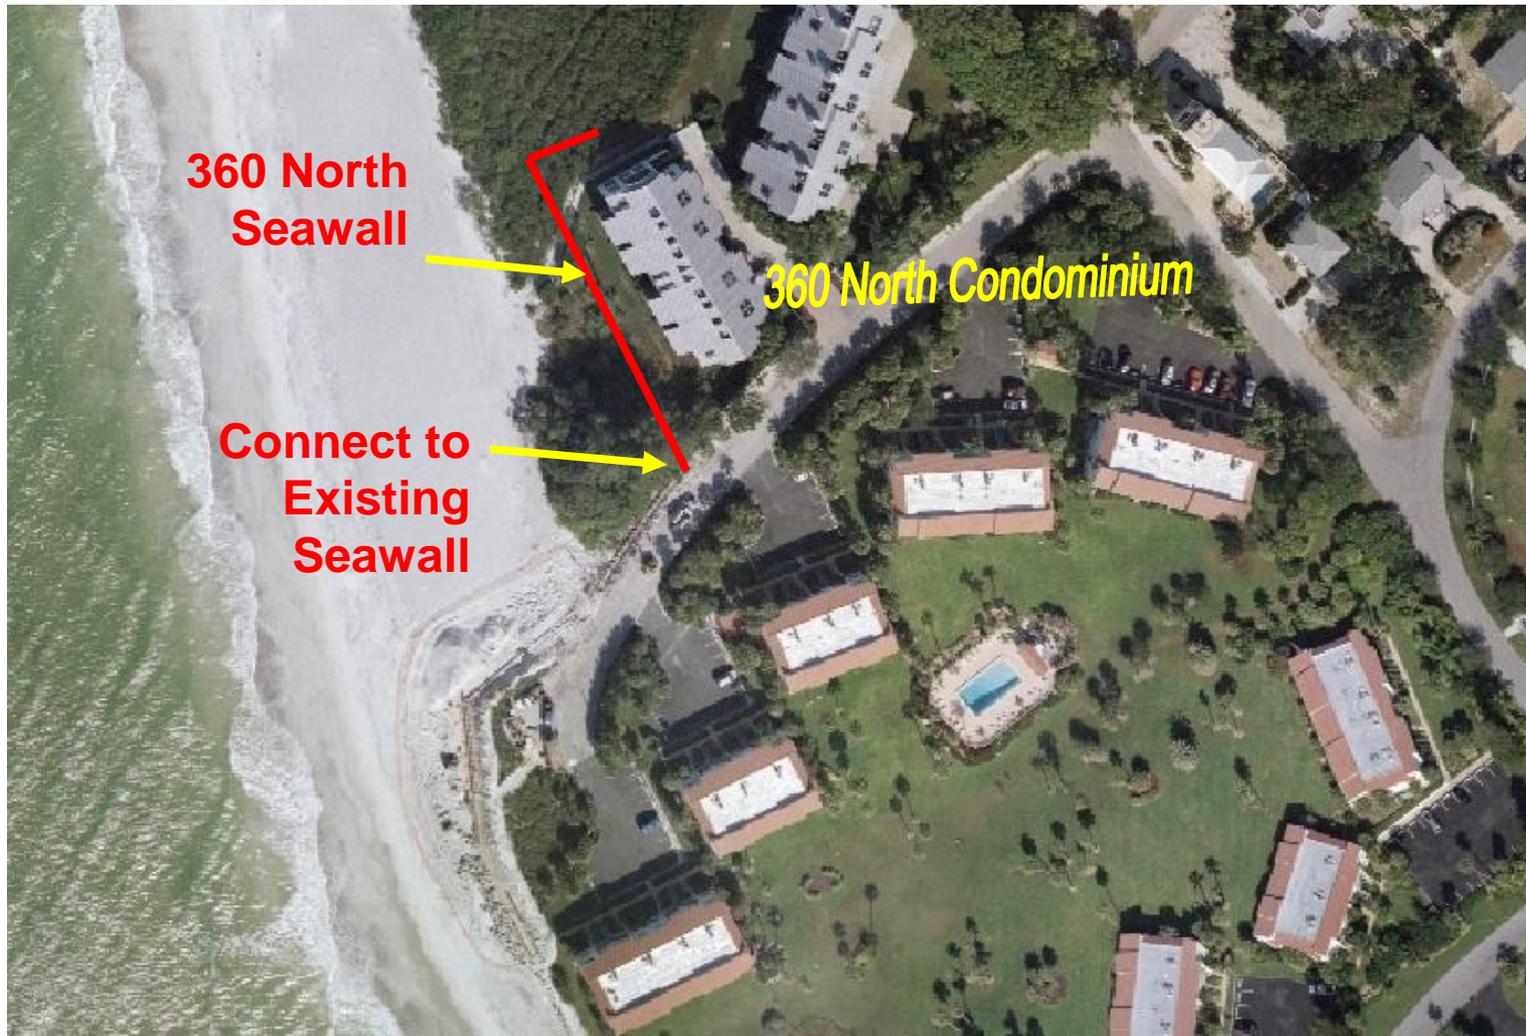
# SEAWALL EXTENSION IN FRONT OF 360 NORTH CONDOMINIUMS

**360 North  
Seawall**

**360 North Condominium**

**Connect to  
Existing  
Seawall**

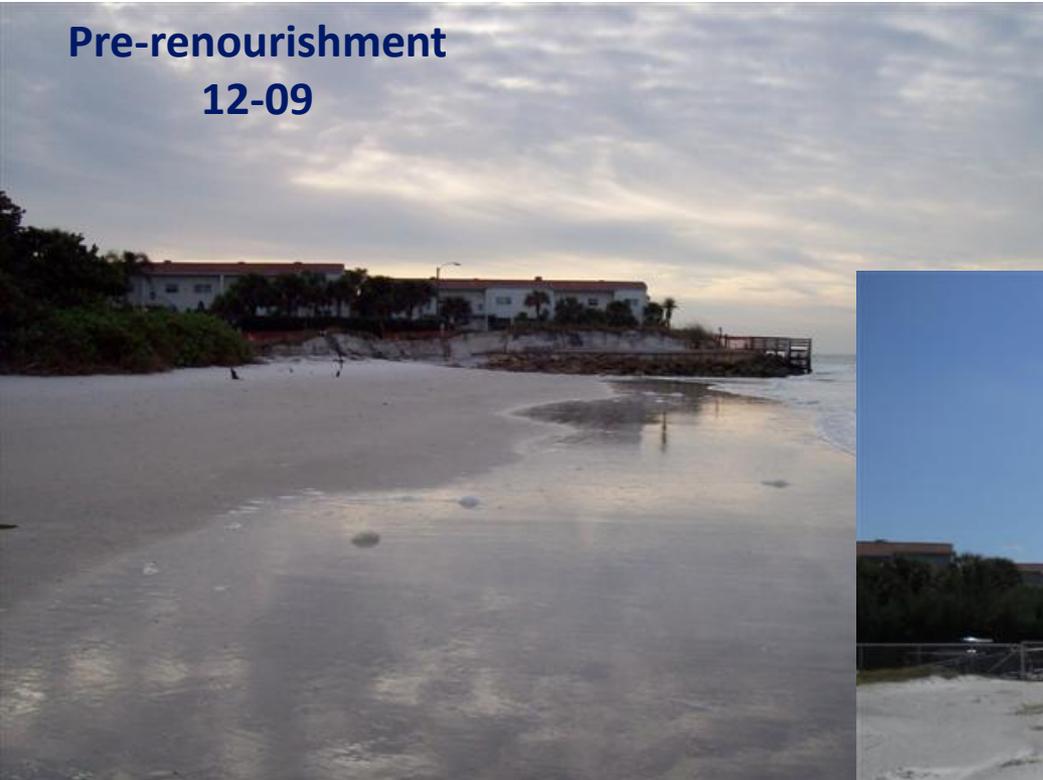
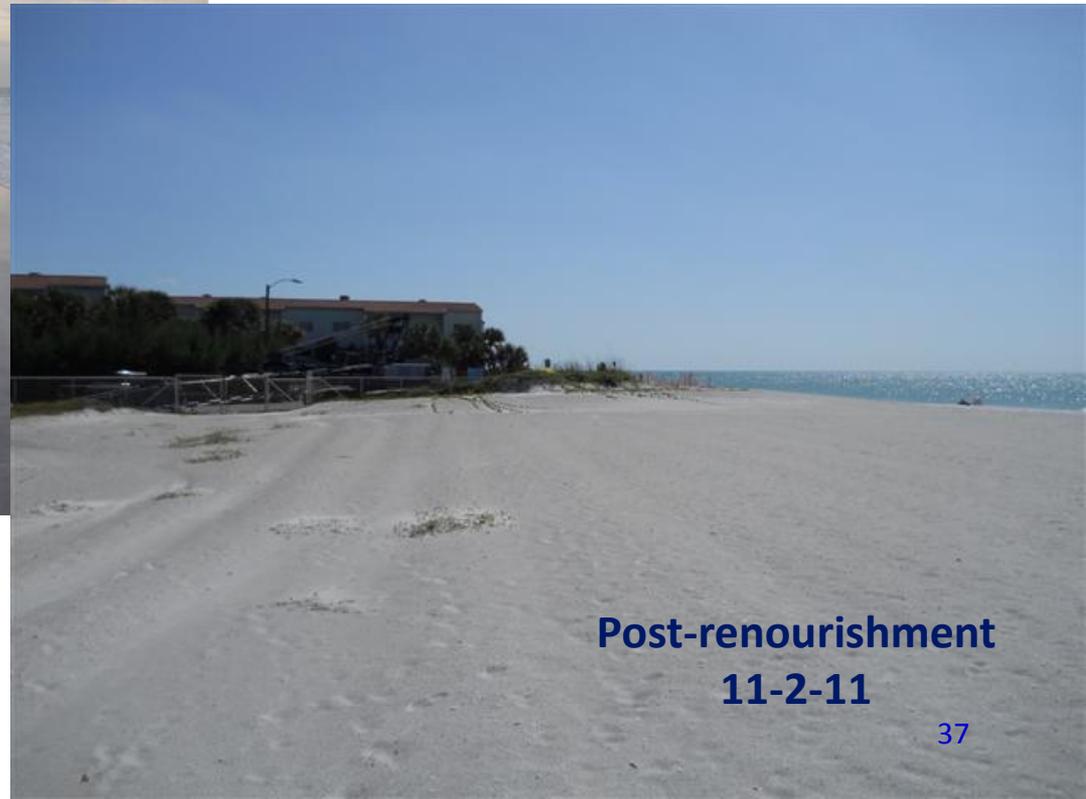
Pre-renourishment  
12-09

Looking South towards  
Coquina Building

Post-renourishment  
11-2-11

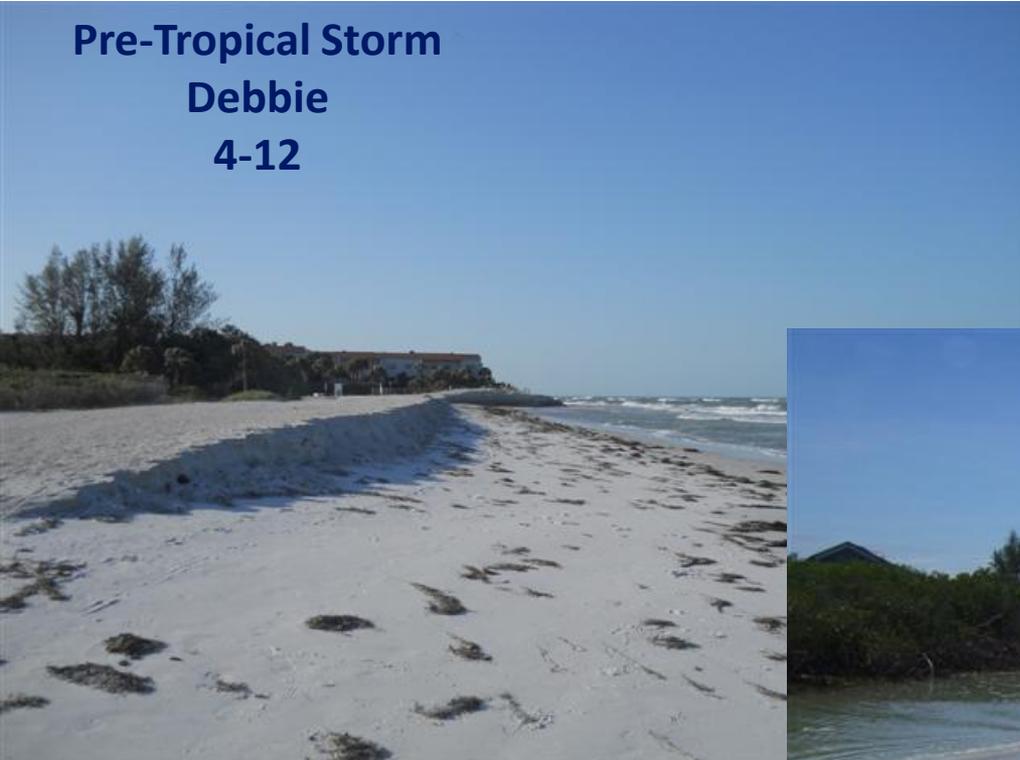
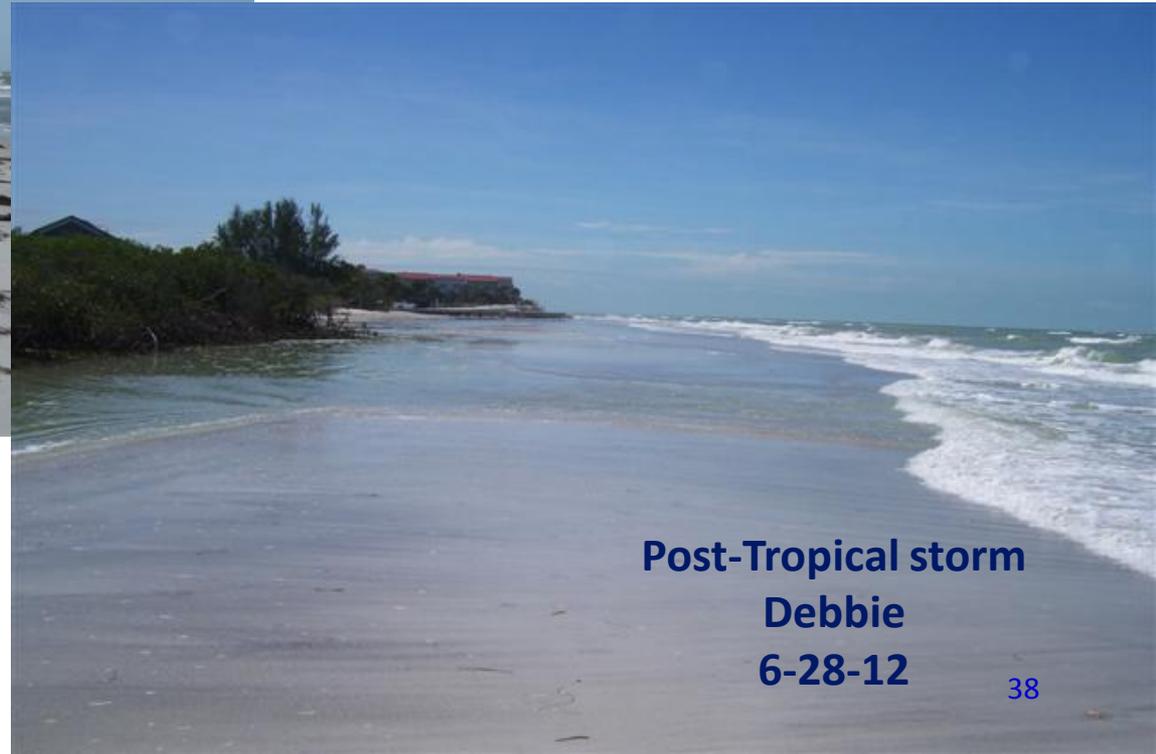
Pre-Tropical Storm  
Debbie  
4-12

Looking South towards  
Coquina Building

Post-Tropical storm  
Debbie  
6-28-12
