Agenda Item: North End Structures Update

**NORTH END EROSION CONTROL STRUCTURE  
DISCUSSION - SEPTEMBER 24, 2012**

## EROSION CONTROL STRUCTURES NORTH LONGBOAT KEY AND GREER ISLAND

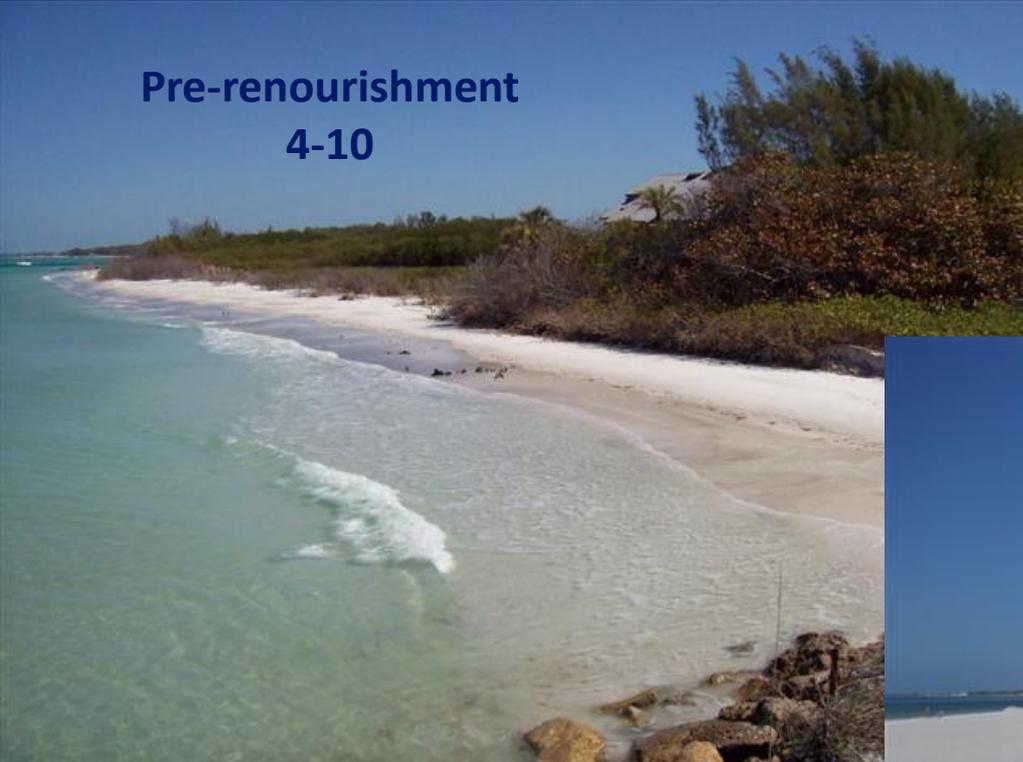
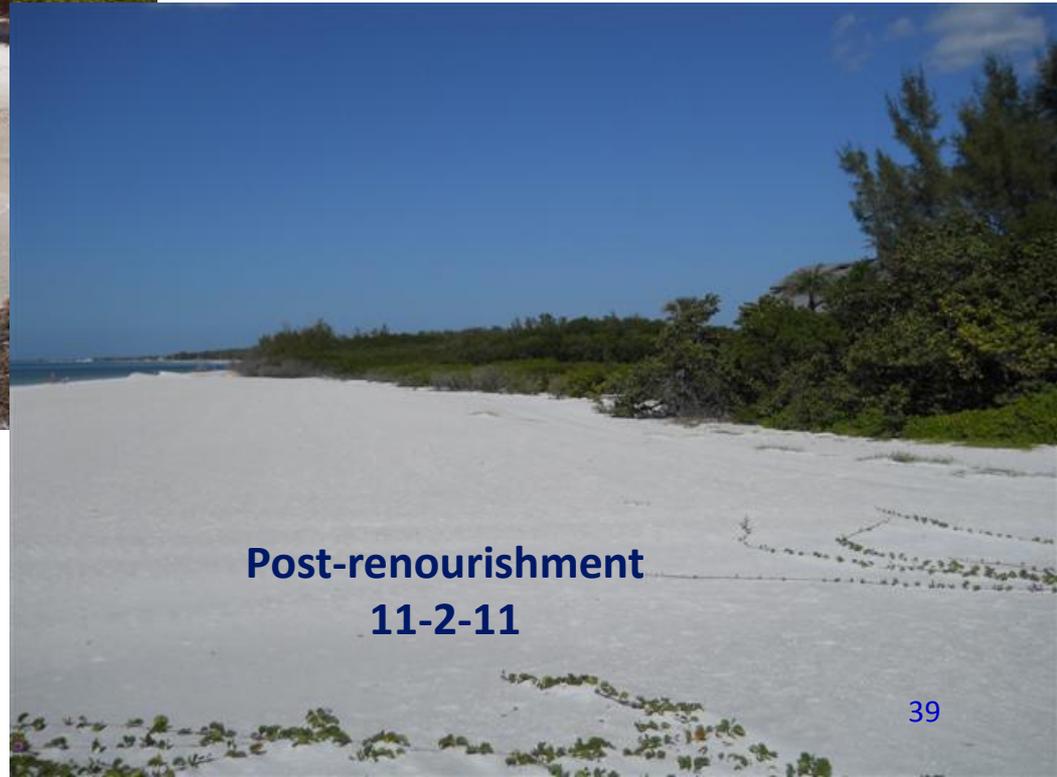
**Pre-renourishment  
4-10**

**Looking North  
towards  
360 North Condos**

**Post-renourishment  
11-2-11**

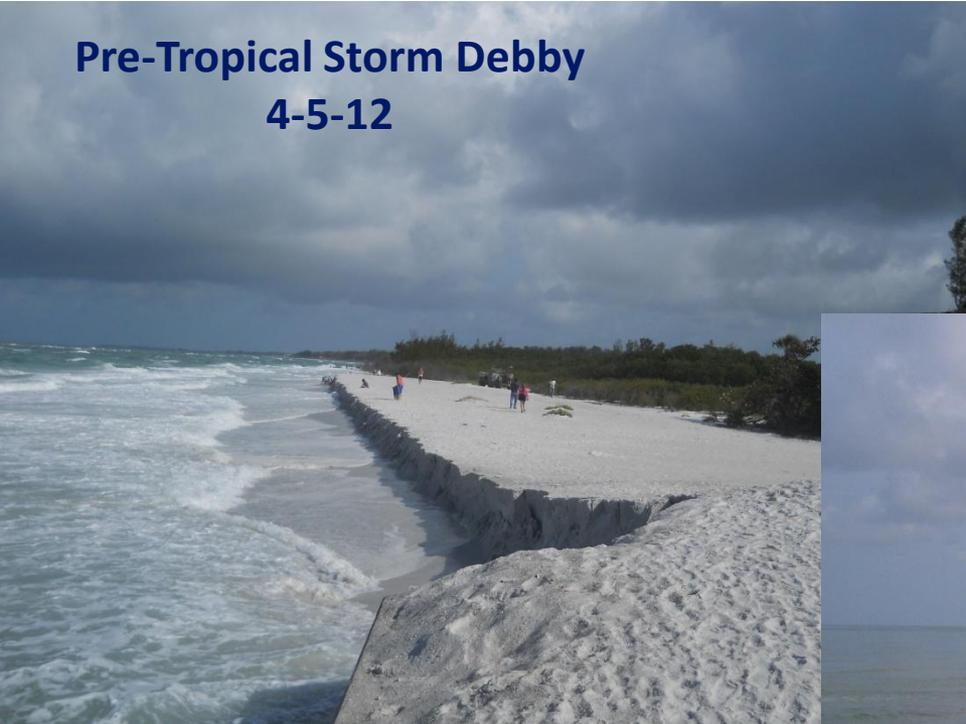
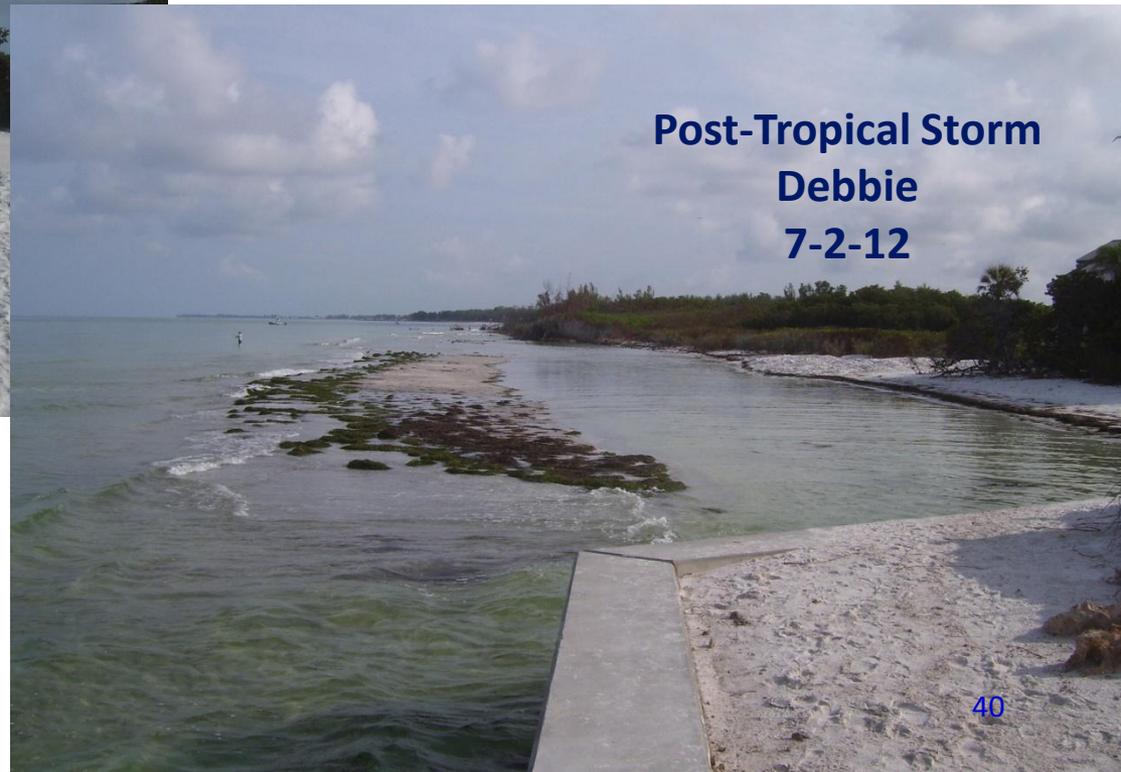
Pre-Tropical Storm Debby  
4-5-12

Looking North  
towards  
360 North Condos

Post-Tropical Storm  
Debbie  
7-2-12

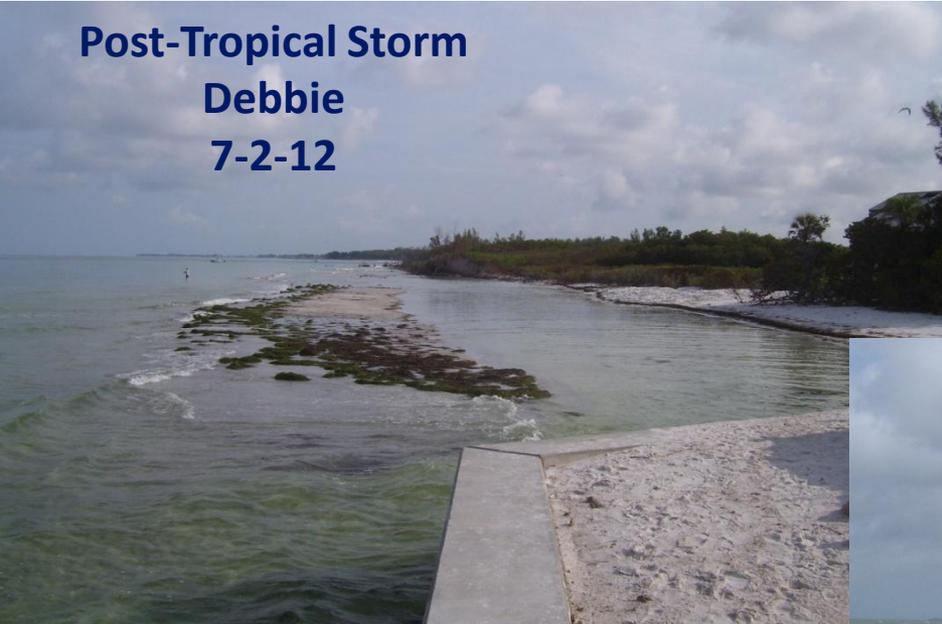
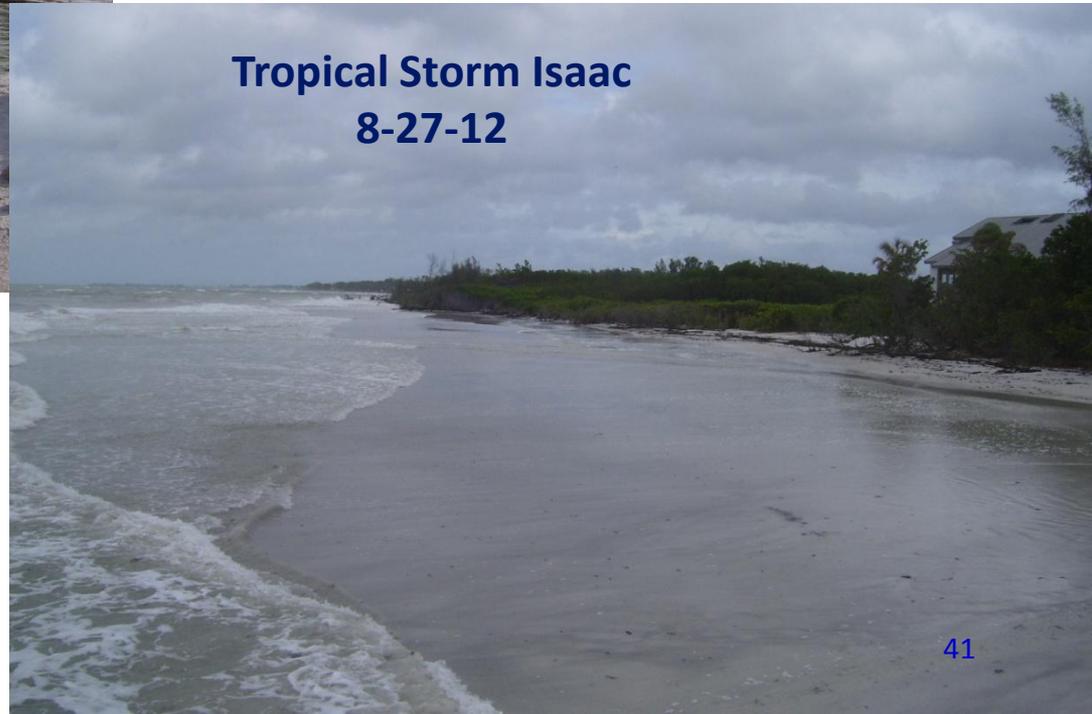
Post-Tropical Storm  
Debbie  
7-2-12

Post-Tropical Storm Isaac  
8-30-12  
Low Tide

Tropical Storm Isaac  
8-27-12

Looking North  
towards  
360 North Condos

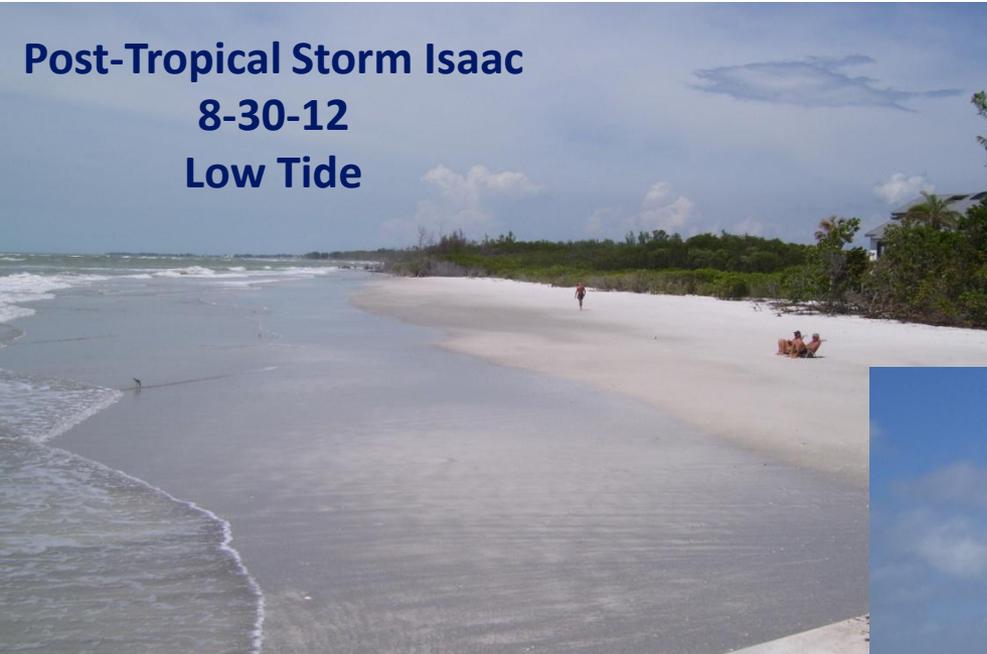
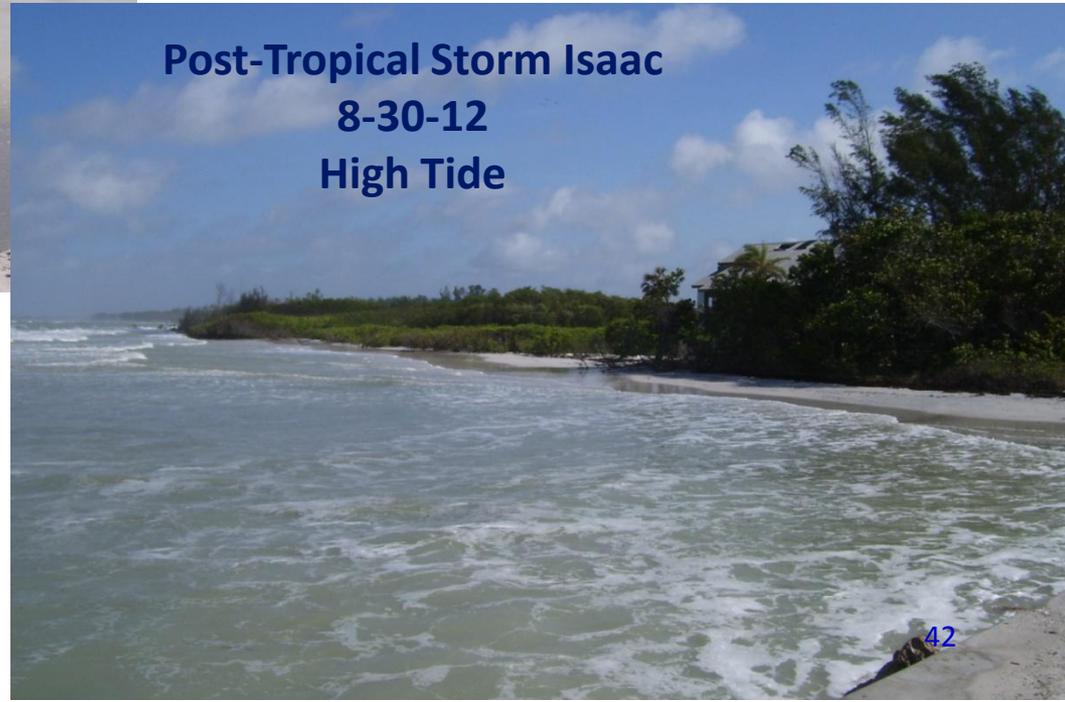
Post-Tropical Storm Isaac  
8-30-12  
Low Tide

Looking North  
towards  
360 North Condos

Post-Tropical Storm Isaac  
8-30-12  
High Tide

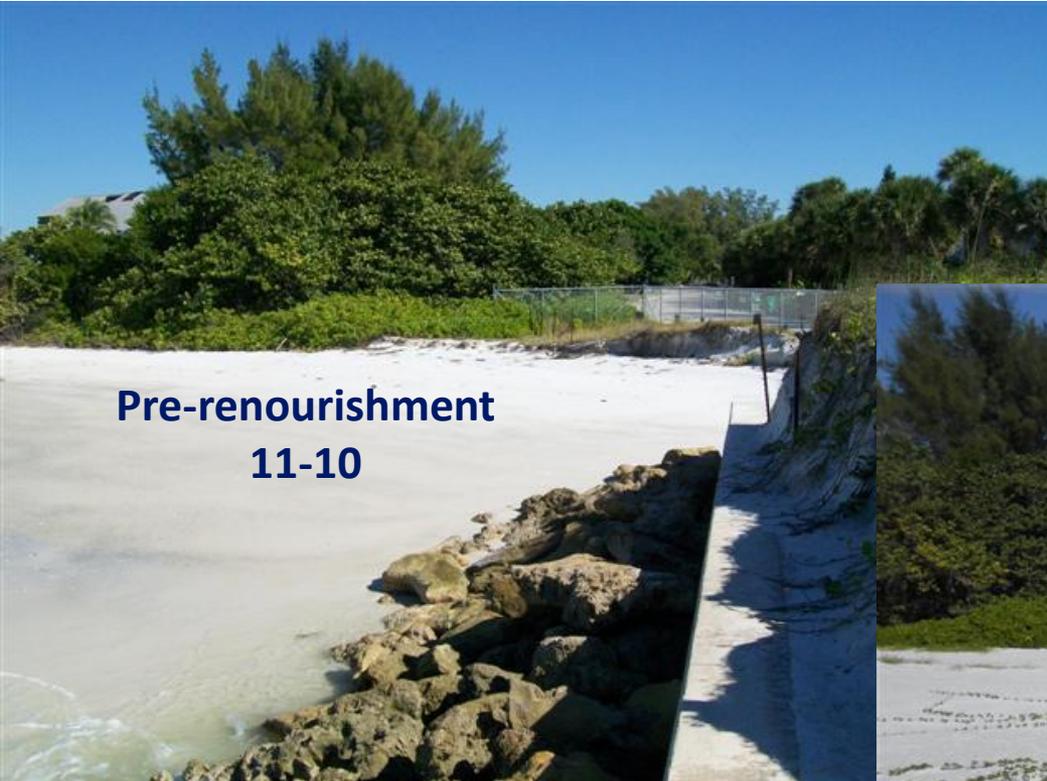
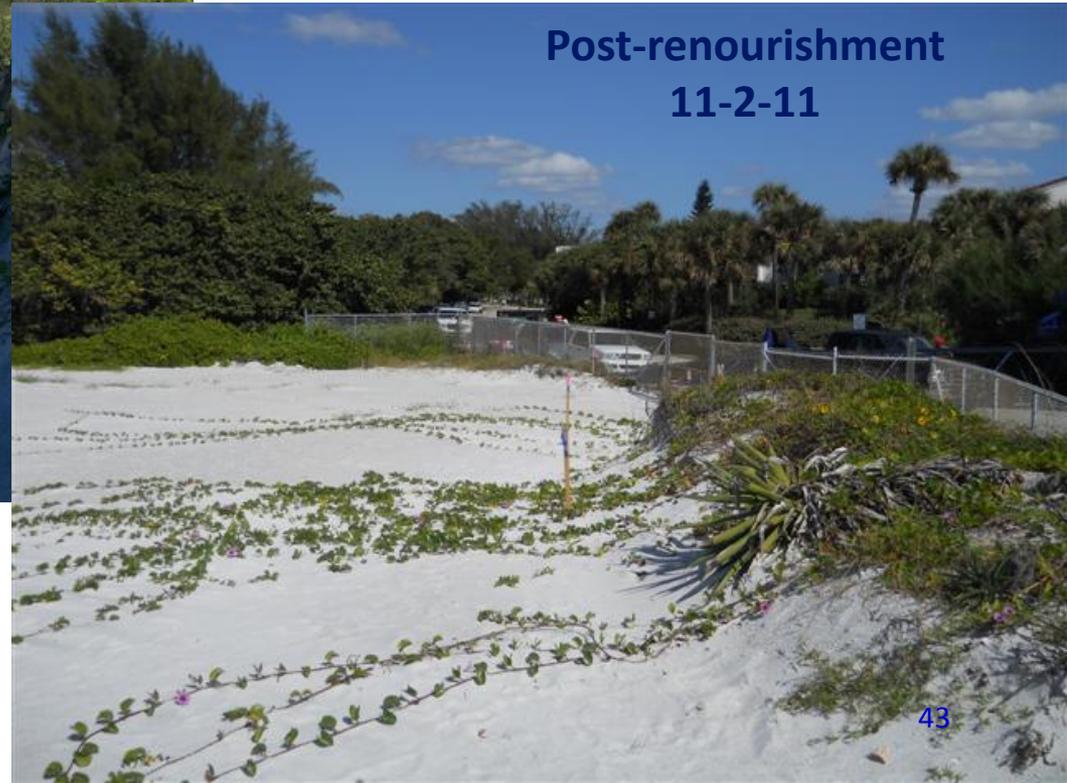
Pre-renourishment  
11-10

Post-renourishment  
11-2-11

Looking East towards  
North Shore Road

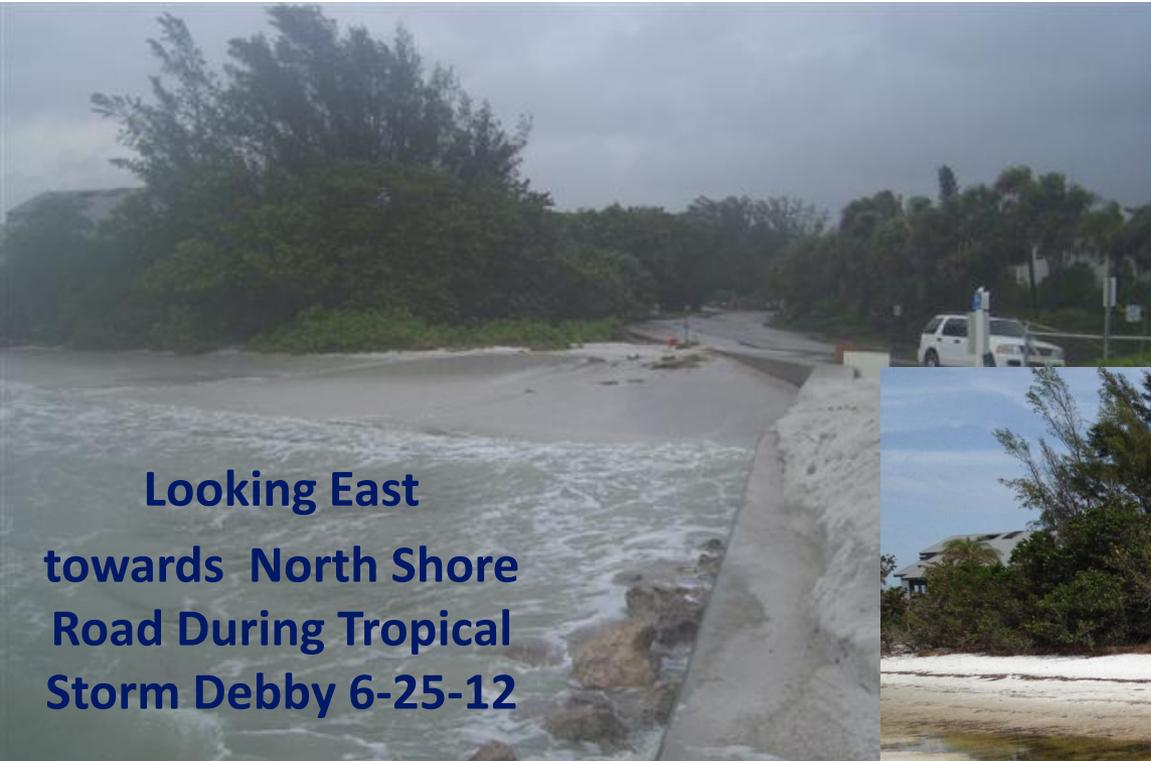
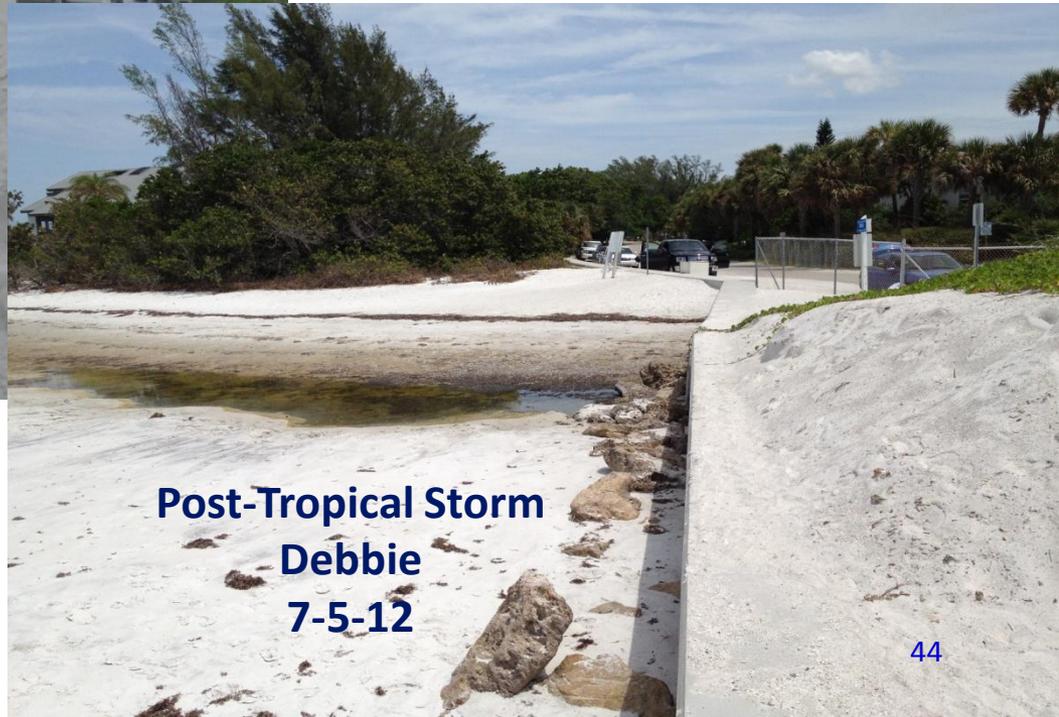
**Looking East  
towards North Shore  
Road During Tropical  
Storm Debby 6-25-12**

**Post-Tropical Storm  
Debbie  
7-5-12**

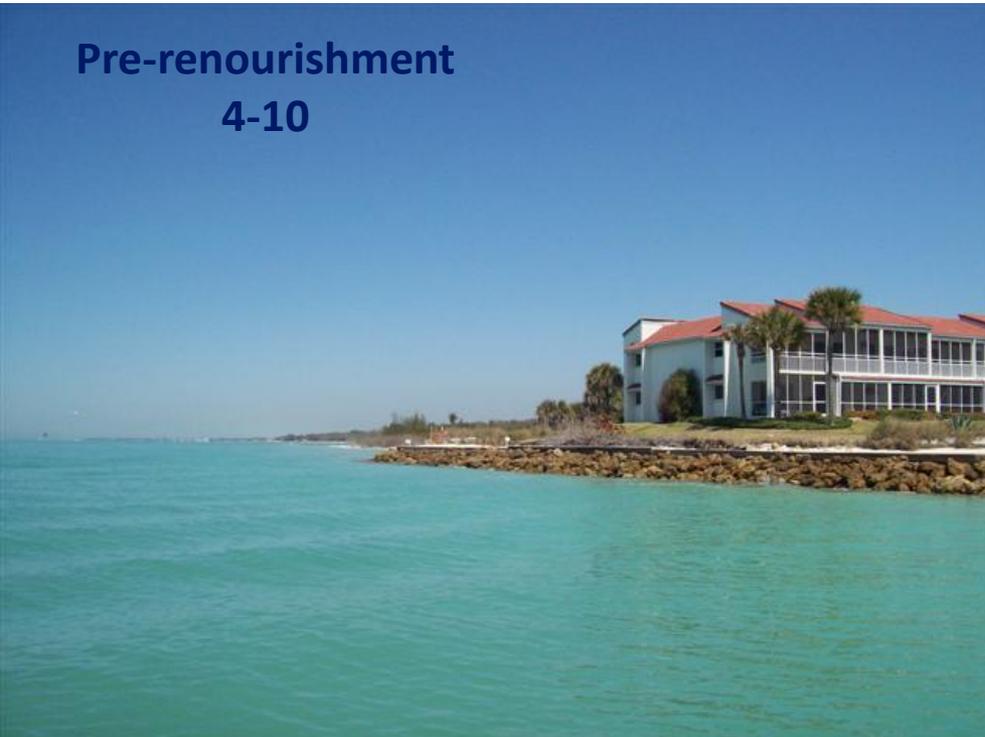
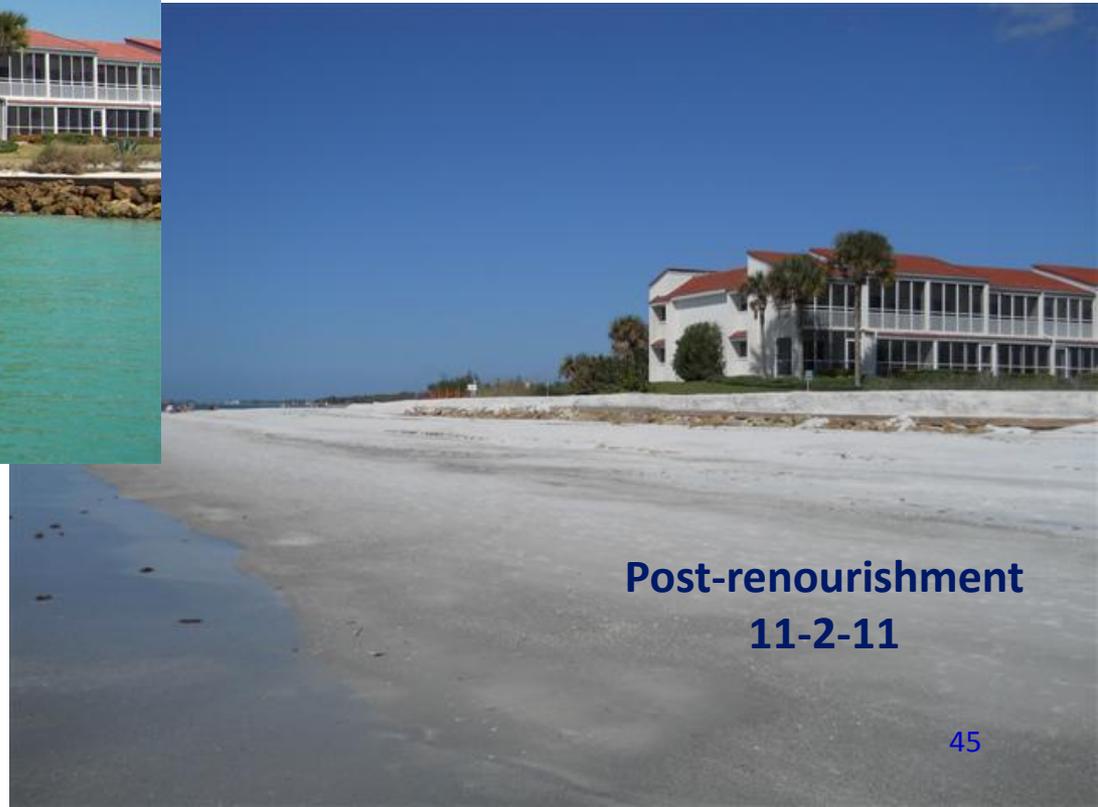
Pre-renourishment  
4-10

Looking East towards  
Coquina Building

Post-renourishment  
11-2-11

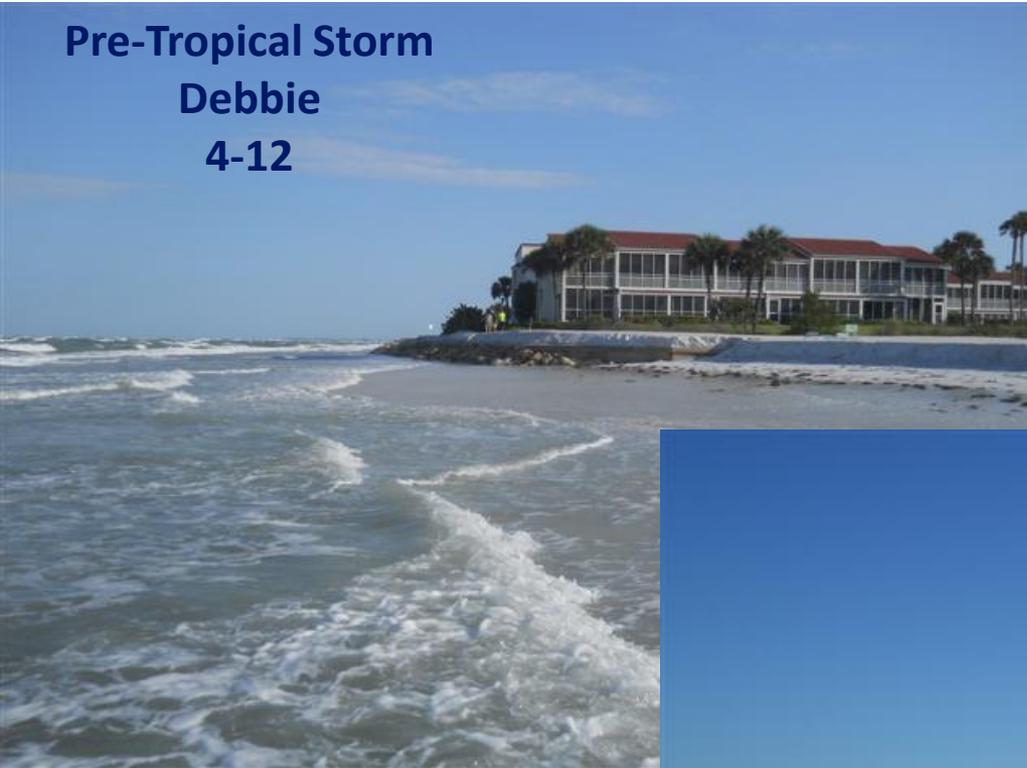
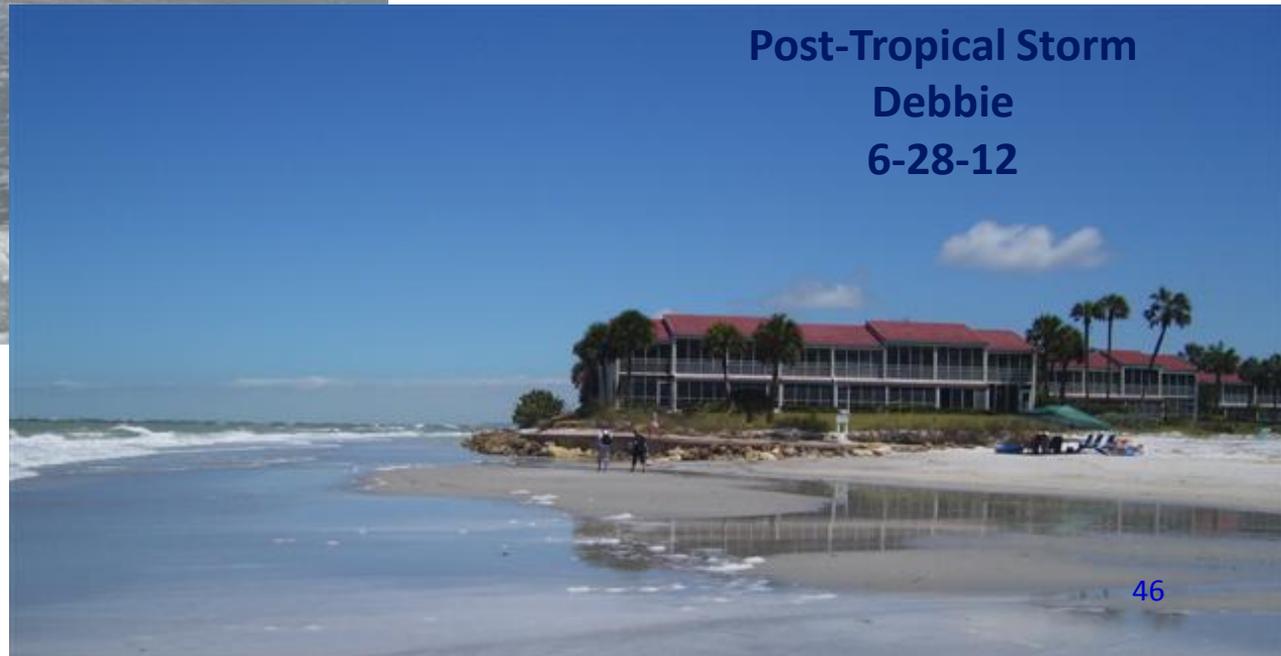
Pre-Tropical Storm  
Debbie  
4-12

Post-Tropical Storm  
Debbie  
6-28-12

Looking Northeast  
towards Coquina  
Building

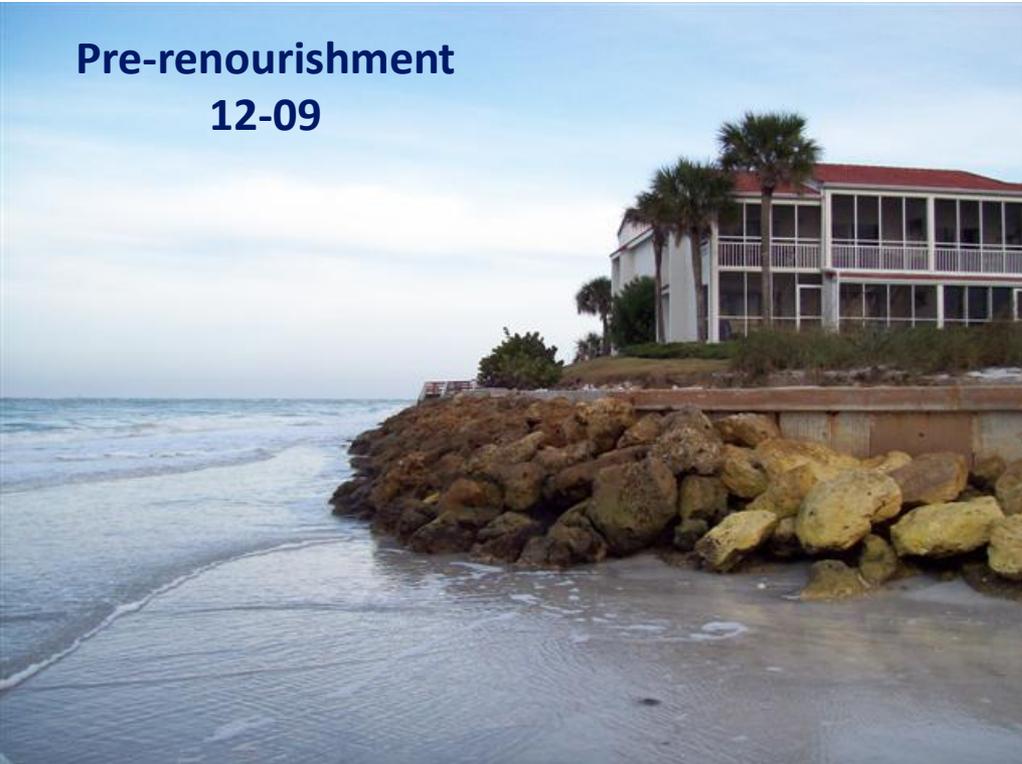
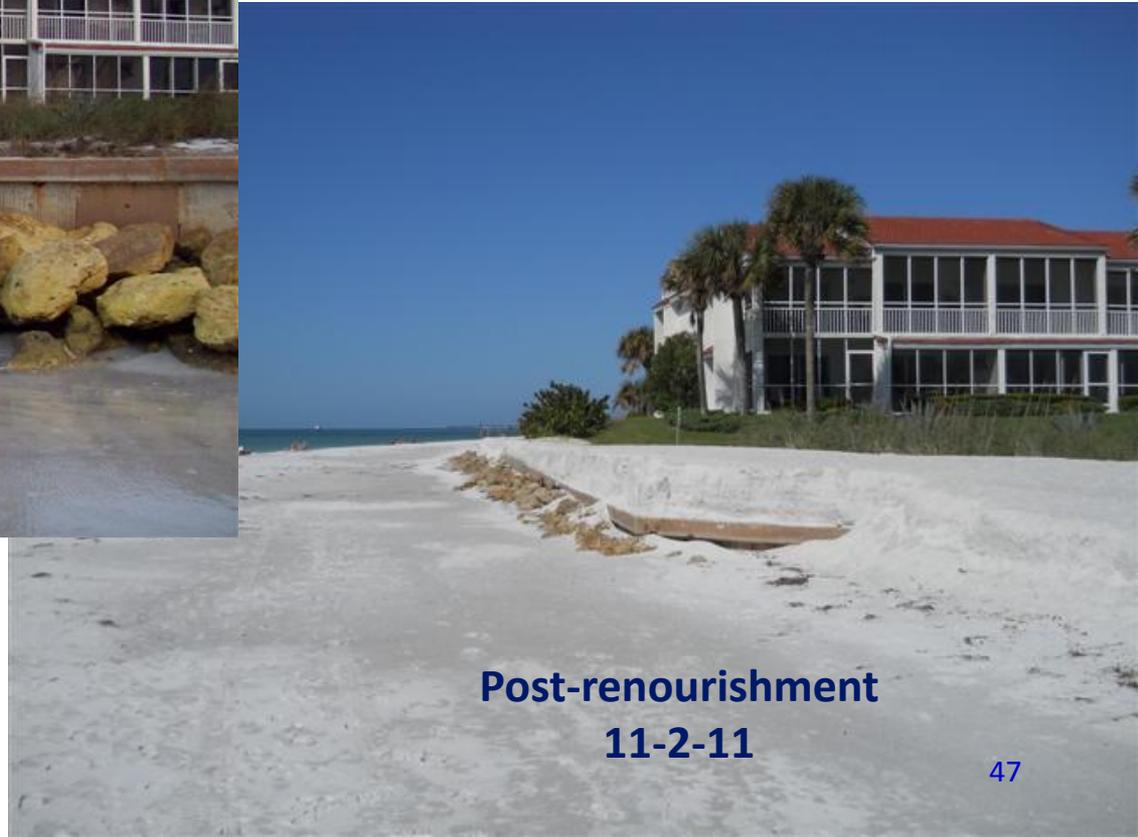
Pre-renourishment  
12-09

Looking North towards  
Coquina Building

Post-renourishment  
11-2-11

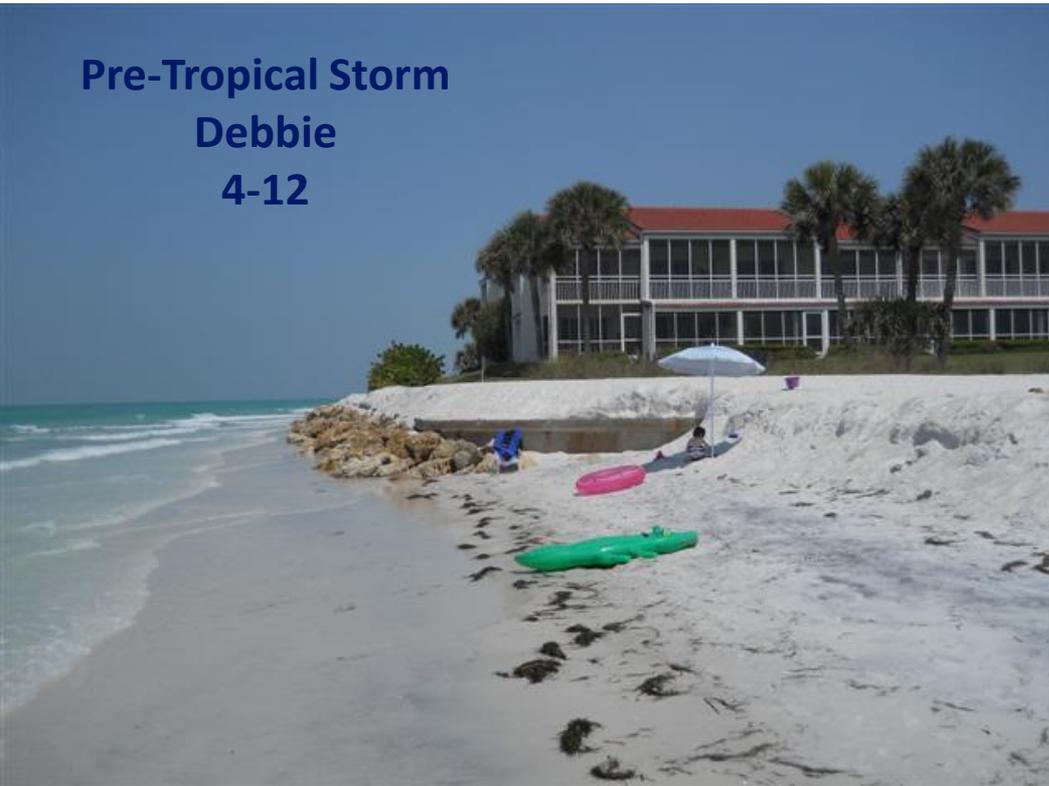
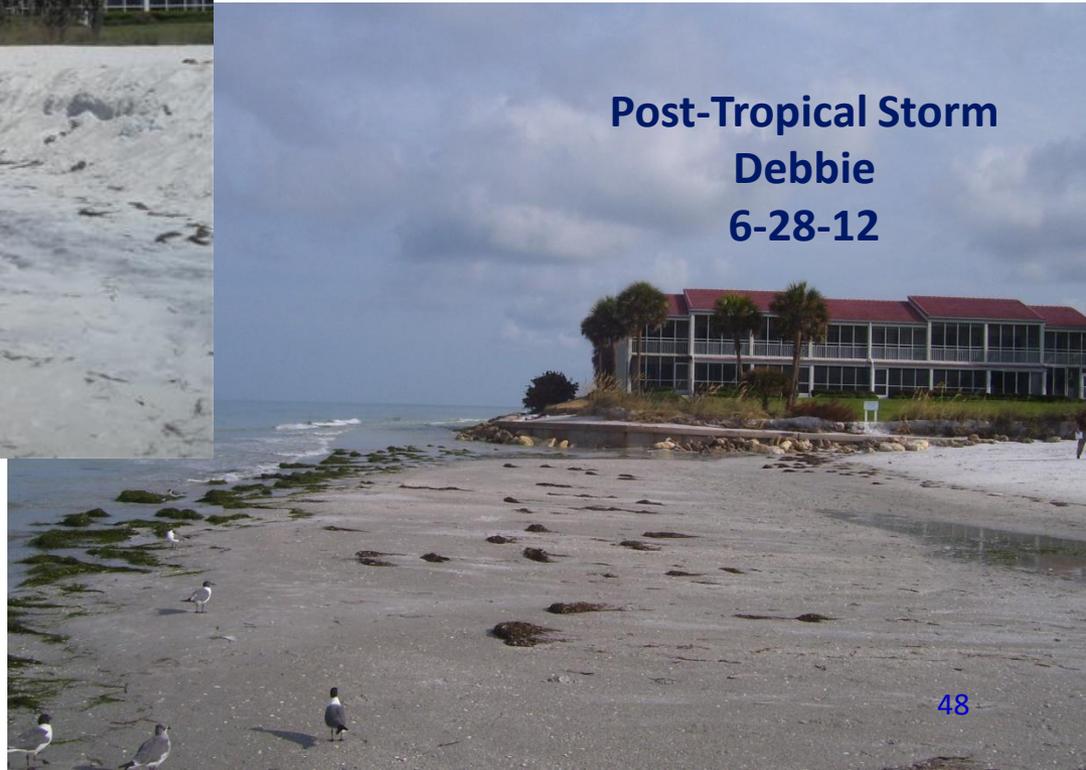
**Pre-Tropical Storm  
Debbie  
4-12**

**Post-Tropical Storm  
Debbie  
6-28-12**

**Looking North towards  
Coquina Building**

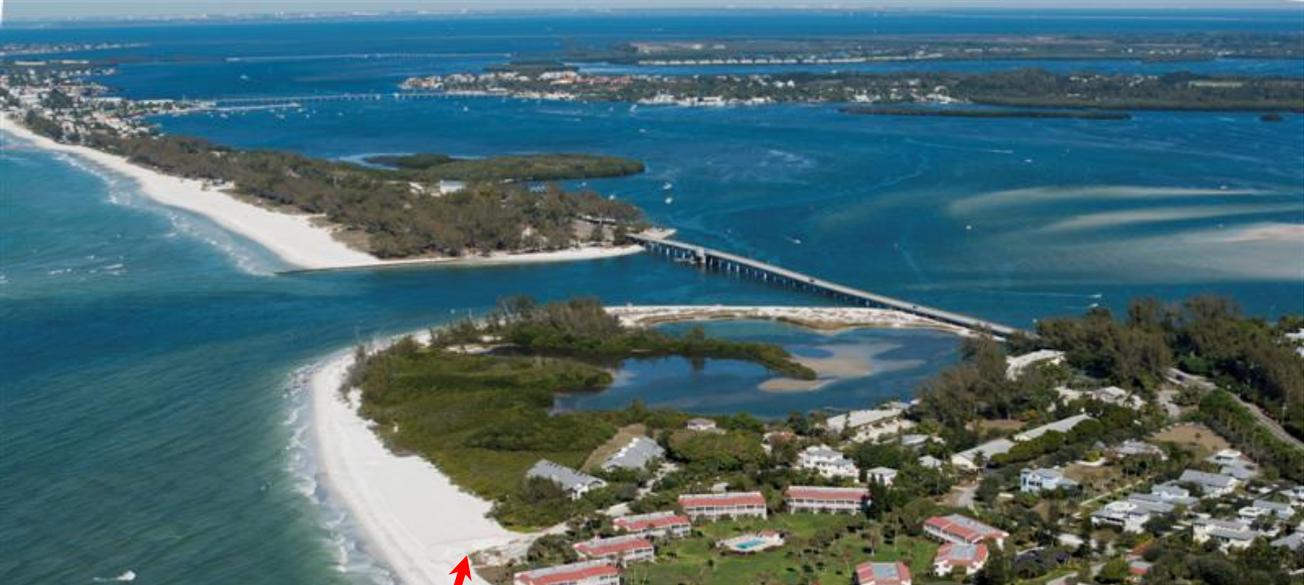
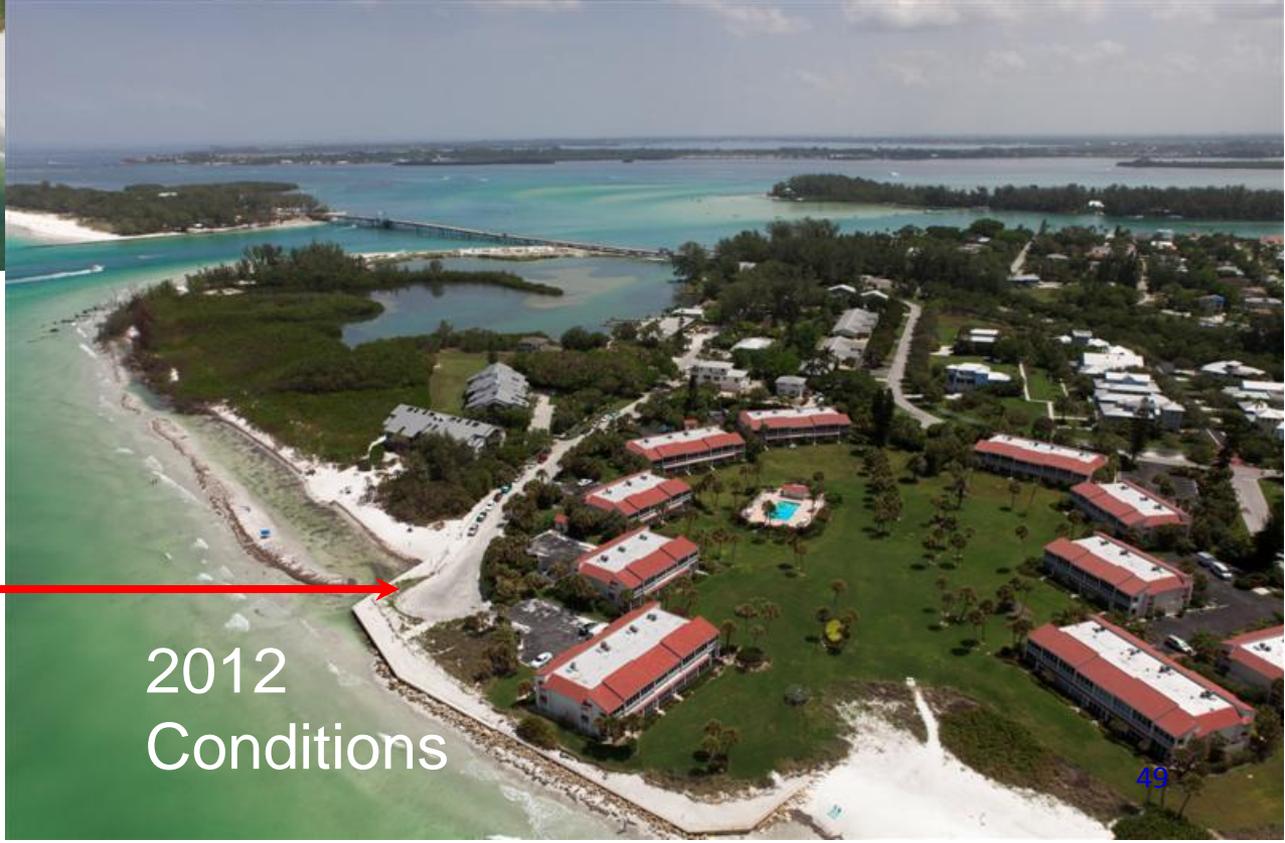
2011  
Conditions

2012  
Conditions

North  
Shore  
Road

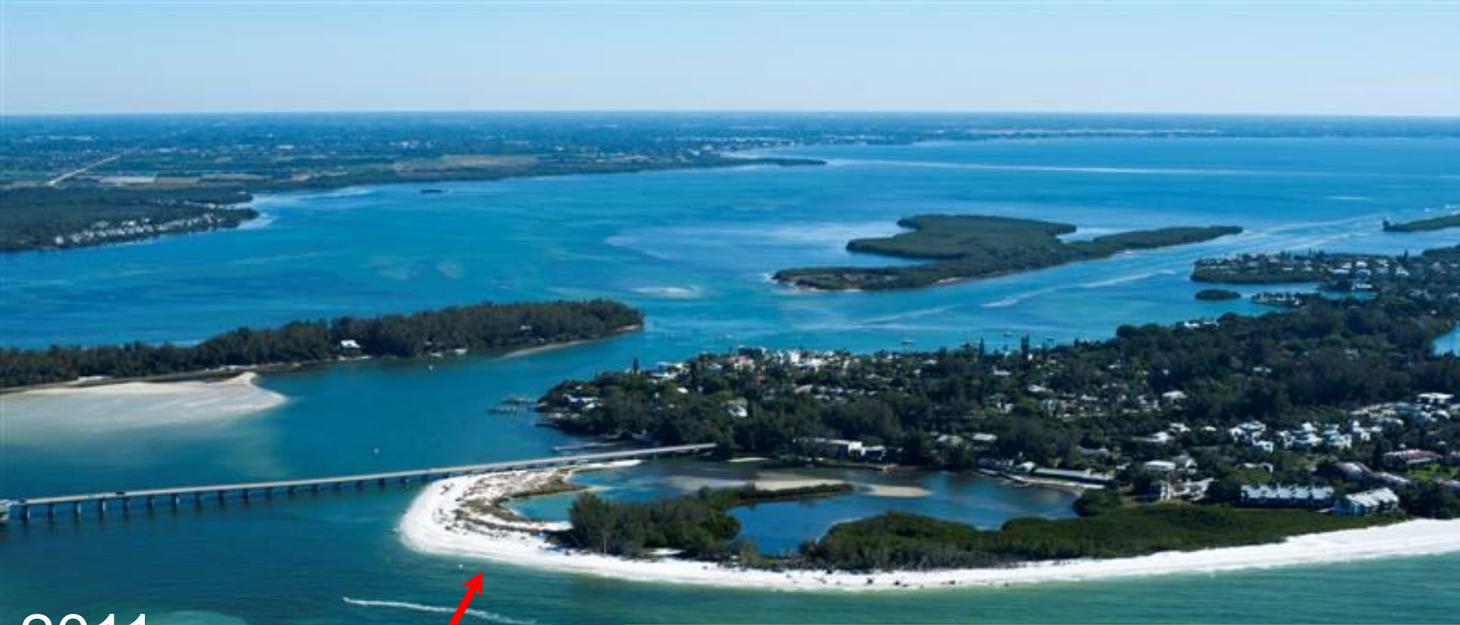
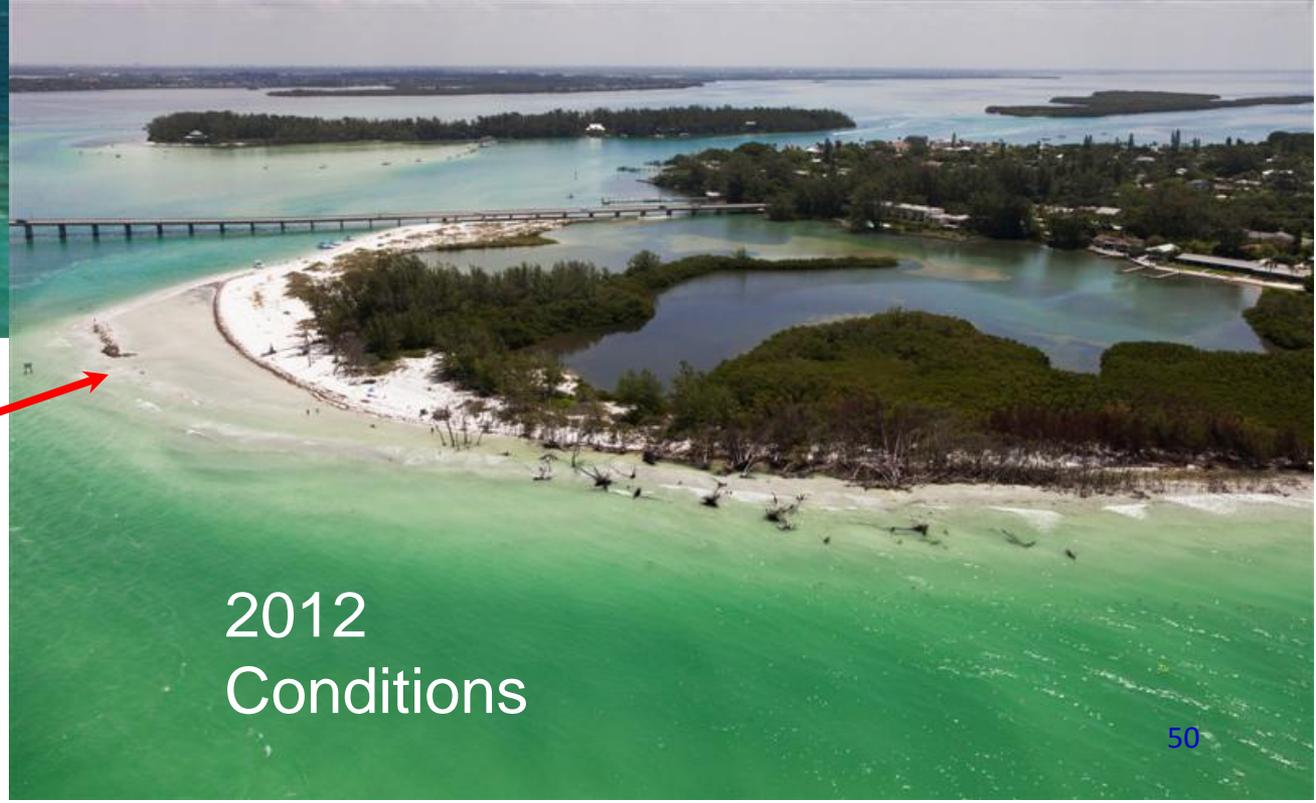
2011  
Conditions

2012  
Conditions

Northern  
Face at  
LBK  
Pass

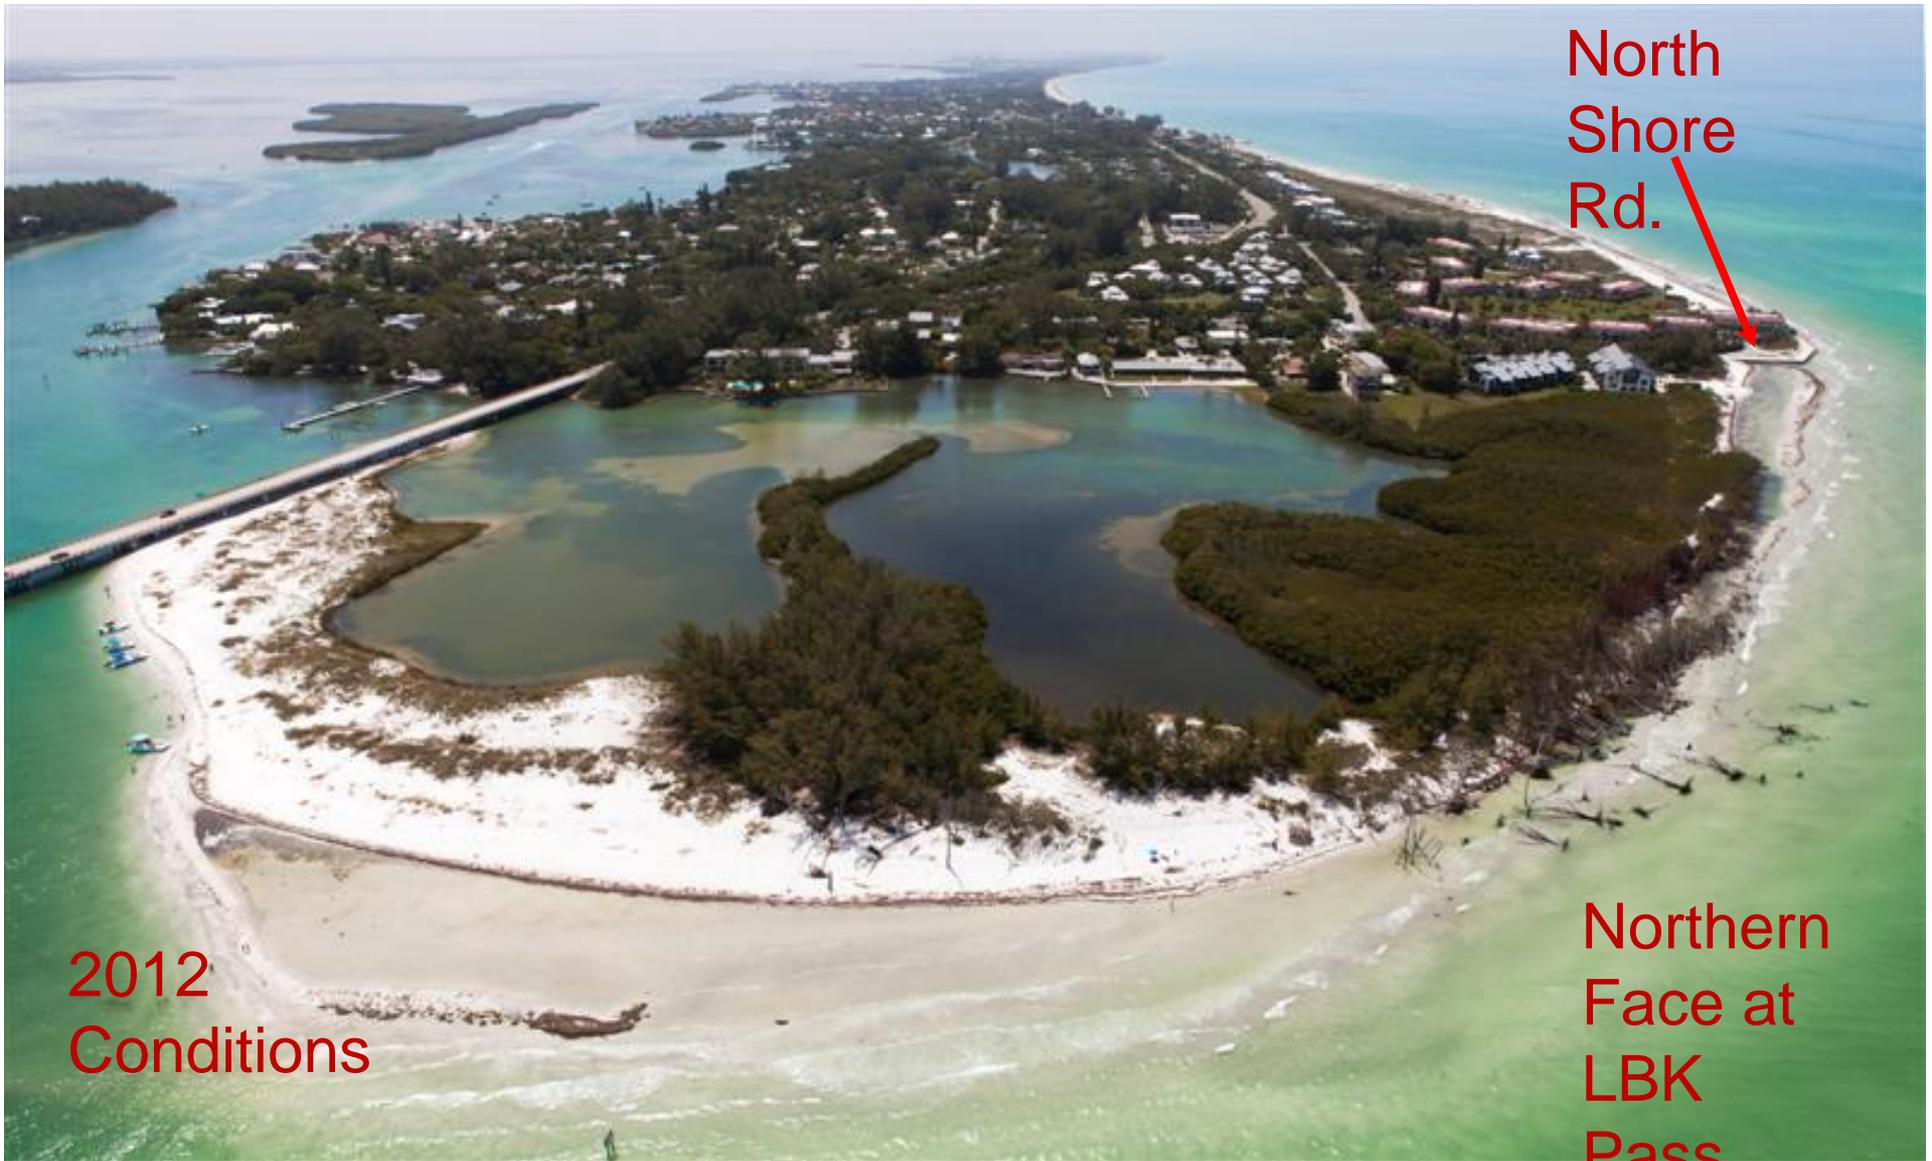
North  
Shore  
Rd.

2012  
Conditions

Northern  
Face at  
LBK  
Pass
