Agenda Item: Inflow and Infiltration (I&I) Pilot Study Project Status

Summary: The Town Commission requested a staff update on the recent Inflow & Infiltration Pilot Study (I&I) and engineering recommendations. The Public Works Director and Ms. Laura Baumberger with Carollo Engineers will present an update on the Town's I&I Pilot Study Project, and future plans.

TO: Dave Bullock, Town Manager
FROM: Juan Florensa, Public Works Director
SUBJECT: Inflow and Infiltration (I&I) Pilot Study Project Status

Inflow & Infiltration (I&I) Rehabilitation Pilot Study

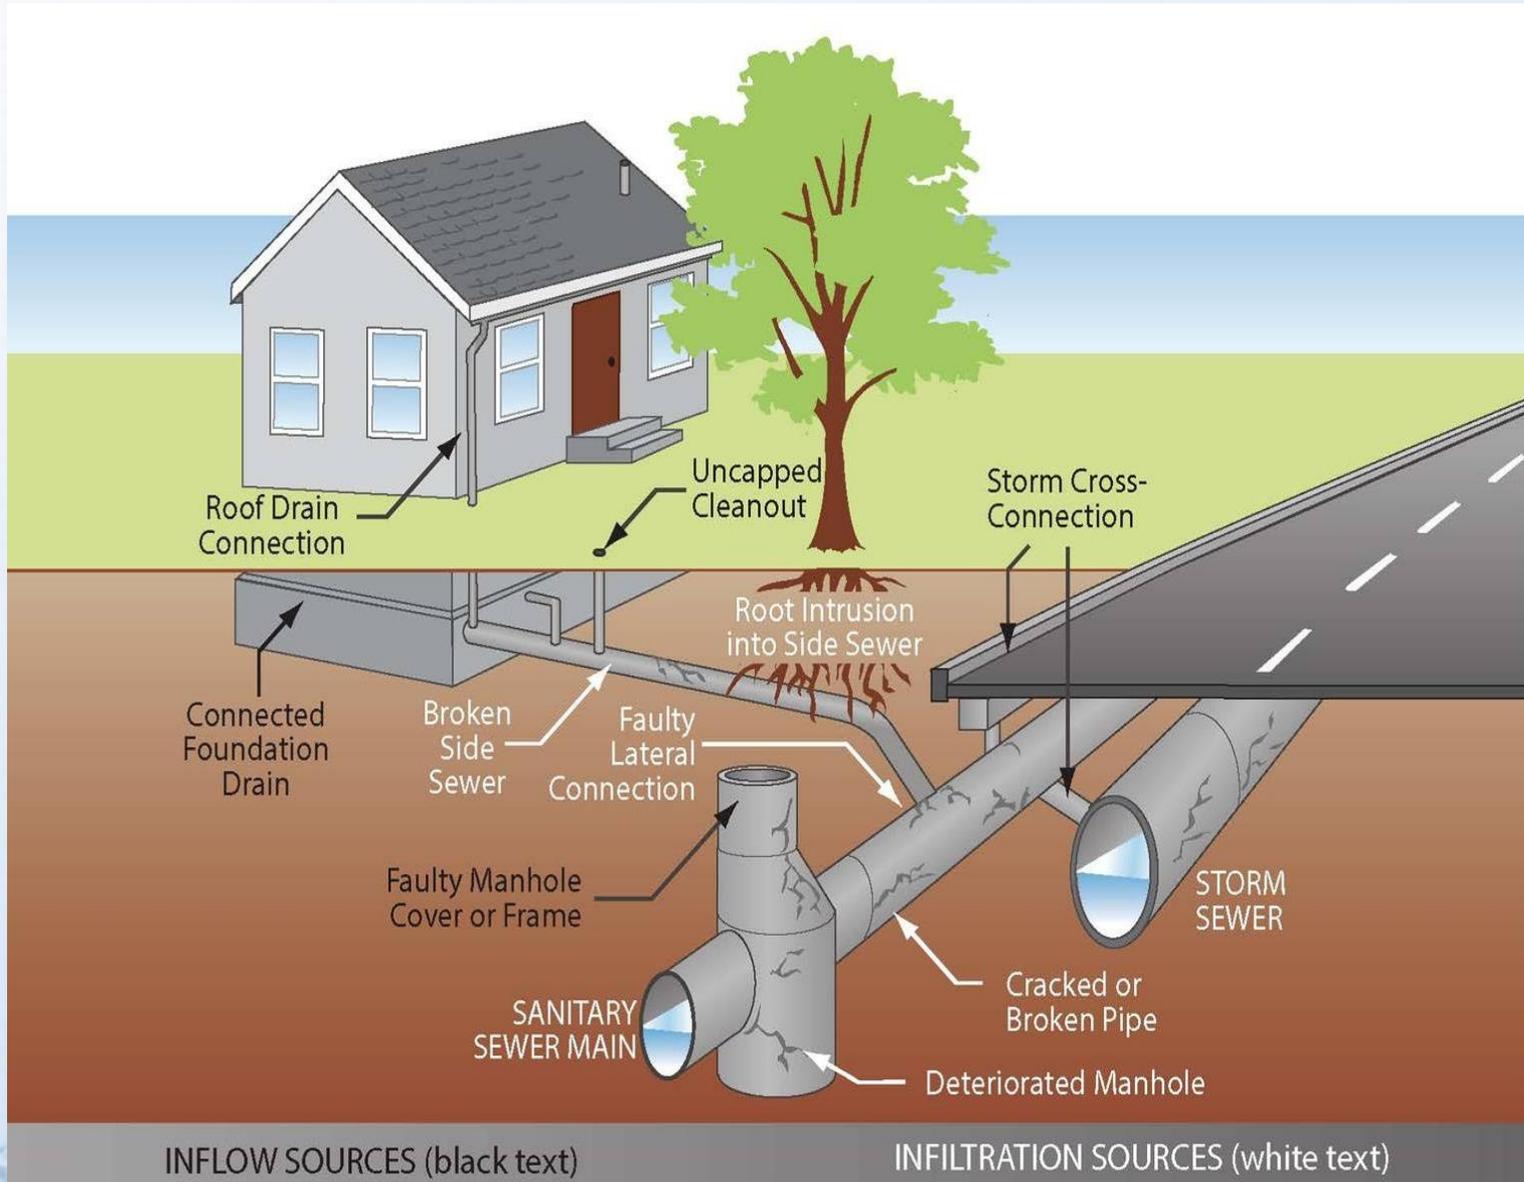
What is Infiltration and Inflow (I&I)?

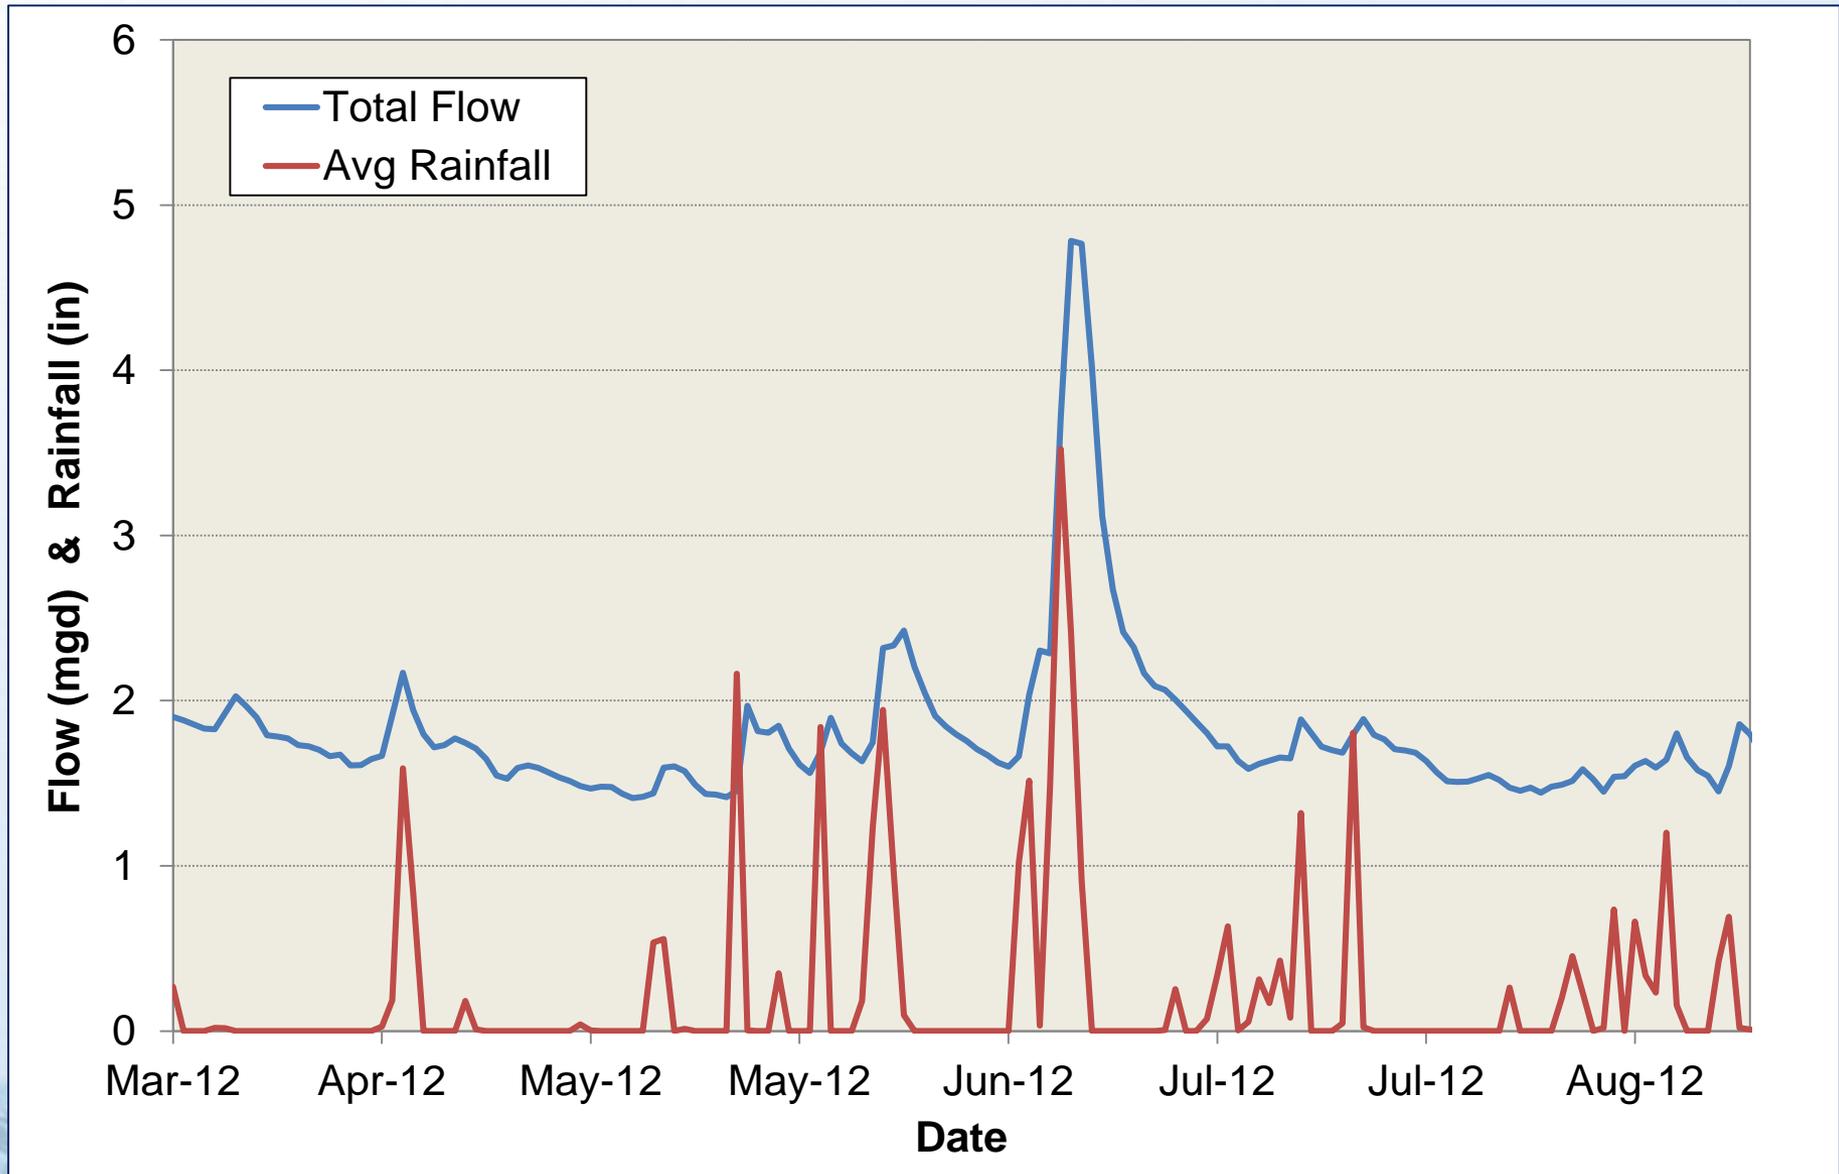
Inflow Occurs During Rainfall Events

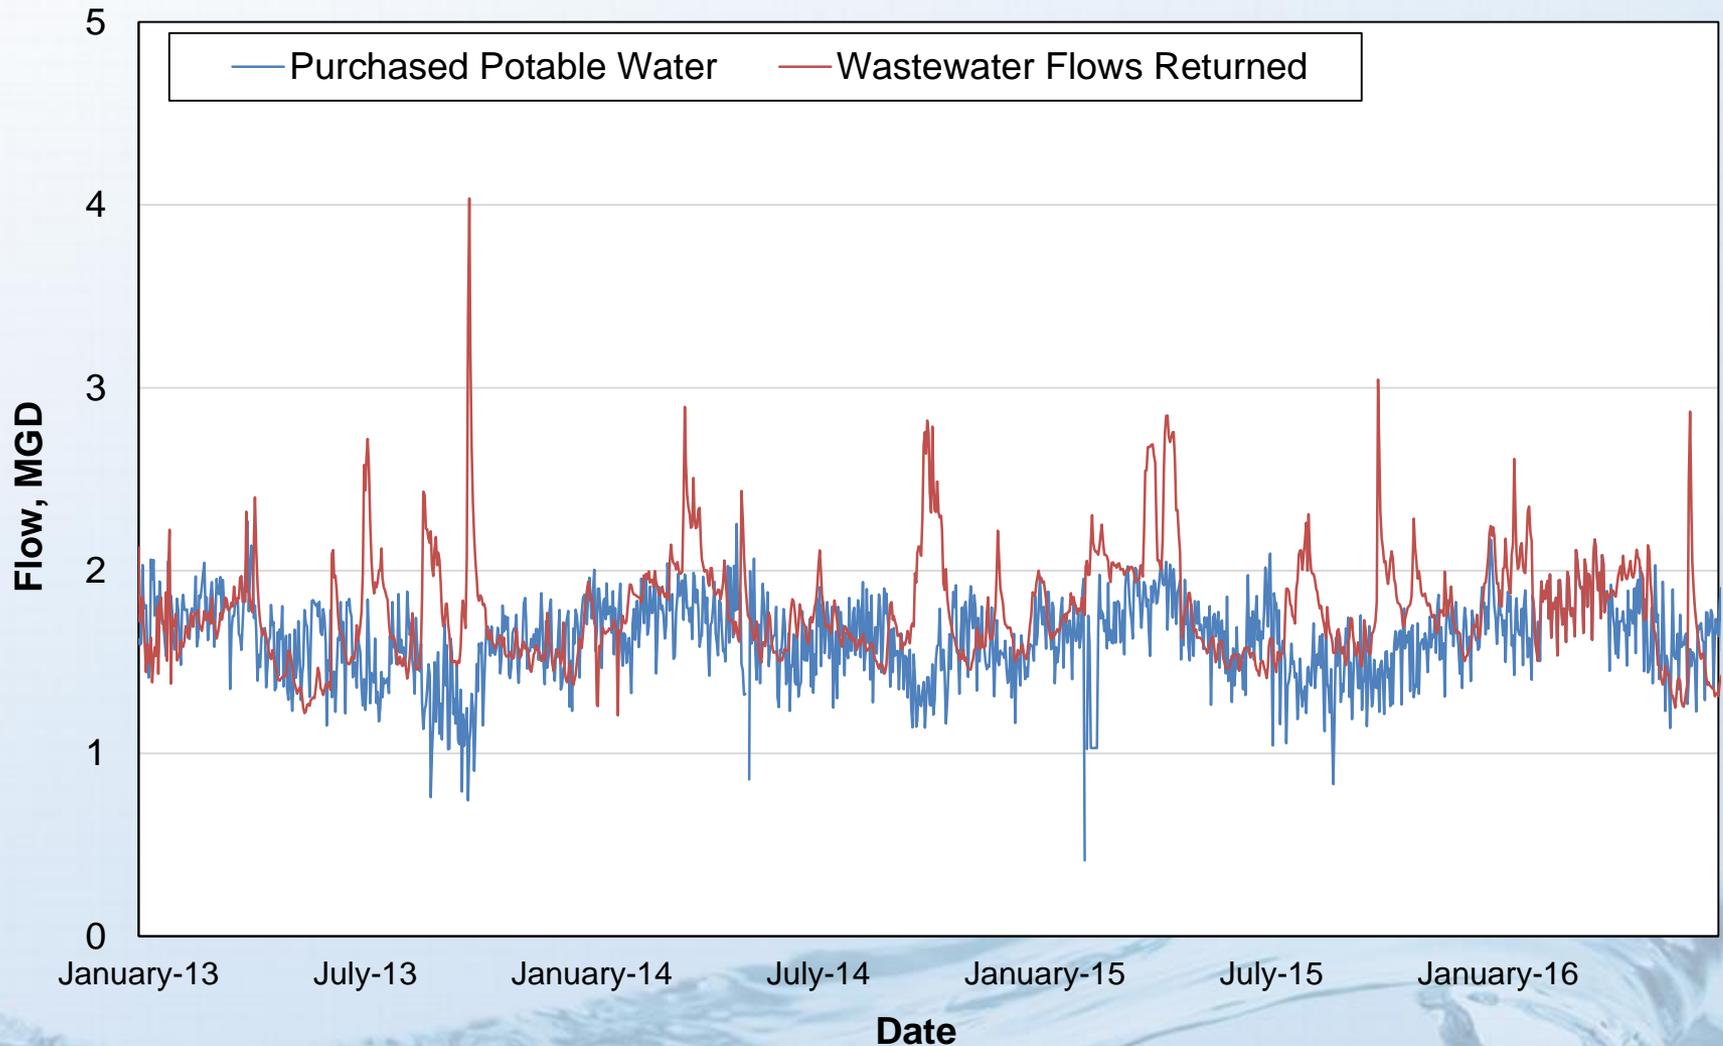
Comparison of Potable Water Purchases and Wastewater Flows Returned

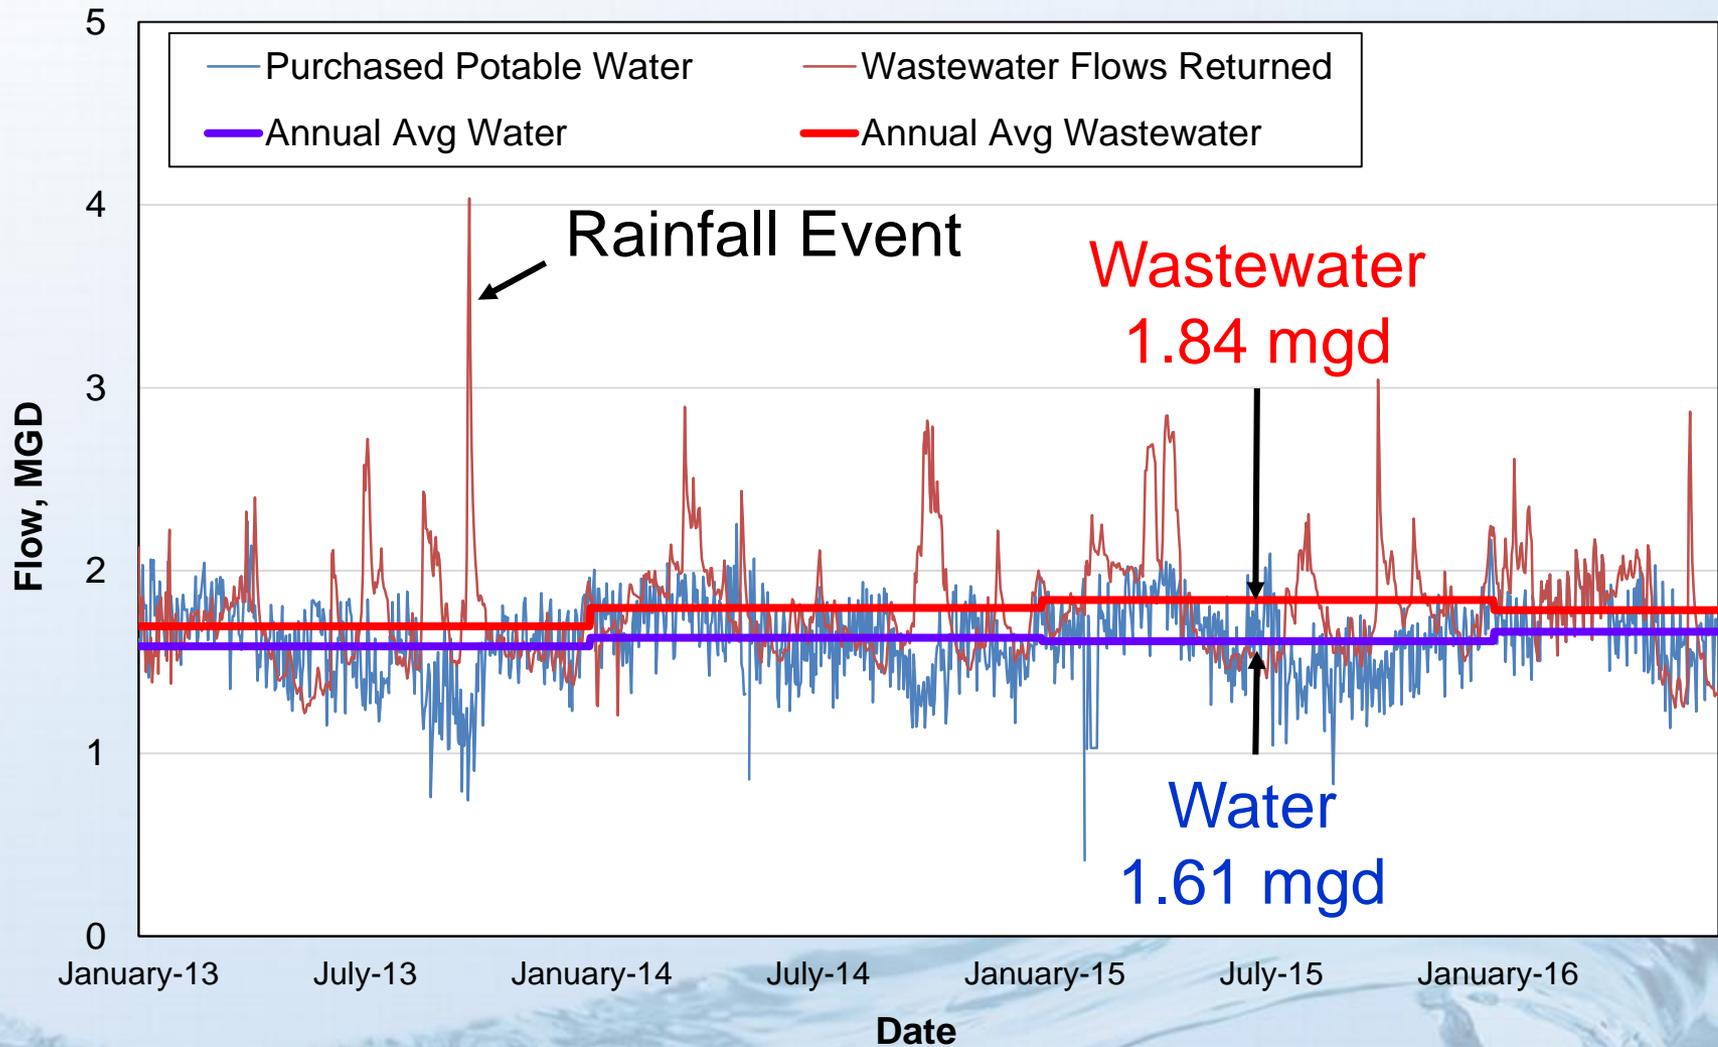
Comparison of Potable Water Purchases and Wastewater Flows Returned

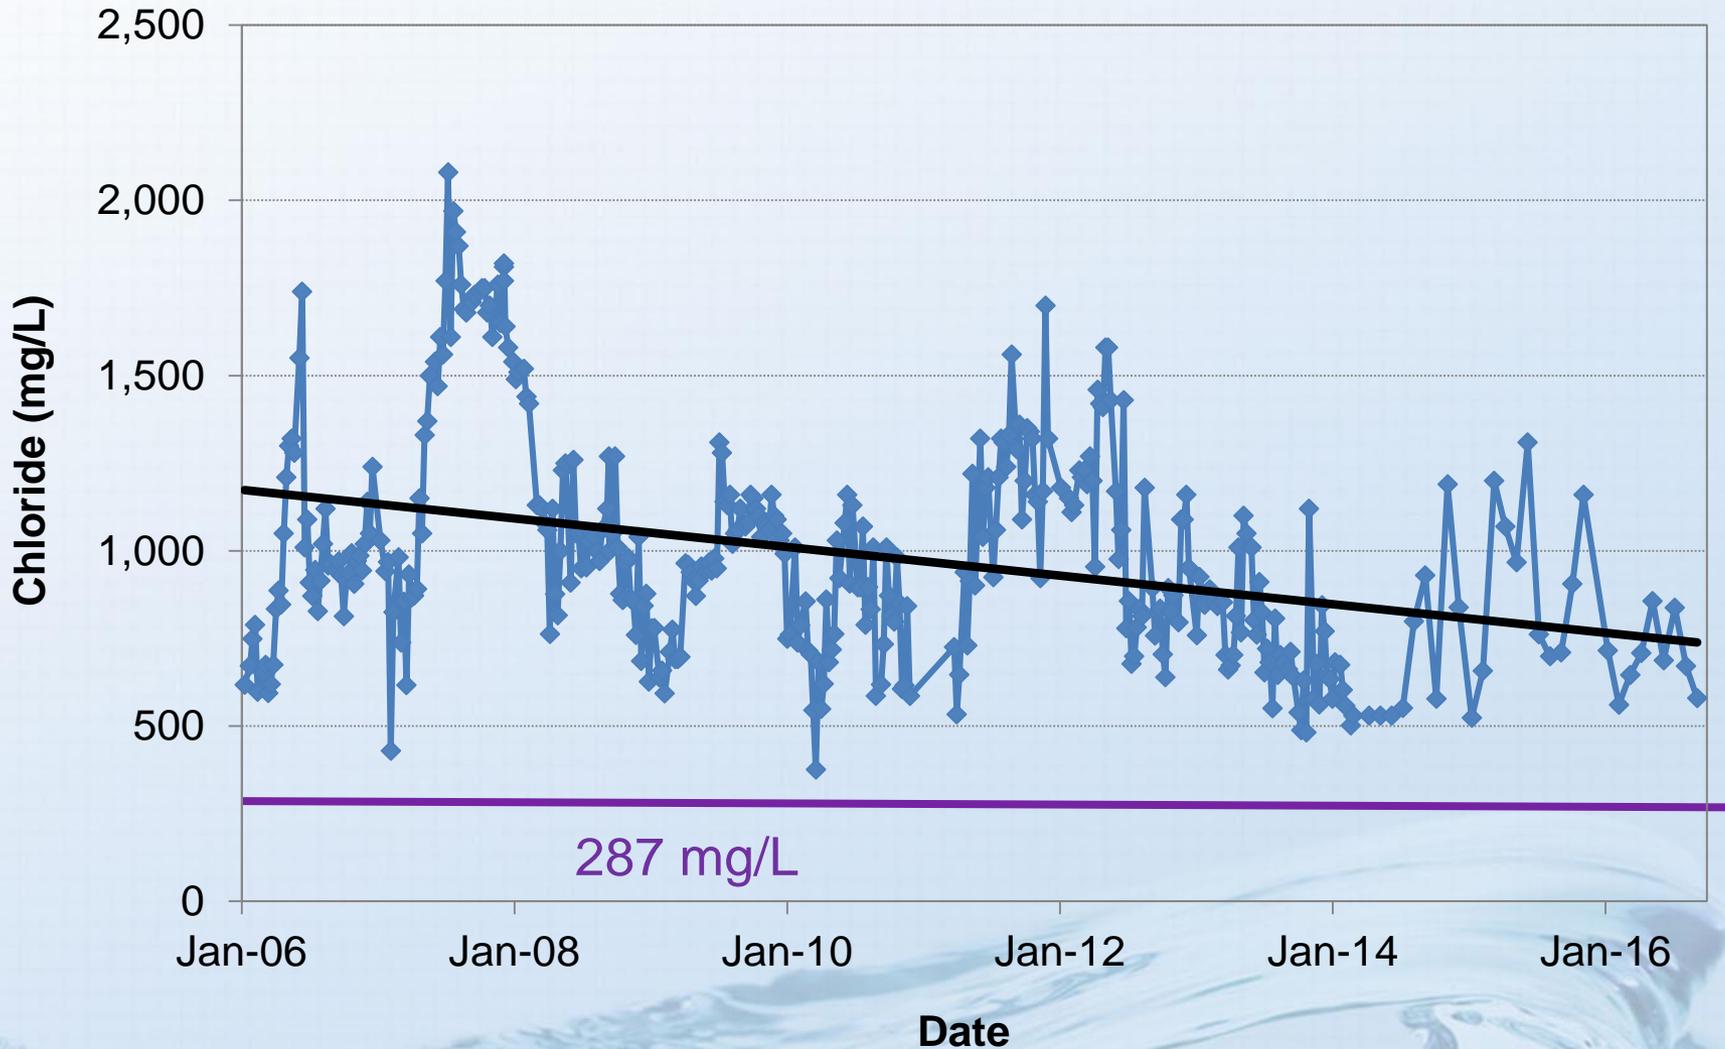
Historical Wastewater Chloride Concentration

287 mg/L

1. Treatment fees are paid to Manatee County to treat this excess water
2. Manatee County Sewer Use Ordinance requires chloride concentration of less than 287 mg/L

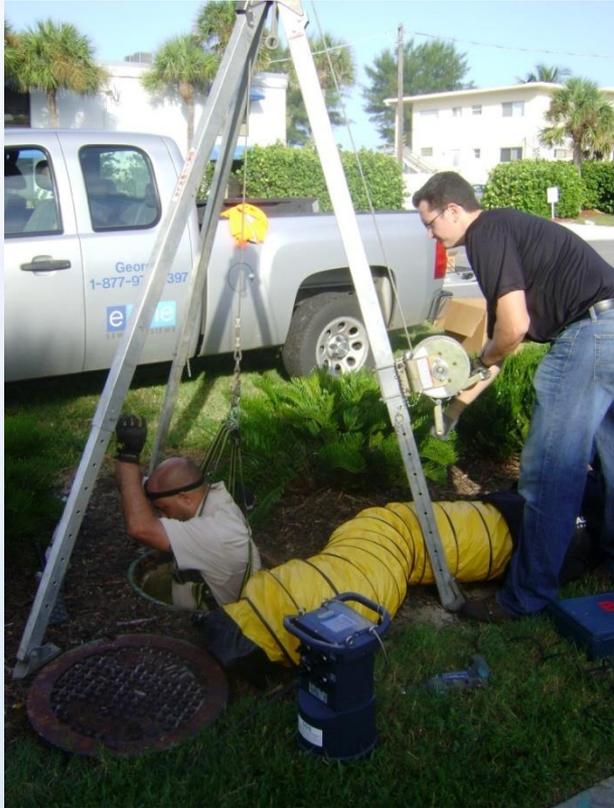
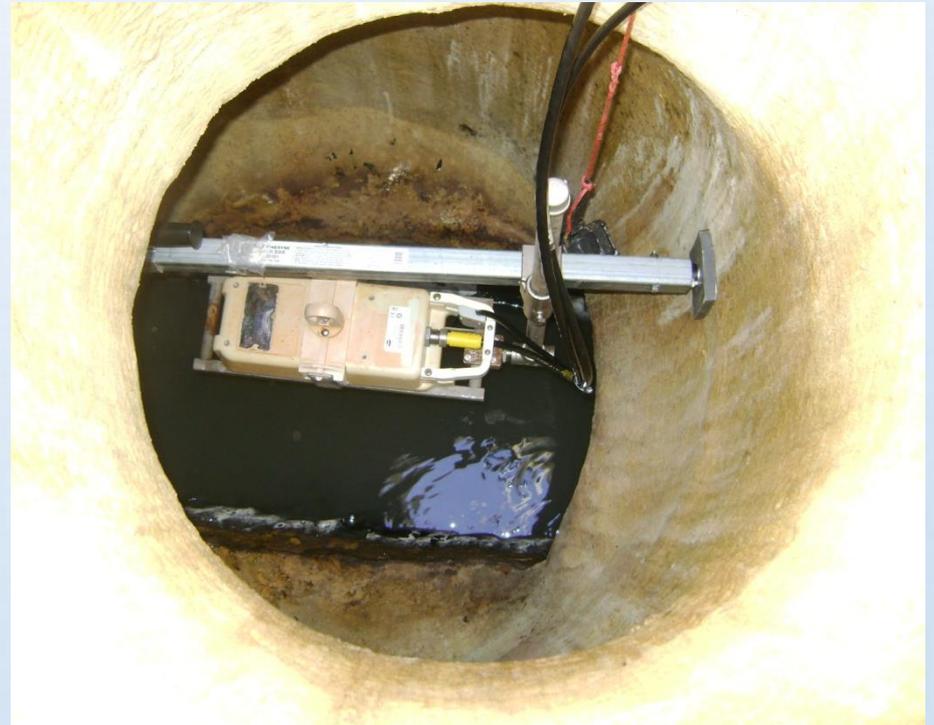
Flow Meters Installed for Lift Stations A & F

Flow monitoring equipment for LS-F (Manhole E-10).

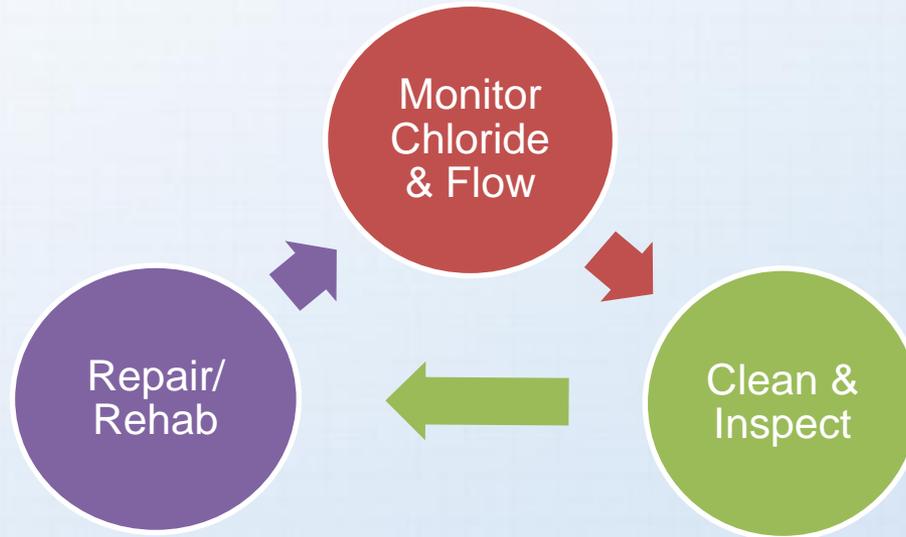
I&I Study Suggests a Three-Step Rehabilitation Process

- Options for rehabilitation are dependent on condition and economics of repair
- Each prioritized area should be inspected to determine the appropriate corrective action measures

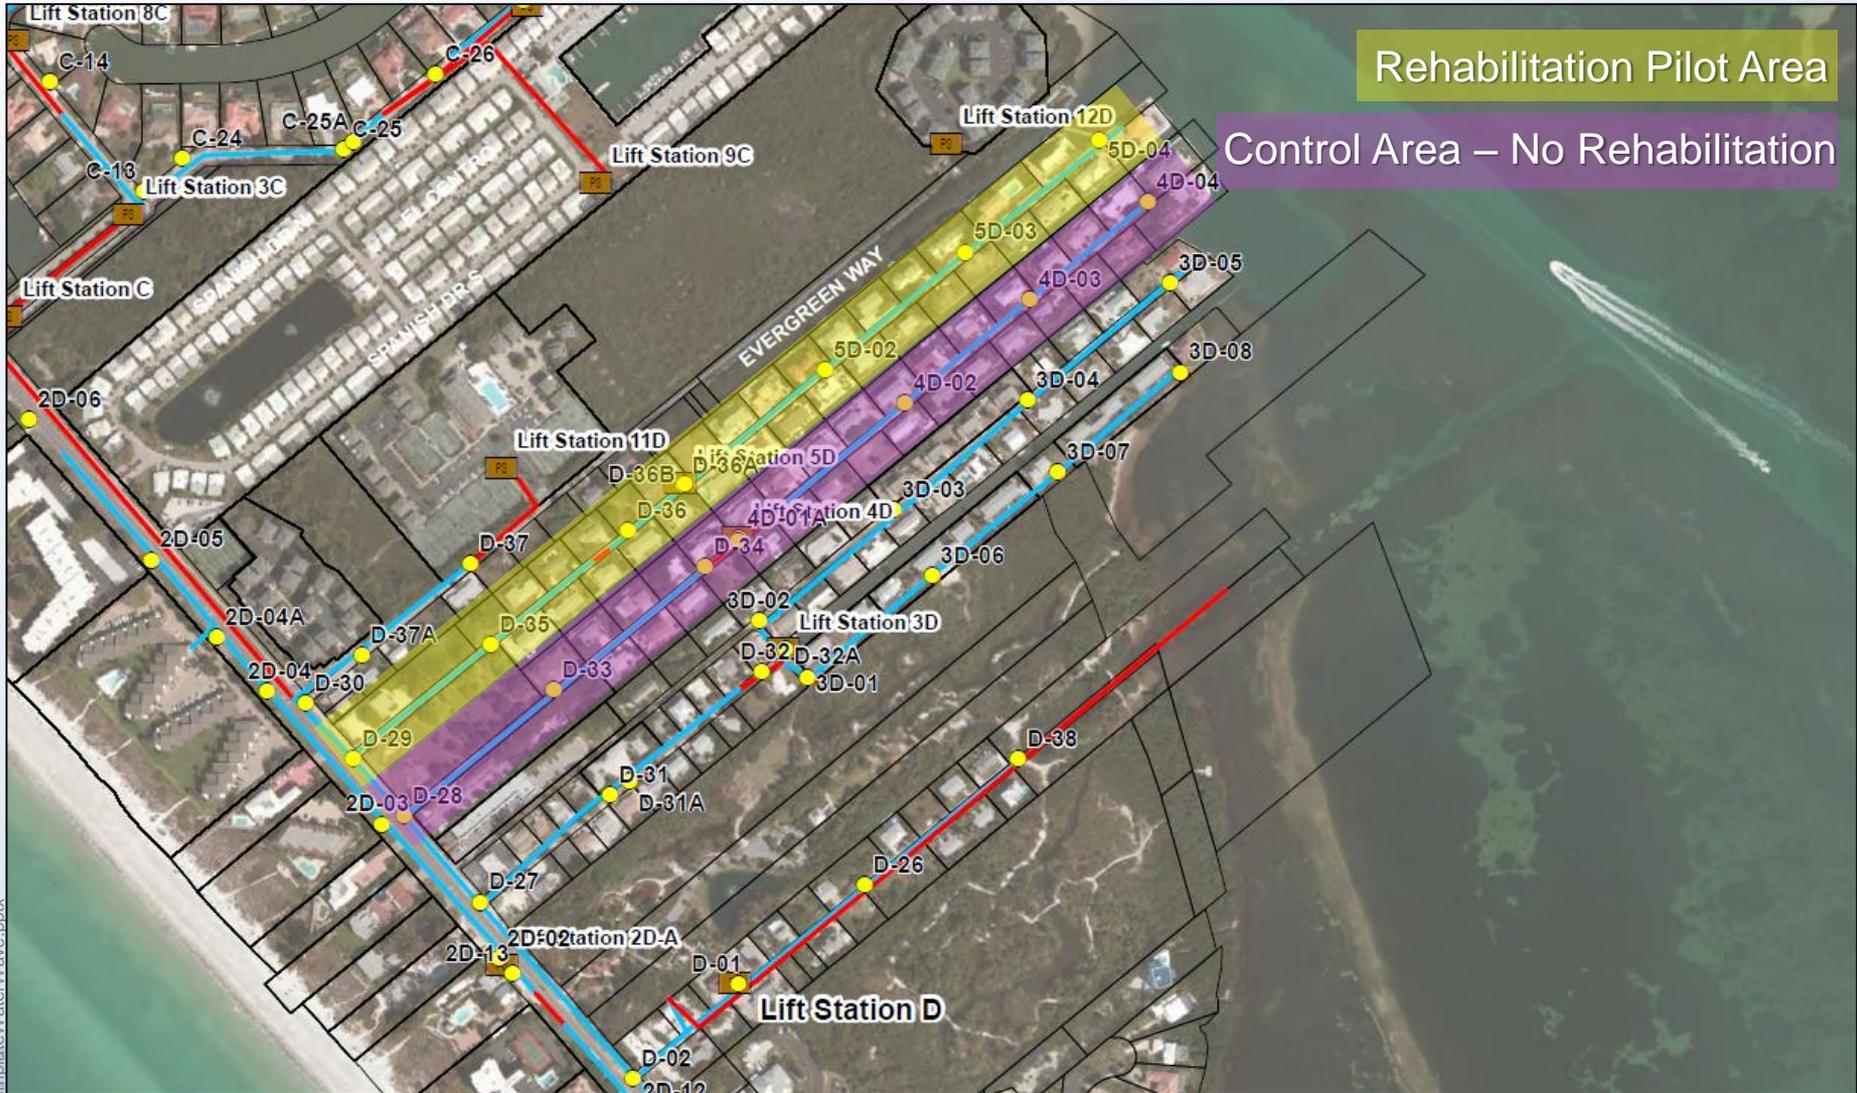
Pilot Test Area – Jungle Queen Way

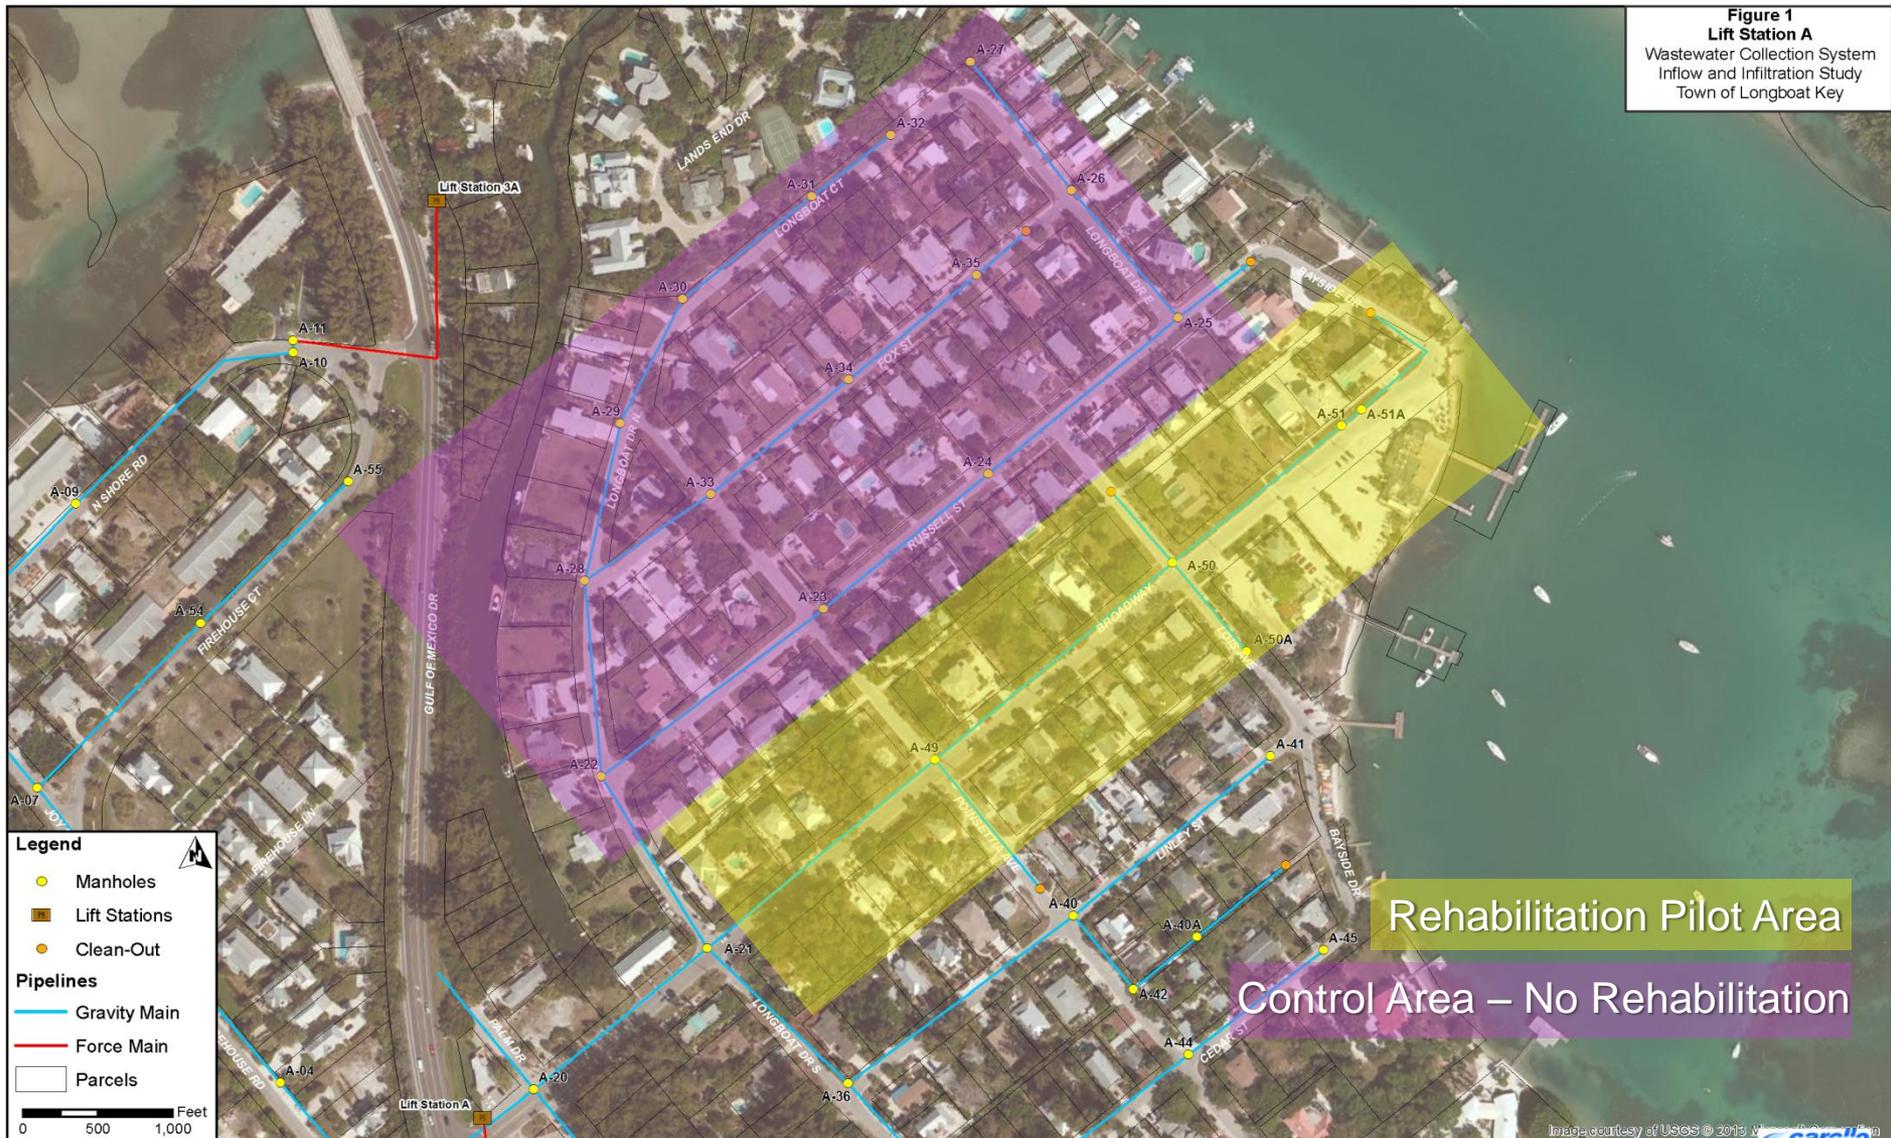
Figure 1
Lift Station A
 Wastewater Collection System
 Inflow and Infiltration Study
 Town of Longboat Key

Pilot Test Area – Broadway Street

Rehabilitation Pilot Area

Control Area – No Rehabilitation

- Mainline previously lined with CIPP and top-hats installed on some laterals
- Previously installed CIPP seen during video inspections and found to be in good condition
- Repaired/lined four laterals that were in poor condition
- Next step - Will install manholes on side streets to allow lining of those streets

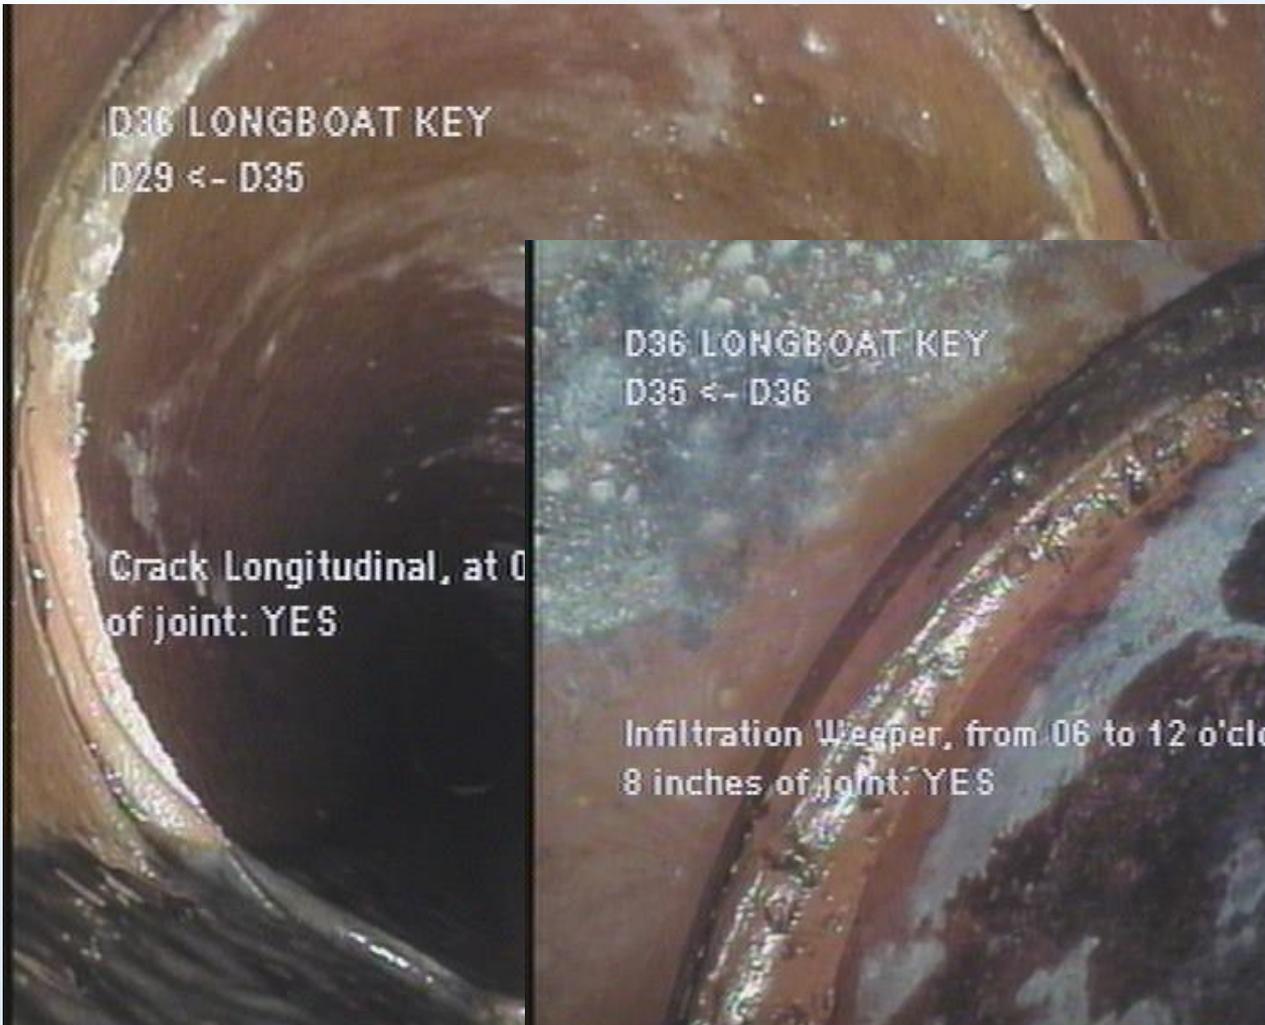
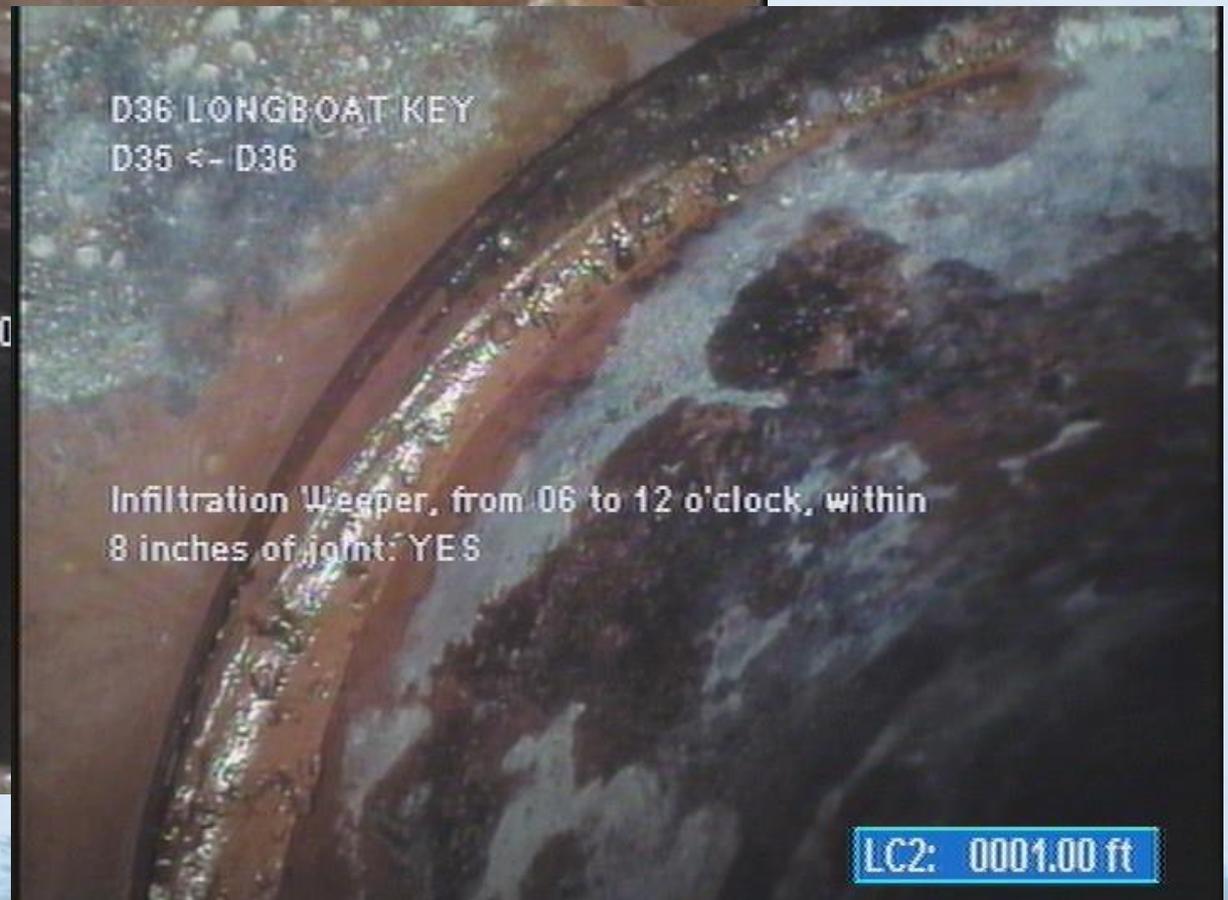
Pilot Study – Pipeline TV and Cleaning

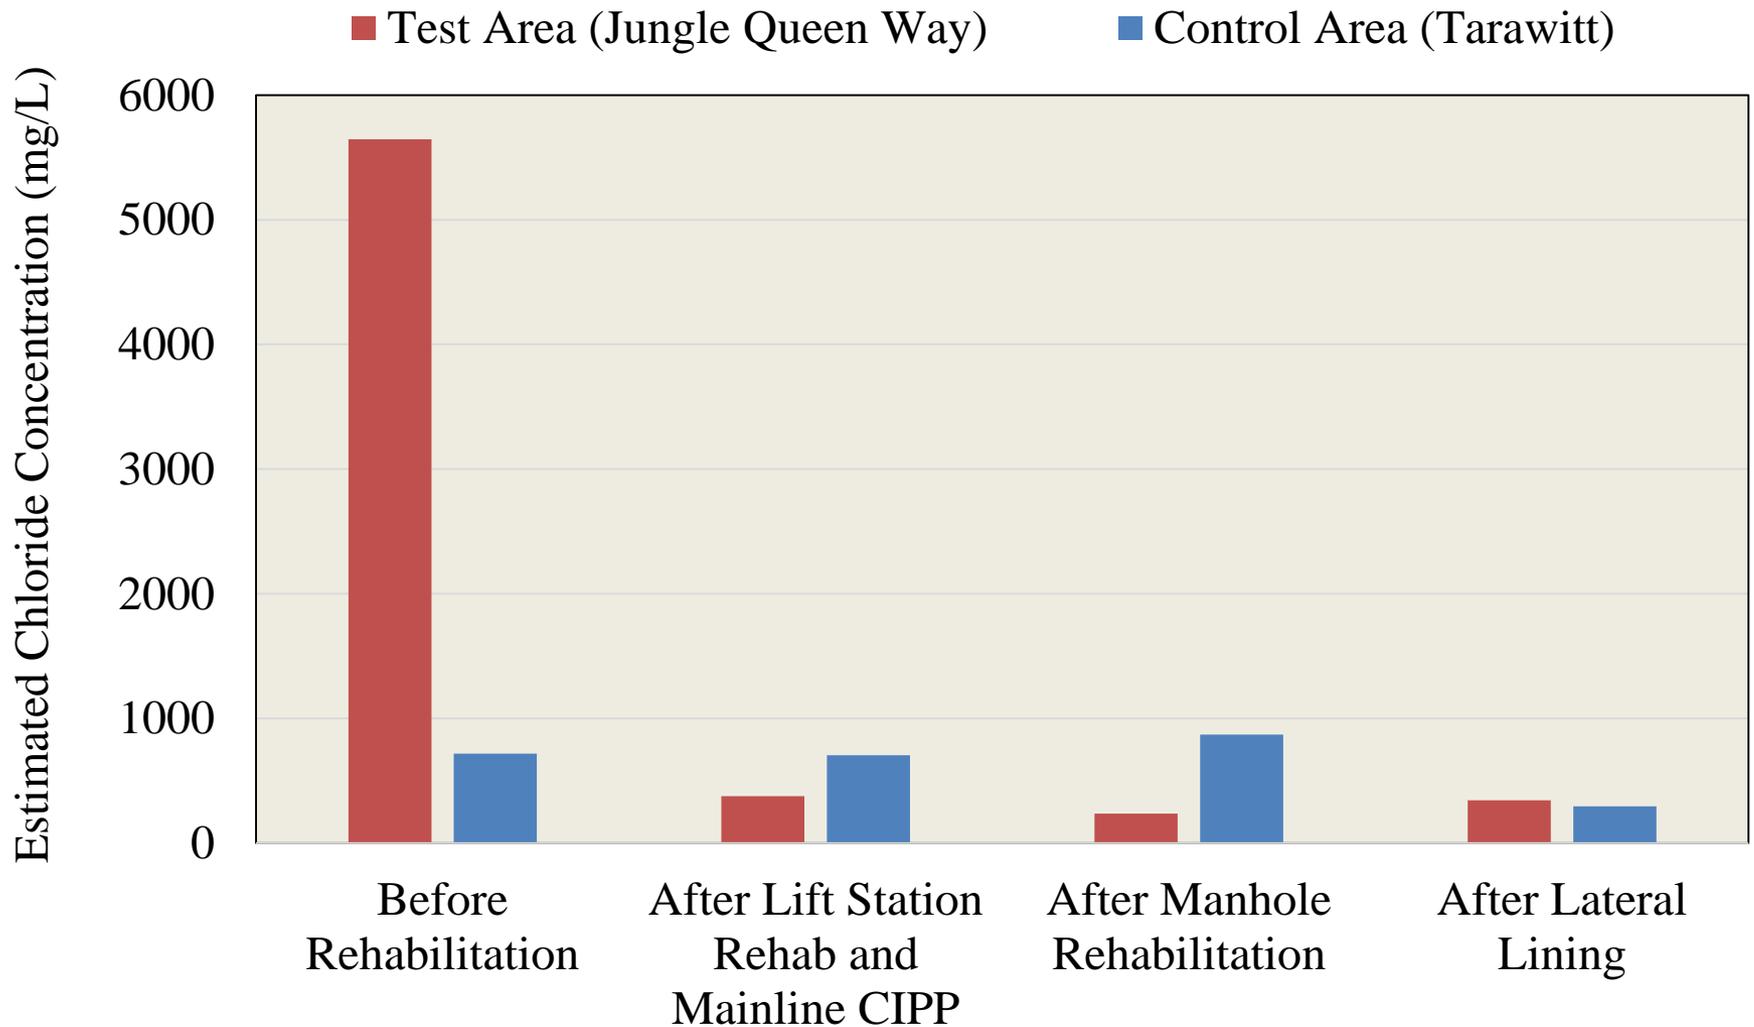
Jungle Queen Way – Pilot Study Results

- Previously unlined
- Installed Cured-in-Place-Pipe (CIPP) in the mainline
- Lined laterals where needed, based on inspection
- Repaired and lined manholes where needed
- Rehabilitated Lift Station 5D wetwell

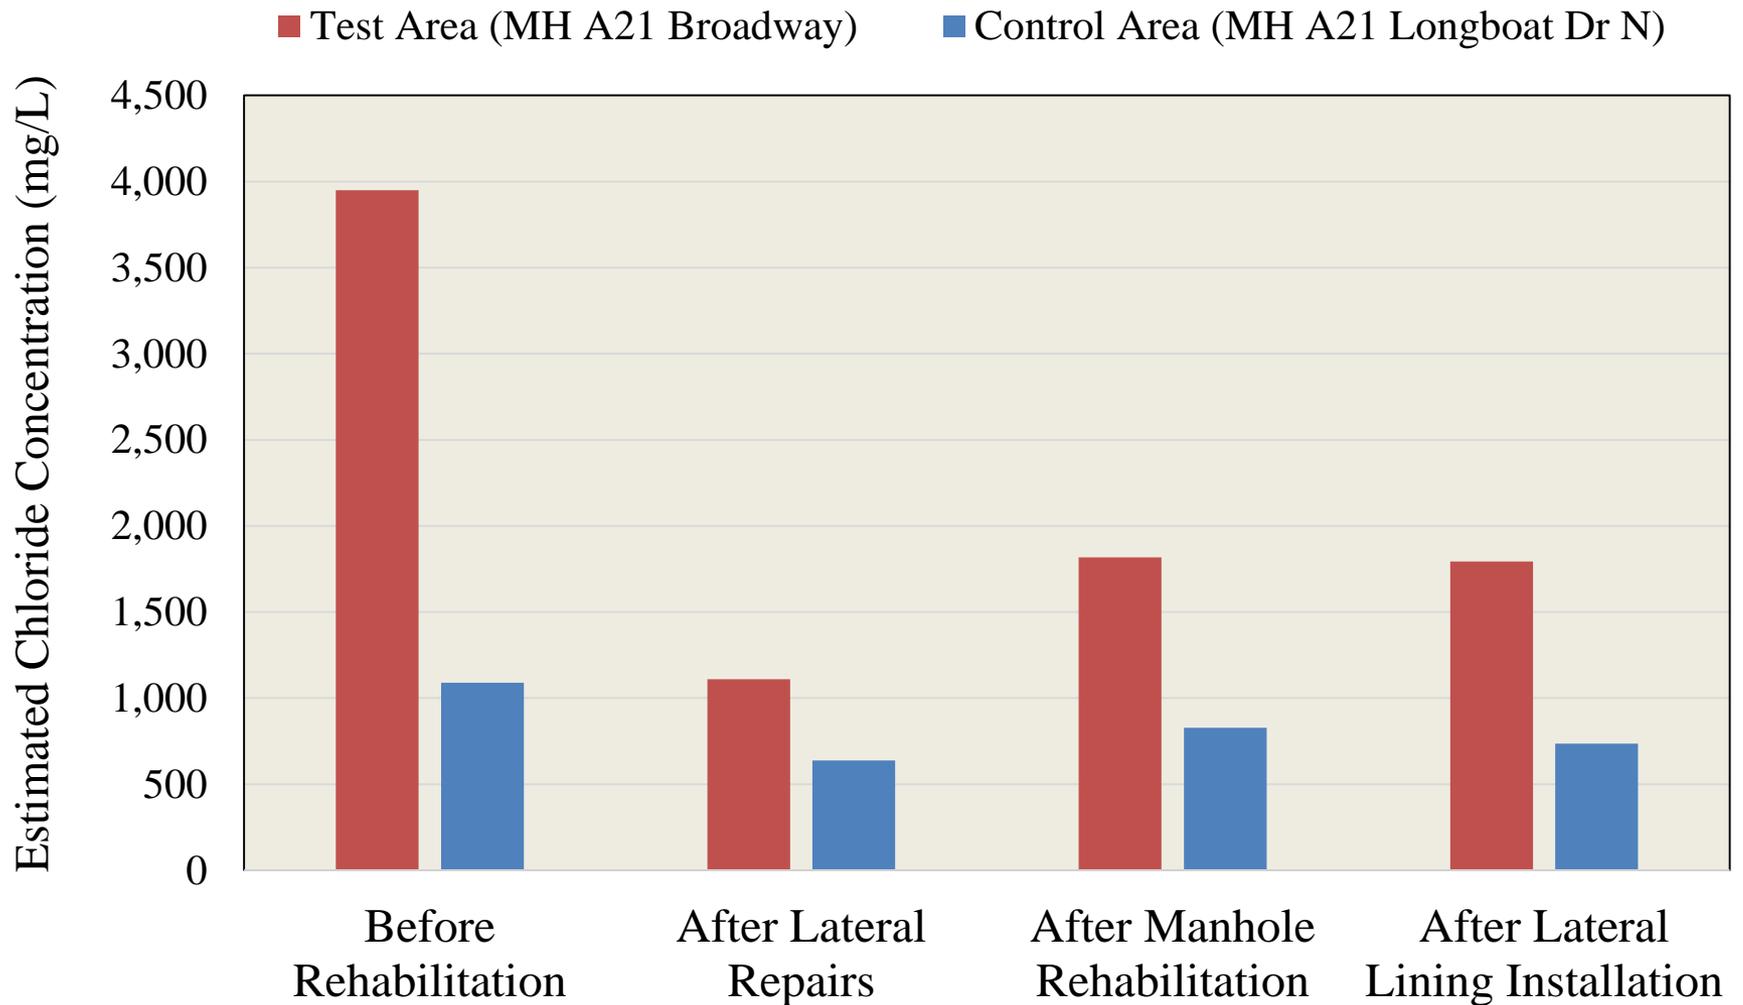
Broadway Street – Results to Date

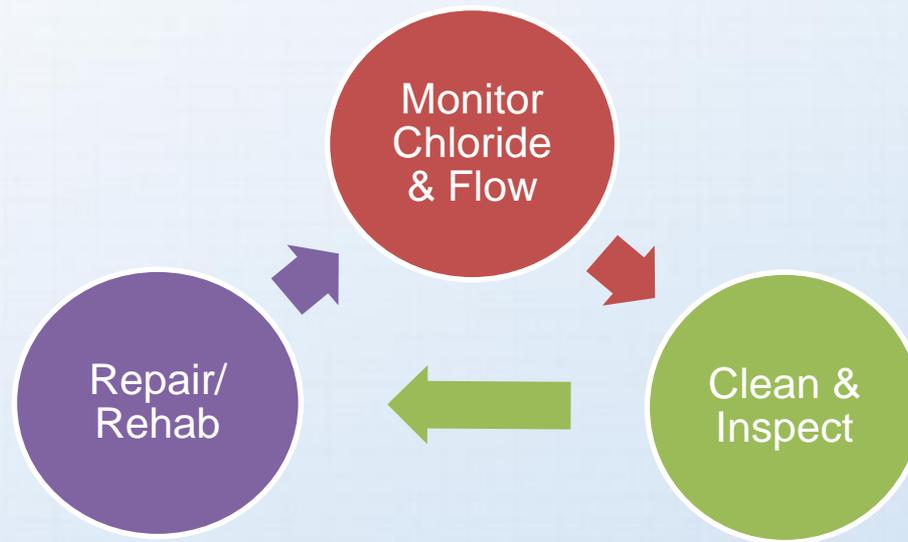
Pilot Study Supports a Three-Step Rehabilitation Process

- Options for rehabilitation are dependent on the condition and economics of repair
- Each prioritized area should be inspected to determine the appropriate corrective action measures
- Targeted I&I repairs provide highest cost-benefit
