Agenda Item: Inflow and Infiltration (I&I) Pilot Study Project Status

Summary: The Town Commission requested a staff update on the recent Inflow & Infiltration Pilot Study (I&I) and engineering recommendations. The Public Works Director and Ms. Laura Baumberger with Carollo Engineers will present an update on the Town's I&I Pilot Study Project, and future plans.

TO: Dave Bullock, Town Manager
FROM: Juan Florensa, Public Works Director
SUBJECT: Inflow and Infiltration (I&I) Pilot Study Project Status

Inflow & Infiltration (I&I) Rehabilitation Pilot Study

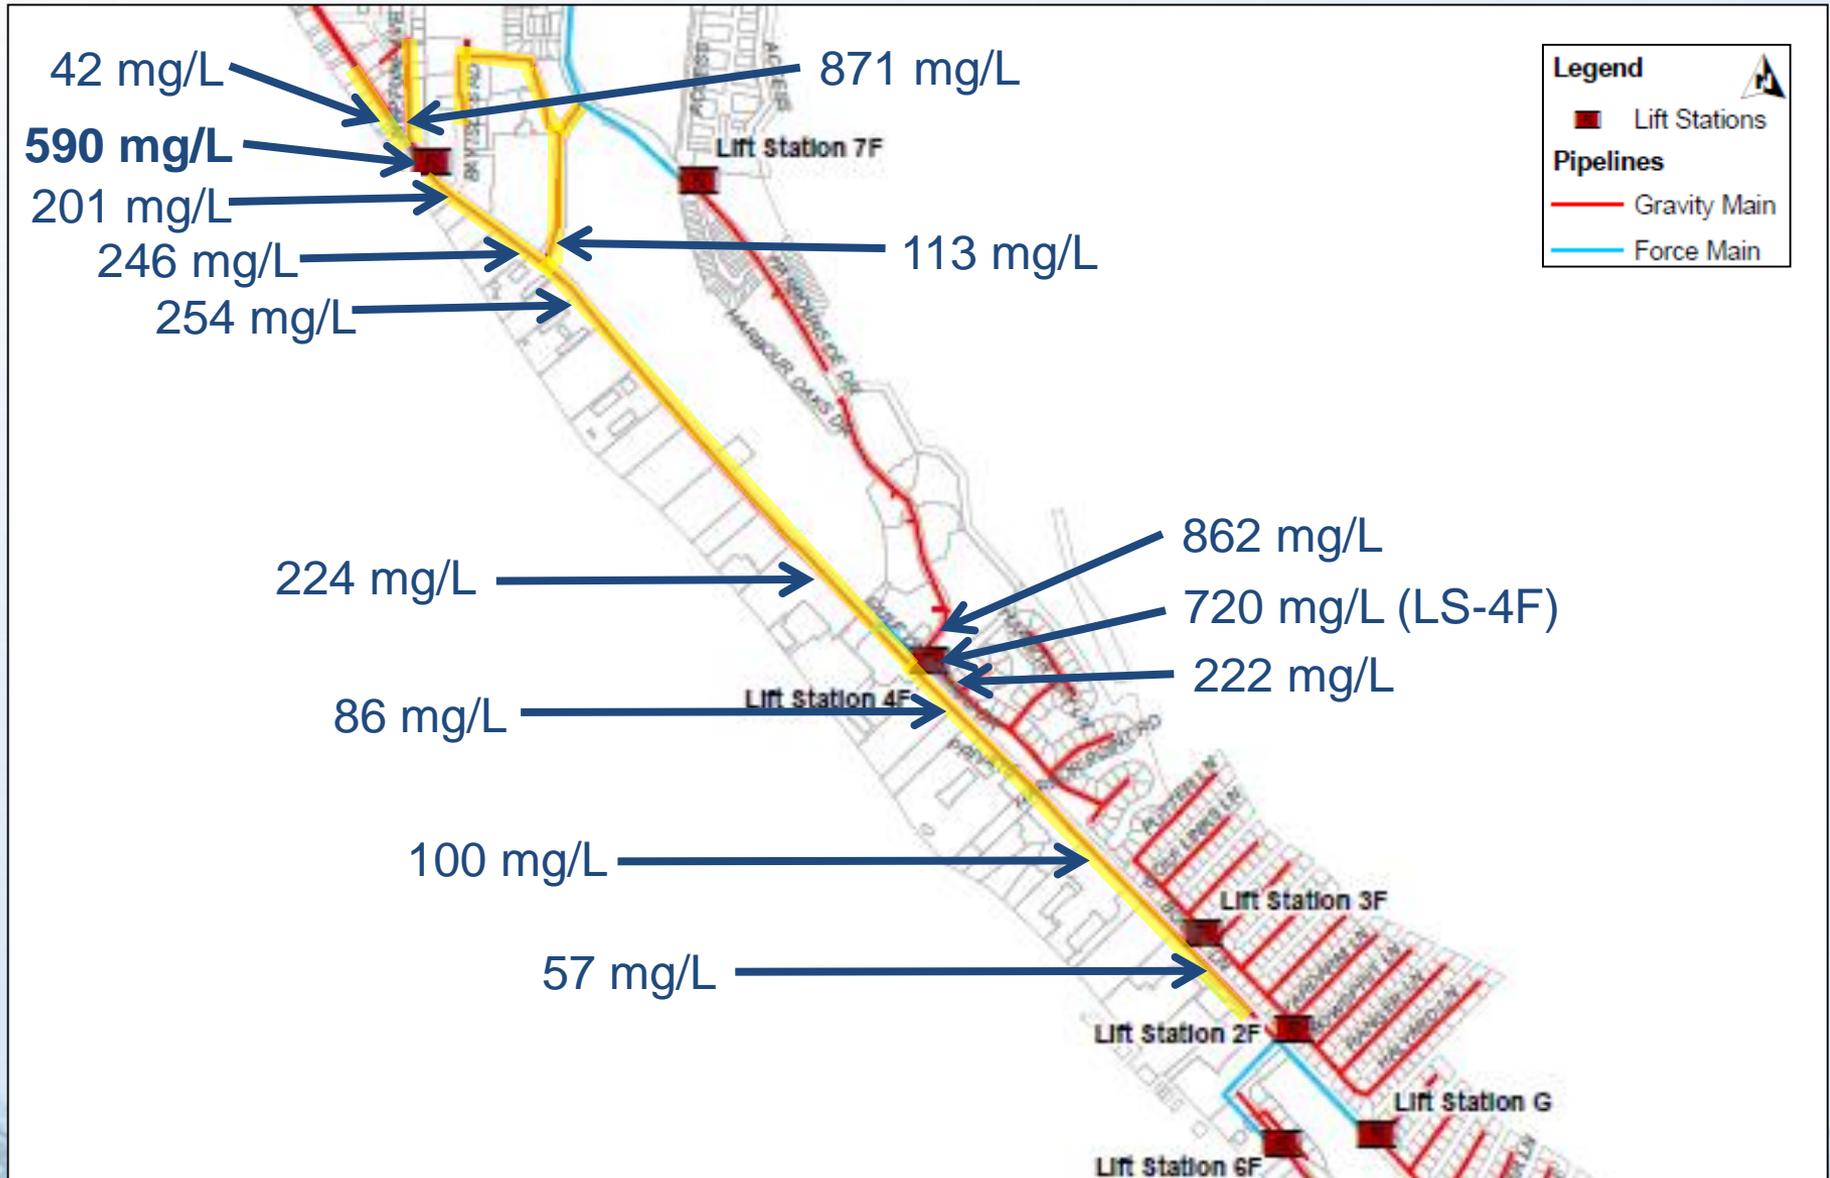
Lift Station F Chloride Concentration Map

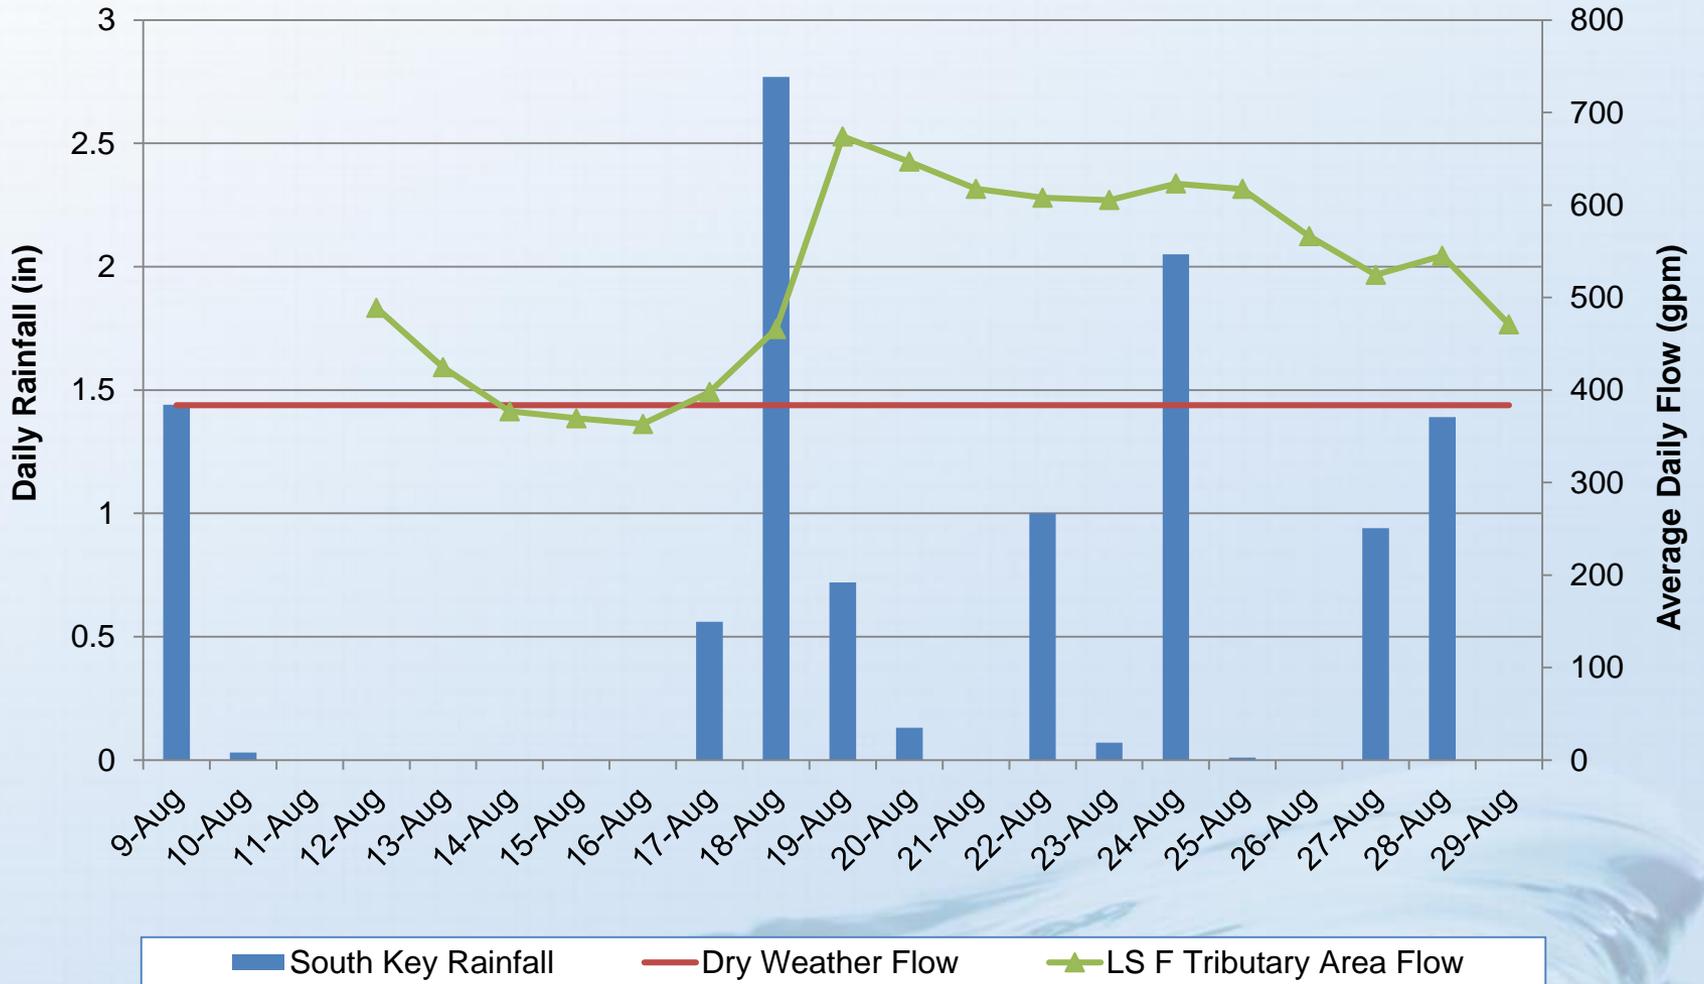
Daily Rainfall and Lift Station F Flow

Lift Station F Tributary Area Hydrograph
(Using flow measured at MH E-10)

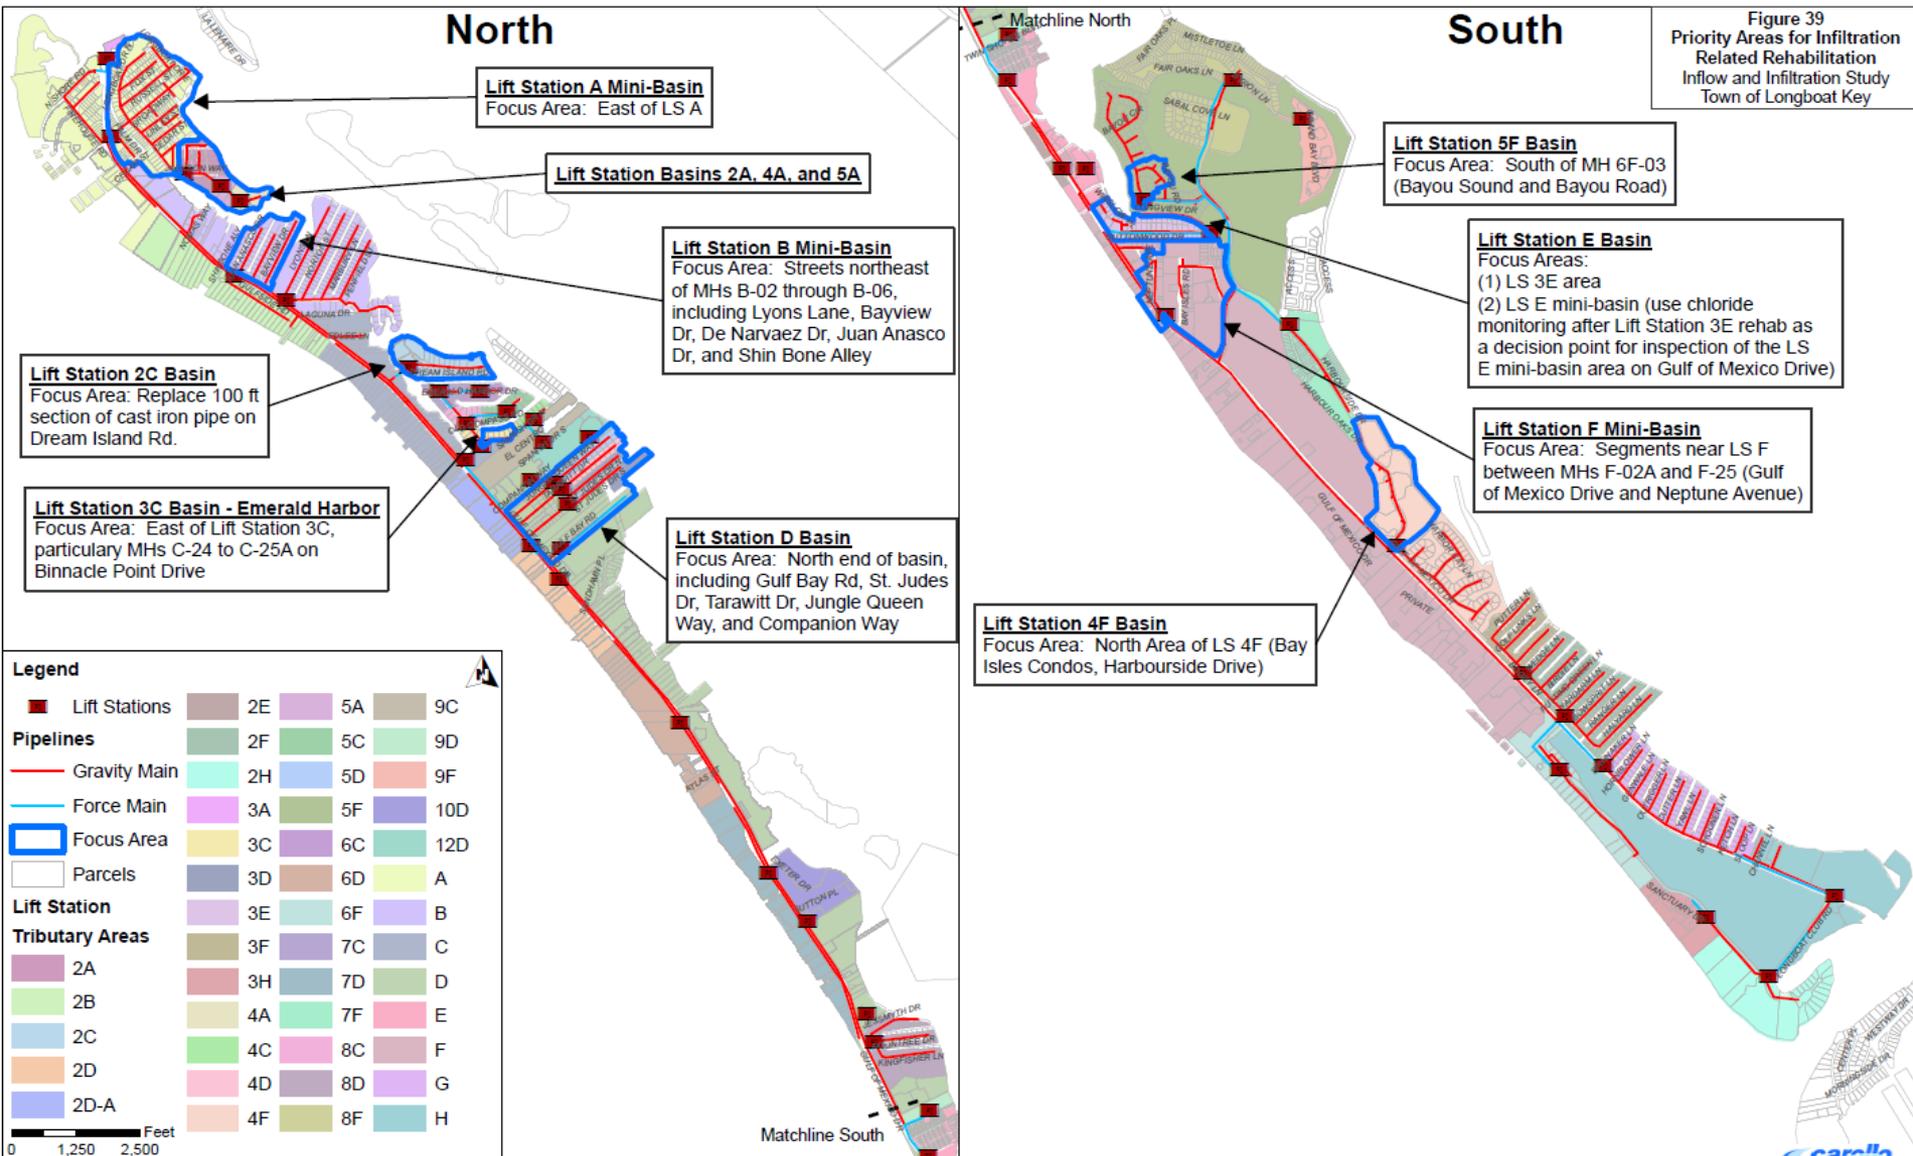
Figure 39
Priority Areas for Infiltration
Related Rehabilitation
Inflow and Infiltration Study
Town of Longboat Key

Priority Areas for Infiltration Related Rehabilitation

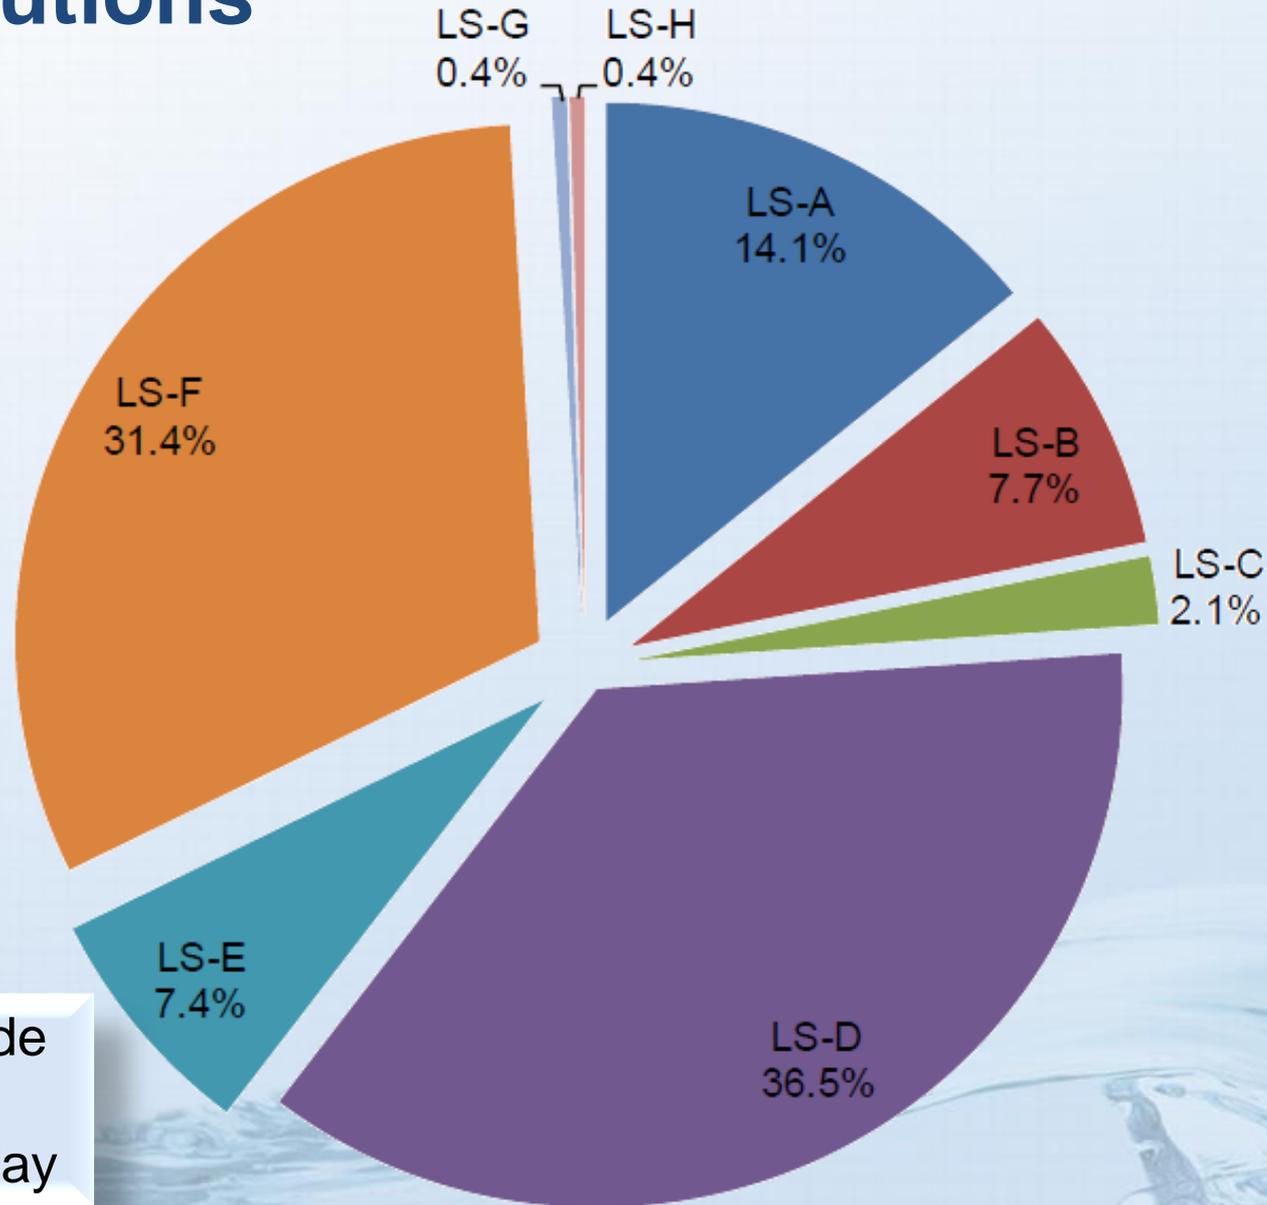
I&I Study Sewer Basin Chloride Contributions

Total Chloride
Mass =
15,610 lbs/day

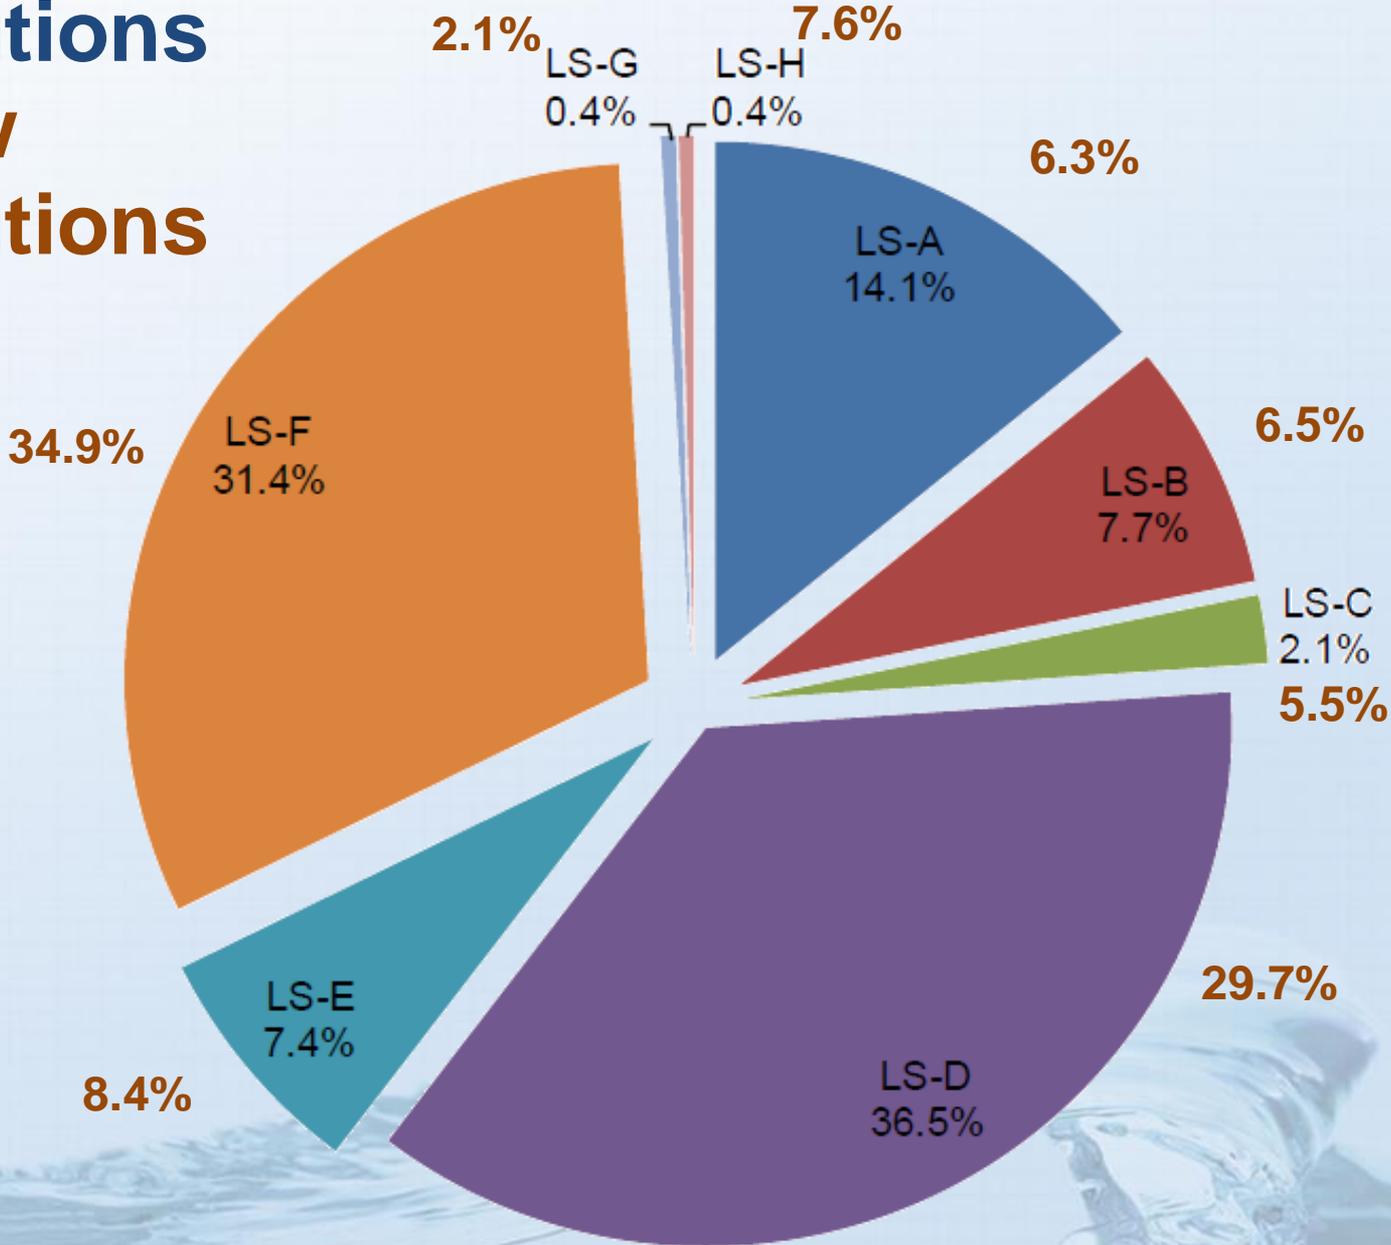
I&I Study Sewer Basin Chloride Contributions and Flow Contributions

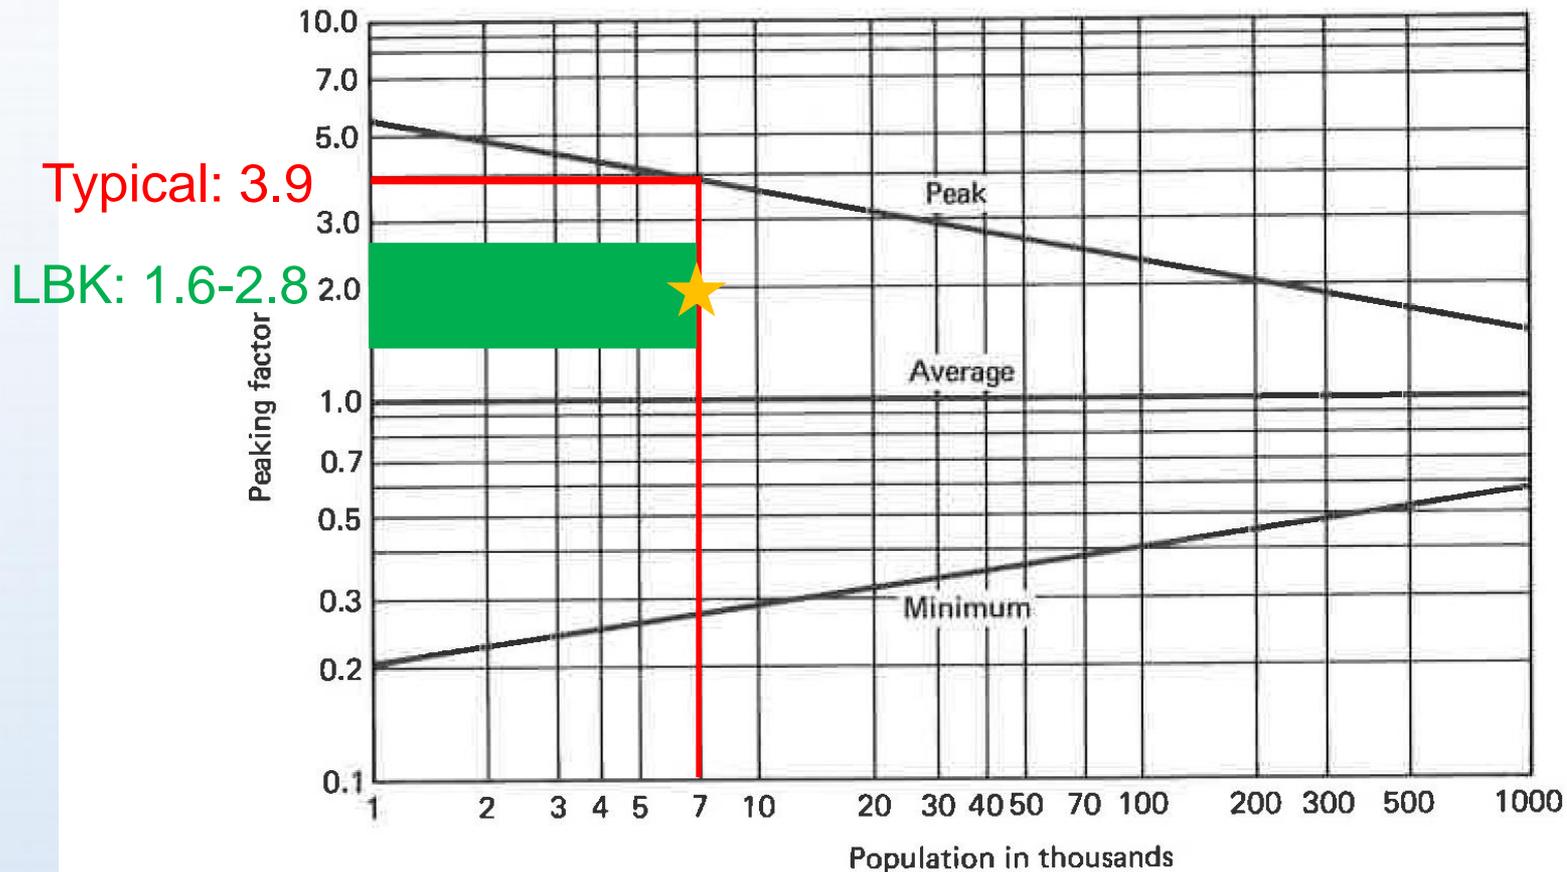
Typical Extreme Flow Peaking Factors

Typical: 3.9

LBK: 1.6-2.8

Figure 3-2 Ratios of Extreme Flows to Average Daily Flow (Peaking Factor) for Municipal Wastewater Under Dry Weather Conditions (from Ref. 16; used with permission of Water Environment Federation, and American Society of Civil Engineers).
