**PUBLIC NUISANCE HEARING  
1620 GULF OF MEXICO DRIVE**

**VILLA 4 BUILDING**

**TOWN COMMISSION SPECIAL MEETING  
MAY 28, 2014  
(CONTINUANCE)**

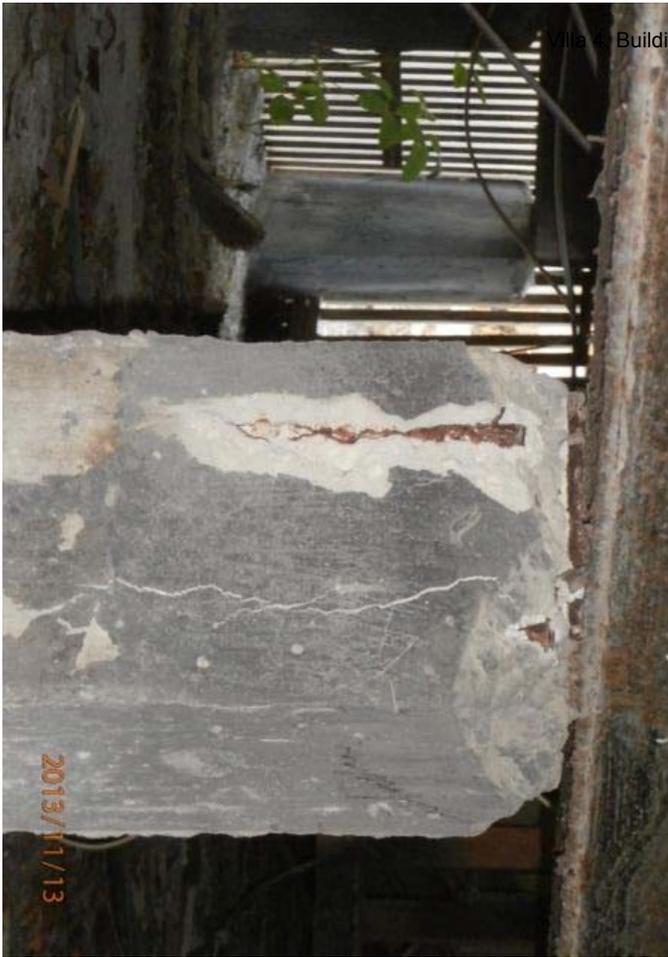
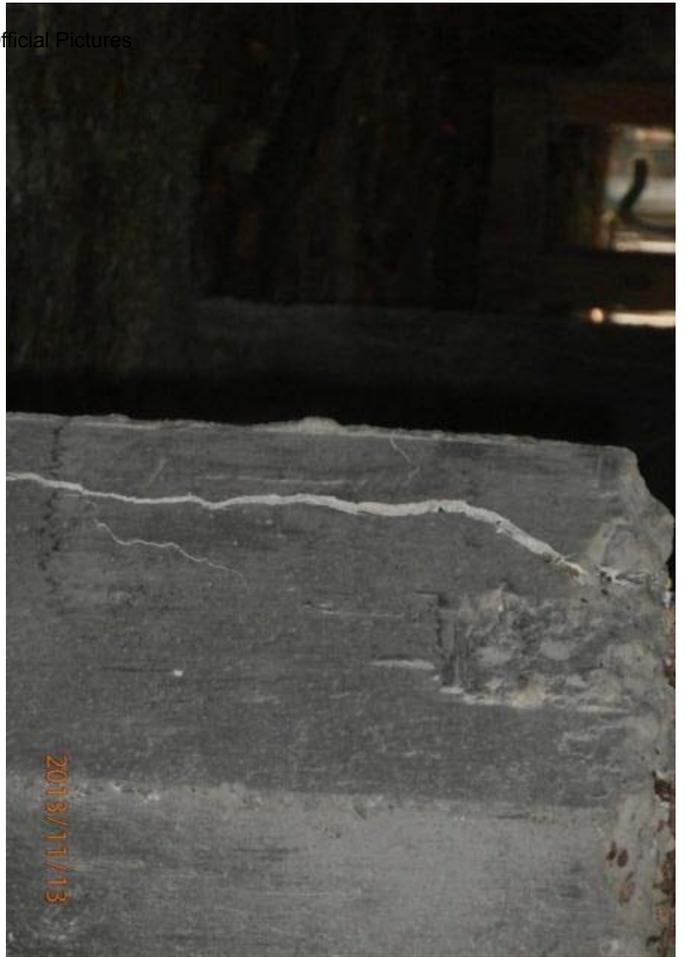
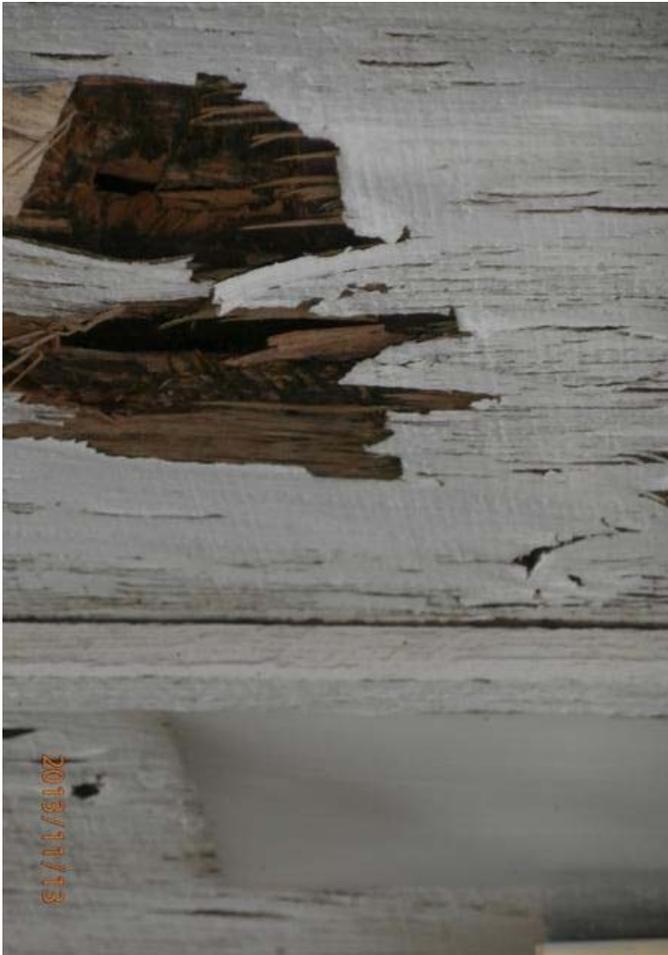
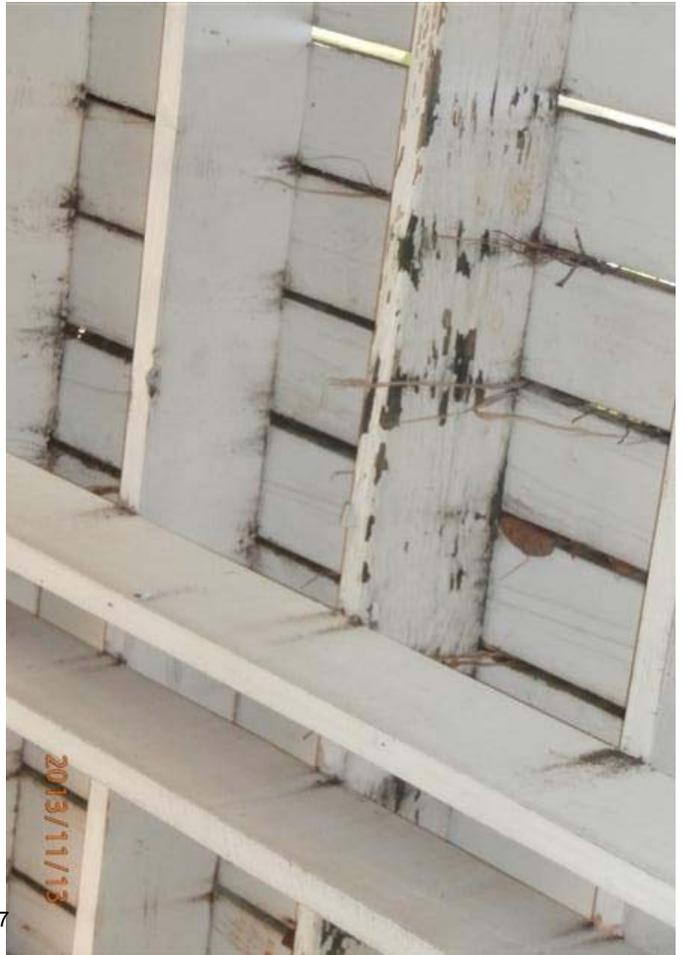
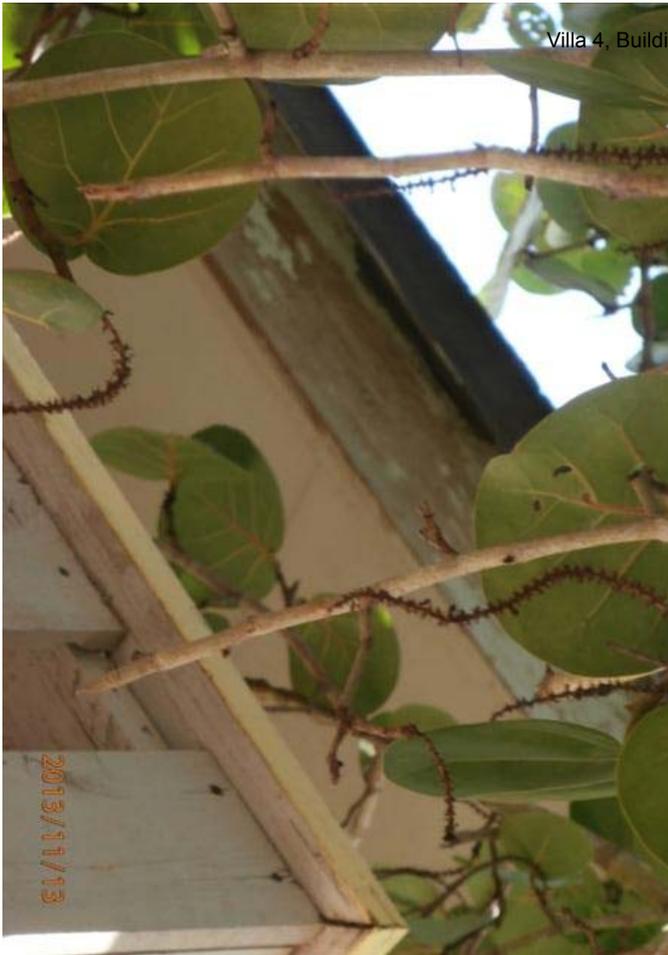
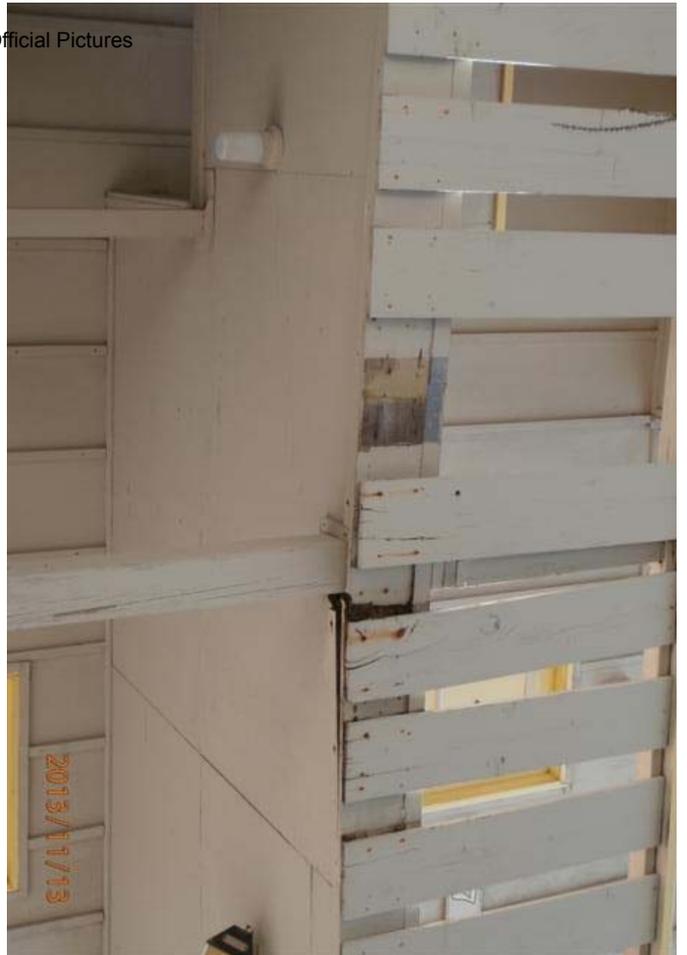
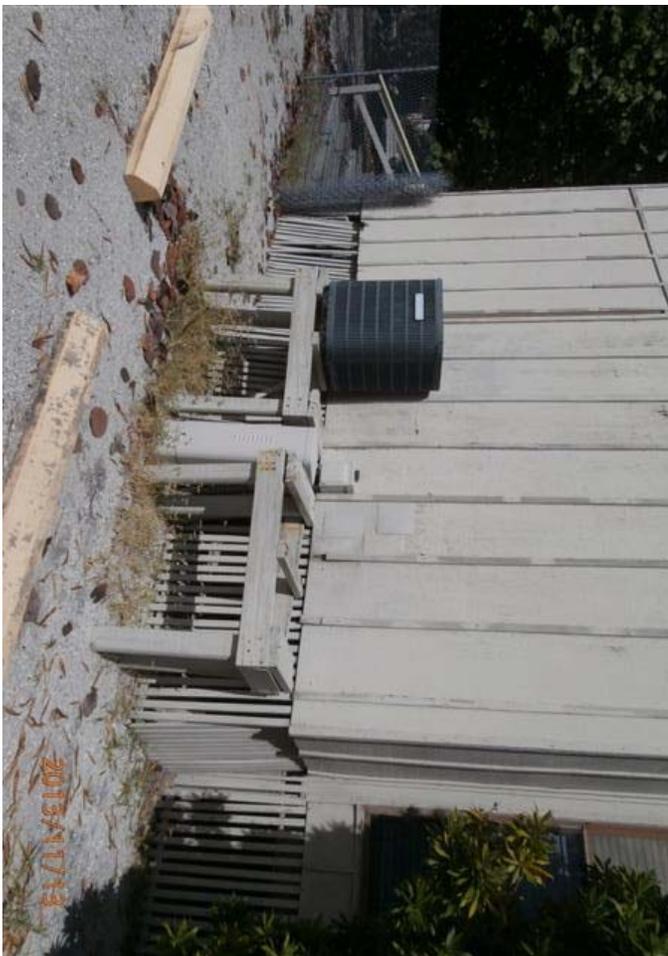
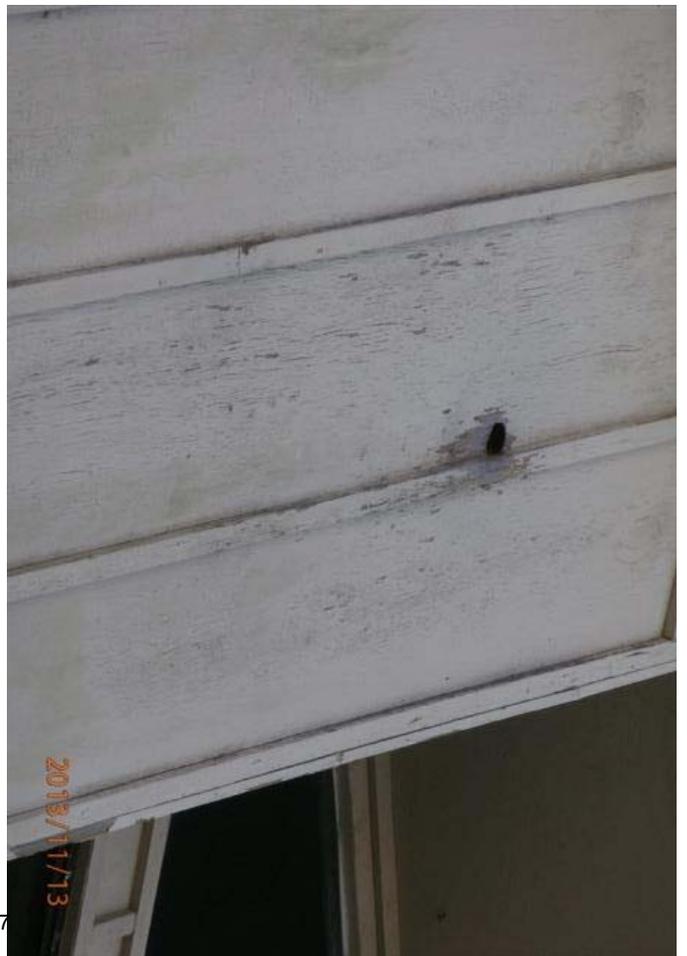
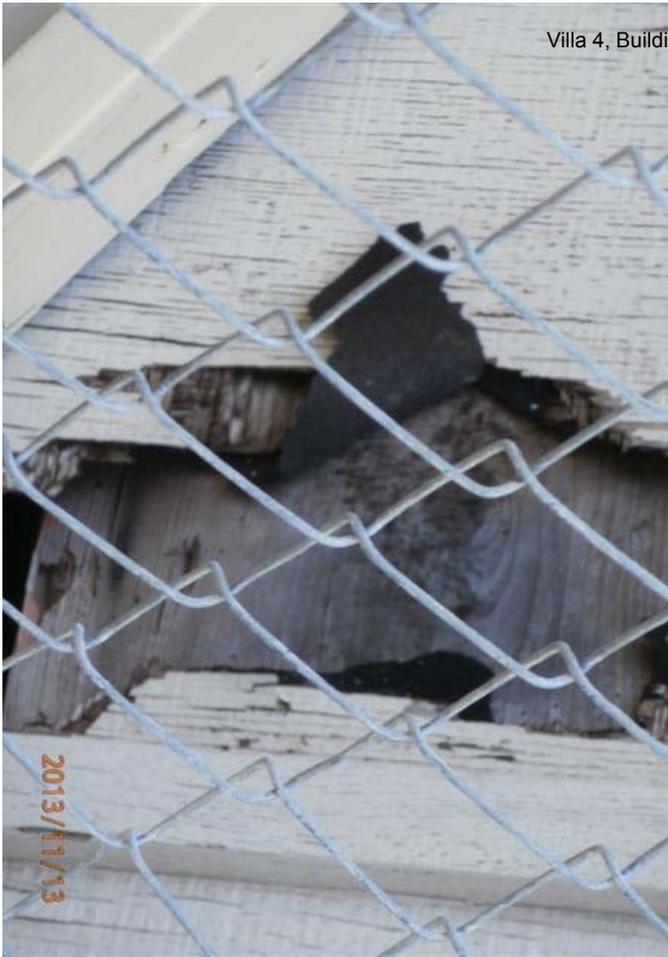
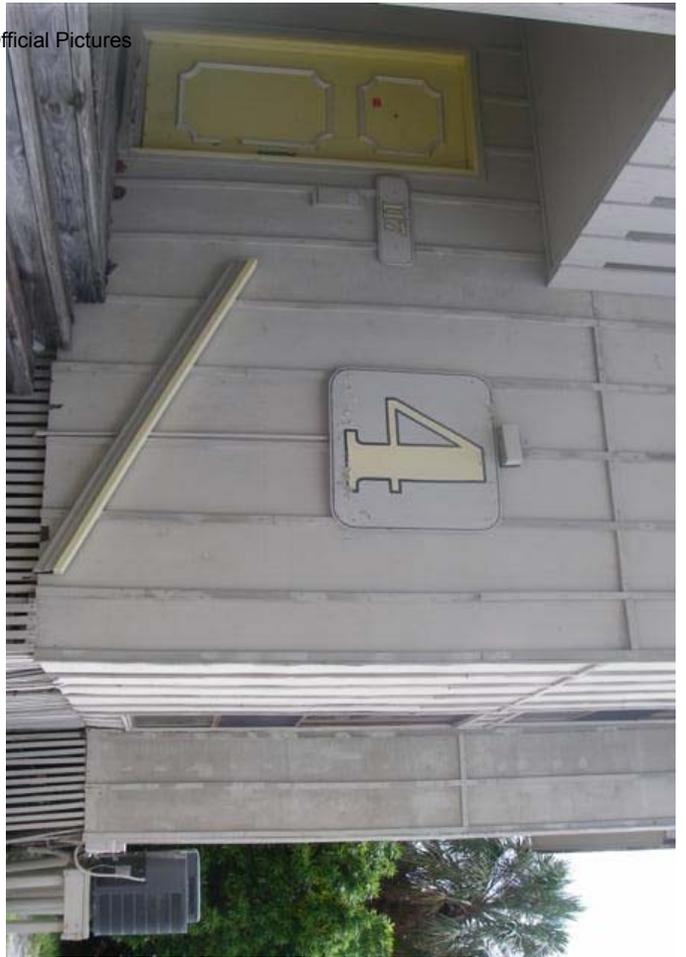
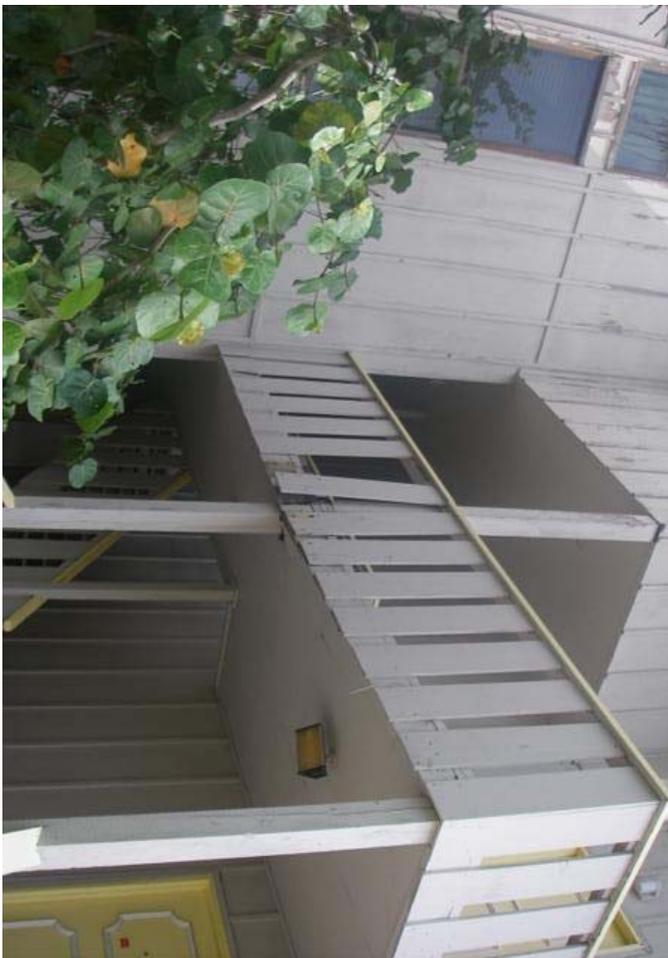
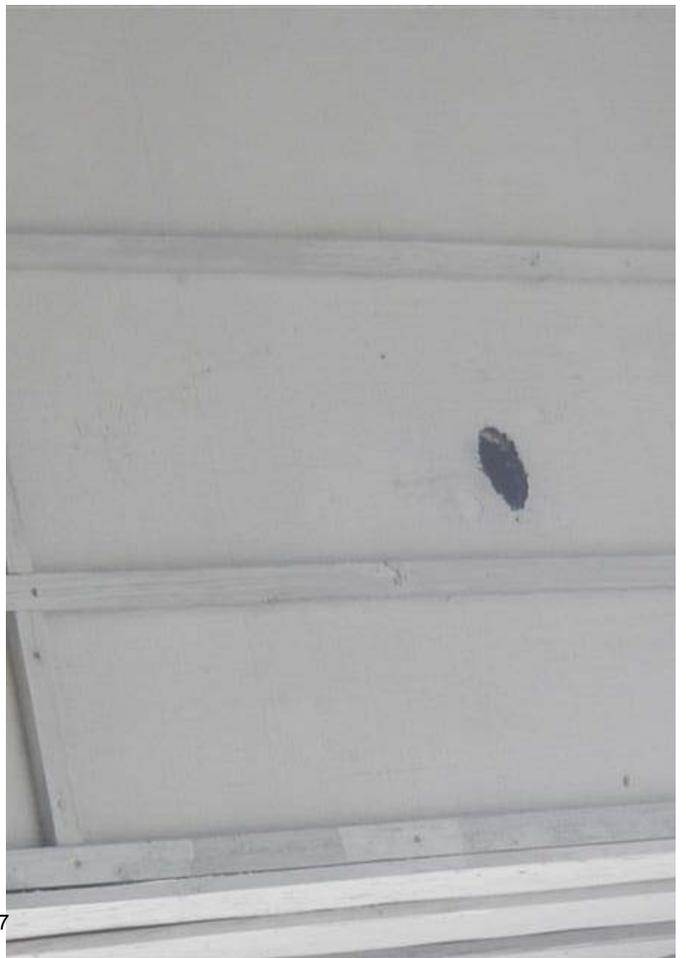
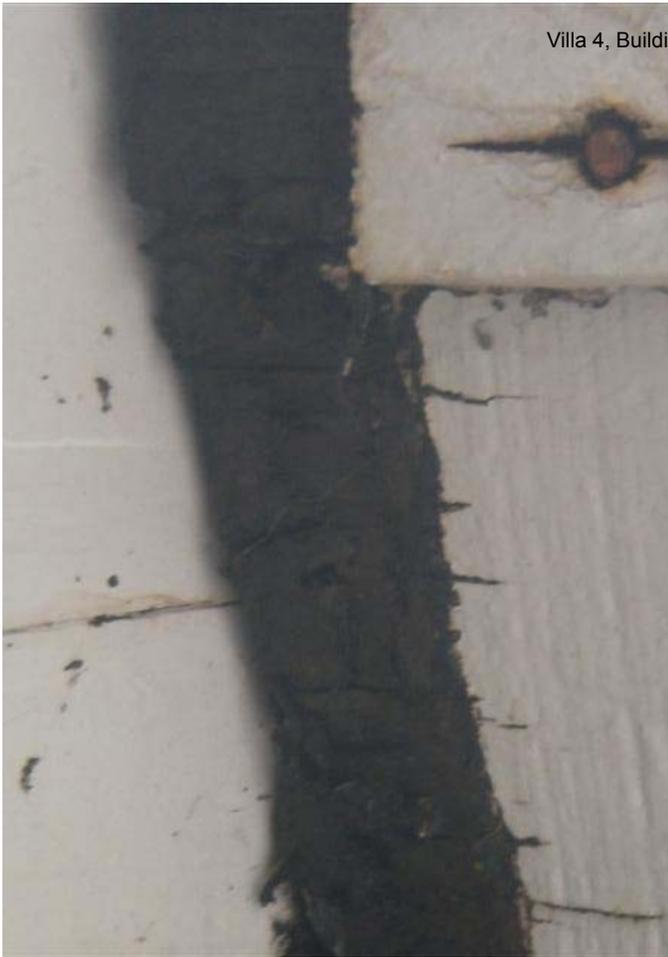
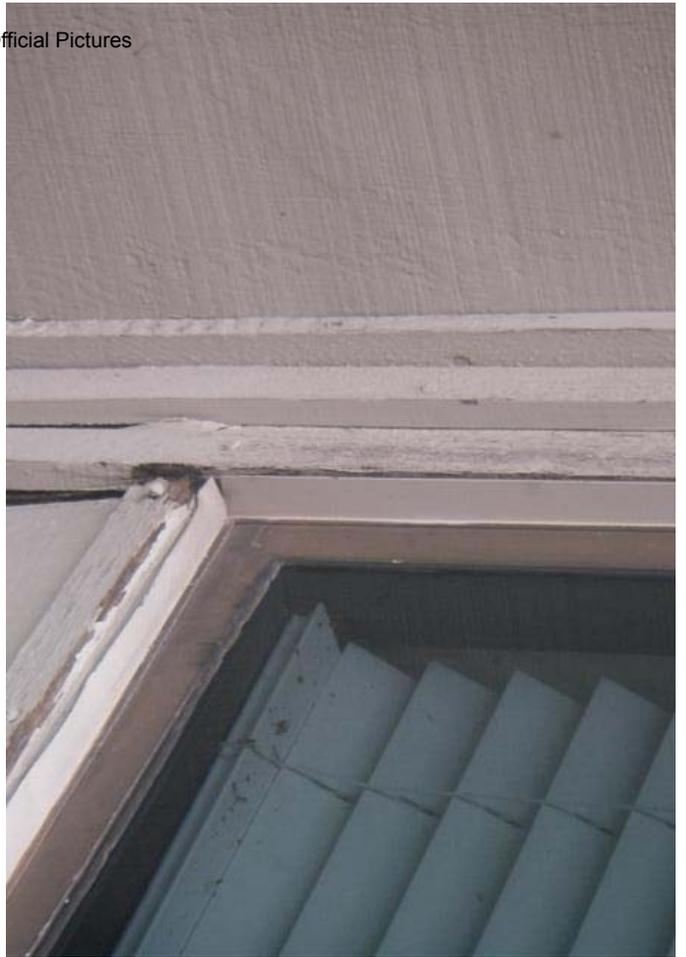
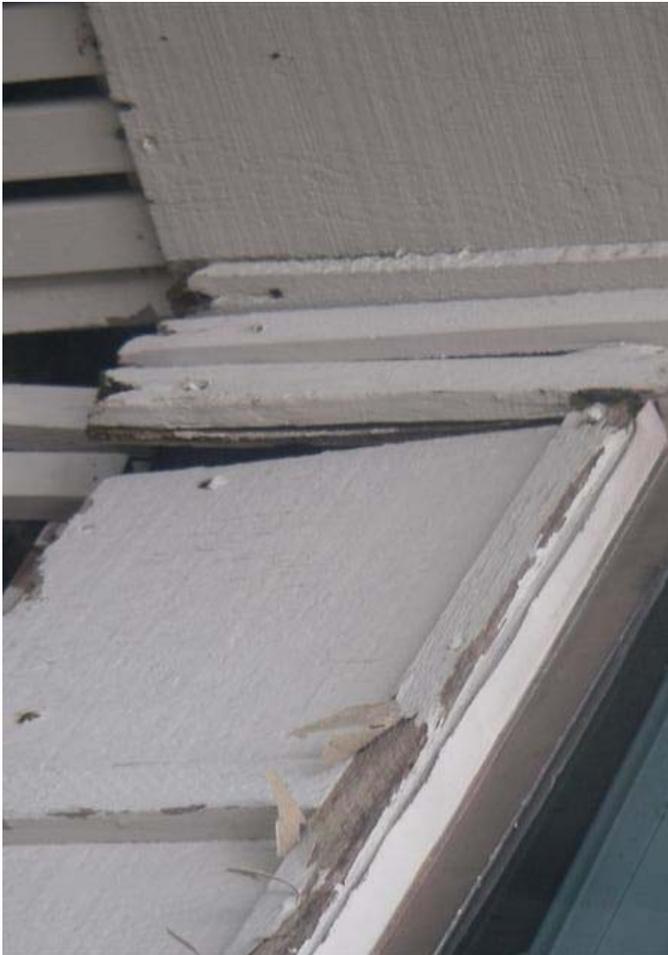
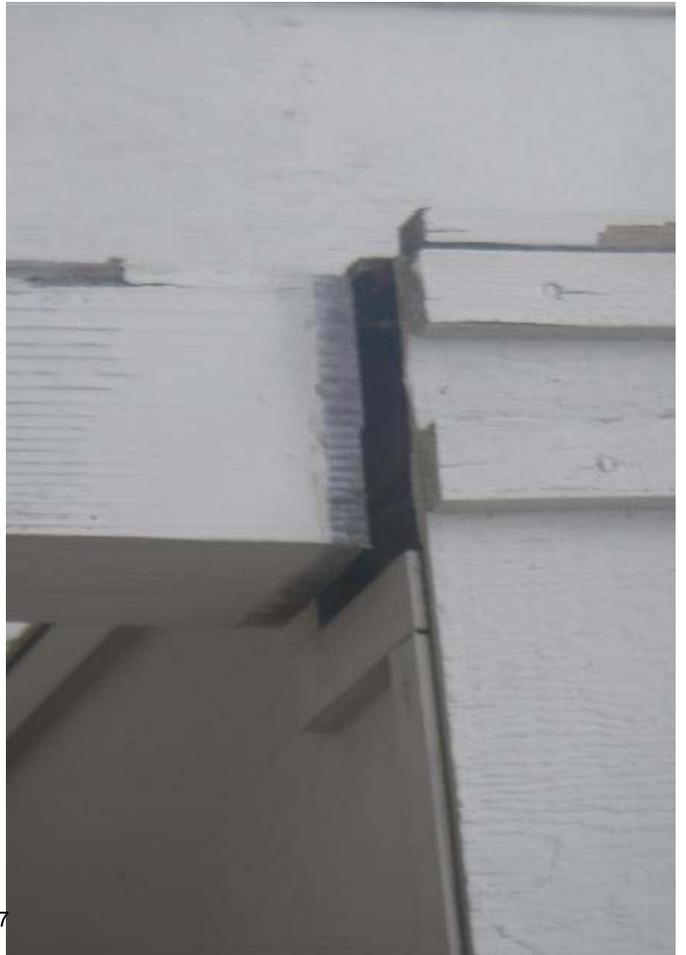
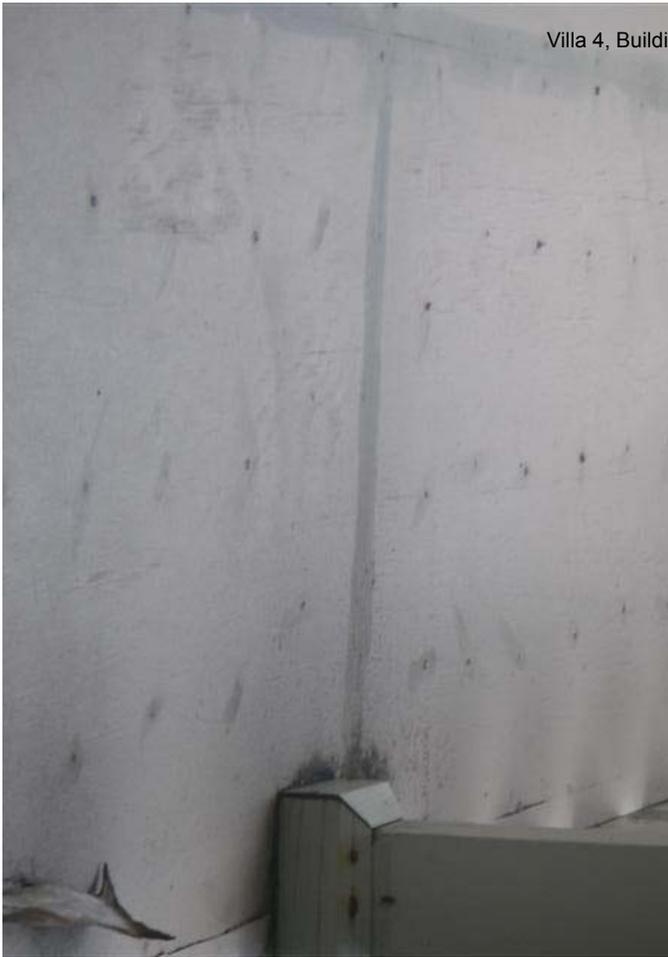
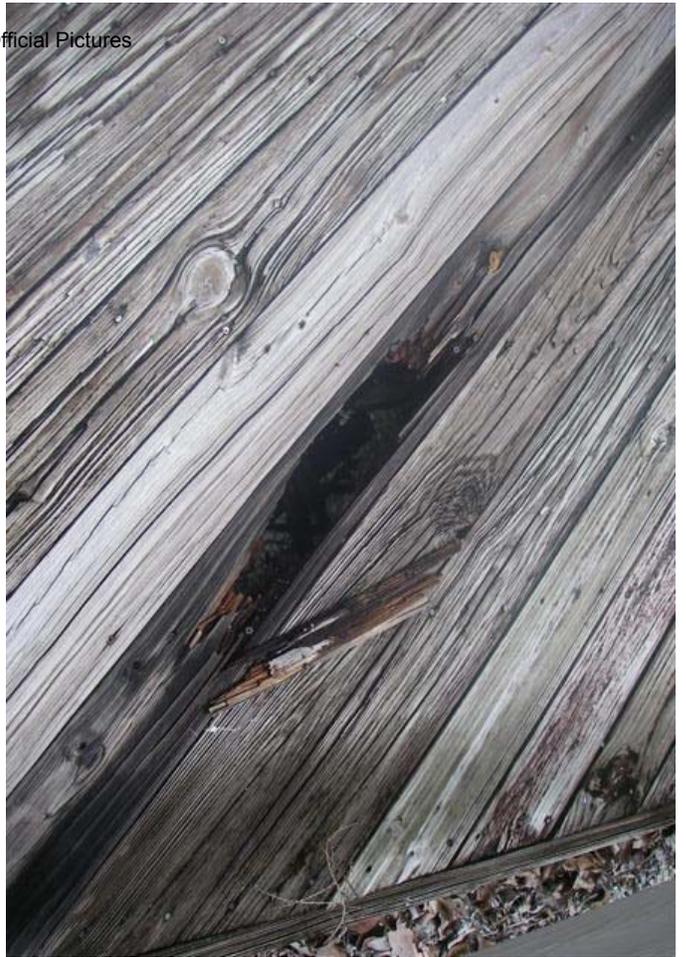
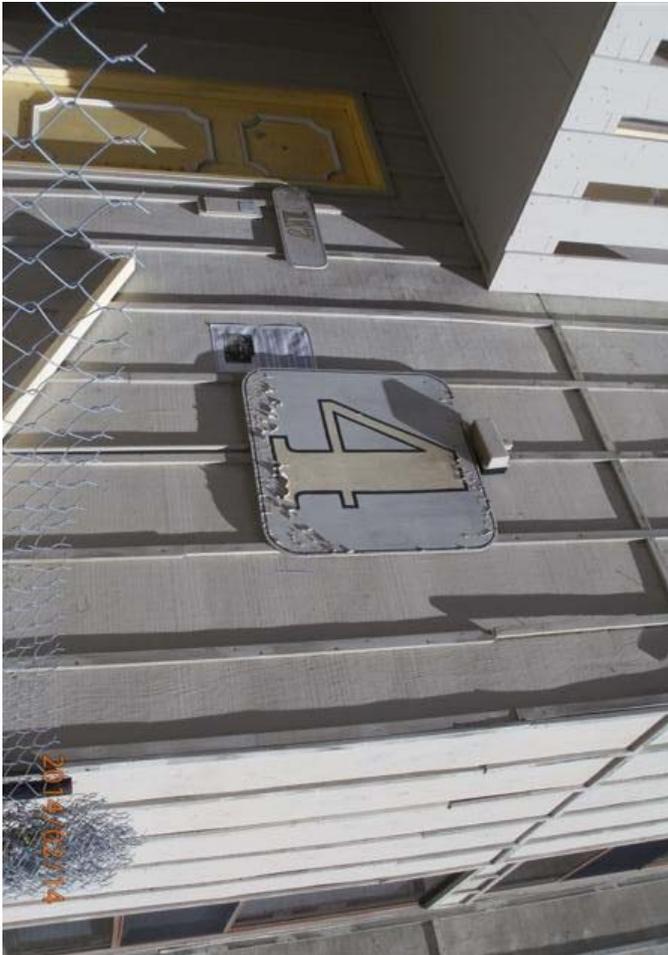
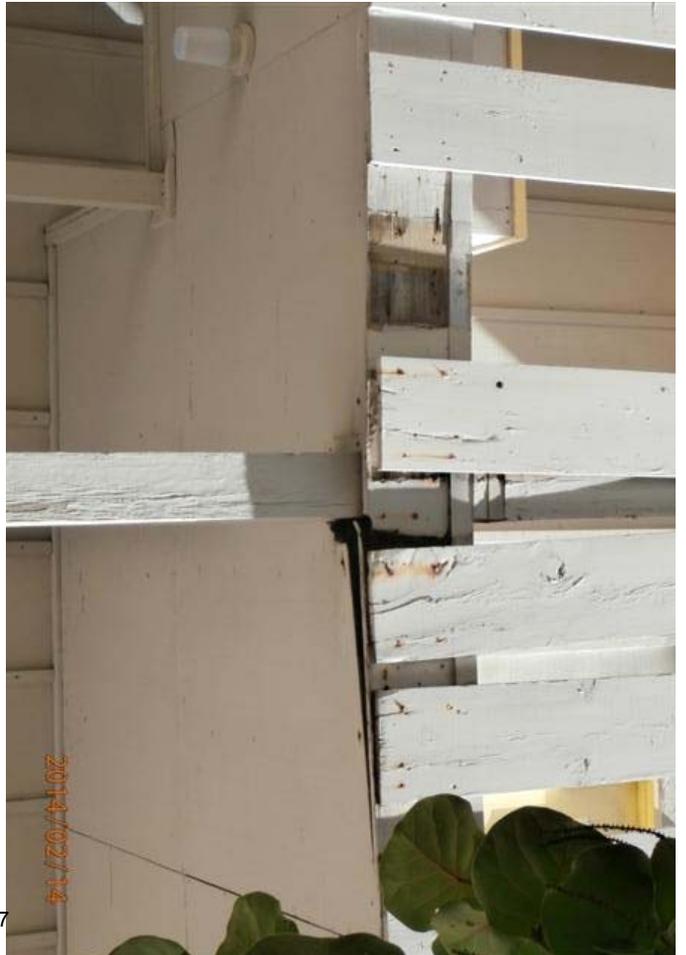
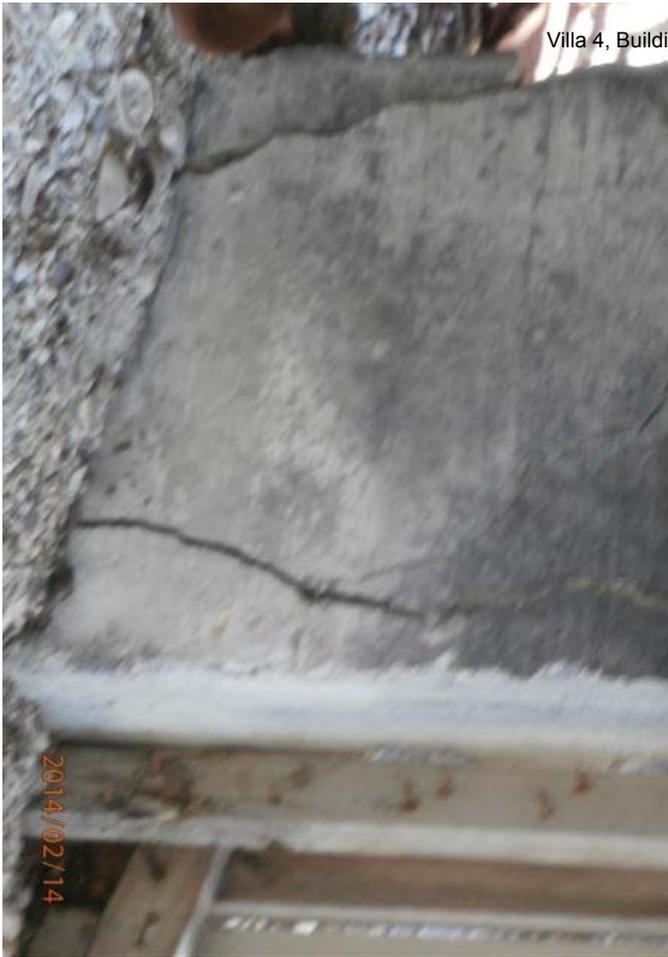
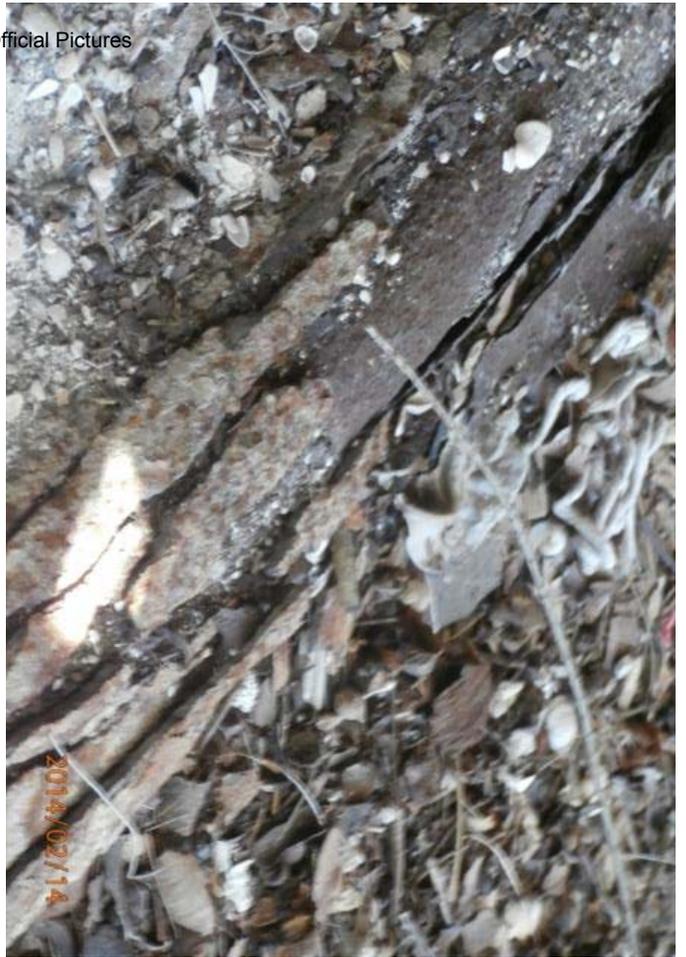
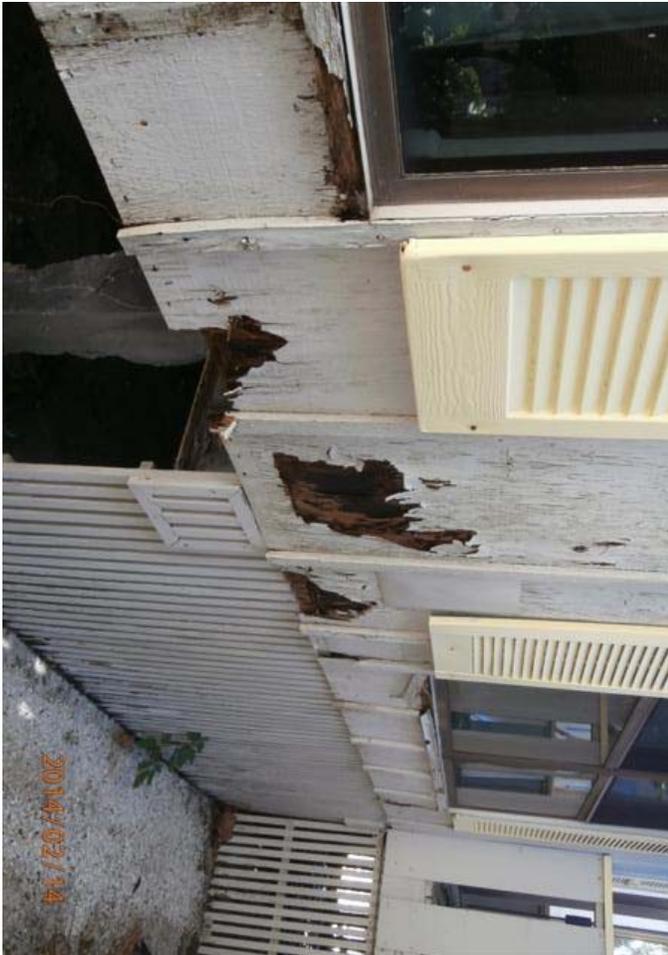
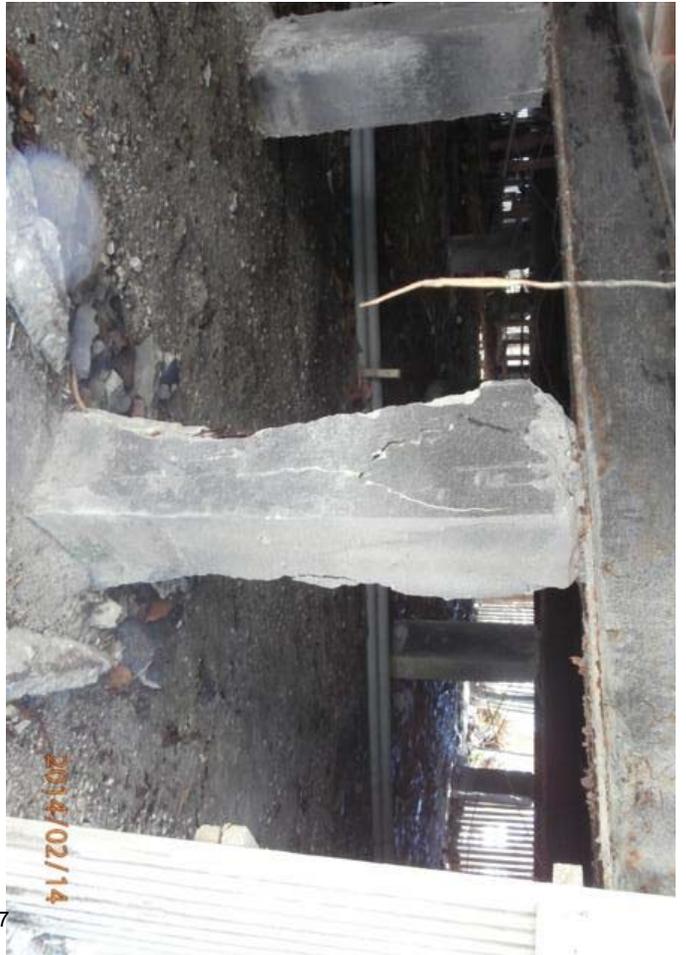
Villa 4, Building Official Pictures

- Extensive spalling, fissures, & fractures of piers
- Rebar exposure
- Failing shutter connection poles
- I-Beam failing by corrosion & rusting
- Extreme distress, rot, & cracking in wood members
- Broken cast iron drains
- Damaged window awnings

- **Maintain existing building entrance and perimeter security fencing**
- **Disconnect and cap off sewer connection**
- **Provide additional support to upper walkway at post at south entrance**

- Seal holes in siding on north and west elevations
- Secure and maintain the structure and property in compliance with Longboat Key Code of Ordinances, State, and Federal Regulations
