**PUBLIC NUISANCE HEARING
1620 GULF OF MEXICO DRIVE**

VILLA 9 BUILDING

**TOWN COMMISSION SPECIAL MEETING
MAY 28, 2014
(CONTINUANCE)**

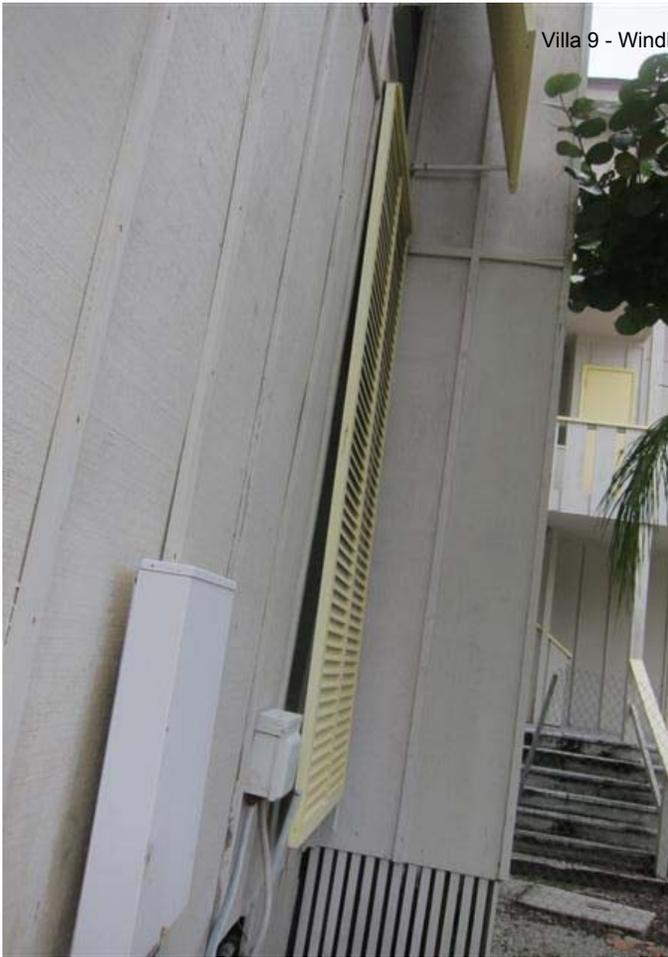
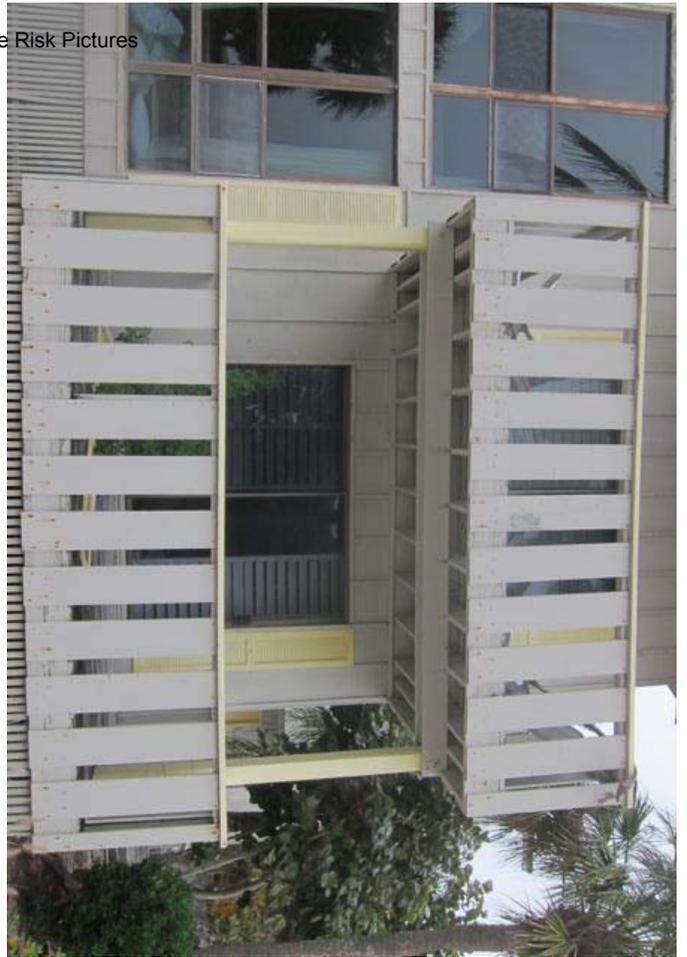
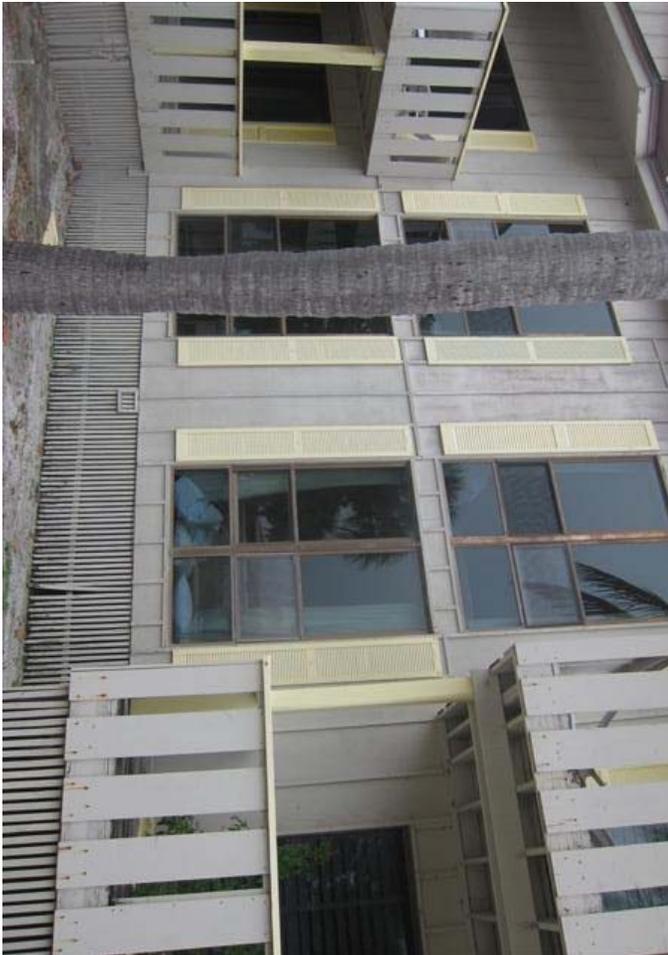
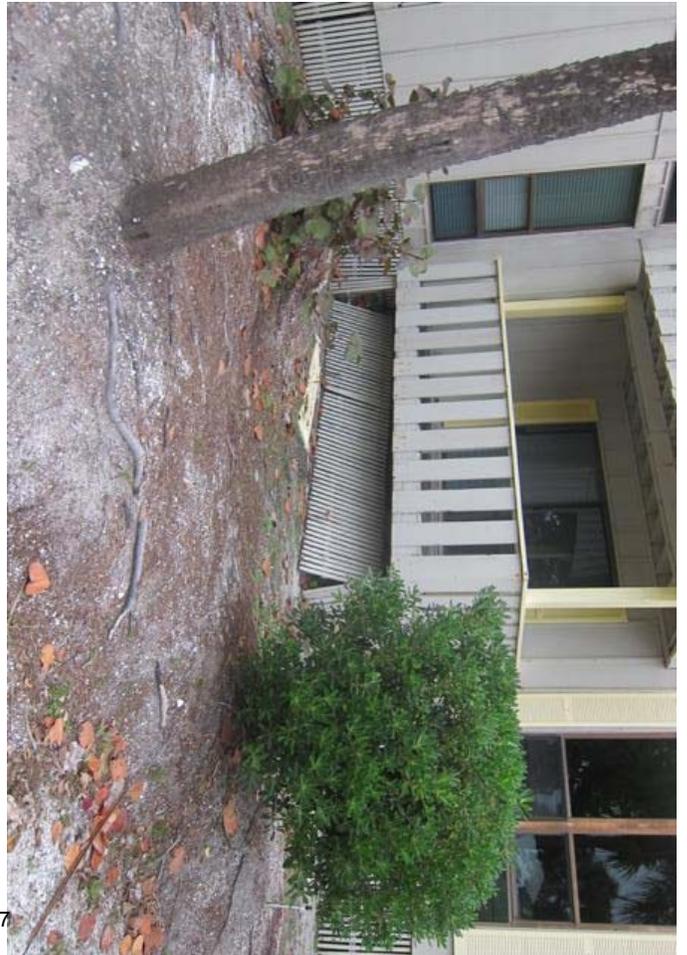
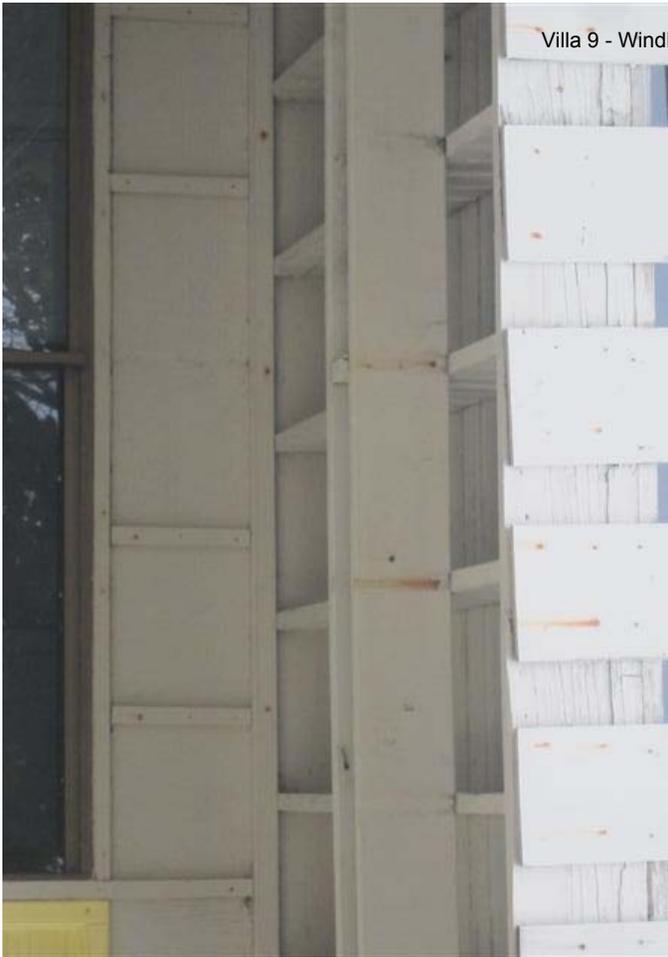
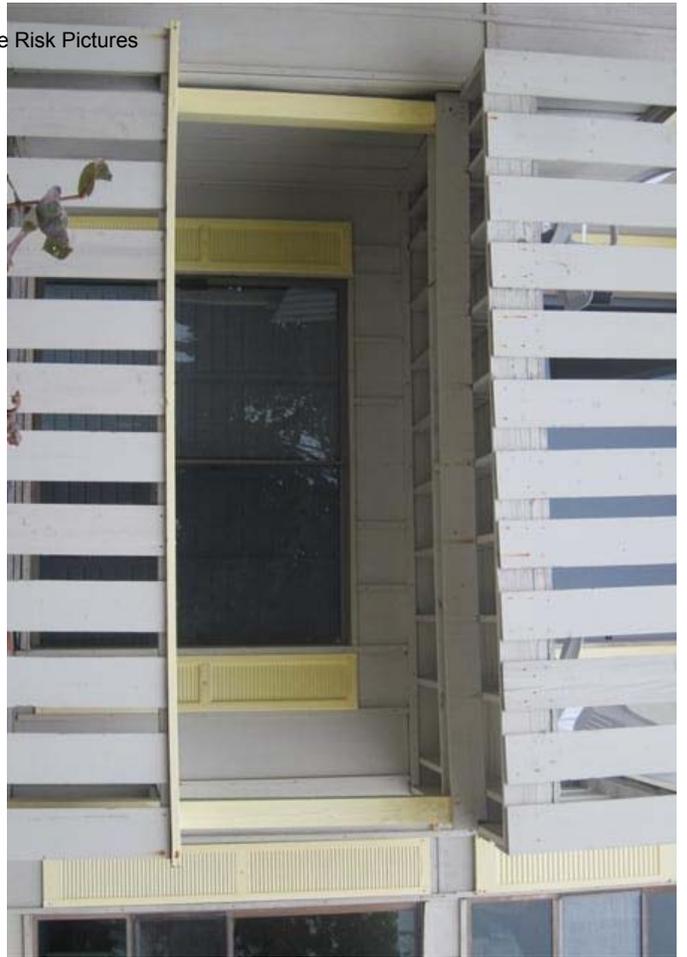
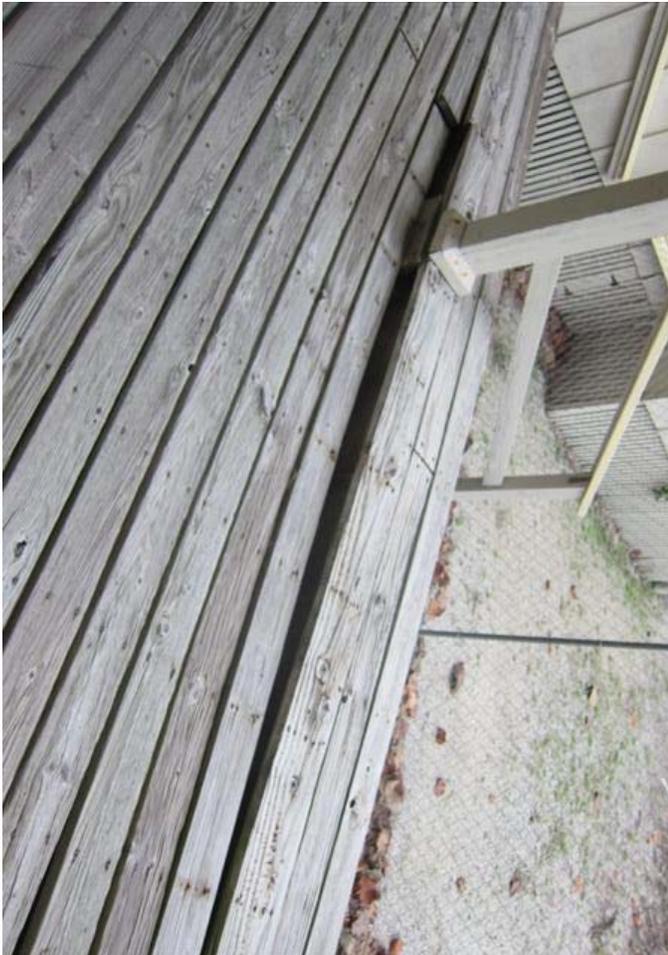
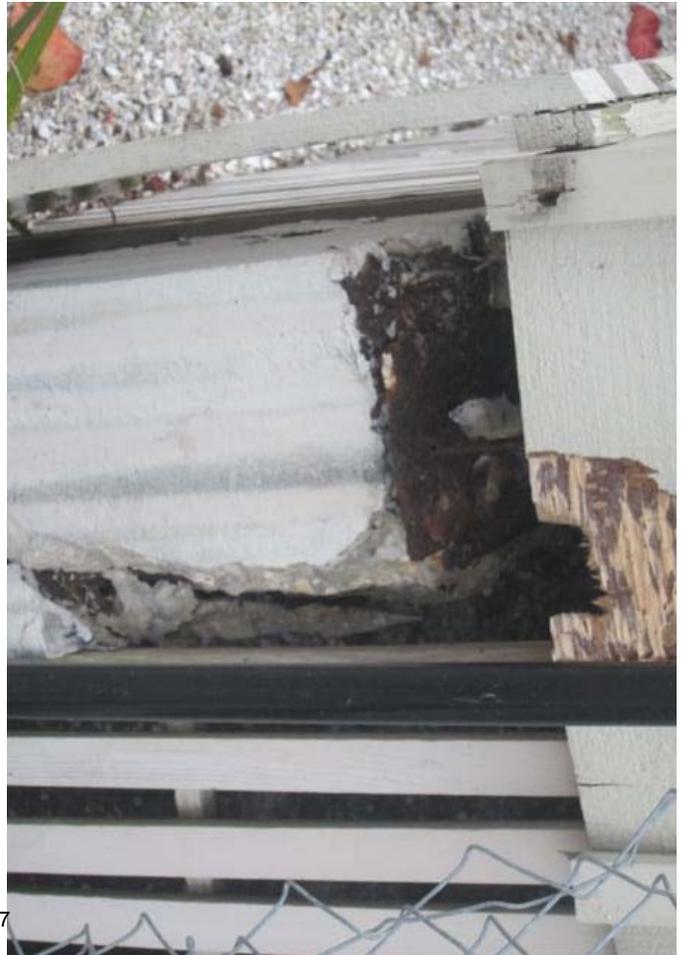
Villa 9 - Windborne Risk Pictures

- Spalling, fissures, cracks, & corrosion of piers
- I-Beams show exterior rust
- Extreme distress of exterior wood
- Wood post connection failure
- Extreme settlement of deck members
