**PUBLIC NUISANCE HEARING  
1620 GULF OF MEXICO DRIVE**

**VILLA 12 BUILDING**

**TOWN COMMISSION SPECIAL MEETING  
MAY 28, 2014  
(CONTINUANCE)**

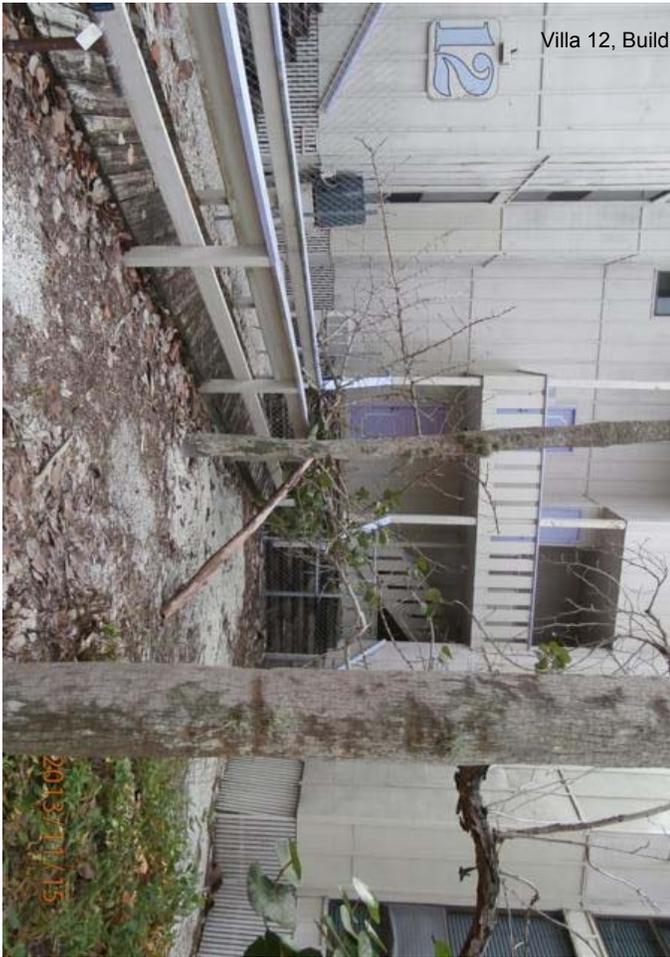
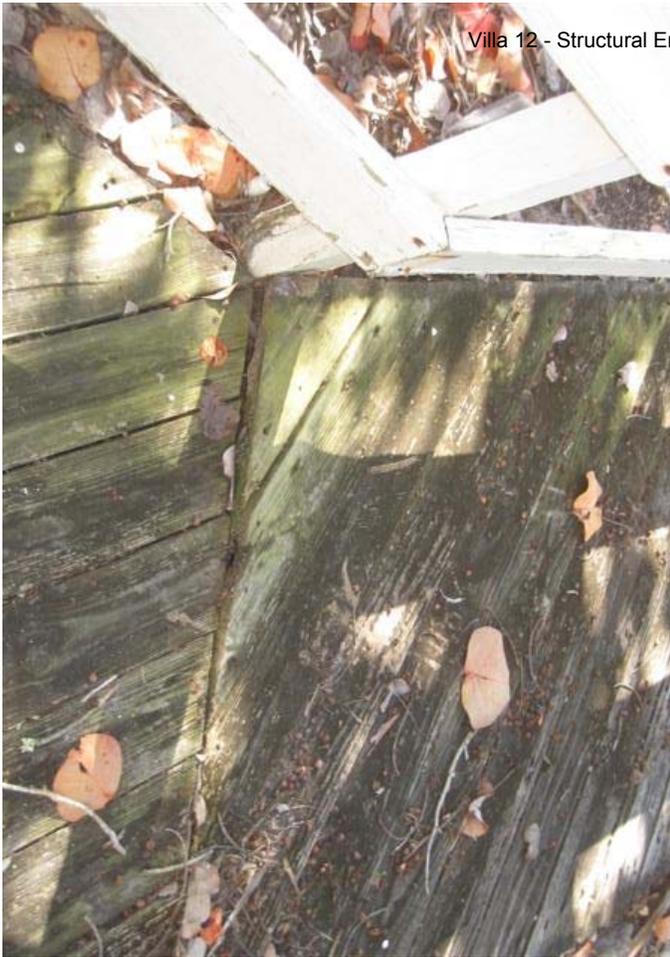
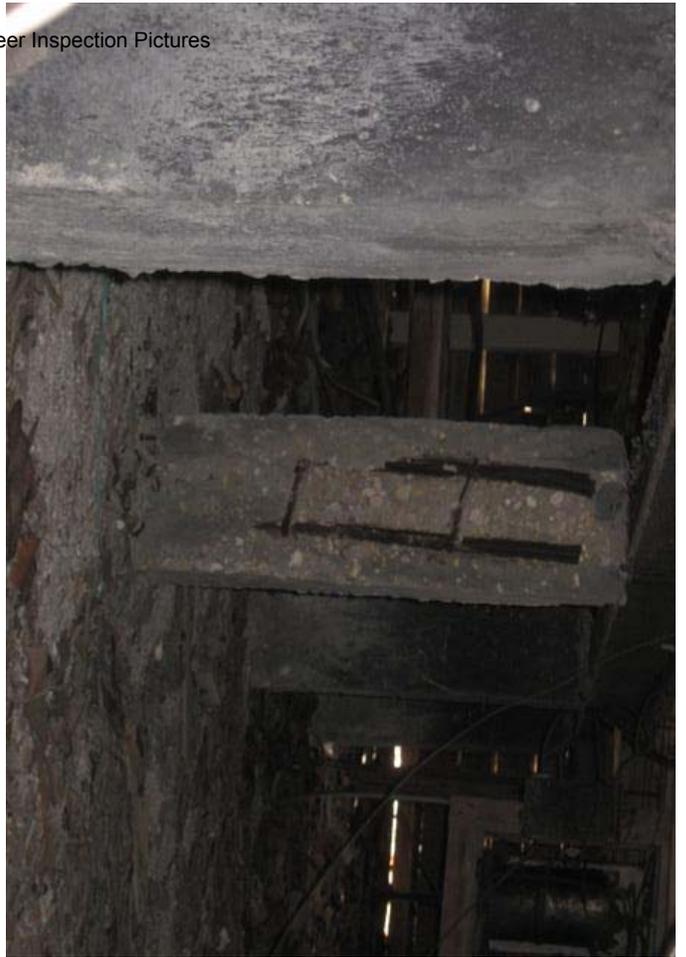
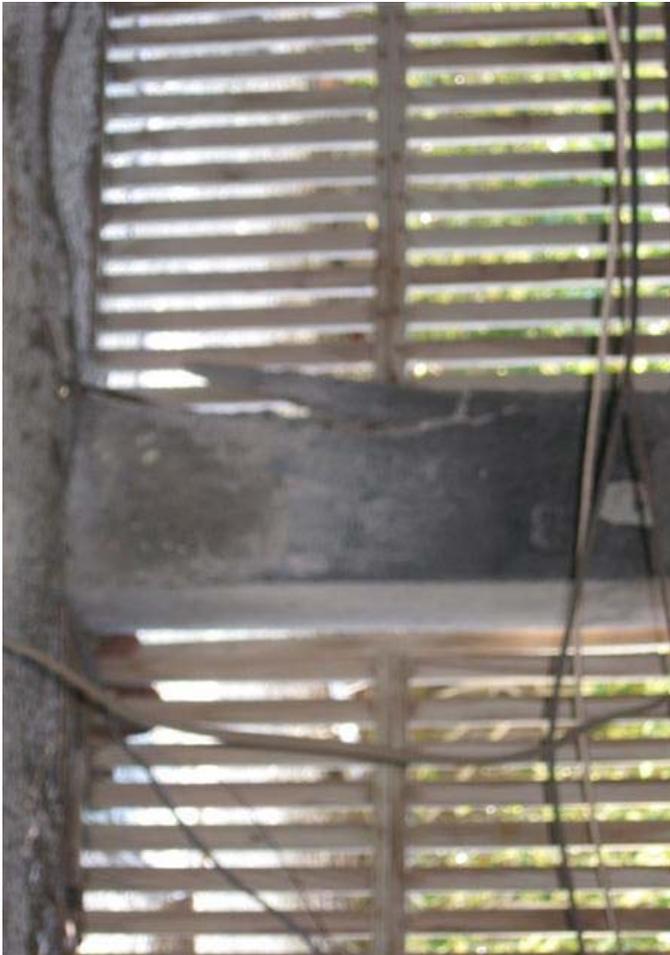
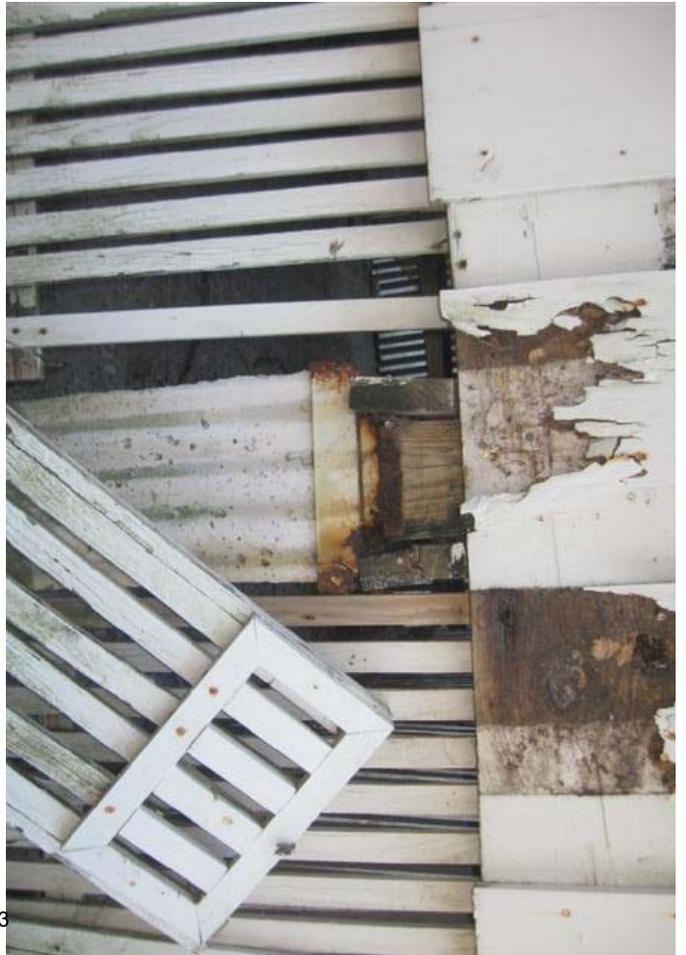
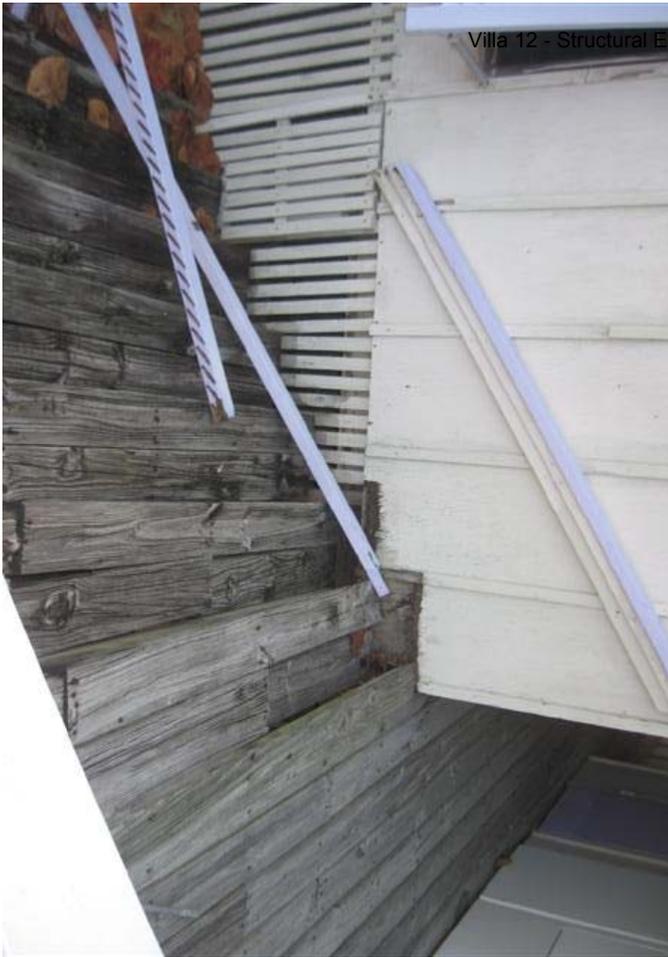
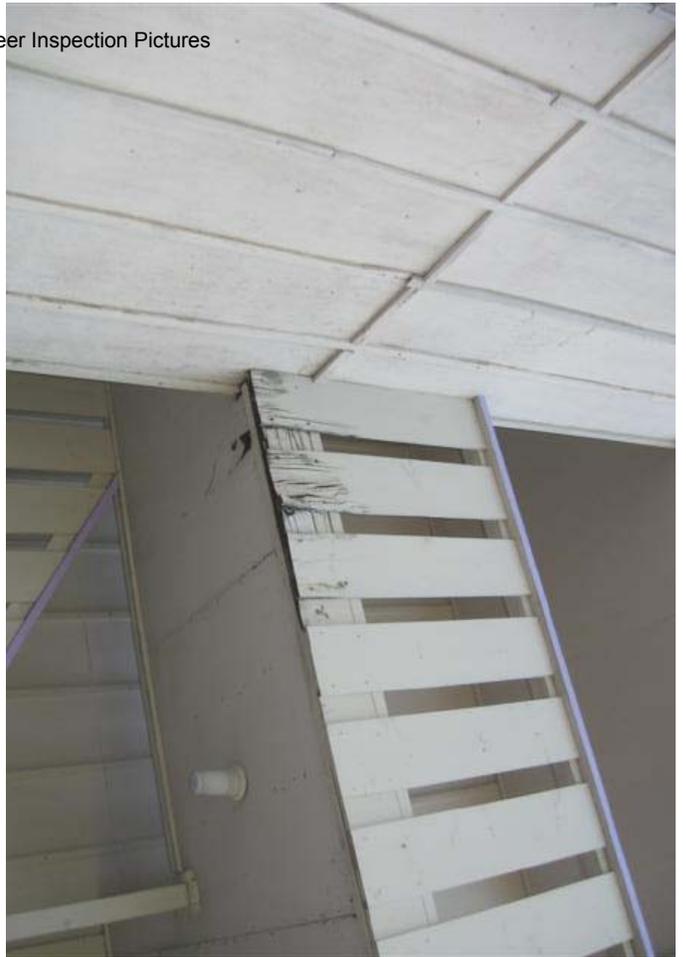
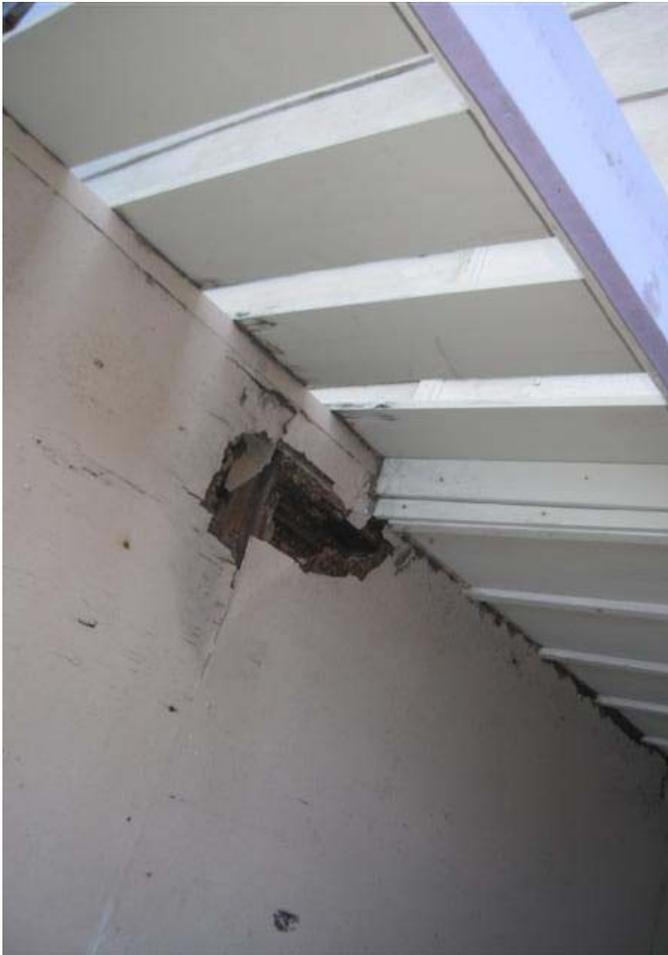
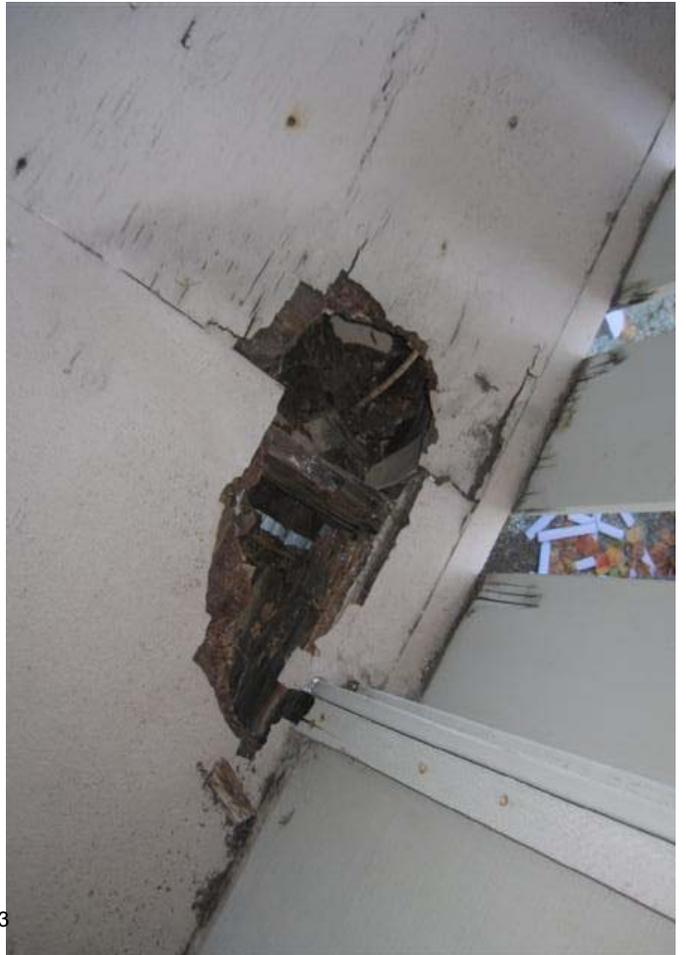
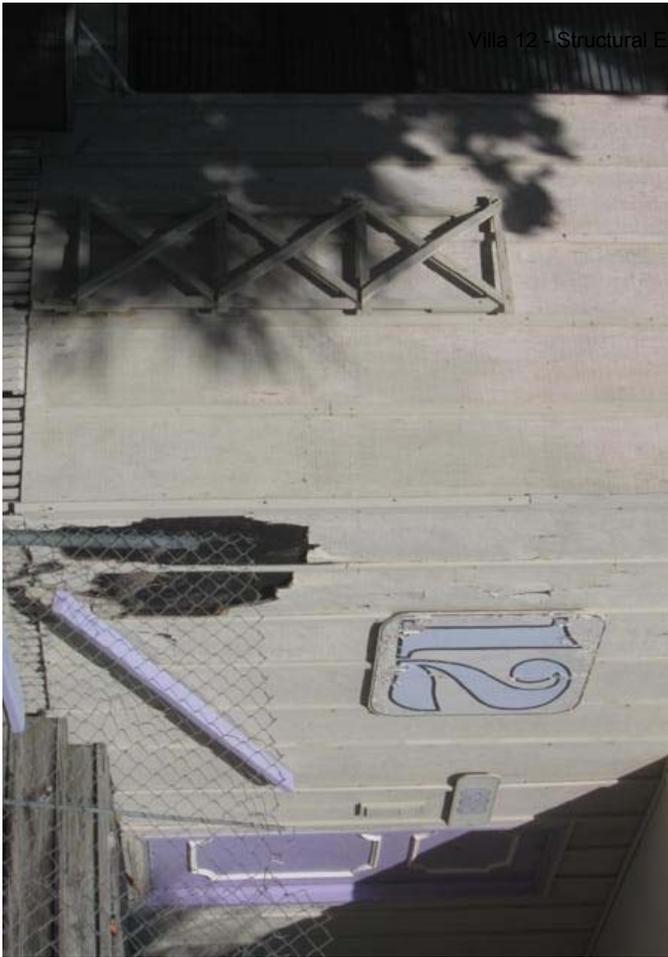
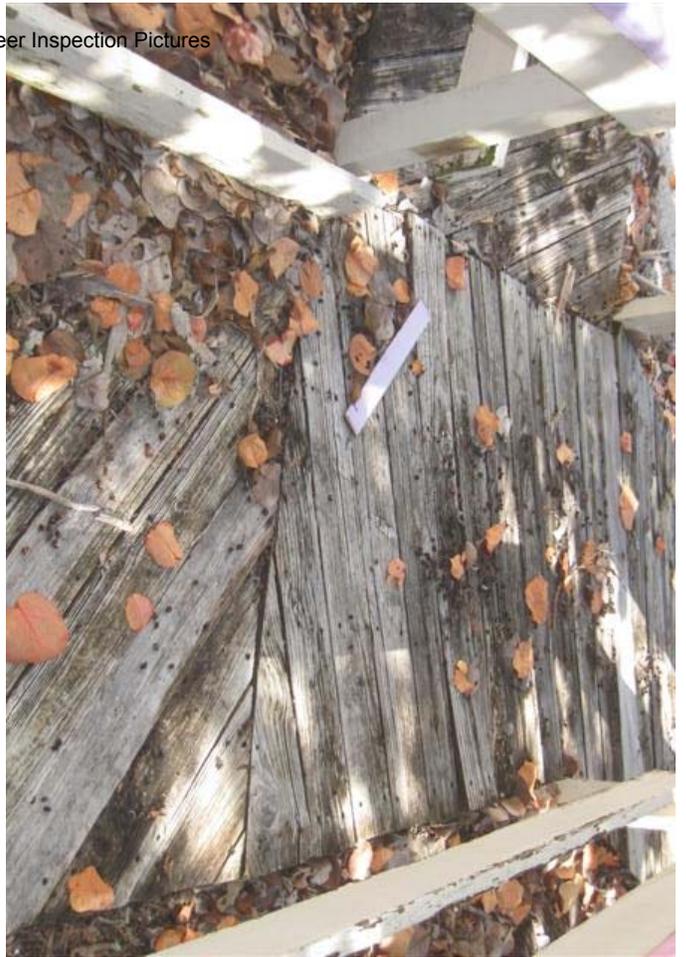
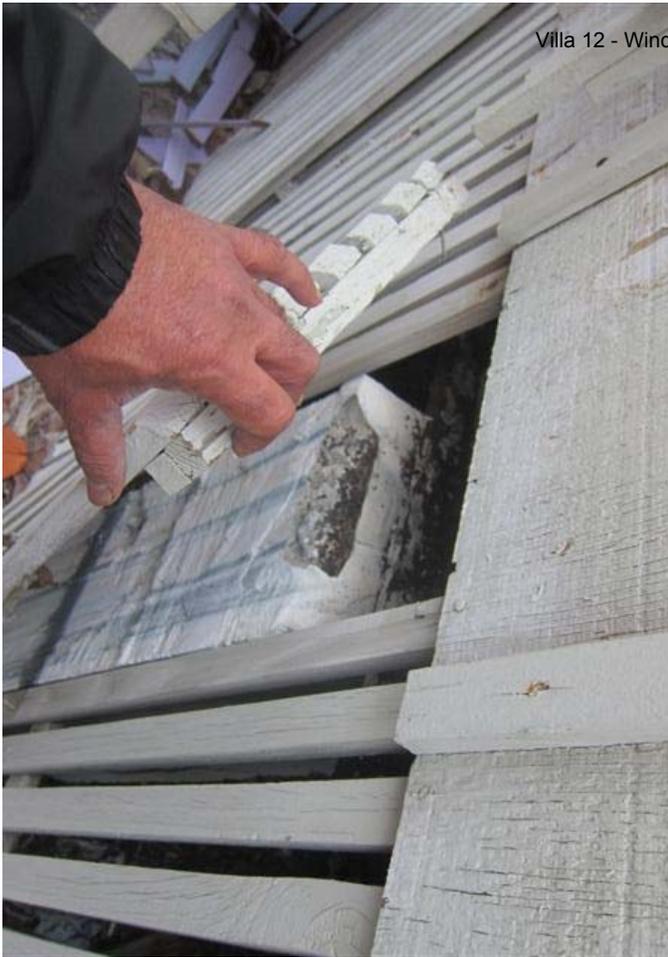
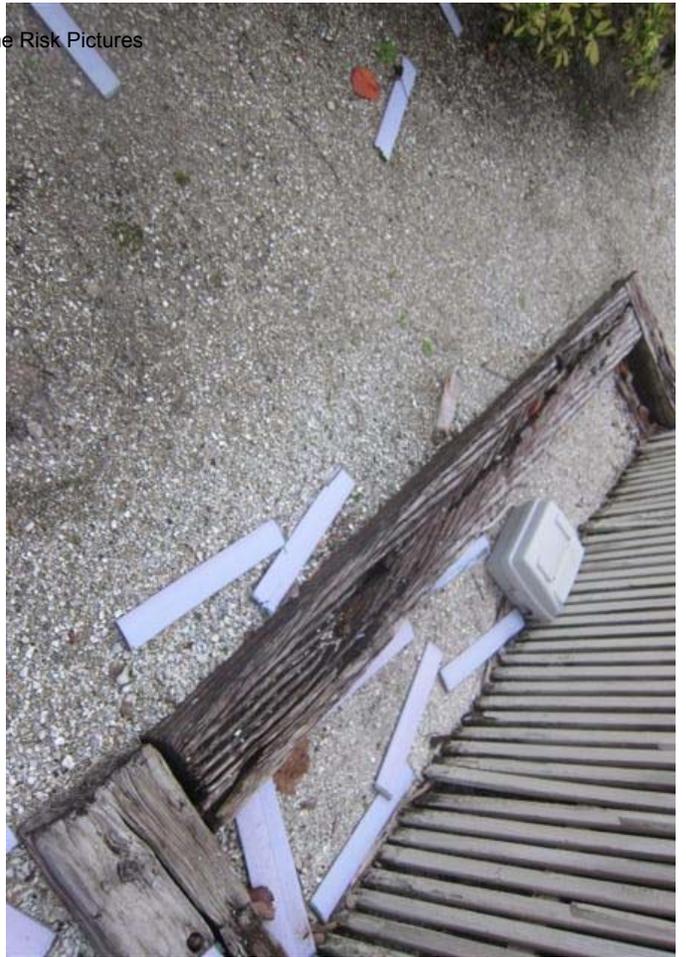
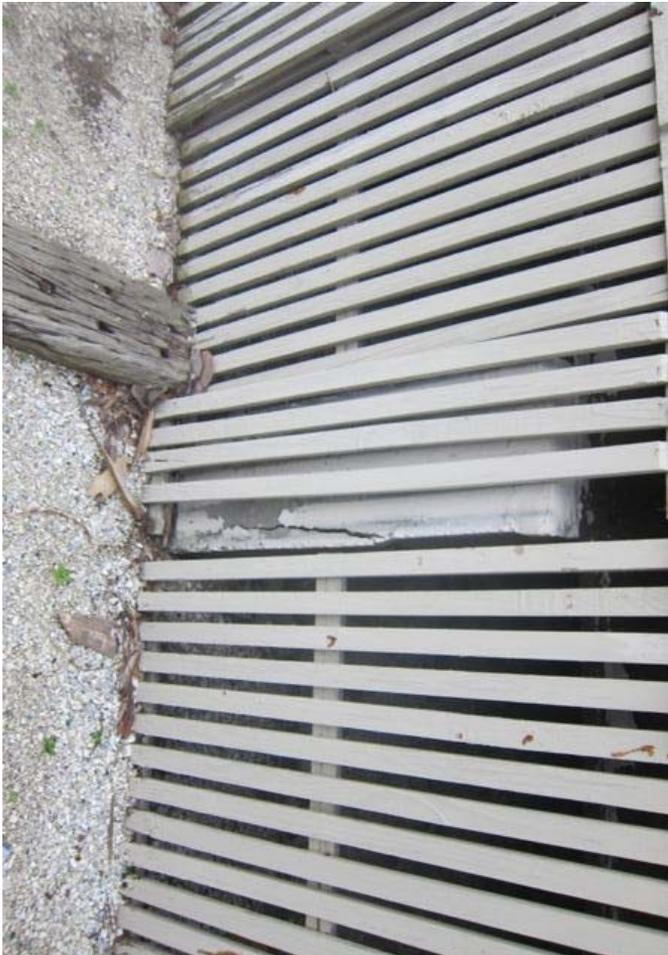
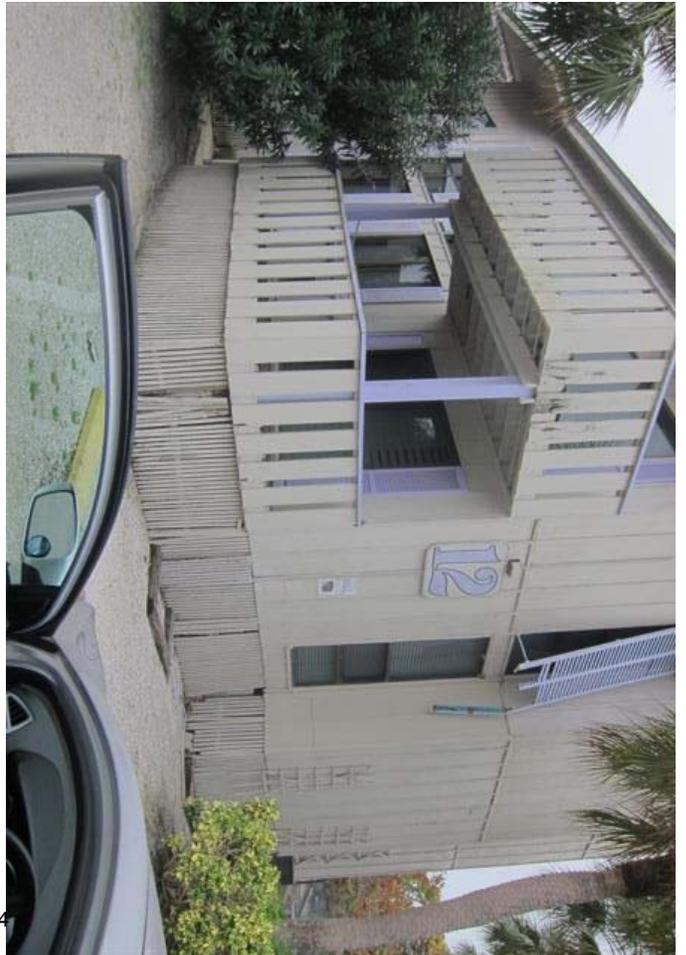
Villa 12 - Windborne Risk Pictures

- Spalling, fissures, fractures, & corrosion of piers
- I-Beams show corrosion
- Awnings failing
- Wooden boards rotting
- Signs of termite & insect damage
