**PUBLIC NUISANCE HEARING  
1620 GULF OF MEXICO DRIVE**

**VILLA 13 BUILDING**

**TOWN COMMISSION SPECIAL MEETING  
MAY 28, 2014  
(CONTINUANCE)**

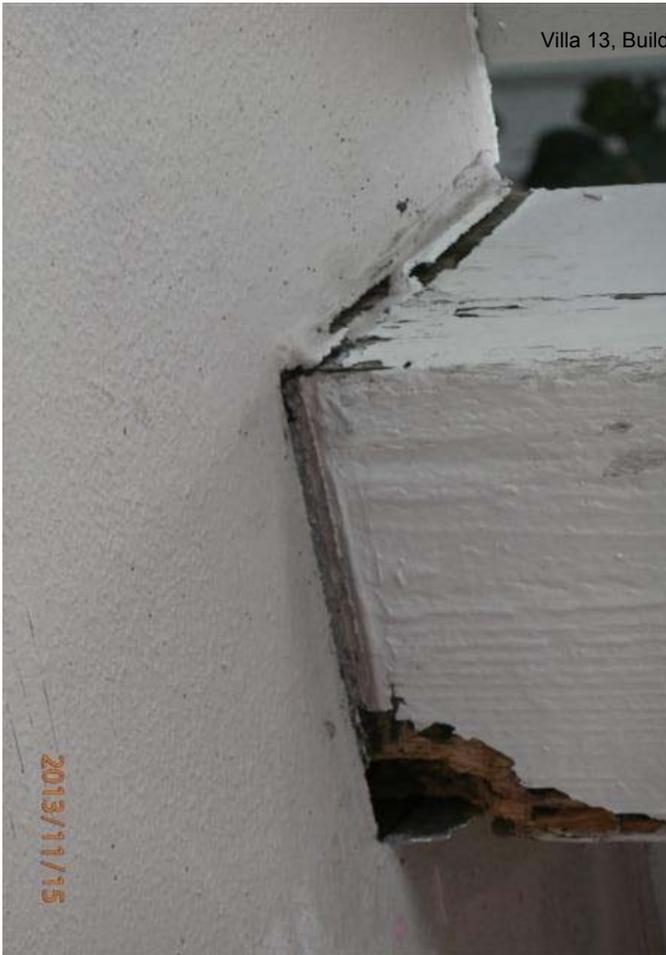
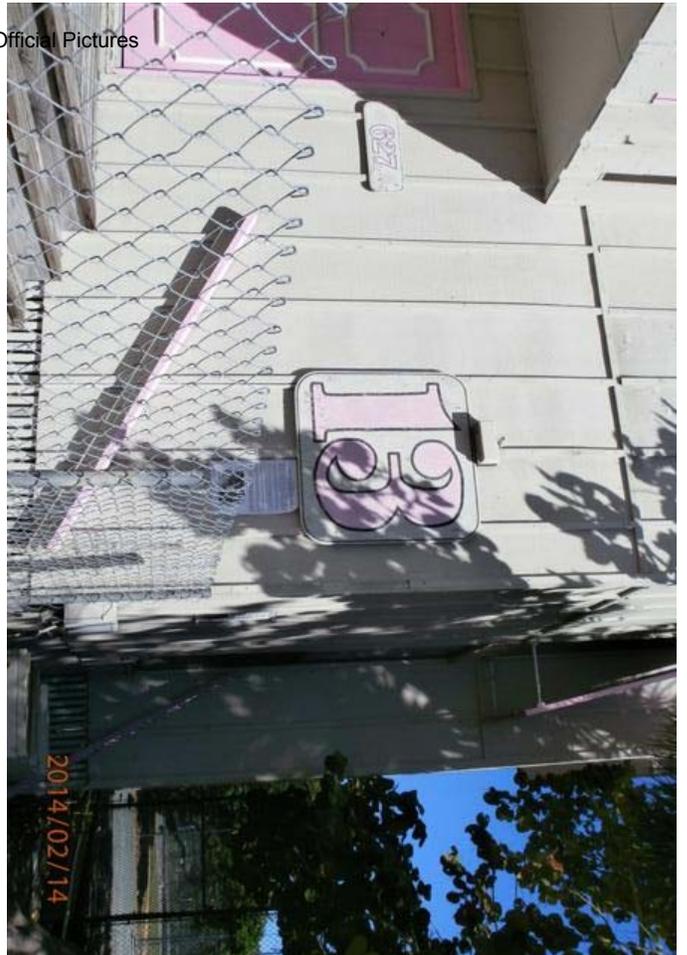
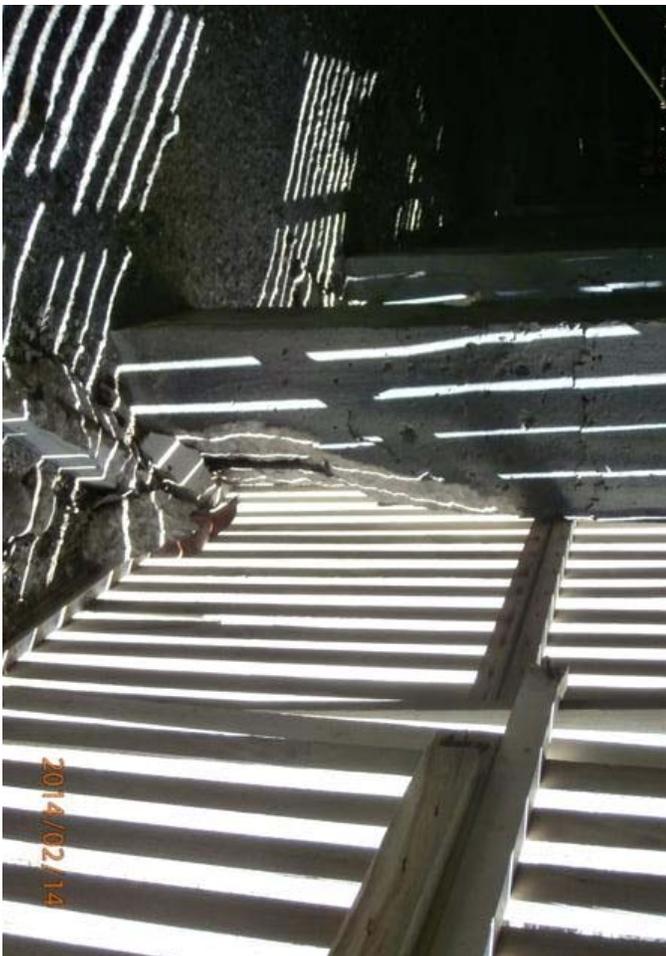
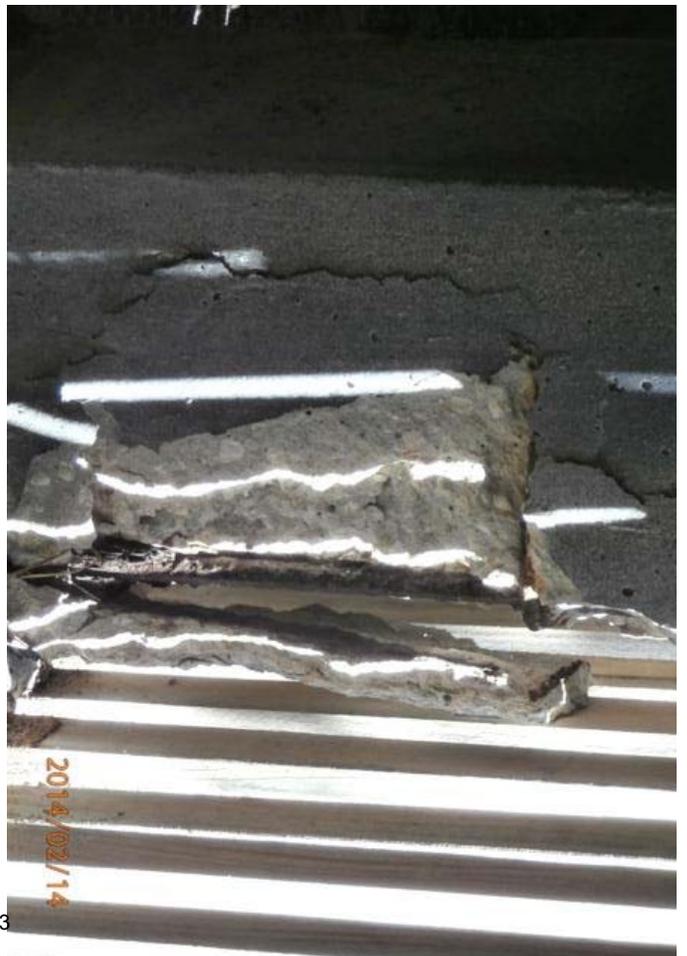
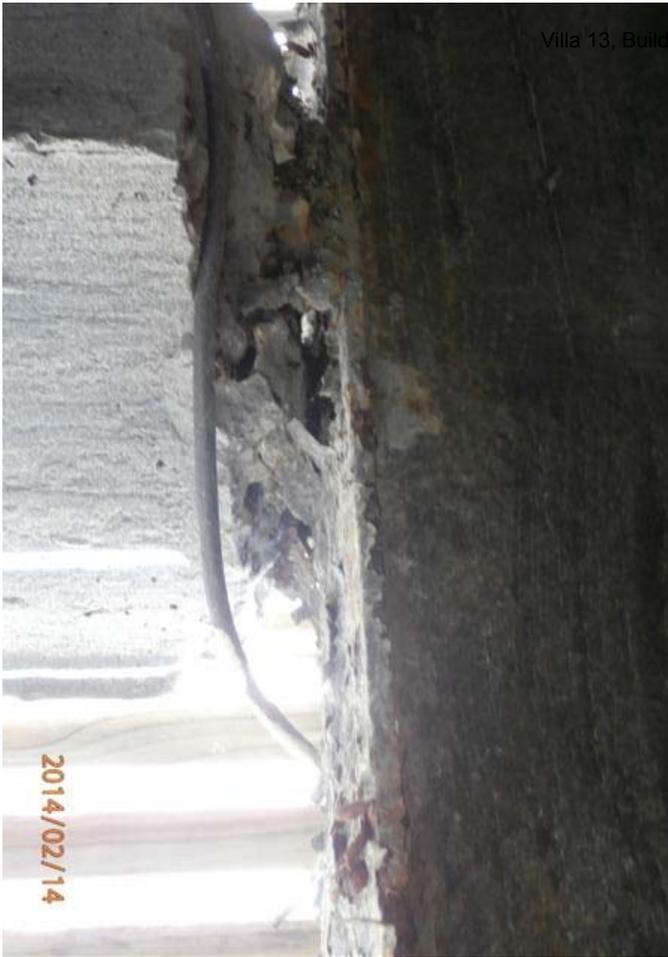
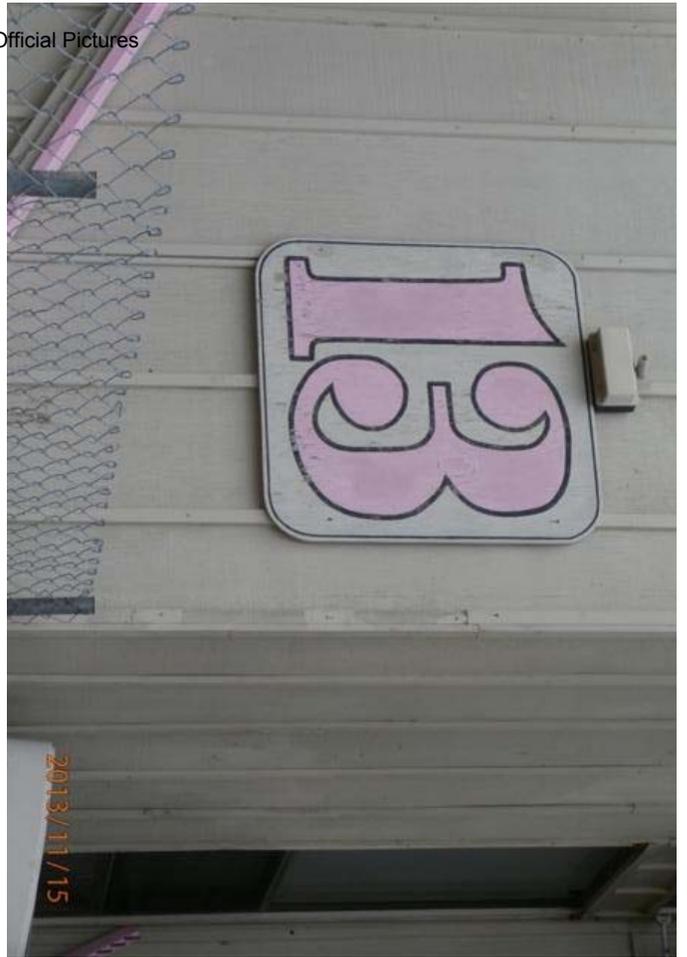
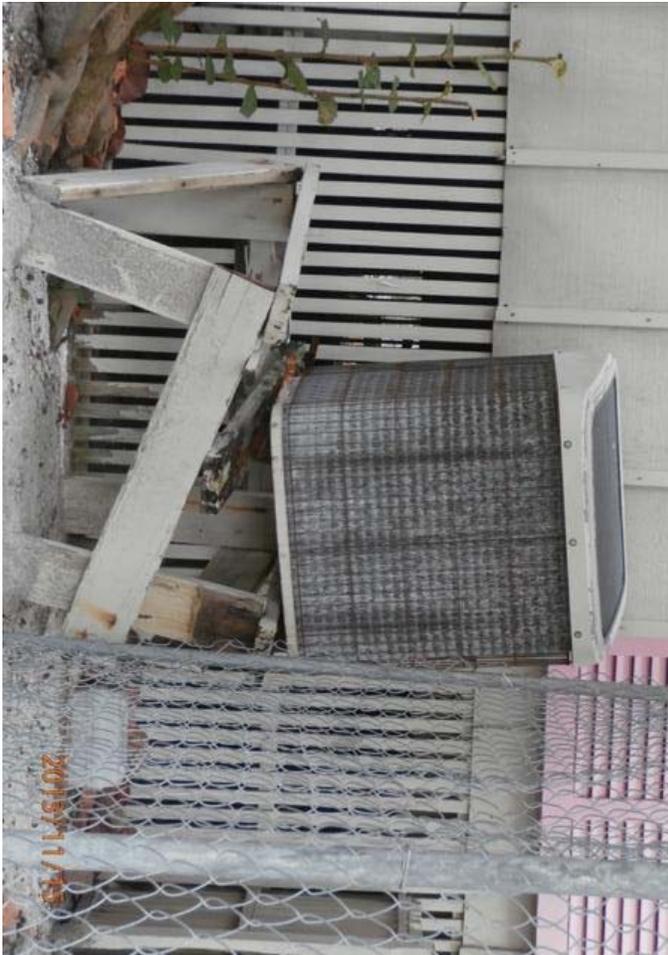
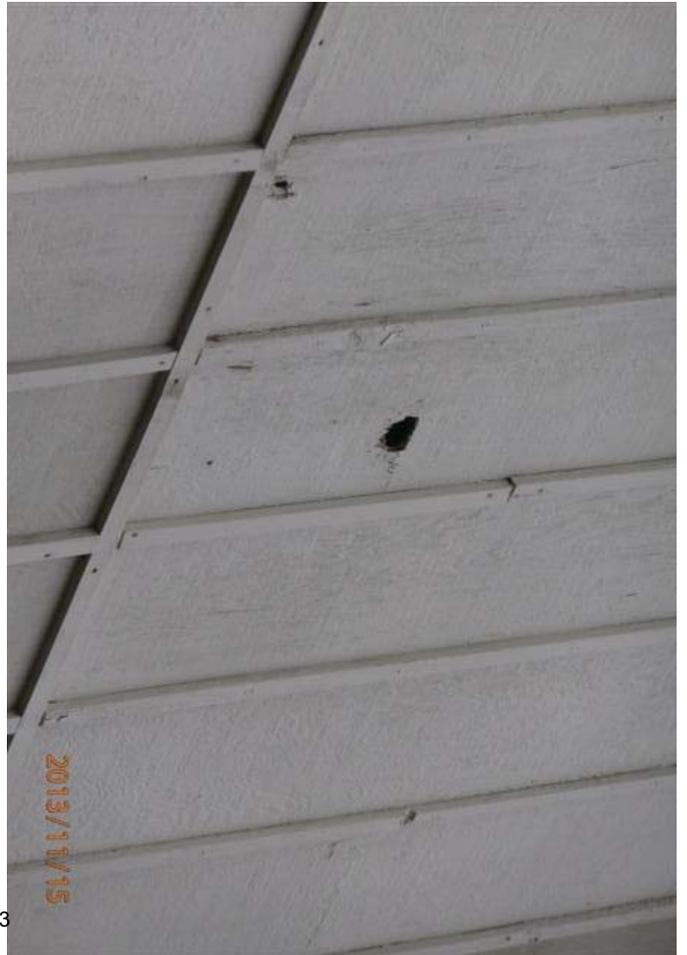
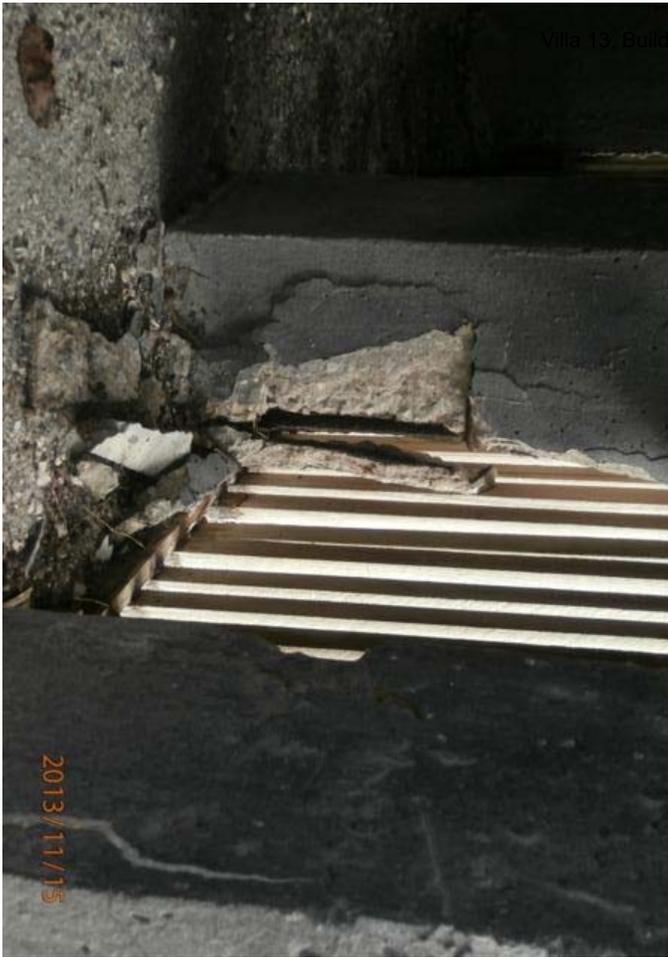
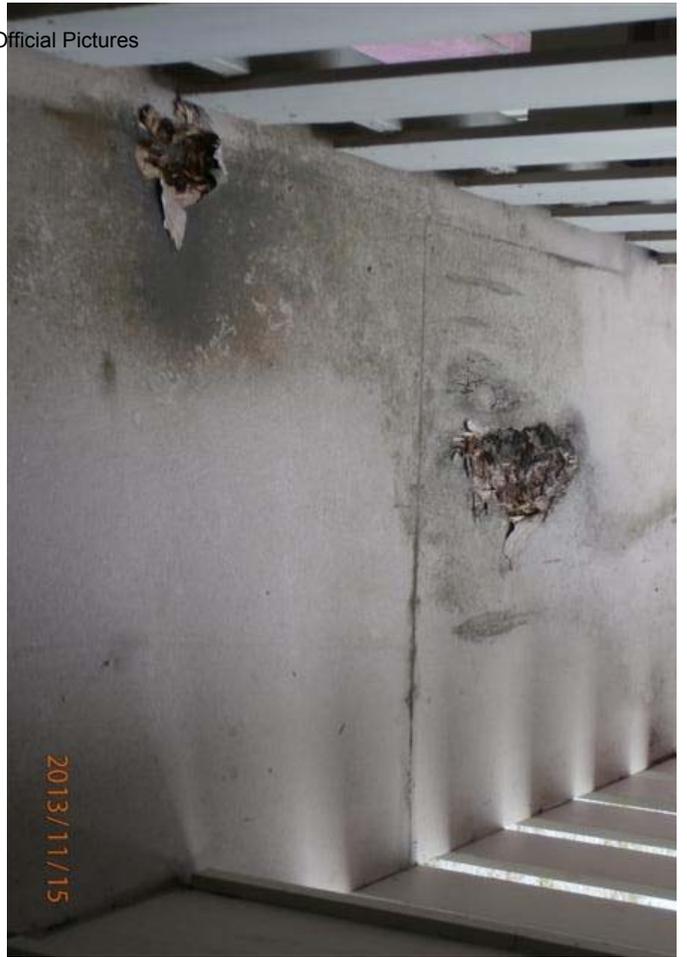
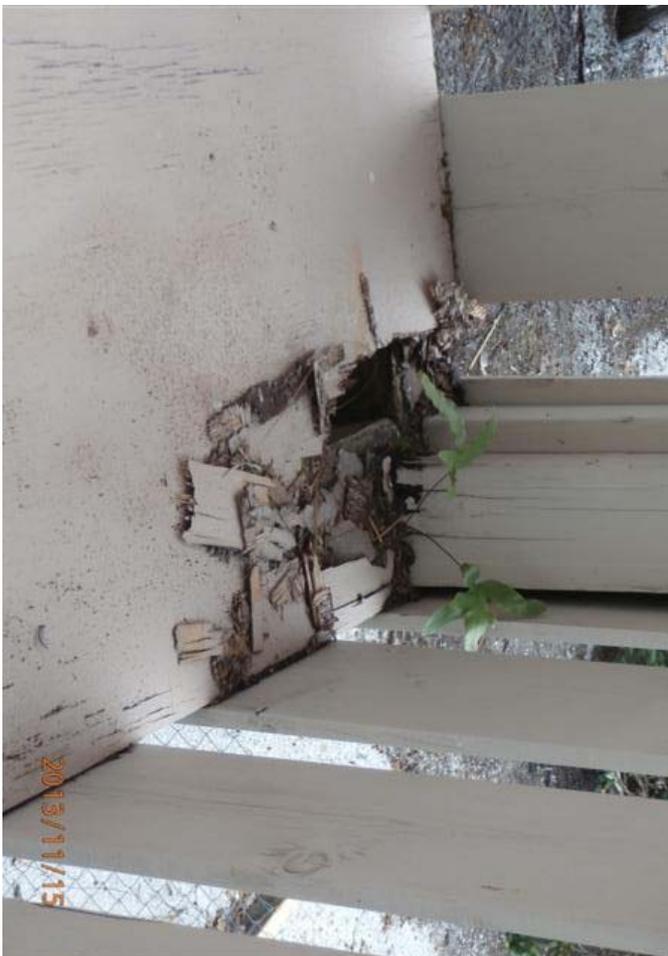
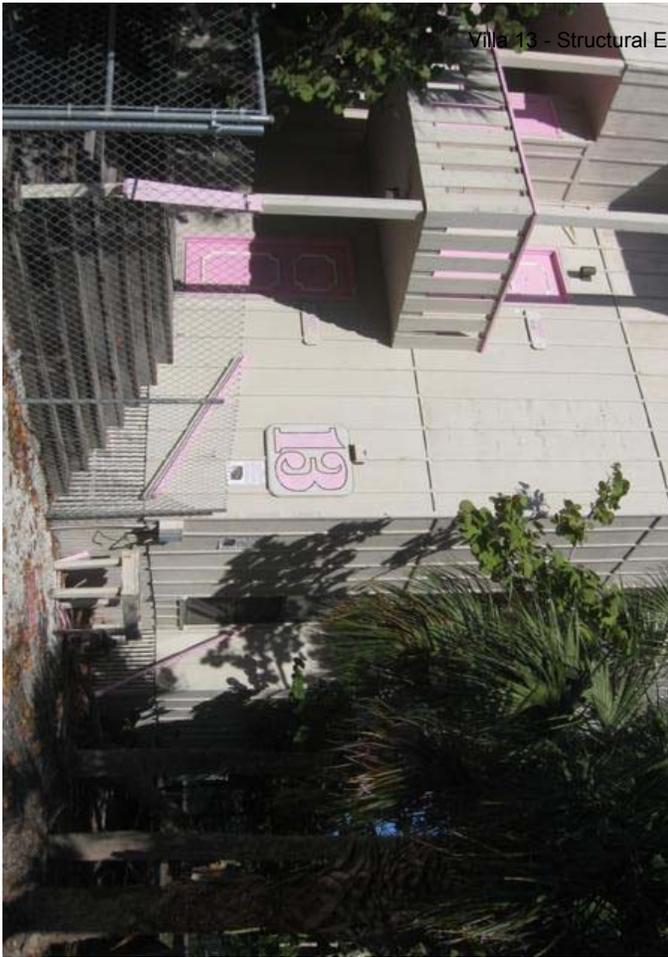
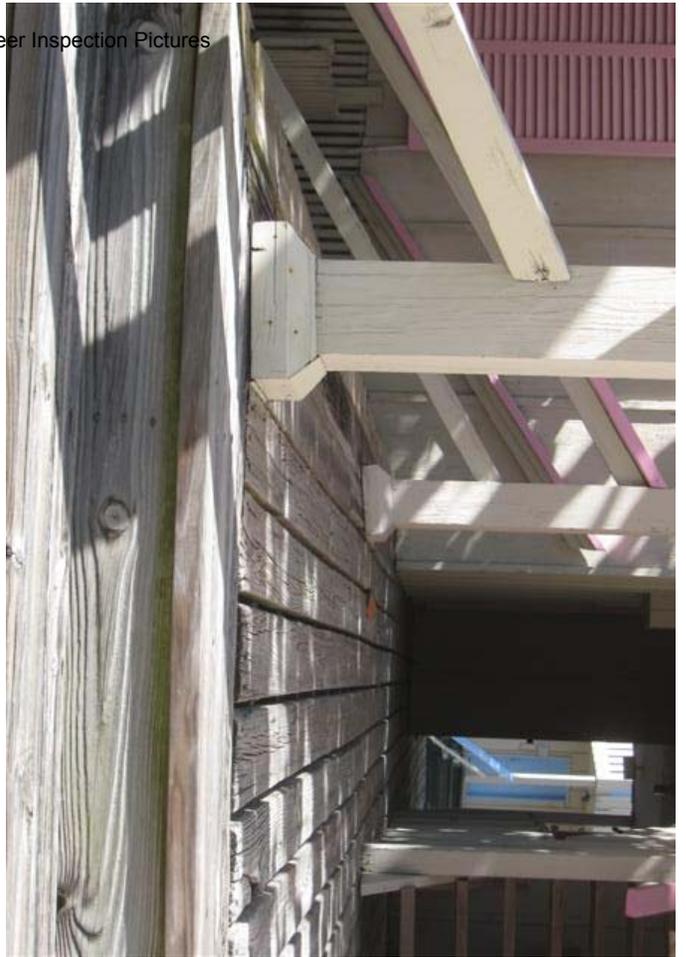
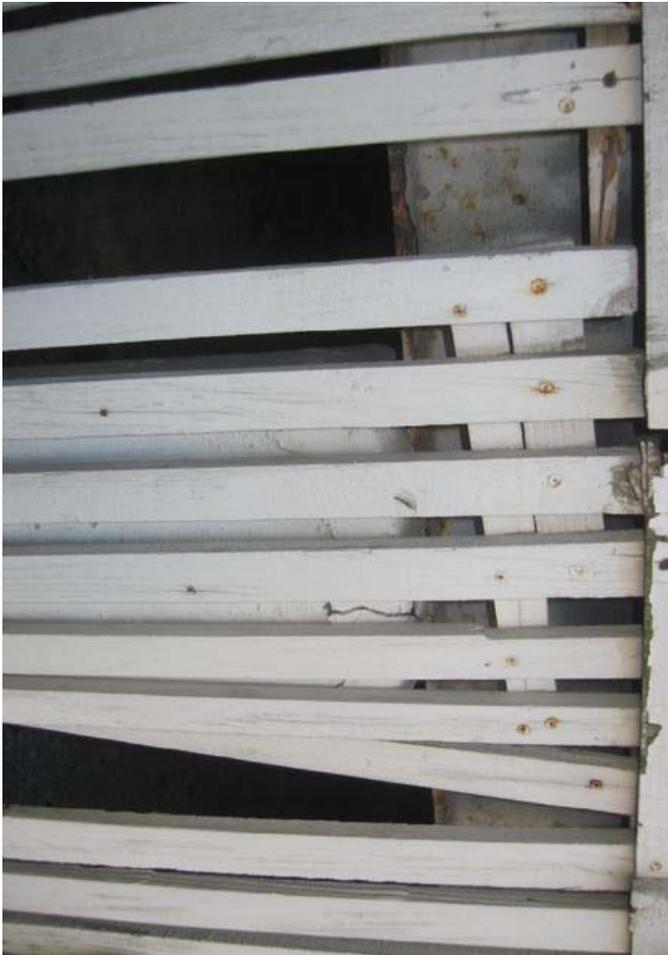
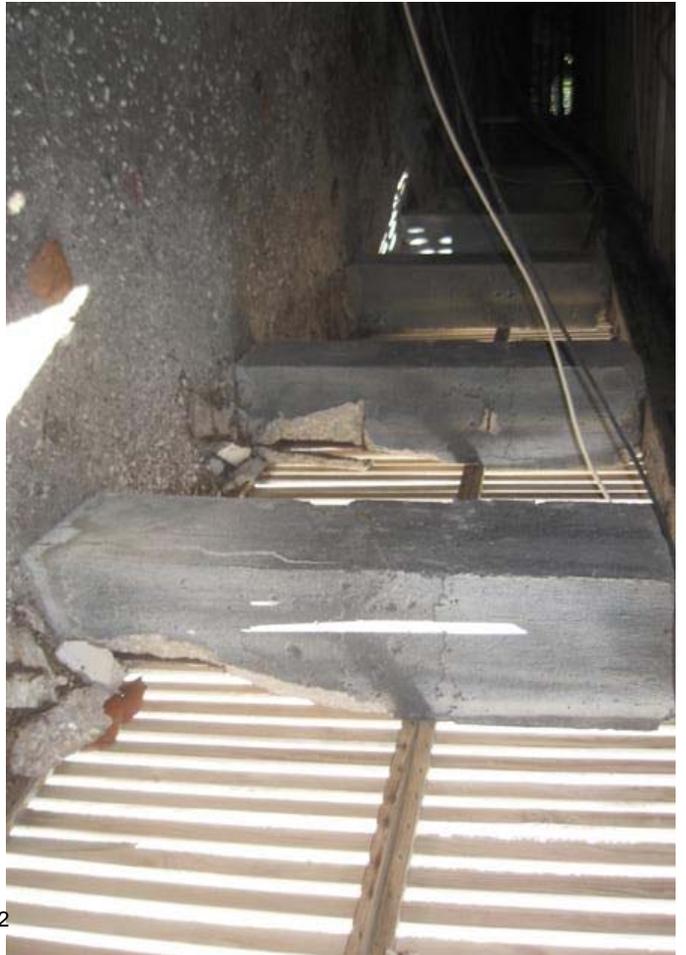
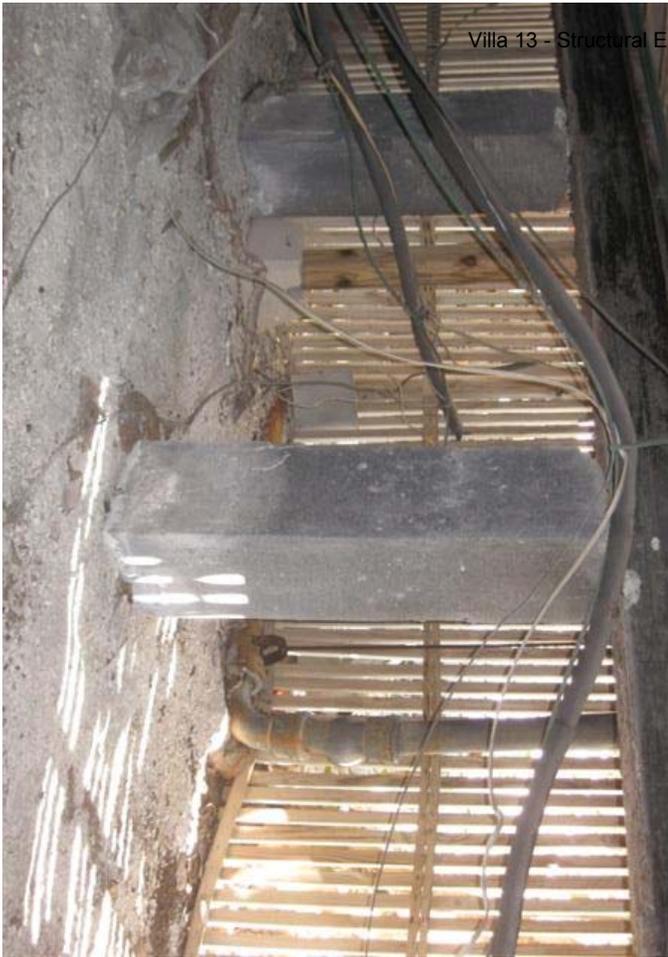
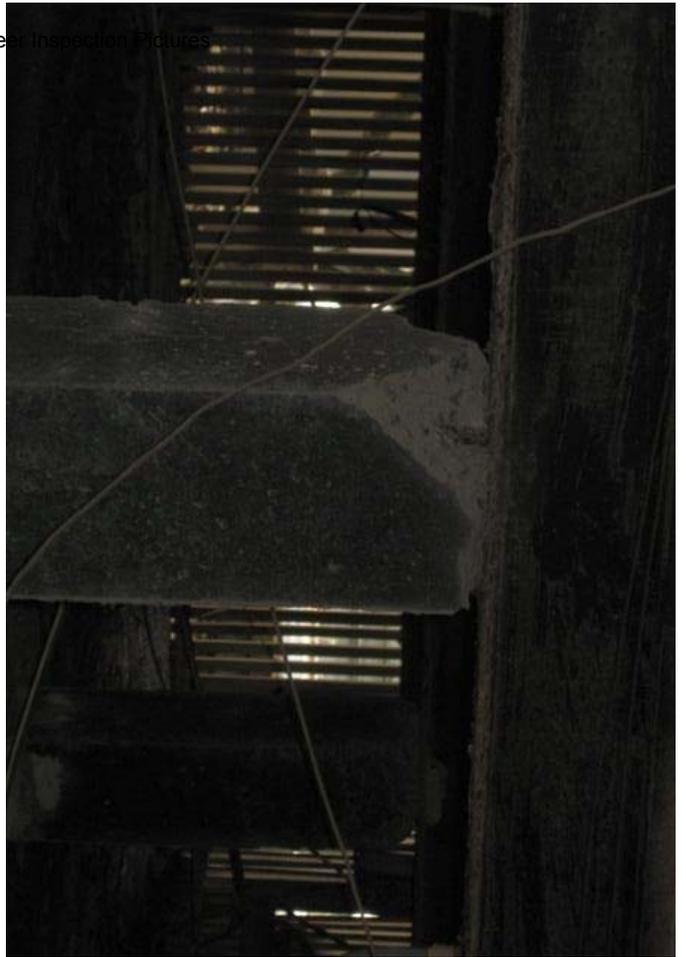
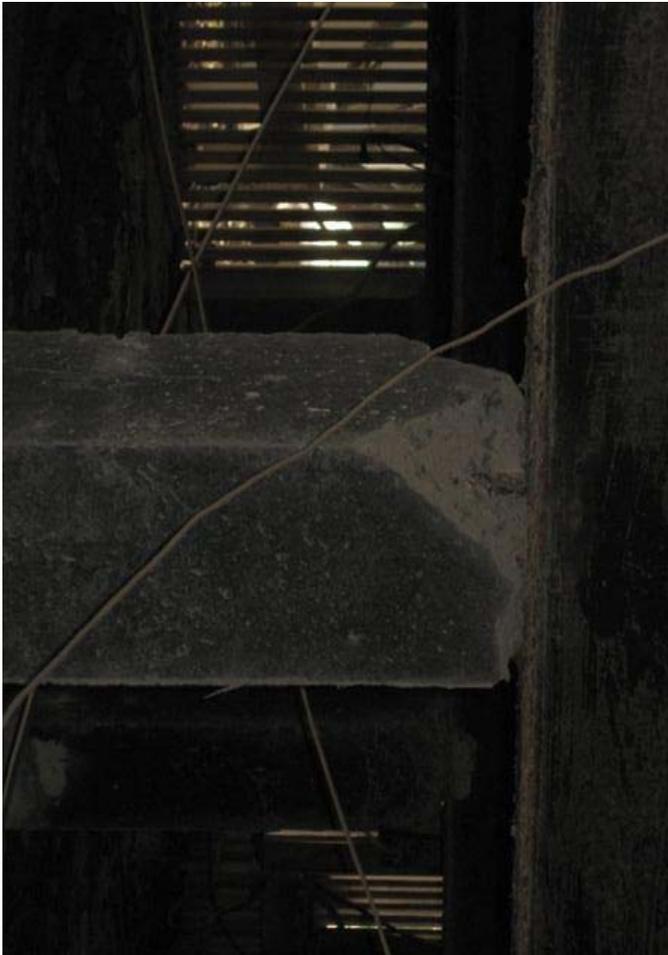
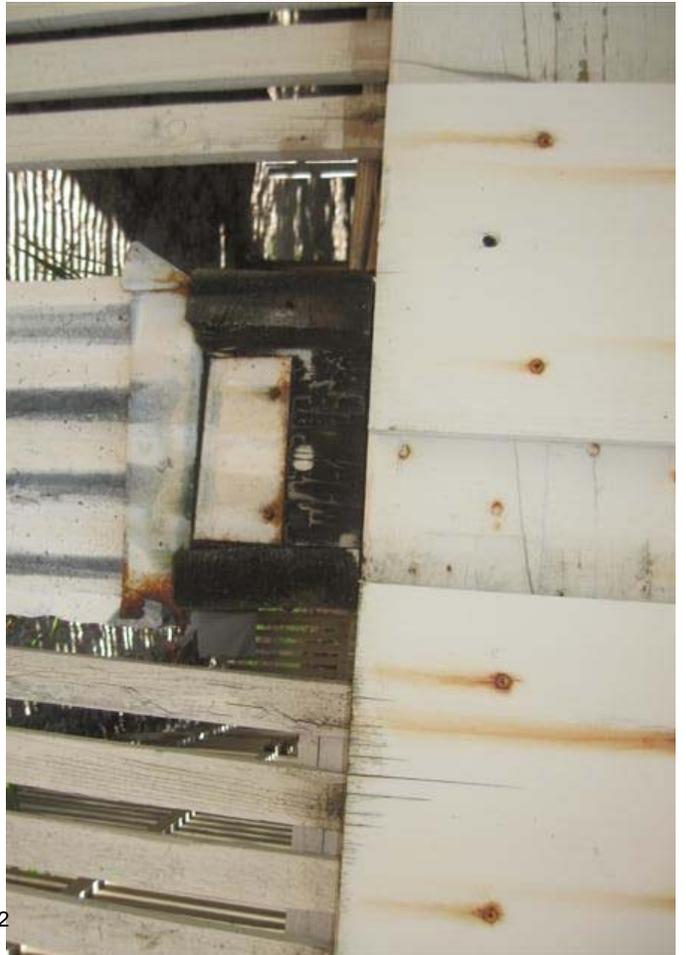
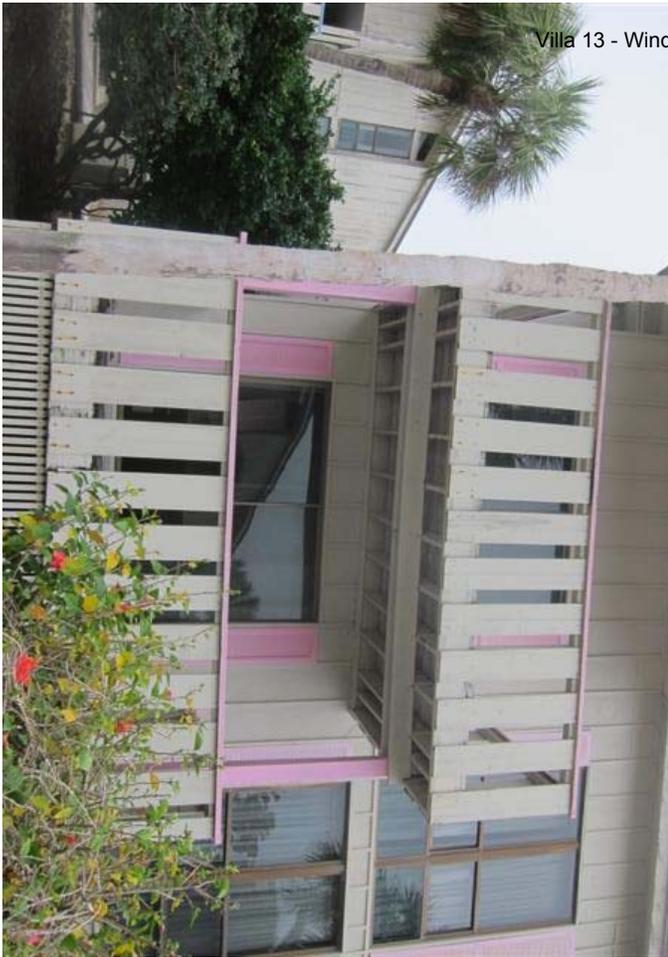
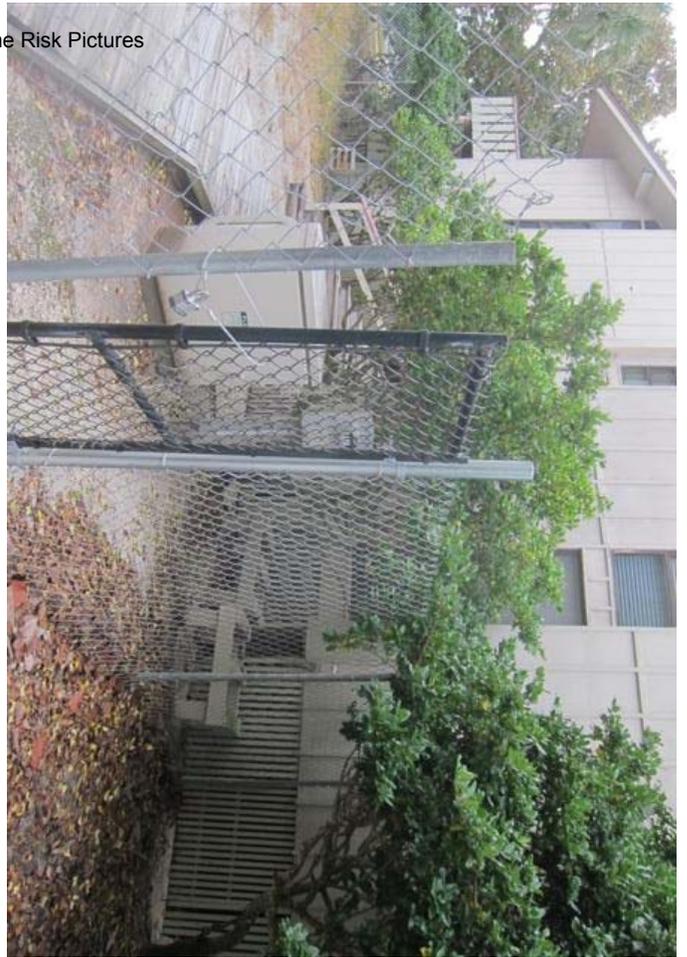
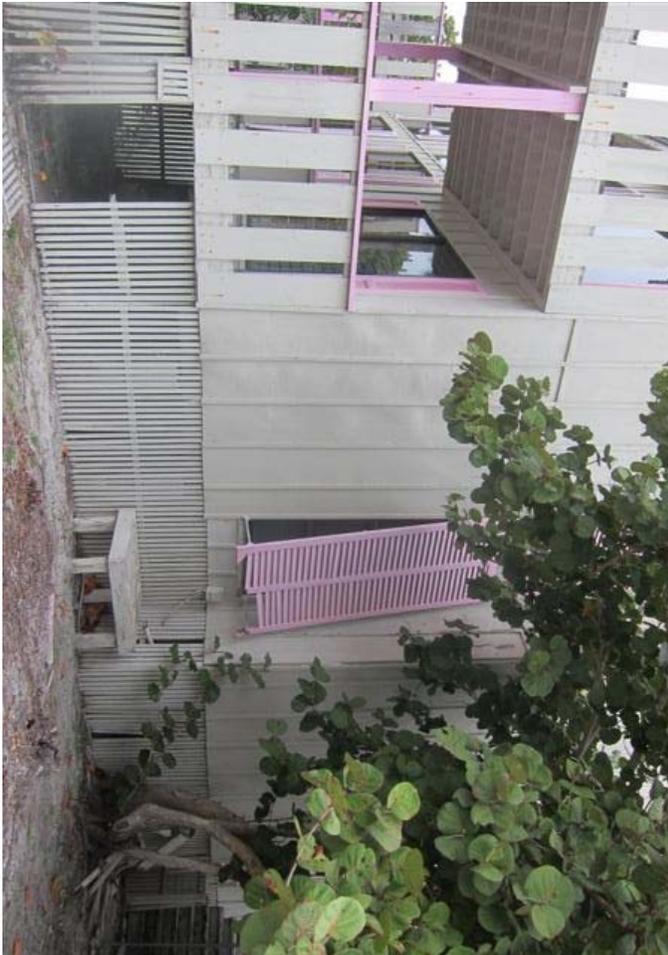
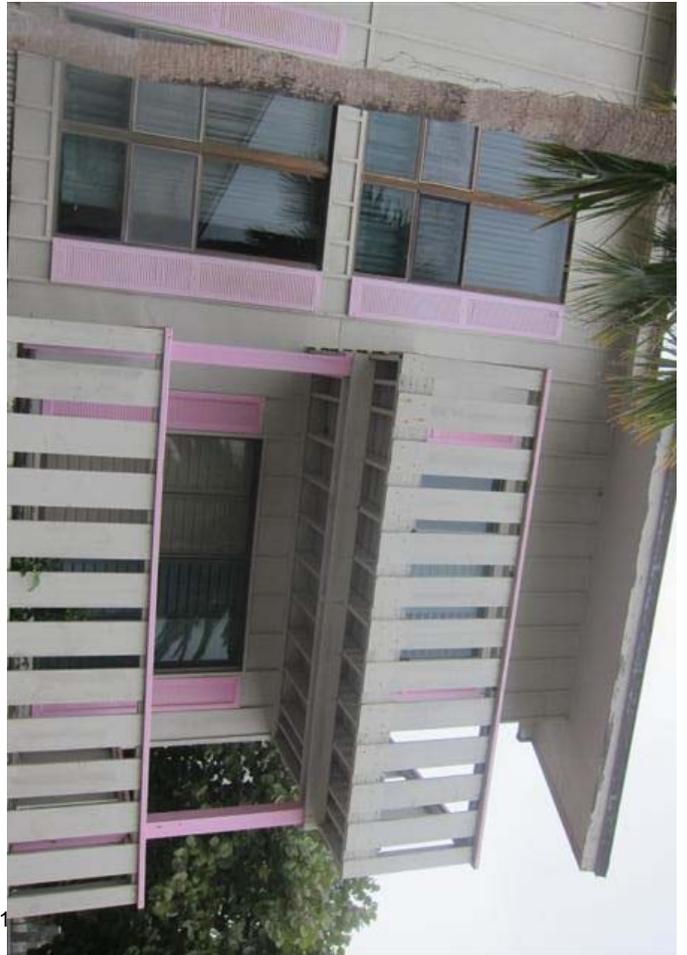
Villa 13 - Windborne Risk Pictures

- Deterioration & corrosion in piers
- Rot in elevated decks & wood posts
- Extreme rot in upper walkway
- Signs of termite & insect damage
- Deflected porch beams
