**PUBLIC NUISANCE HEARING
1620 GULF OF MEXICO DRIVE**

VILLA 17 BUILDING

**TOWN COMMISSION SPECIAL MEETING
MAY 28, 2014
(CONTINUANCE)**

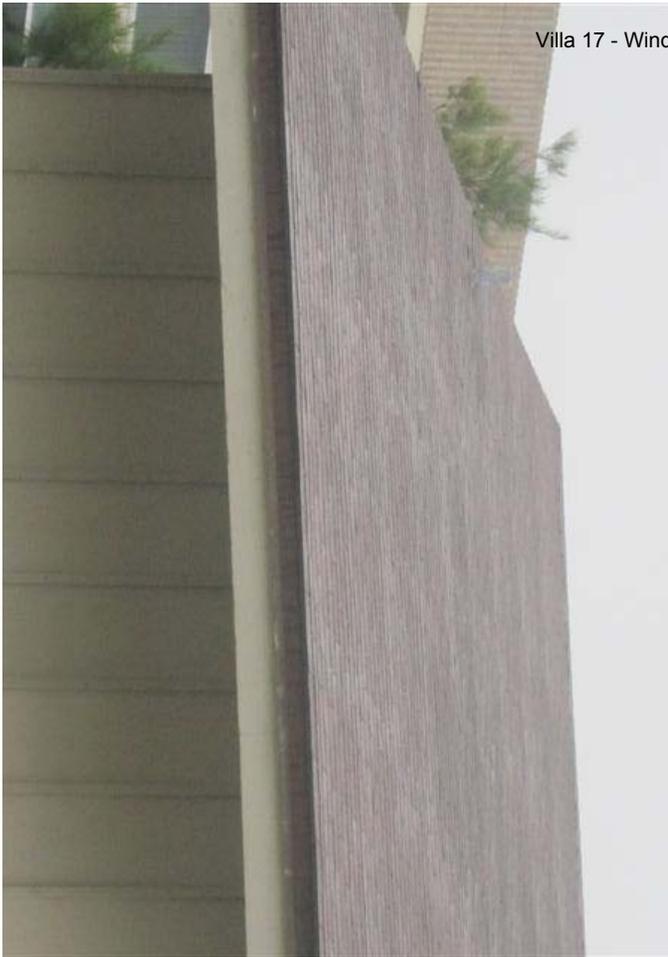
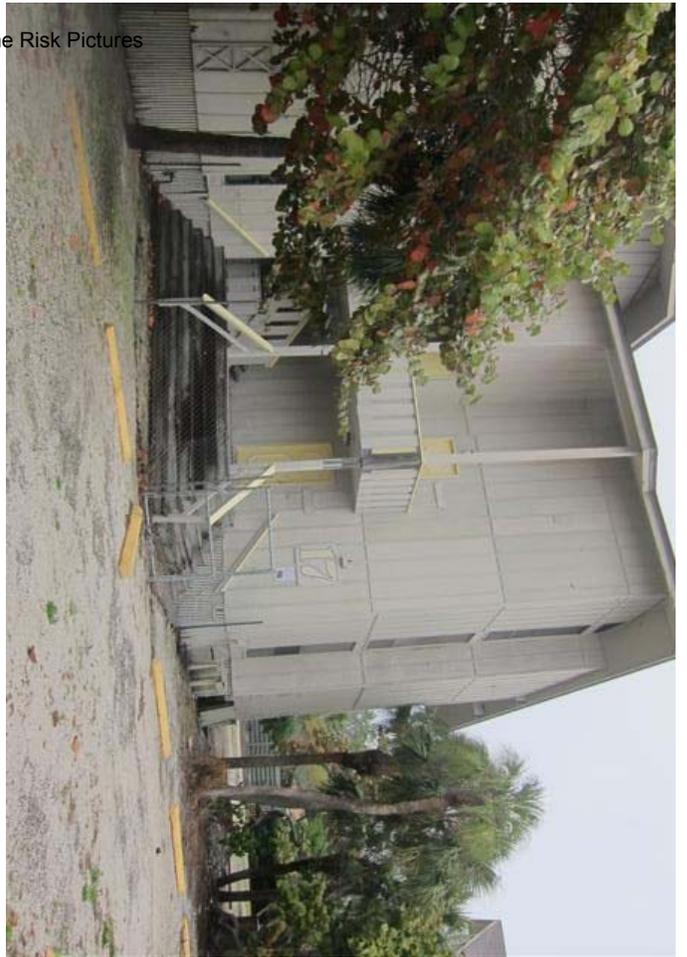
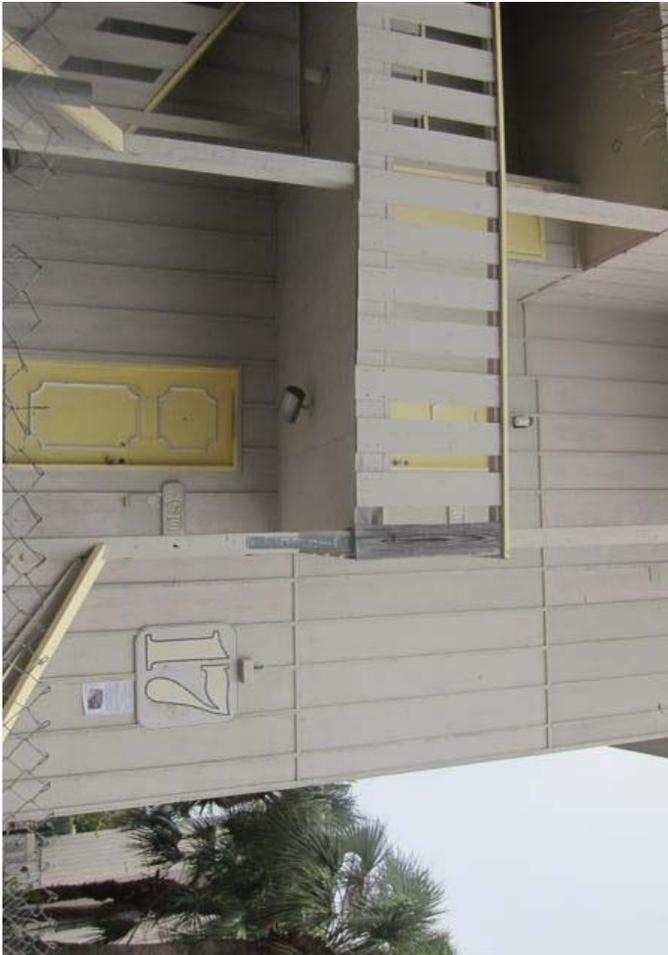
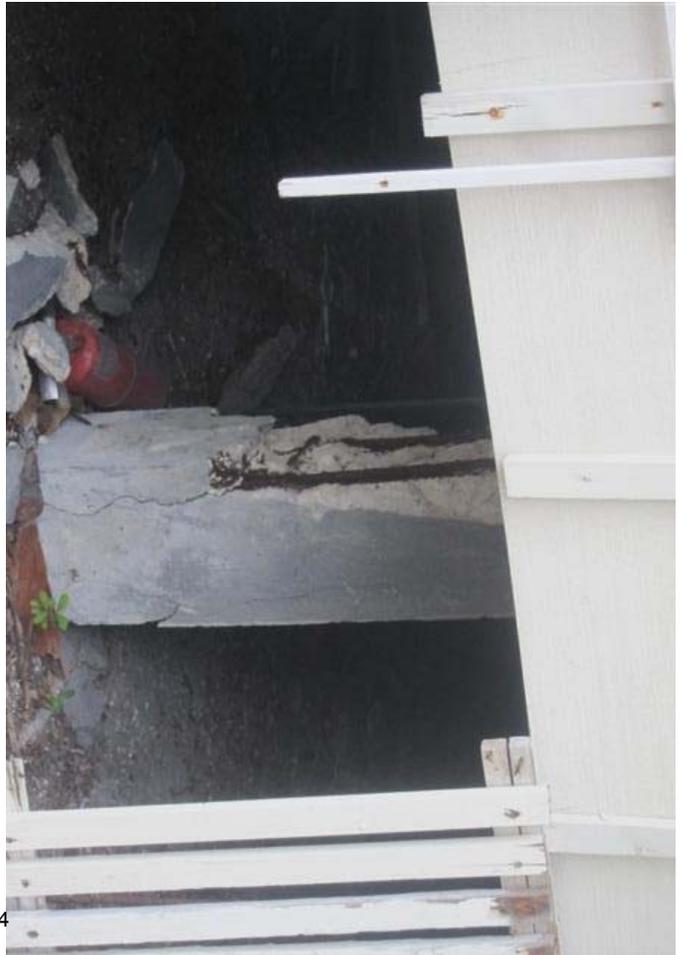
Villa 17 - Windborne Risk Pictures

- **Spalling, cracks, & corrosion in piers**
- **Siding rot**
- **Deterioration, detached, & dislodged exterior wood**
- **Lattice skirting failure**
