**Building Official Inspection Report
February 26, 2014
1620 Gulf of Mexico Drive
The Colony**

Building Official Report

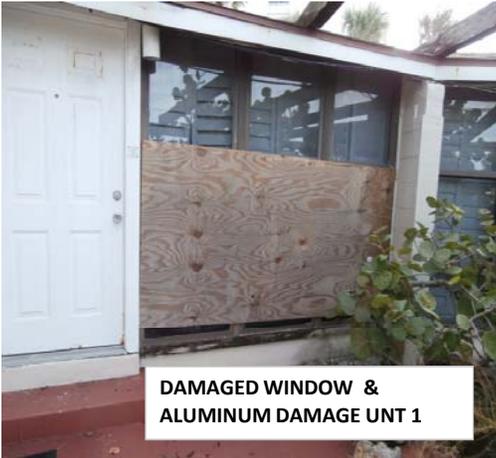
Windows damaged due to vandalizing.

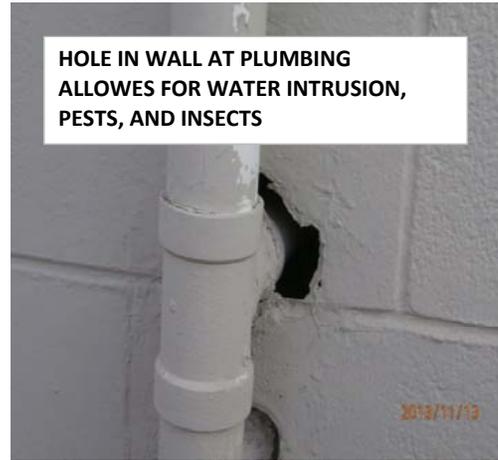
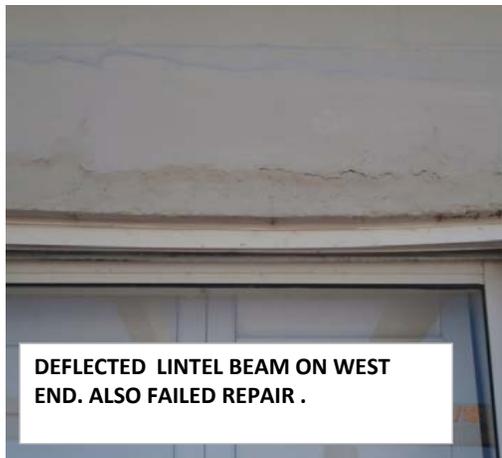
WEST SIDE OF BUILDING

Around plumbing stack on west end of building

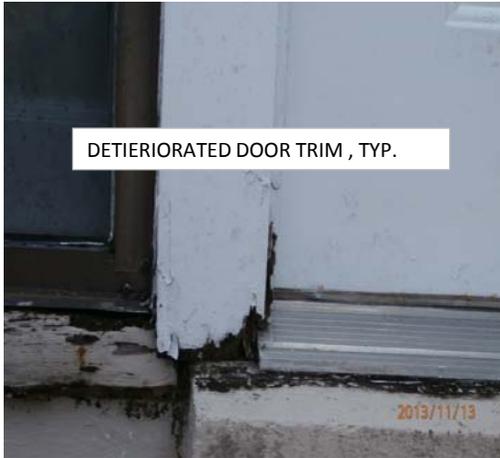
DETERIORATED DOOR TRIM , TYP.

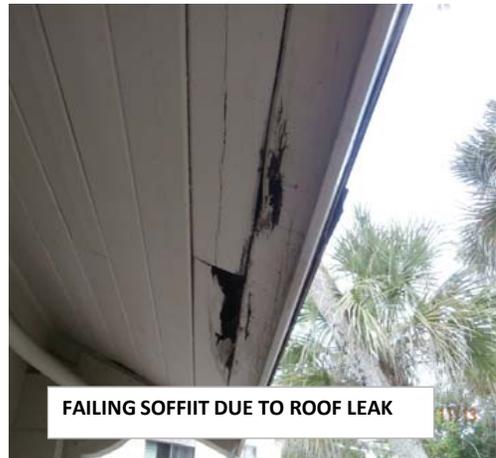
FAILING SOFFIT DUE TO ROOF LEAK

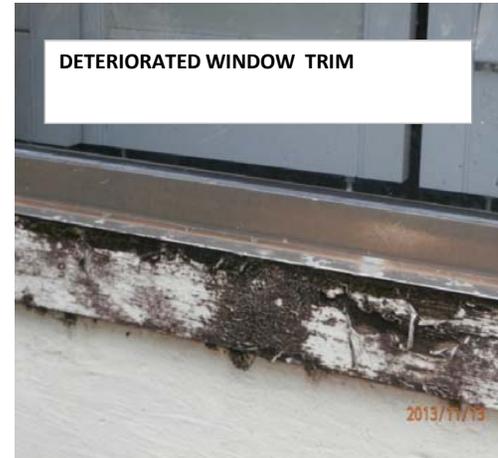
DETERIORATED WINDOW TRIM

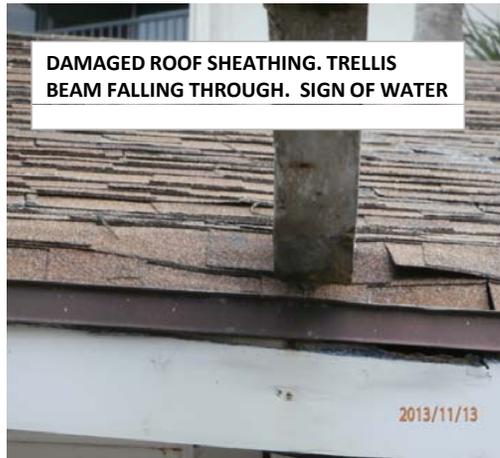
DAMAGED ROOF SHEATHING. TRELLIS BEAM FALLING THROUGH. SIGN OF WATER

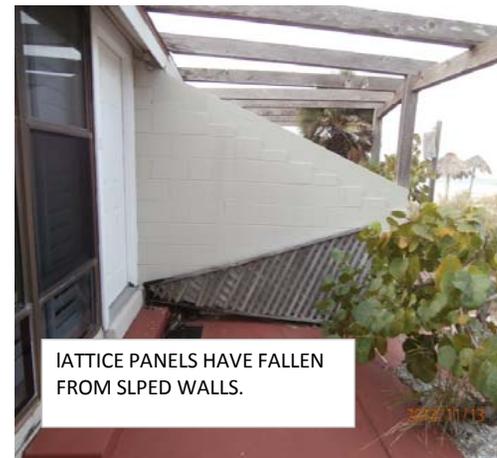
LATTICE PANELS HAVE FALLEN FROM SLPED WALLS.

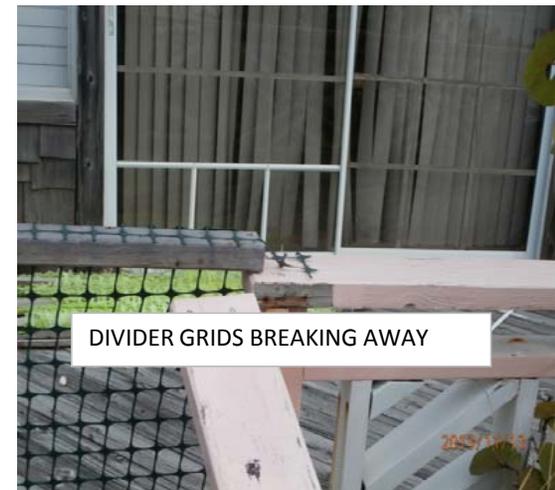
Window grids breaking away

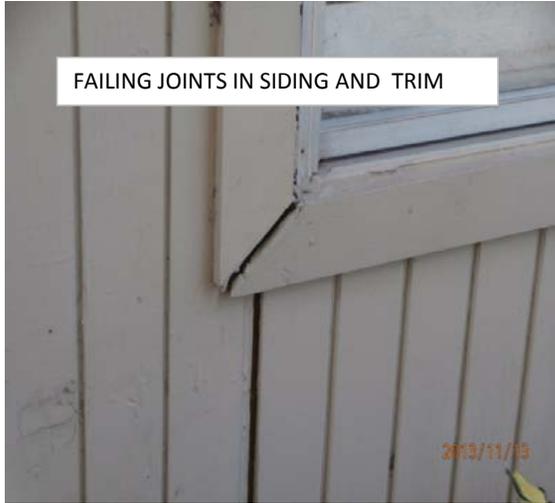
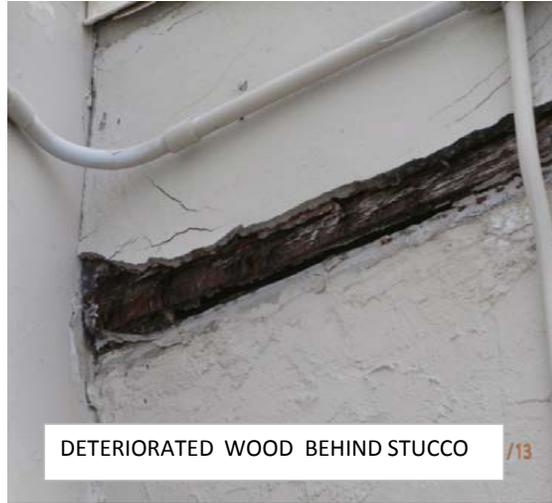
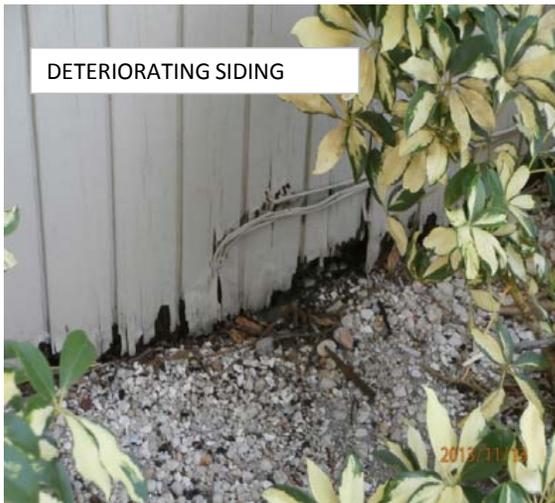
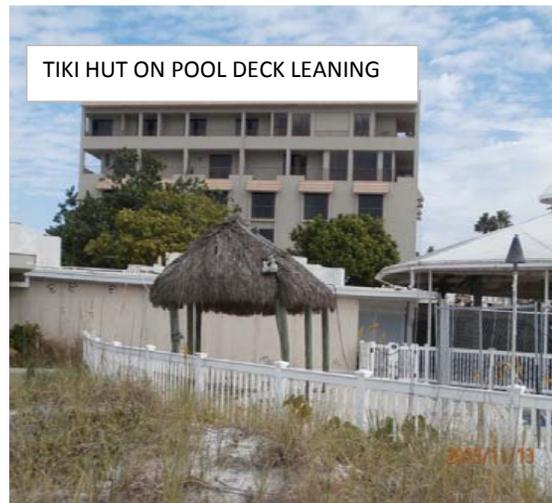
Exposed I beams, canopies. Doors showing signs of failure. Large anaopy area in rear on tube steel and weld joints

Bee infestation at the rear caused removal of siding

Found vertical separation at on window of realtors office.

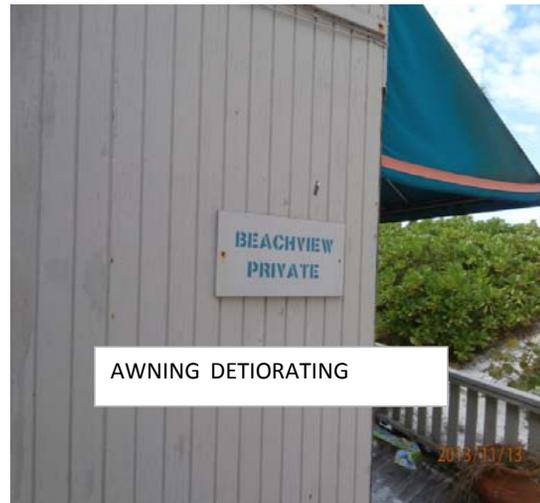
SCREEN DOOR NOT IN POSITION

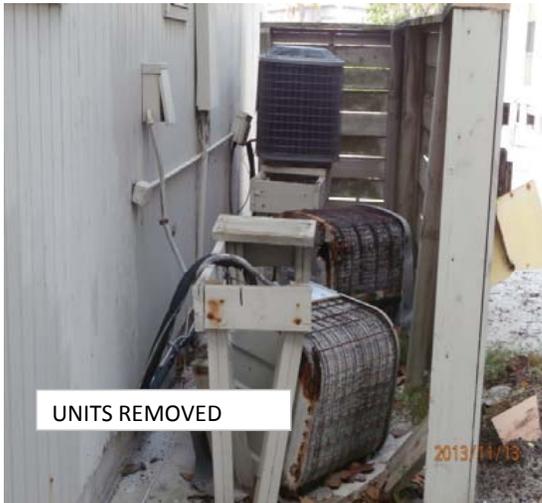
Awnings at all units, air conditioning units

Bottom of air conditioning units
Corroded joints to awnings.

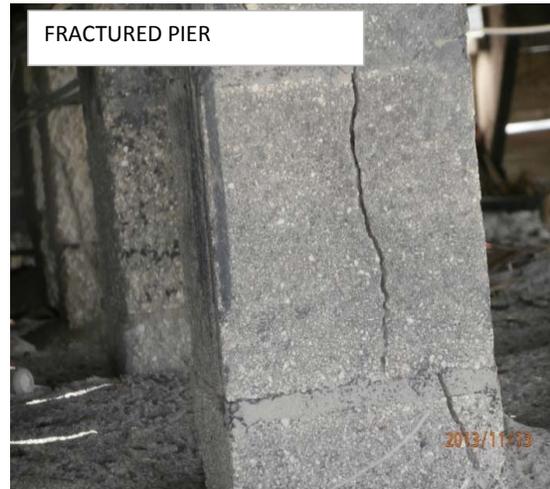
Column supports to deck

Column supports to building and deck.

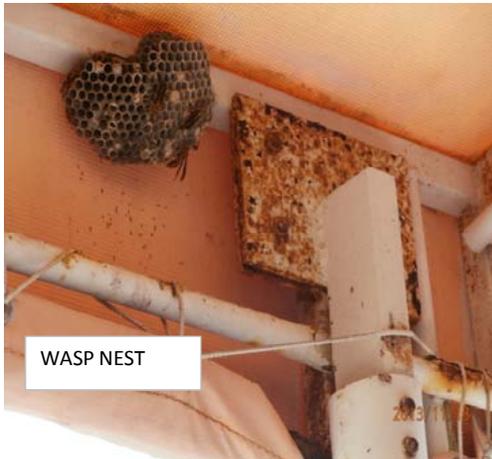
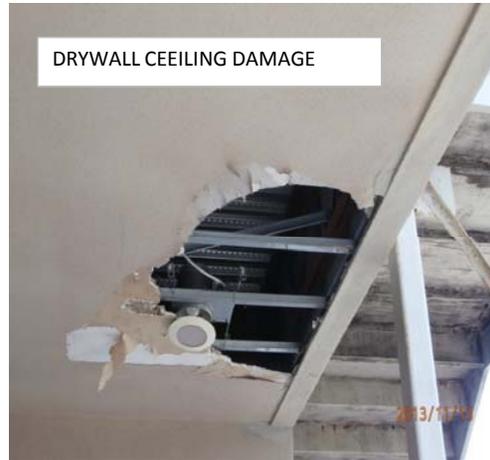
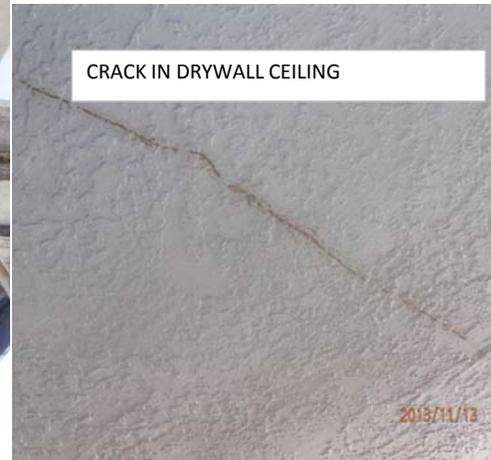
Building has been posted for a non working fire alarm system including the required monitoring. Restricted access.
Building has been posted for failing joists and connection. Temporary shoring in place. No permanent work completed.
The interior of the building has extensive mold. No report indicating that it is a health hazard.
Boarding of opening due to vandalizing.
Drywall soffits and ceilings cracking, damaged and falling.
Found windows propped open. Closed days later.
Wasps nest found.

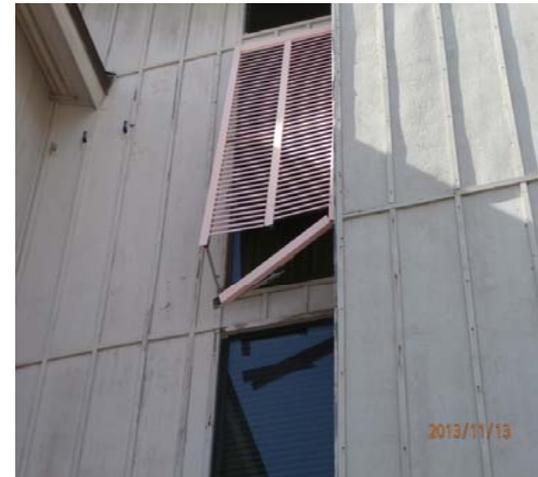
Shutter supports

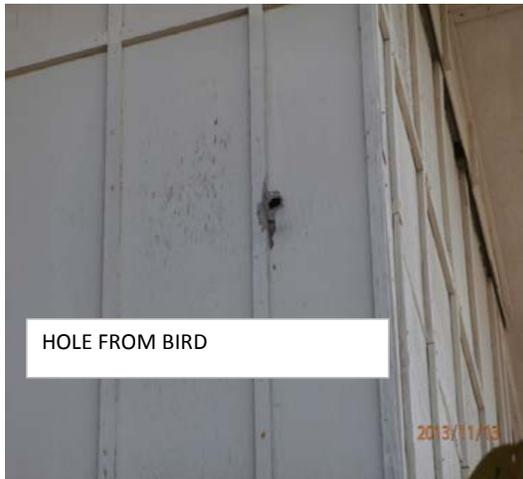
HOLE FROM BIRD

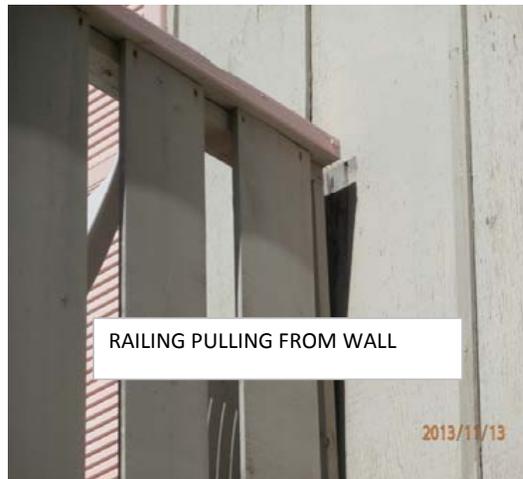
RAILING PULLING FROM WALL

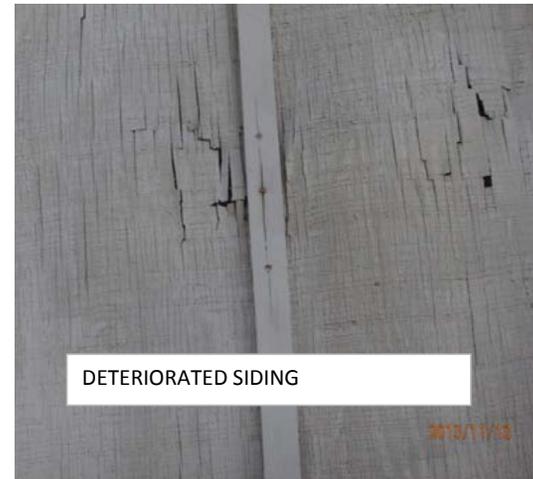
DETERIORATED SIDING

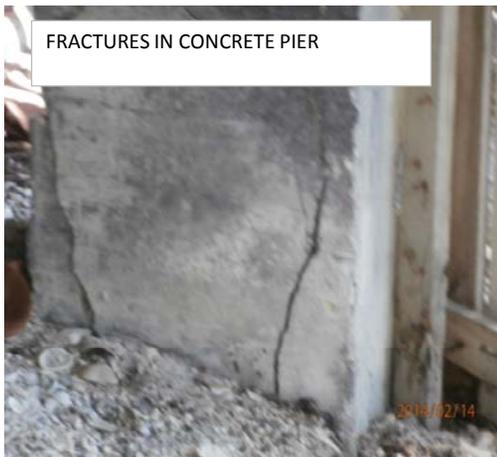
- Deterioration
- Ultimate deformation
- Fractures
- Fissures
- Spalling
- Exposed reinforcement
- Detached, dislodged, or failing connections

- Approximately 40% of the piers, some extensive
- 70 % or more of the piers.
- Approximately 25% of the piers
- Extensive on approximately 20% of the piers

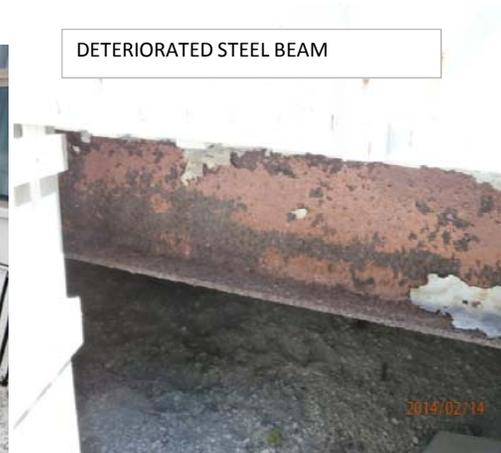
Bottom of I- beams. Some joist hangers and visible clips. Many A/C units are showing signs of failure.

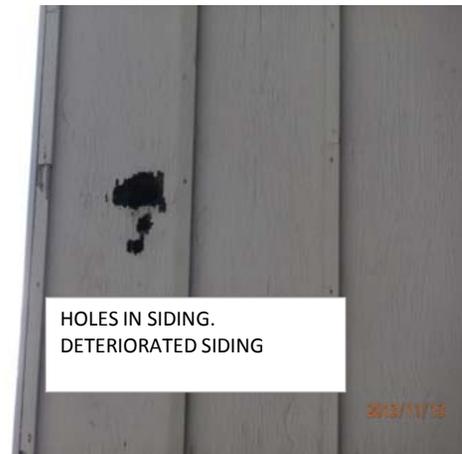
HOLES IN SIDING.
DETERIORATED SIDING

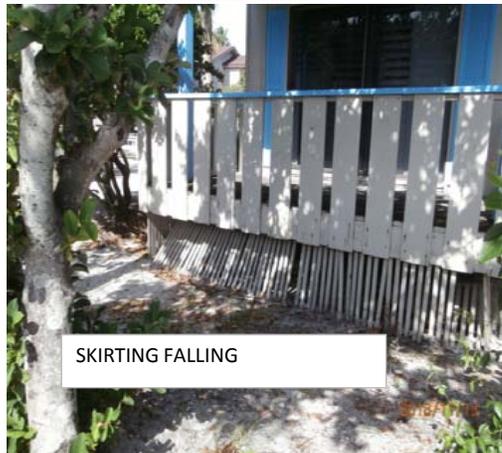
SKIRTING FALLING

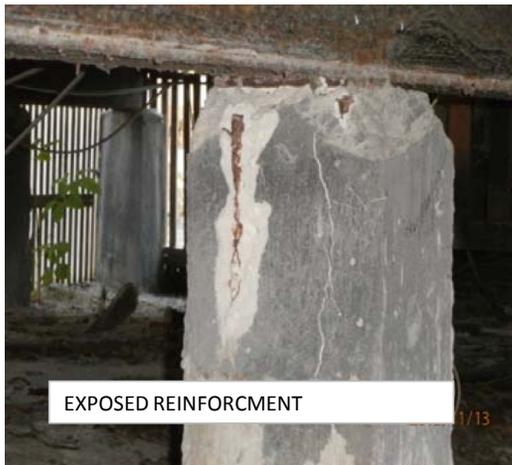
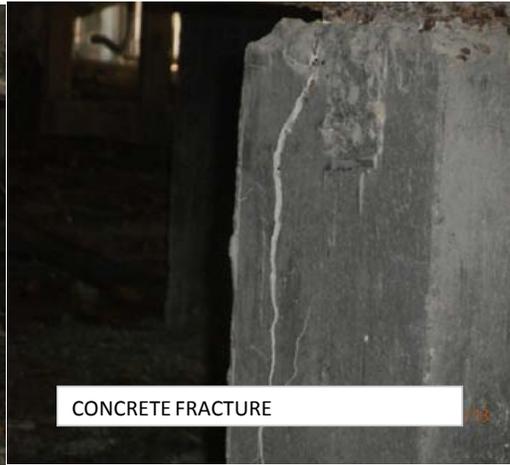
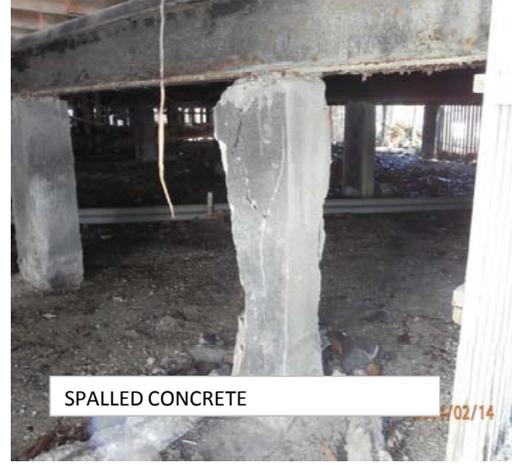
Approximately 35% of the piers, some extensive
75 % or more of the piers.
Approximately 35% of the piers
Extensive on approximately 20% of the piers

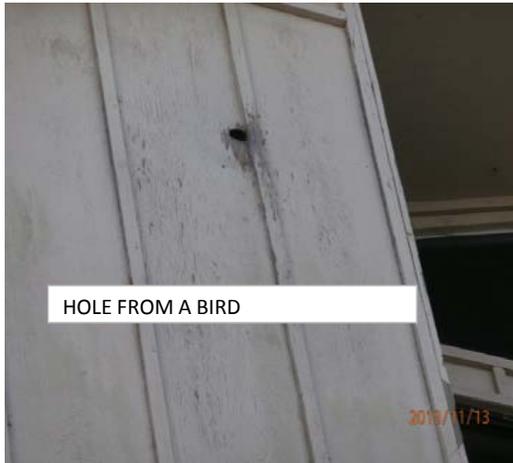
Signs of termite and other insect damage. Extensive on the siding. Holes in siding from birds.

Column failing to support upper walkway deck and living roof above. A/C unit stands.

Siding, trims, floor framing, wood shutters, fascia and soffits. The entry stairs and lower walkway show signs of failing to support. Railings pulling from walls. Railing missing balusters.

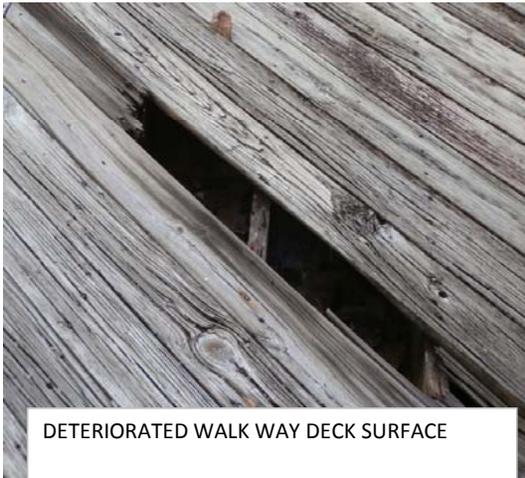
DETERIORATED WALK WAY DECK SURFACE

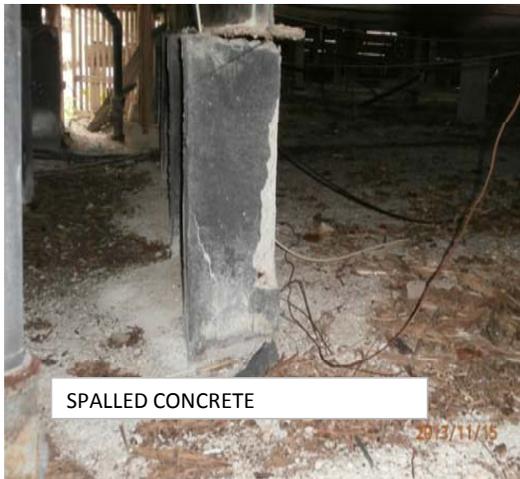
Approximately 20% of the piers

Extensive on approximately 20% of the piers

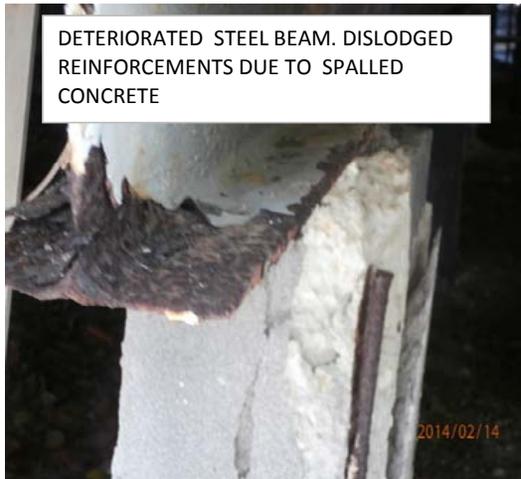
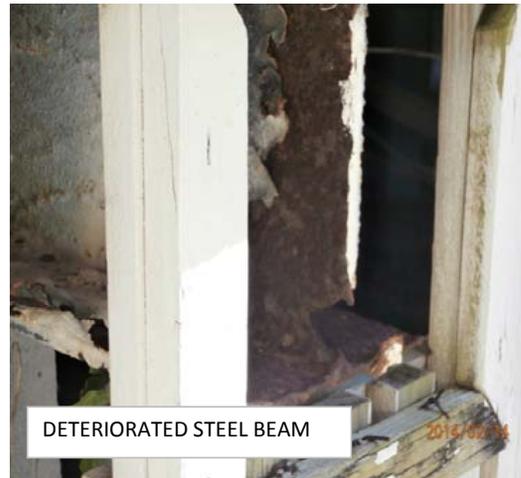
Bottom of I- beams. Some joist hangers and visible clips. Many A/C units are showing signs of failure.

A/C units at the bottom

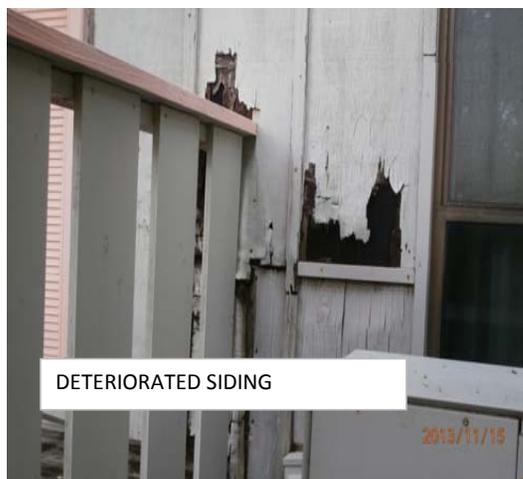
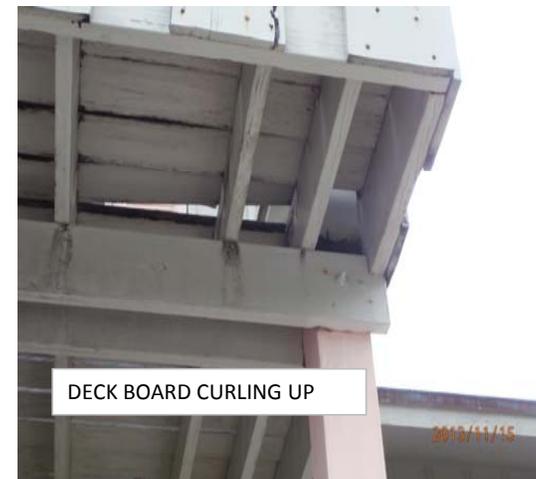
Many porch beams deflected 1/2-inch and more at the center.
Siding, trims, floor framing, upper floor deck , wood shutters, .
Signs of termite and other insect damage. Extensive on the siding. Holes in siding from birds.

Some deck joists

A/C unit stands.
Siding, trims, floor framing, wood shutters, fascia and soffits. The entry stairs and lower walkway show signs of failing to support. Railings pulling from walls. Railing missing balusters.

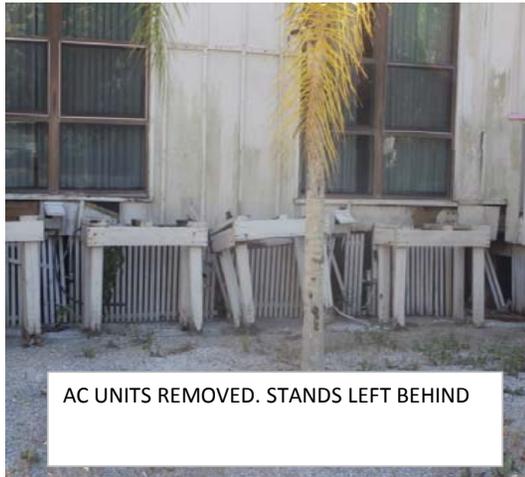
Cast iron building drains corroded and broken

Air conditioning unit are beginning to fail. A/C unit may fall and have potential to have electrical issues as well as possible leaking for the refrigerant.

Removed soffit material due to having bee infestation.

Lattice skirting falling from position.

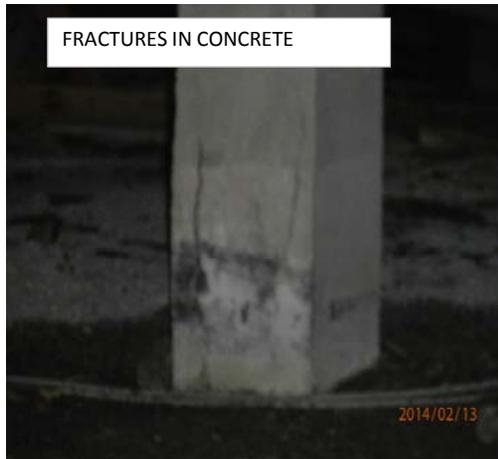
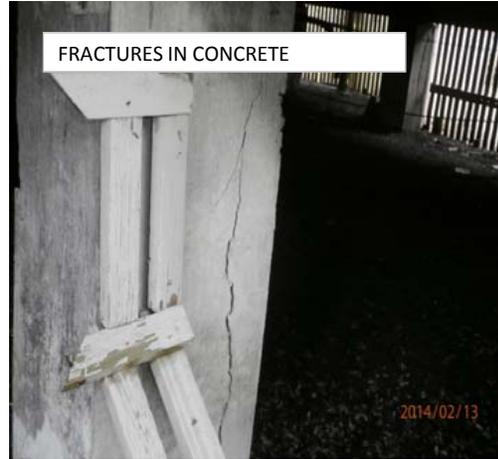
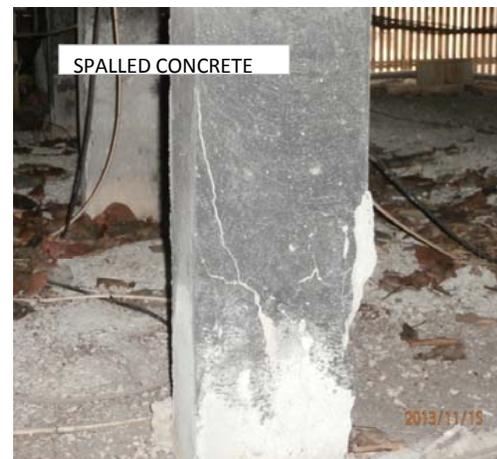
This building appears to be seaward of the coastal construction control line. Code limitation associated to working on the foundation.

Approximately 20% of the piers

Extensive on approximately 20% of the piers

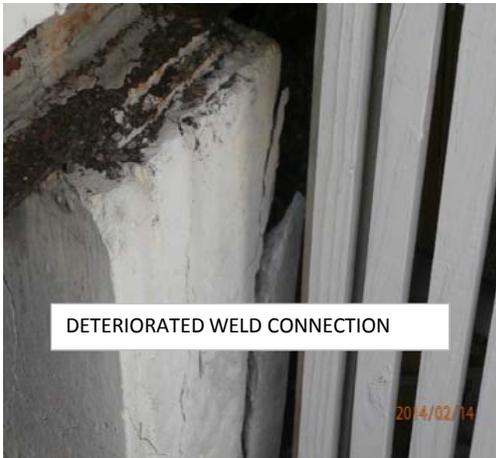
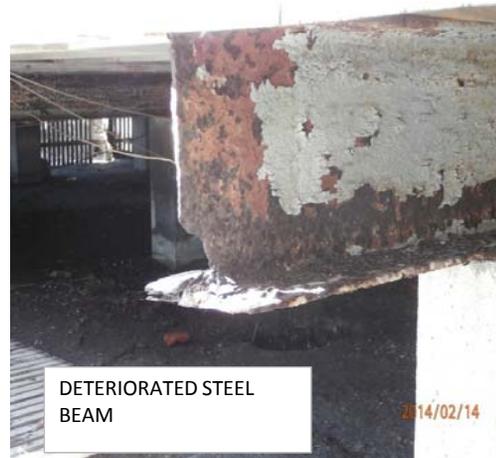
Bottom of I- beams. Some joist hangers and visible clips. Many A/C units are showing signs of failure.

A/C units at the bottom

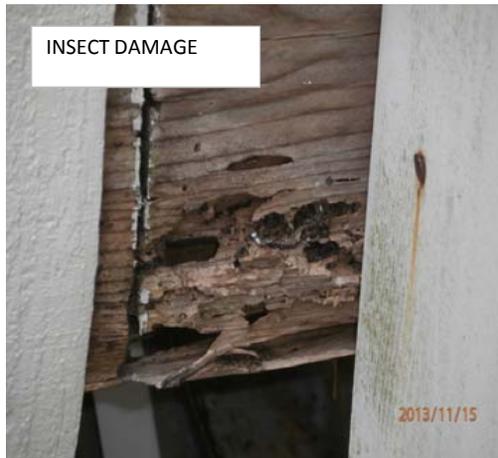
Many porch beams deflected 1/2-inch and more at the center.
Siding, trims, floor framing, upper floor deck, wood shutters, .
Signs of termite and other insect damage. Extensive on the siding. Sign of animal digging into upper walkway. Holes in siding from birds.

Some deck joists

A/C unit stands.
Siding, trims, floor framing, wood shutters, fascia and soffits. The entry stairs and lower walkway show signs of failing to support. Railings pulling from walls. Railing missing balusters.

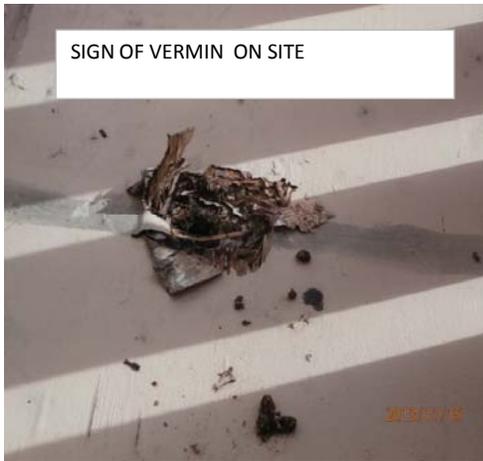
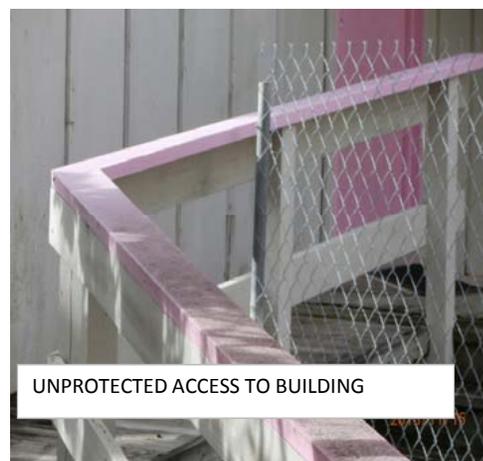
Cast iron building drains corroded and broken

Air conditioning unit are beginning to fail. A/C unit may fall and have potential to have electrical issues as well as possible leaking for the refrigerant.

Lattice skirting falling from position.

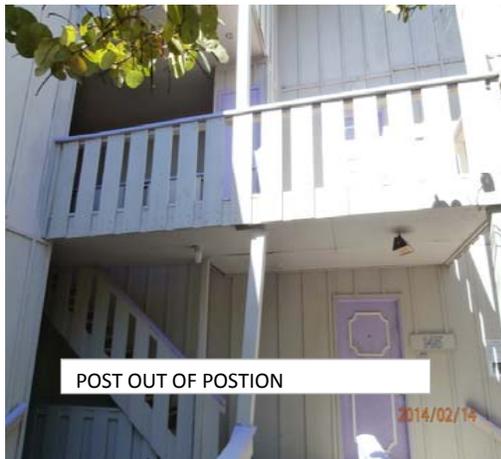
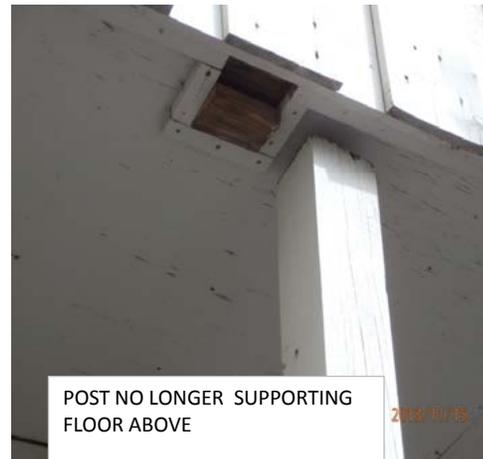
Many porch beams deflected 1/2-inch and more at the center.
Siding, trims, floor framing, upper floor deck, wood shutters, .
Signs of termite and other insect damage. Extensive on the siding. Holes in siding from birds.

Some deck joists

Post not supporting upper walkway. A/C unit stands.
Siding, trims, floor framing, wood shutters, fascia and soffits. The entry stairs and lower walkway show signs of failing to support. Railings pulling from walls. Railing missing balusters.

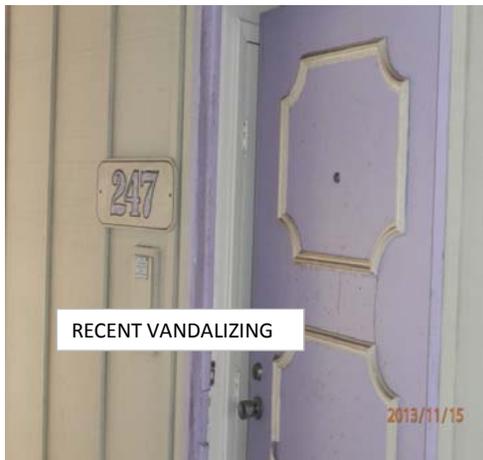
Air conditioning unit are beginning to fail. A/C unit may fall and have potential to have electrical issues as well as possible leaking for the refrigerant.

Lattice skirting falling from position.

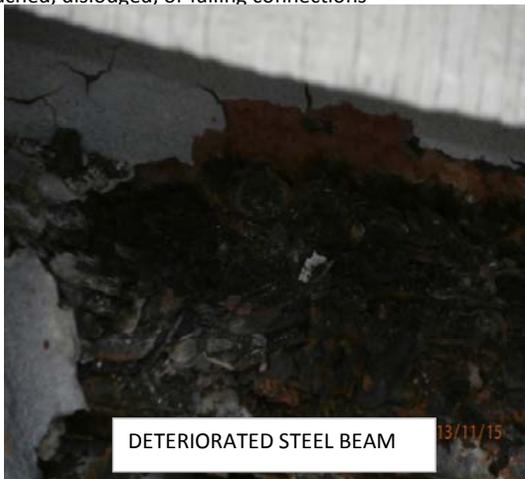
Bottom of I- beams. Some joist hangers and visible clips. Many A/C units are showing signs of failure.

A/C units at the bottom

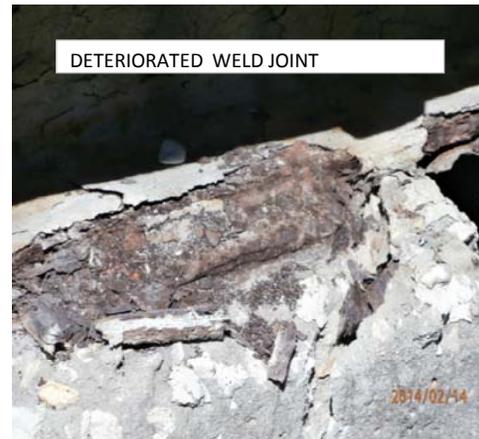
Bottom of I- beams. Some joist hangers and visible clips. Many A/C units are showing signs of failure.

A/C units at the bottom

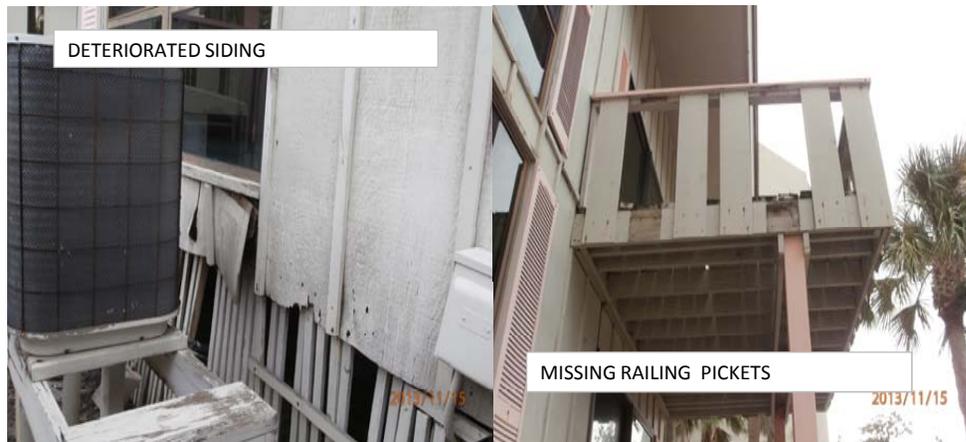
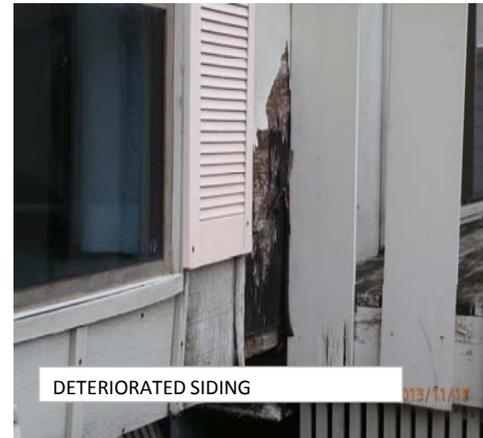
Many porch beams deflected 1/2-inch and more at the center.
Siding, trims, floor framing, upper floor deck, wood shutters, .
Signs of termite and other insect damage. Extensive on the siding. Holes in siding from birds.

A/C unit stands.
Siding, trims, floor framing, wood shutters, fascia and soffits. The entry stairs and lower walkway show signs of failing to support. Railings pulling from walls. Railing missing balusters.

Excessive cutting and notching

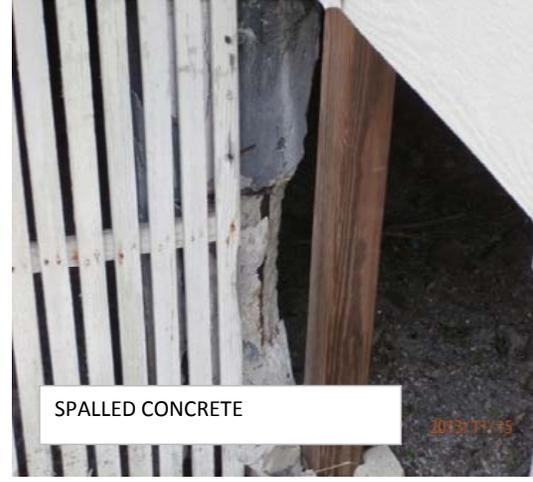
This building is seaward of the coastal construction control line. Code limitation associated to working on the foundation.

Approximately 35% of the piers, some extensive
60 % or more of the piers.

Approximately 20% of the piers
Extensive on approximately 20% of the piers

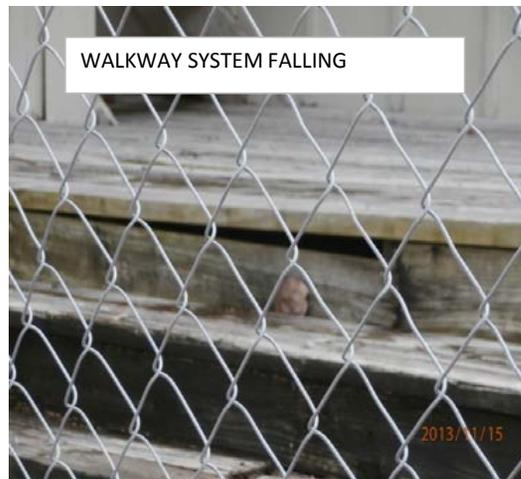
Many porch beams deflected 1/2-inch and more at the center.
Siding, trims, floor framing, upper floor deck, wood shutters, .
Signs of termite and other insect damage. Extensive on the siding. Currently has wasp nests.
Holes in siding from birds.

Some deck joists

A/C unit stands
Siding, trims, floor framing, wood shutters, fascia and soffits. The entry stairs and lower walkway show signs of failing to support. Railings pulling from walls. Railing missing balusters.

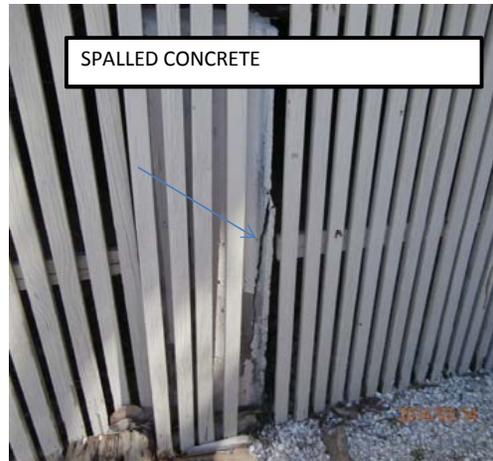
This building maybe seaward of the coastal construction control line. Code limitation associated to working on the foundation.

Approximately 50% of the piers, some extensive
75 % or more of the piers.
Approximately 40% of the piers
Extensive on approximately 40% of the piers

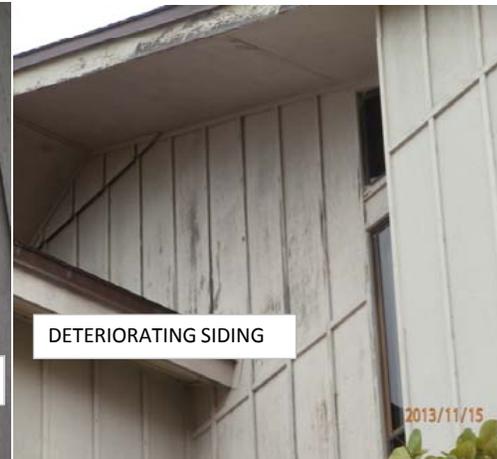
Many porch beams deflected 1/2-inch and more at the center.
Siding, trims, floor framing, upper floor deck, wood shutters, .
Signs of termite and other insect damage. Extensive on the siding. Holes in siding from birds.

Some deck joists

A/C unit stands.
Siding, trims, floor framing, wood shutters, fascia and soffits. The entry stairs and lower walkway show signs of failing to support. Railings pulling from walls. Railing missing balusters.

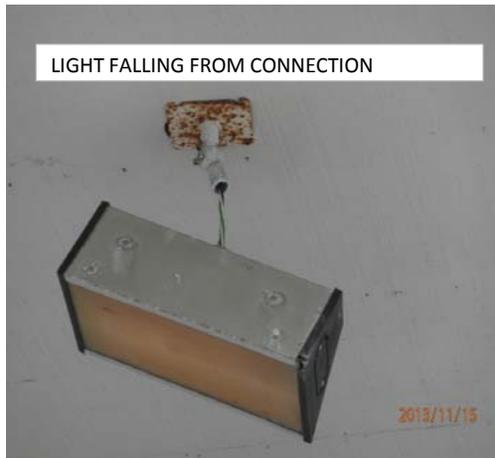
Security light hanging by wires

Tree branch has fallen onto security fence.

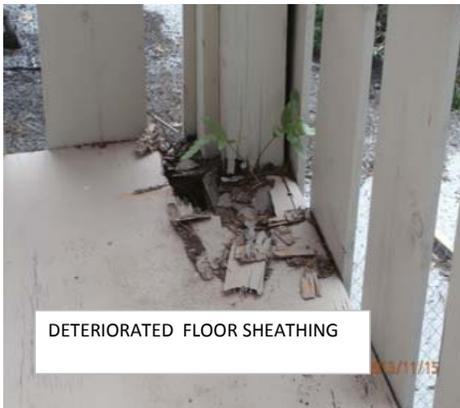
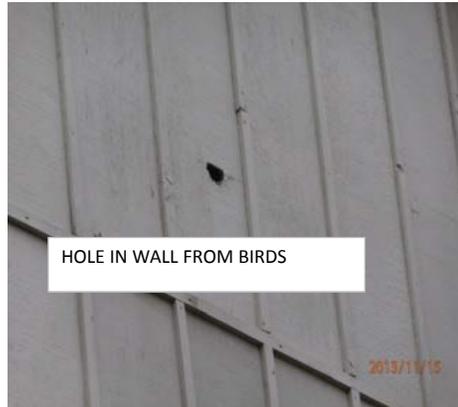
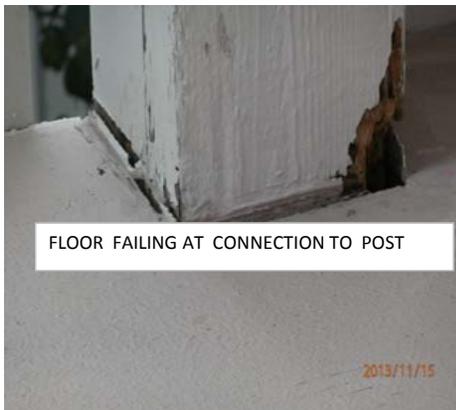
Many porch beams deflected 1/2-inch and more at the center.
Siding, trims, floor framing, upper floor deck, wood shutters, .
Signs of termite and other insect damage. Extensive on the siding. Holes in siding from birds.

Upper walkway deck showing extensive rot and is showing signs of drooping. A/C unit stands.

Siding, trims, floor framing, wood shutters, fascia and soffits. The entry stairs and lower walkway show signs of failing to support. Railings pulling from walls. Railing missing balusters.

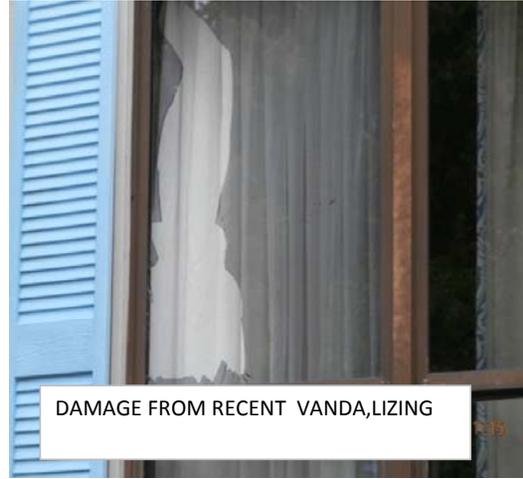
Cast iron building drains corroded and broken

Broken window from recent vandalizing.

Air conditioning unit are beginning to fail. A/C unit may fall and have potential to have electrical issues as well as possible leaking for the refrigerant.

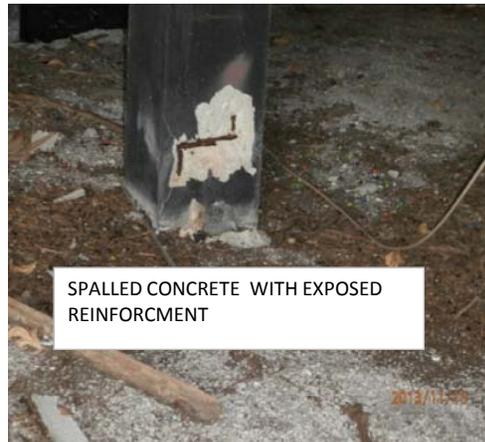
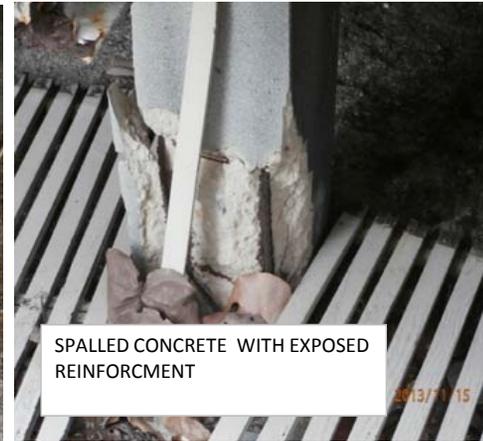
Approximately 15% of the piers

Extensive on approximately 15% of the piers

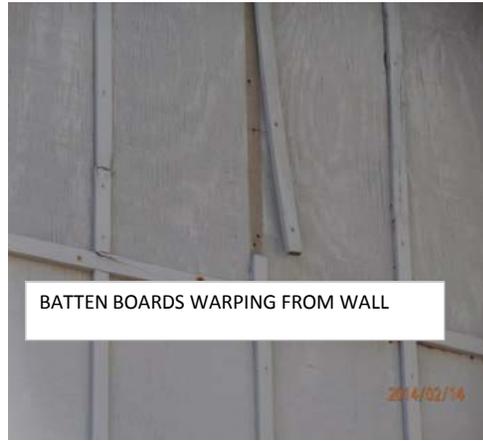
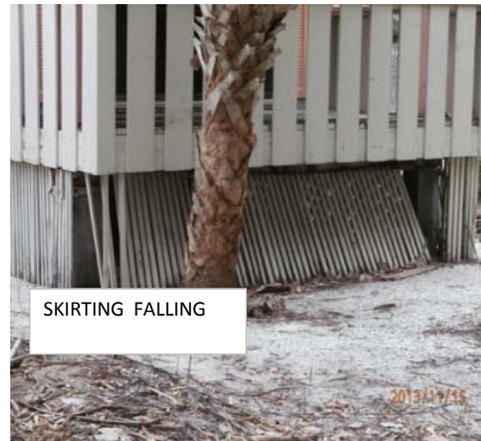
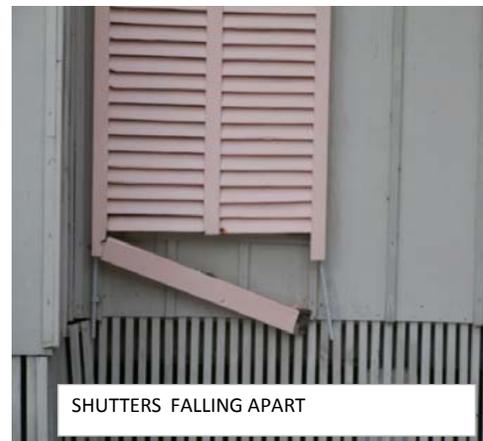
Many porch beams deflected 1/2-inch and more at the center.
Siding, trims, floor framing, upper floor deck, wood shutters, .
Signs of termite and other insect damage. Extensive on the siding. Holes in siding from birds.

Some deck joists

A/C unit stands
Siding, trims, floor framing, wood shutters, fascia and soffits. The entry stairs and lower walkway show signs of failing to support. Railings pulling from walls. Railing missing balusters.

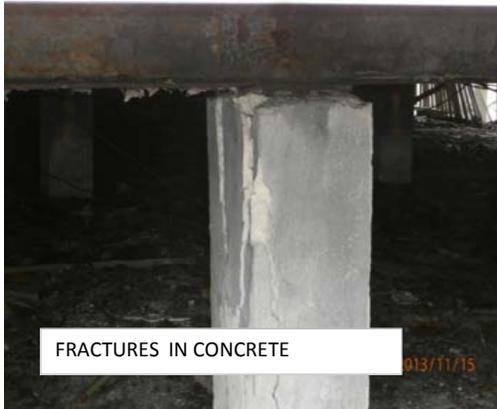
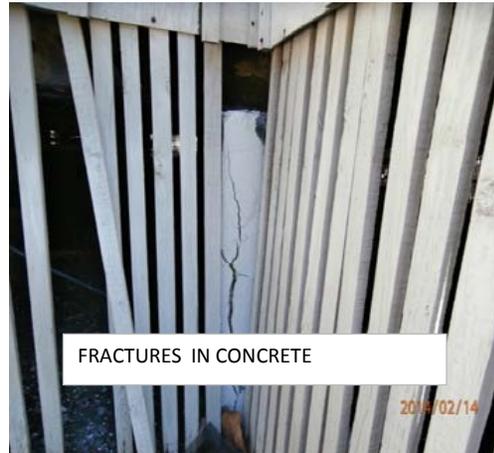
This building is seaward of the coastal construction control line. Code limitation associated to working on the foundation.

Approximately 20% of the piers

Extensive on approximately 10% of the piers

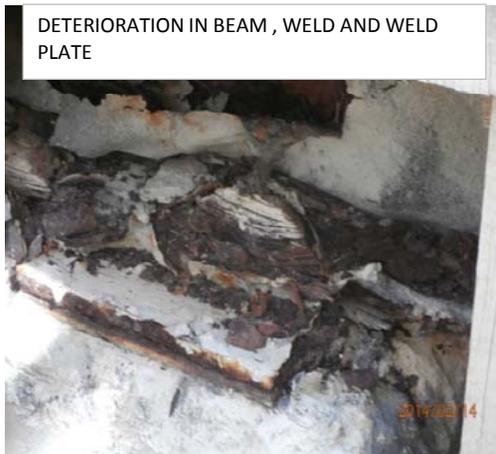
A/C units at the bottom

Bottom of I- beams. Some joist hangers and visible clips. Many A/C units are showing signs of failure.

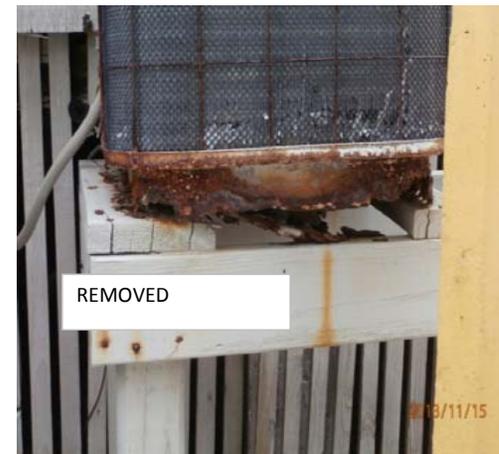
Cast iron building drains corroded and broken

Boarded up windows and doors due to vandalizing. Broken window due to recent vandalizing.

Air conditioning unit are beginning to fail. A/C unit may fall and have potential to have electrical issues as well as possible leaking for the refrigerant. One unit has dropped to the ground.

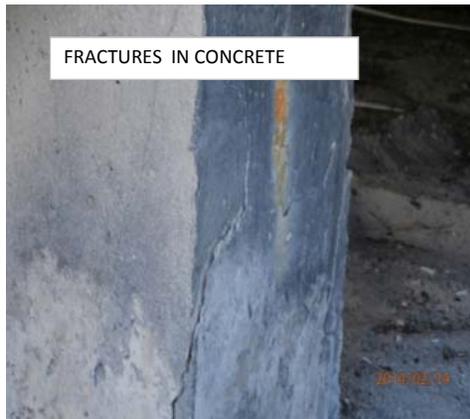
This building is seaward of the coastal construction control line. Code limitation associated to working on the foundation.

Approximately 40% of the piers

Extensive on approximately 40% of the piers

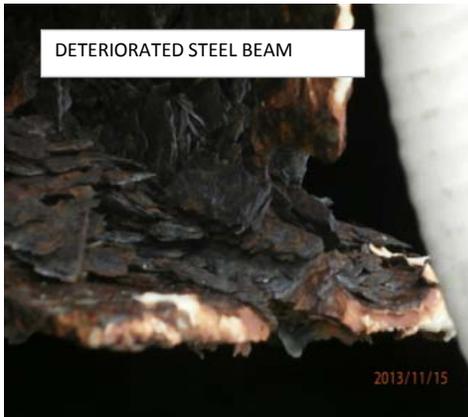
A/C units at the bottom

Bottom of I- beams. Some joist hangers and visible clips. Many A/C units are showing signs of failure.

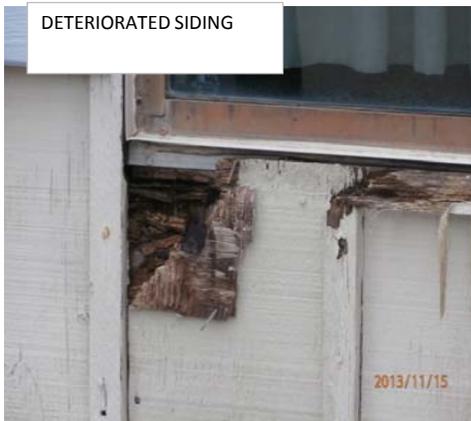
Many porch beams deflected 1/2-inch and more at the center.
Siding, trims, floor framing, upper floor deck , wood shutters, .
Signs of termite and other insect damage. Extensive on the siding. Currently has wasp nests.
Holes in siding from birds.

Post appears to not be supporting upper walkway. A/C unit stands
Siding, trims, floor framing, wood shutters, fascia and soffits. The entry stairs and lower
walkway show signs of failing to support. Railings pulling from walls. Railing missing balusters.

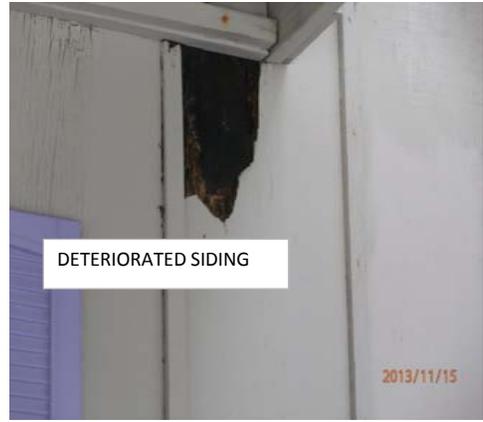
DETERIORATED SIDING

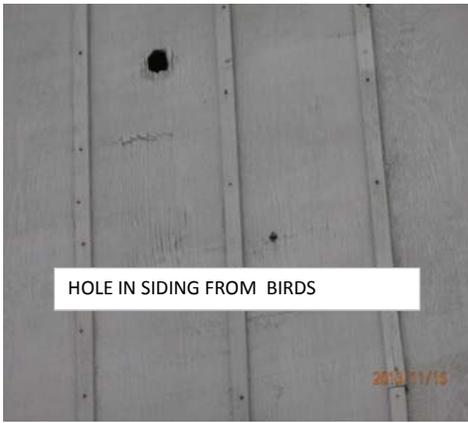
HOLE IN SIDING FROM BIRDS

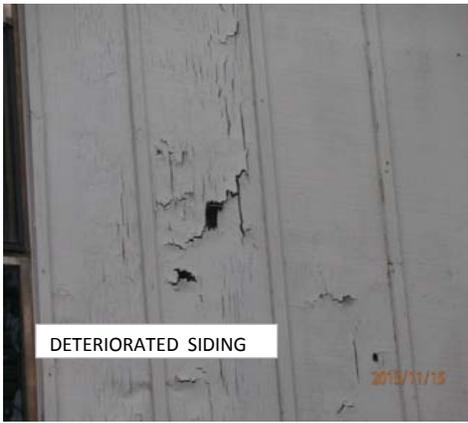
DETERIORATED SIDING

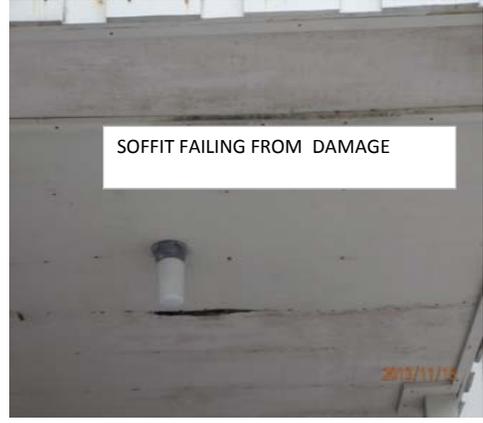
SOFFIT FAILING FROM DAMAGE

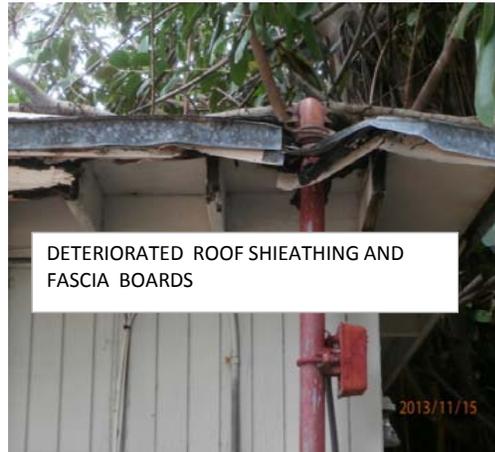
DETERIORATED ROOF SHEATHING AND FASCIA BOARDS

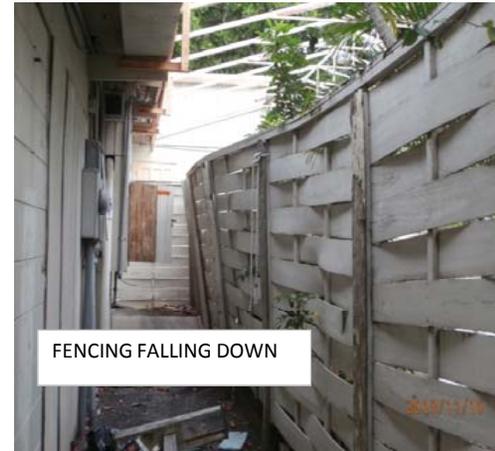
FENCING FALLING DOWN

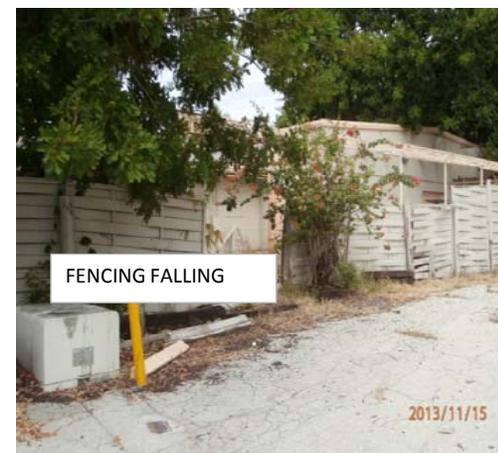
FENCING FALLING

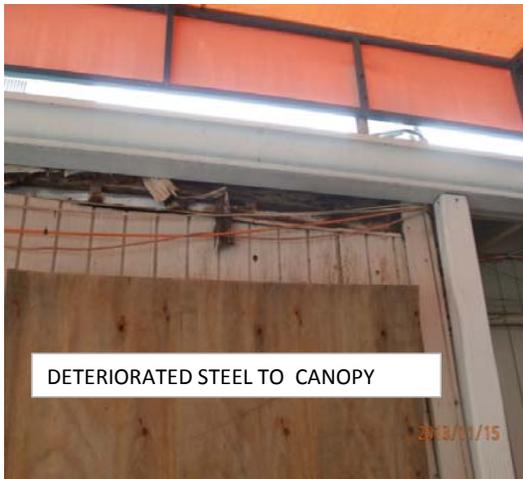
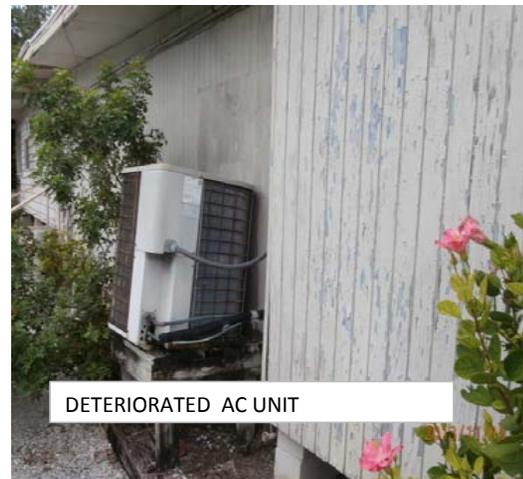
Deterioration Fabric structure

Detached, dislodged, or failing connections

Fabric structure

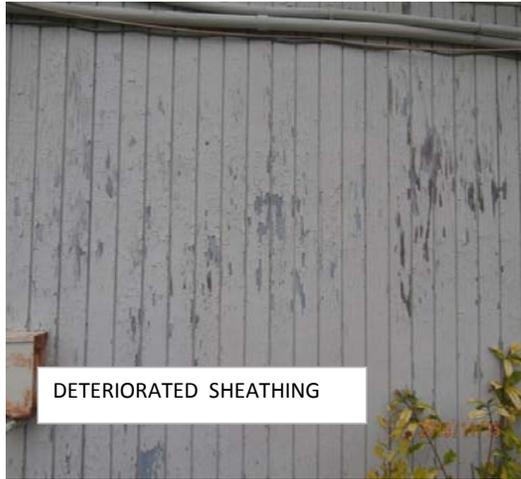
DETERIORATED SHEATHING

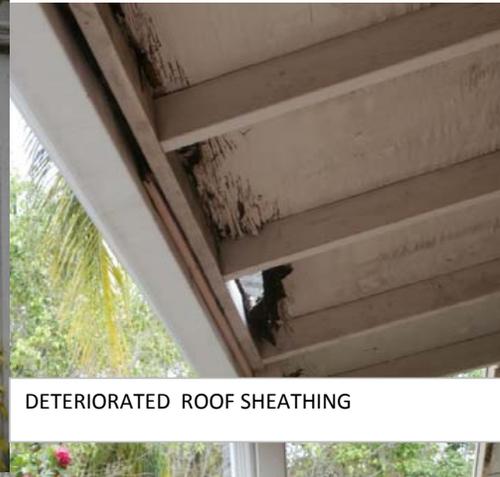
DETERIORATED ROOF SHEATHING
