**Building Official Inspection Report
February 26, 2014
1620 Gulf of Mexico Drive
The Colony**

Building Official Report

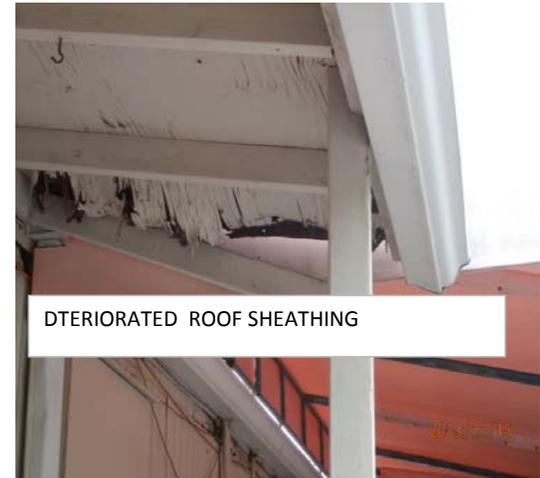
DETERIORATED ROOF SHEATHING

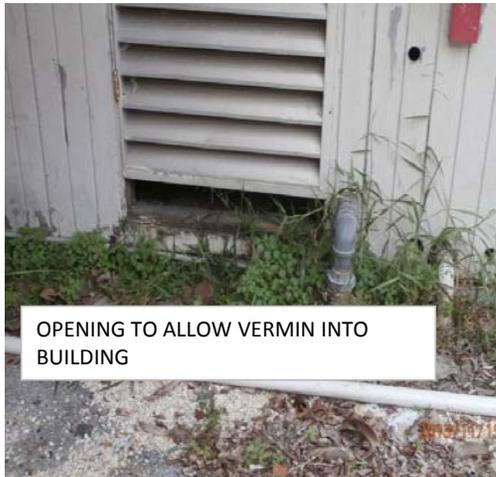
OPENING TO ALLOW VERMIN INTO BUILDING

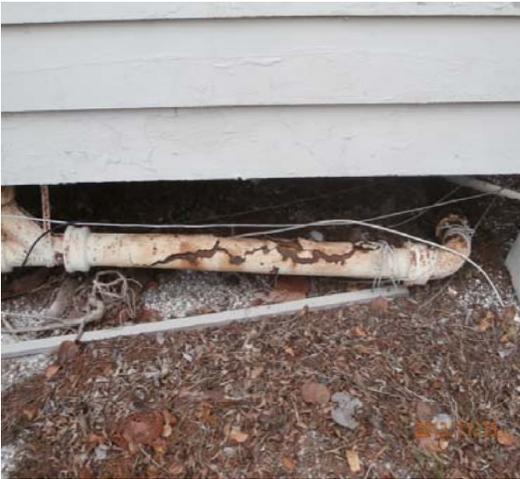
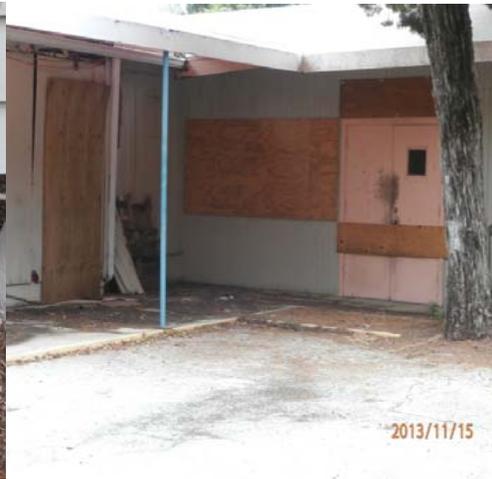
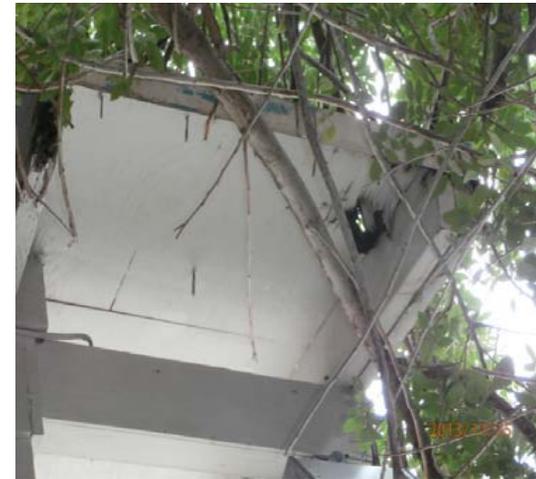
Broken, corroded, and cracked building drains.

Roofing at end of its life.

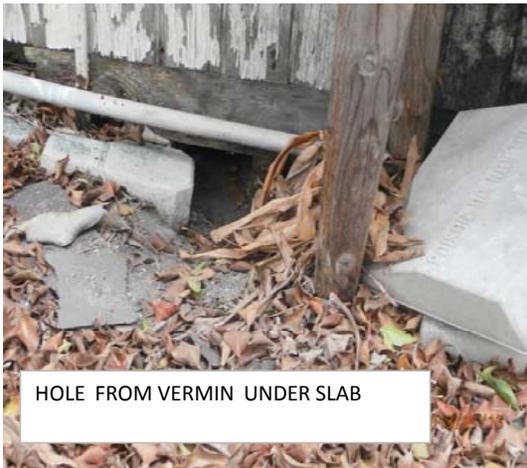
This building appears to have a slab on grade foundation without footings. Unable to verify the condition.

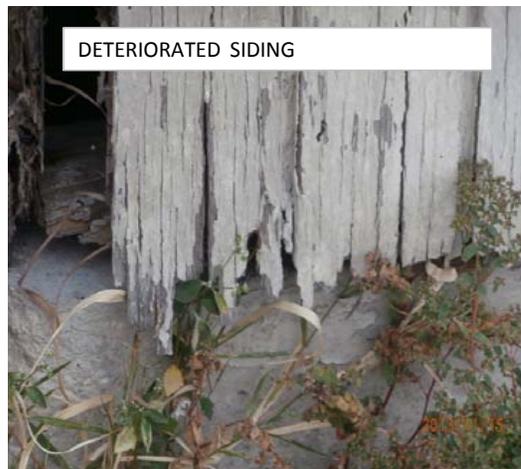
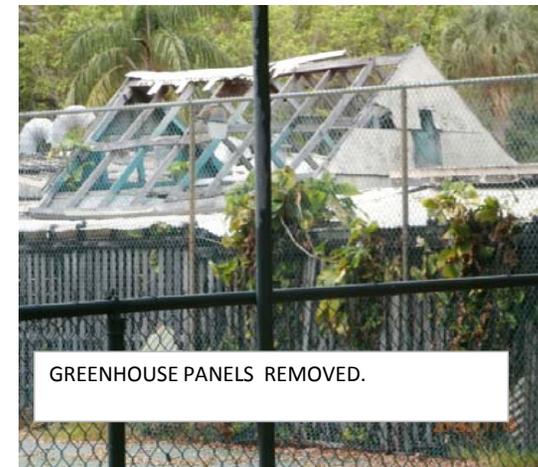
Siding, fascia boards, trims, doors. Roof framing over green house
Appears to have some kind of animal under slab at rear.

Doors from building openings.

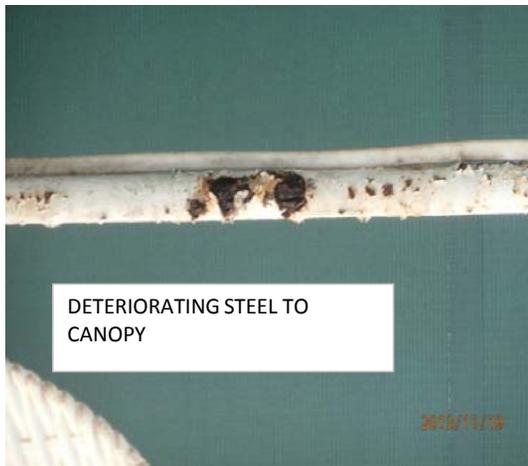
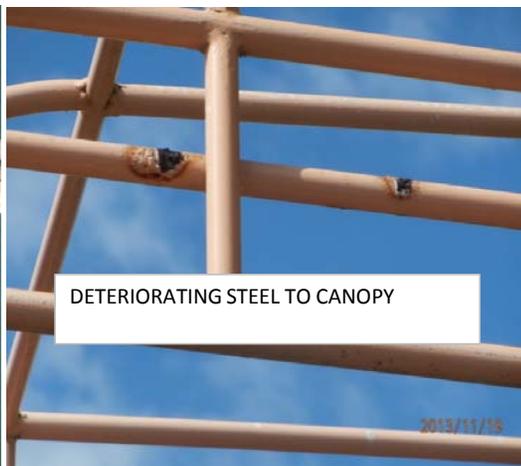
Fabric canopy frames

Fabric awning structures

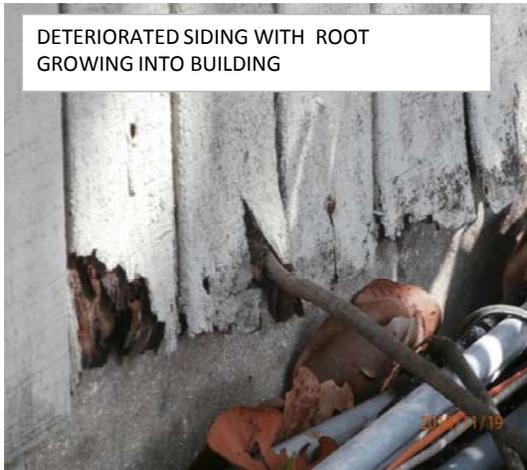
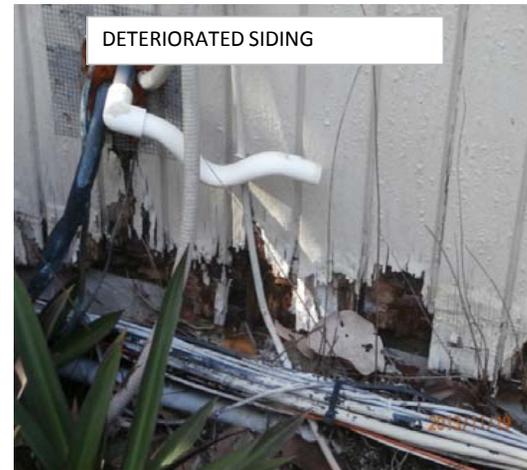
Extensive siding, fascia boards, soffits, trims, doors, roof sheathing.
Signs of termite damage.

Doors from building openings. Rear deck walking surface is lifting and signs of rot.

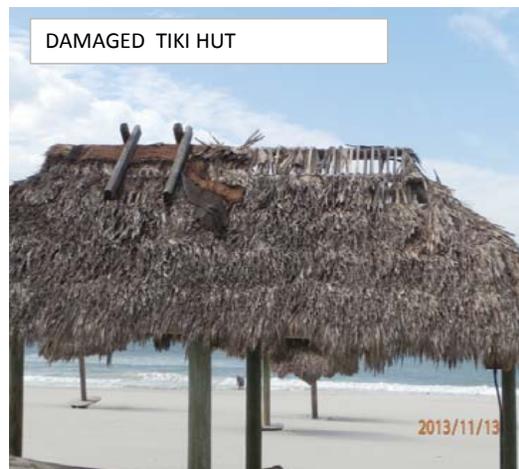
General site conditions.

Loose trash and debris throughout property.

Tiki huts starting to fall and thatch coming loose. This is out on the beach as well as within the site.

Fencing falling down in various locations on the site. Loose lattice fence panel falling down. Fallen branches throughout property. One in the front right of way.

Tennis courts showing signs of deterioration and has vegetation growing throughout them.

All ground level walkways and ramps have rotted wood, warp deck boards, rotted deck boards, and broken railings

Security fencing incomplete at some building. At first inspection appeared complete until an up close inspection was made. Some locations have had vandalizing requiring repair and or reset.
