ENGINEERING INSPECTION REPORT

THE COLONY BEACH and TENNIS RESORT

Longboat Key, Florida

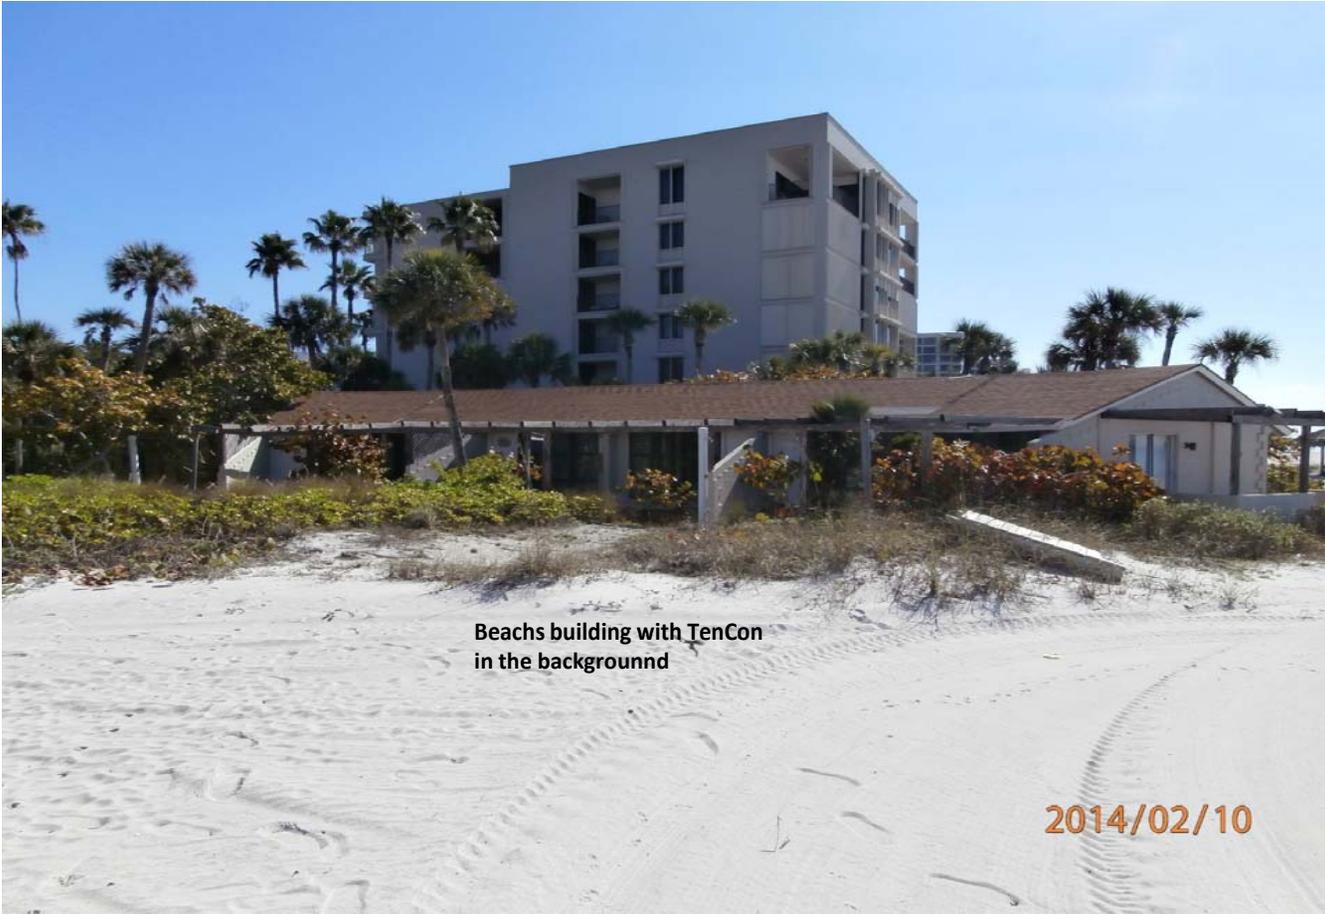
**Beachs building with TenCon
in the background**

Concrete: This building is seaward of the coastal construction control line. Code limitation associated to working on the foundation. This building has a slab on grade foundation. Unable to verify condition.

Windows damaged due to vandalizing.

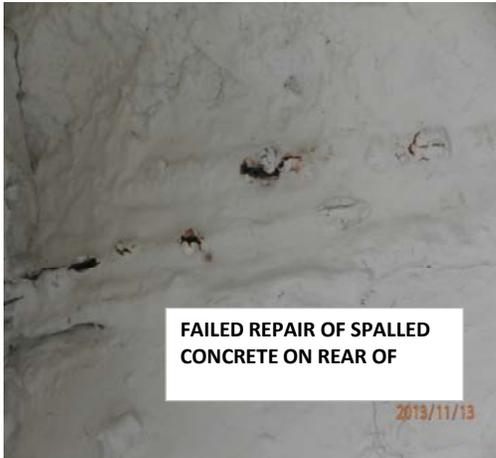
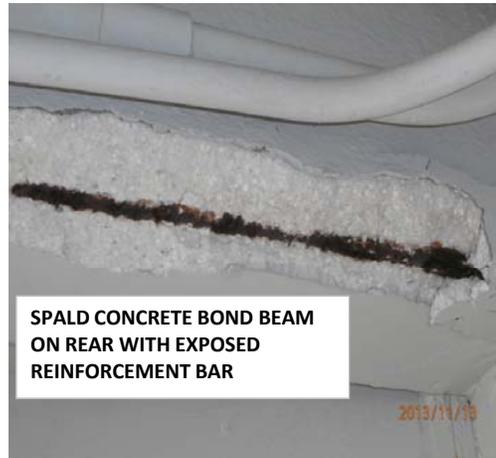
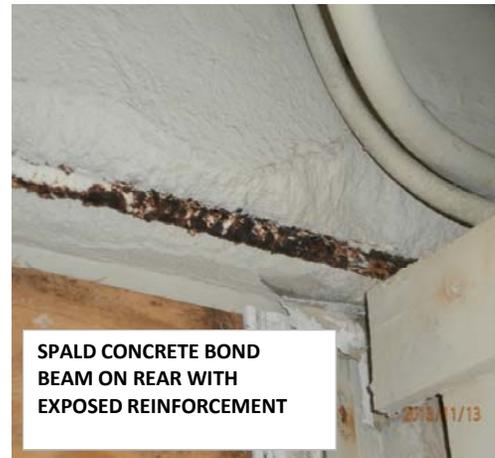
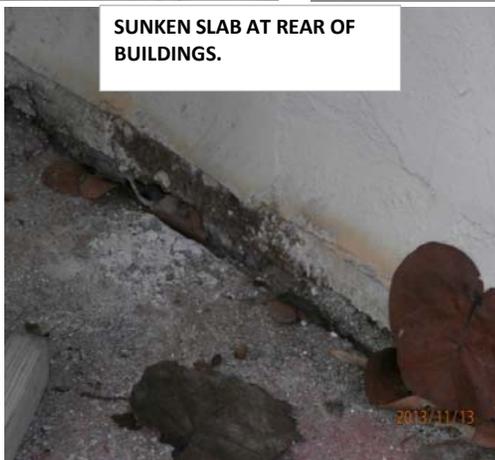
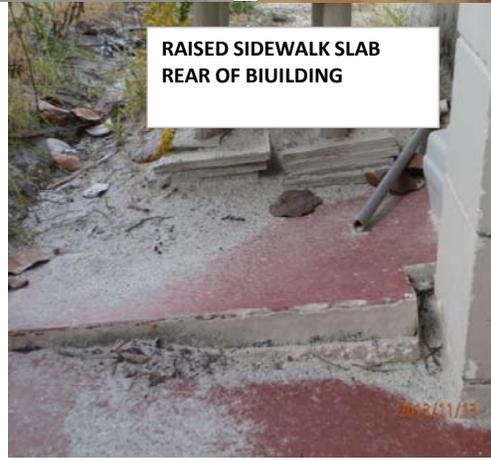
Rear of building in the lintel beam.
Rear of building walkway separating, sinking and heaving

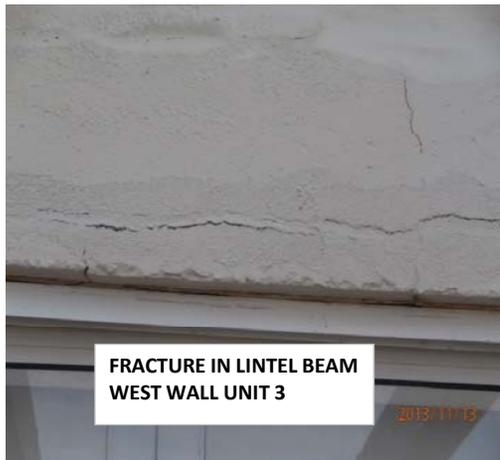
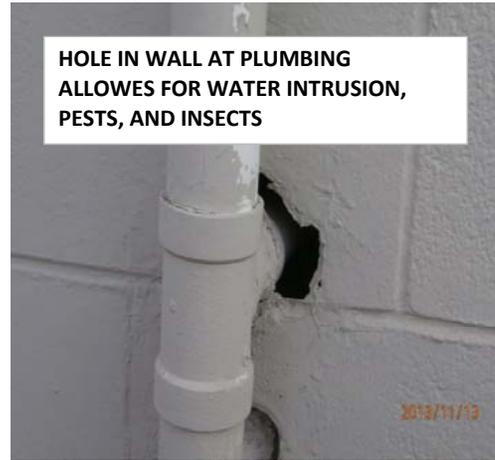
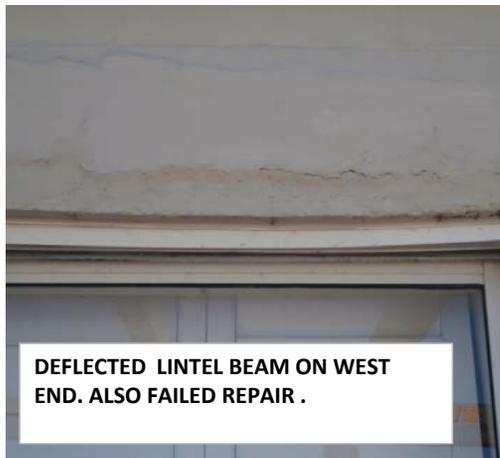
Around plumbing stack on west end of building

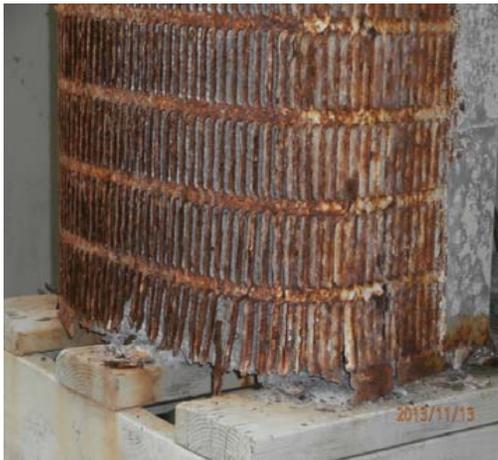
**DETERIORATED STEEL AT AIR
CONDITIONING UNIT. COULD ALSO**

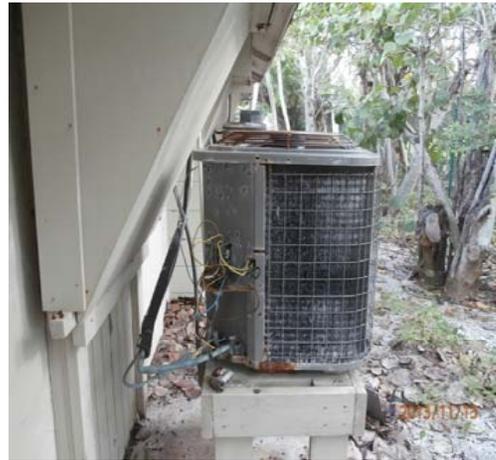
**DETERIORATION OF METAL AT
MULTIPLE AREAS OF AN AIR
CONDITIONIN UNIT.**

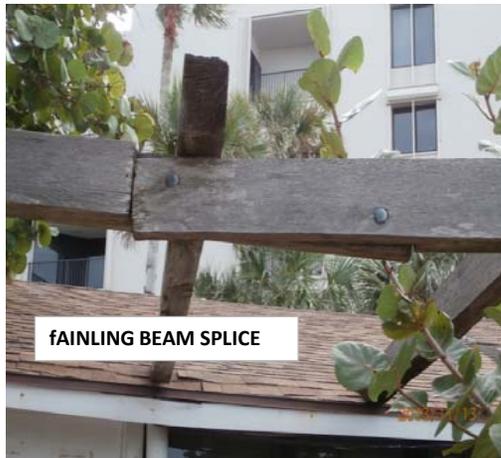
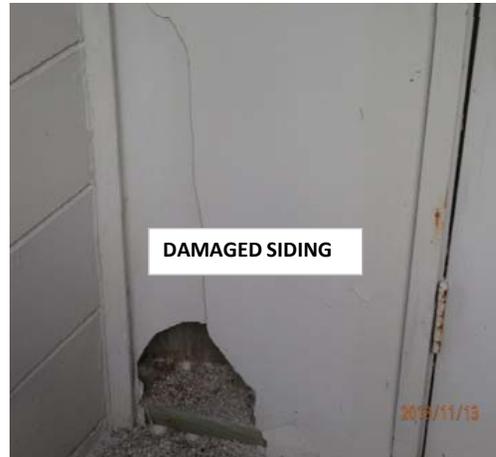
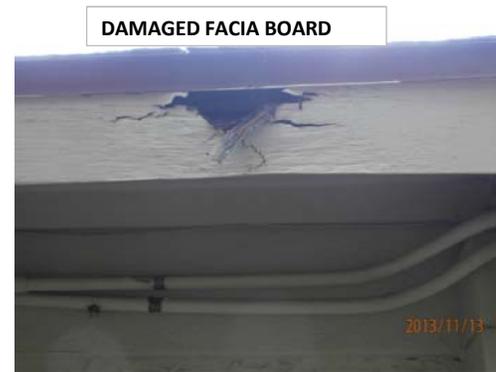
Roof sheathing supporting trellis beams.
Soffits, fascia boards, siding, trim boards, door jambs

Splice in support beam of trellis,
plywood failing to support trellis,
Splice in support beam of trellis

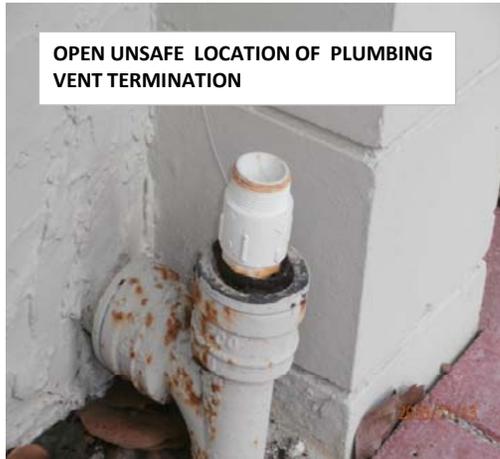
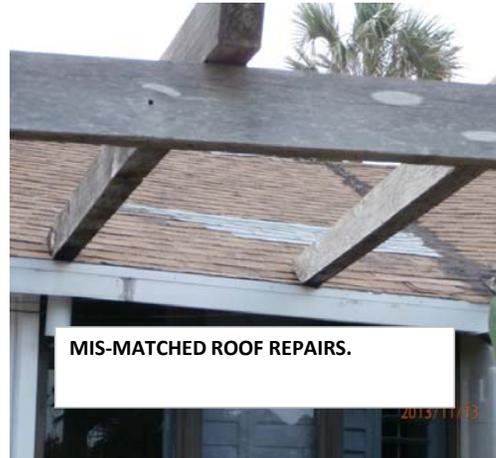
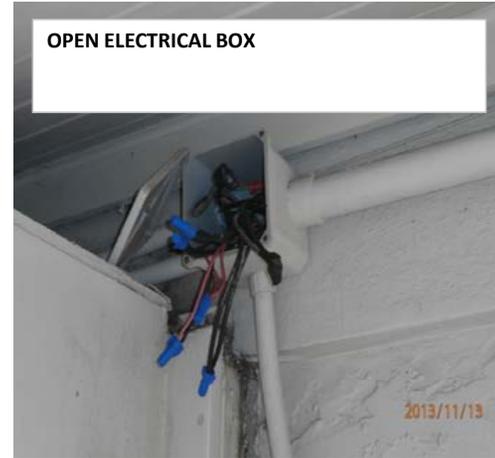
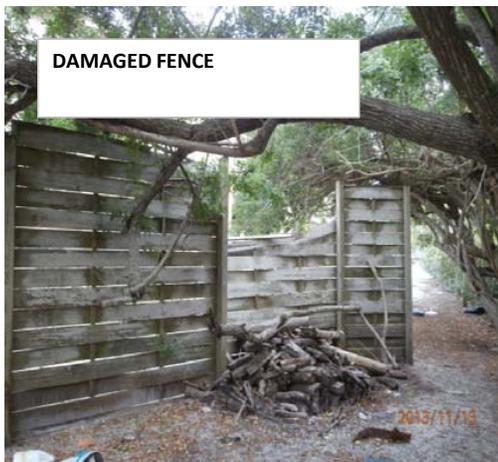
- Roof at end of its life. Showing signs of leaking.
- Mismatched roofing repairs.
- Wood fence damaged
- Exposed wiring
- Windows and doors boarded due to damage from vandalizing.
- Open plumbing vent and drain.

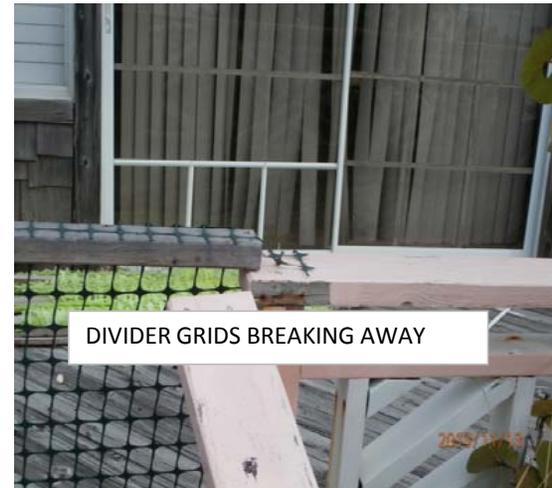
Window grids breaking away

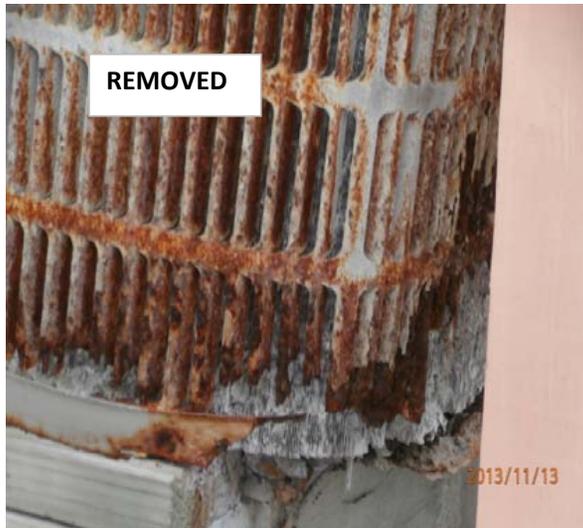
AC units to a point that they no longer function

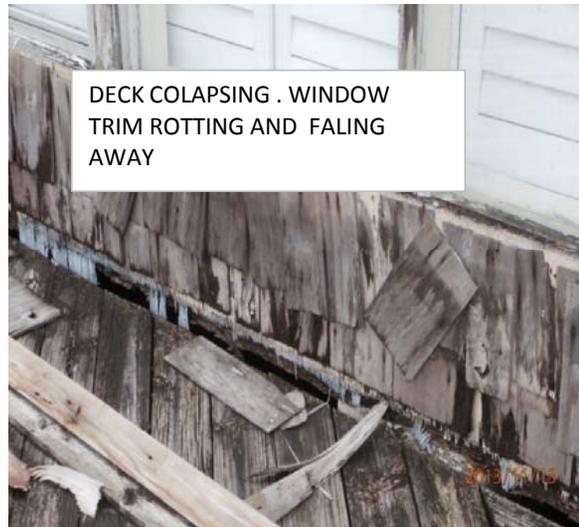
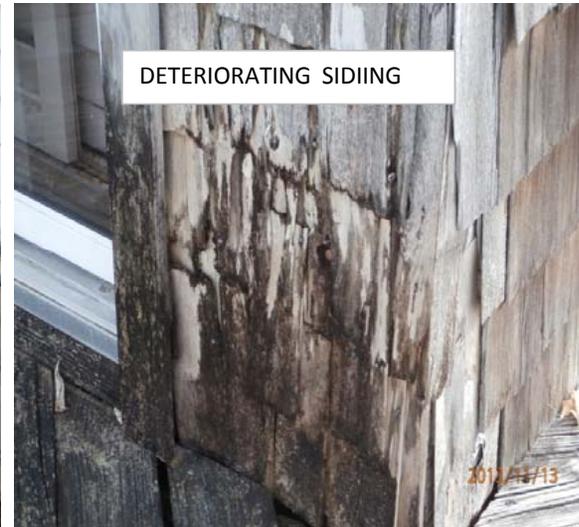
Fascia, soffits, siding, windows, doors, trims, roof sheathing
Signs of Possible damage due to termites

Joists and supports appear to be failing through out deck systems.
Through out deck systems, joists, decking surface, guard and hand railing. Window planter boxes falling from walls, lattice skirting.

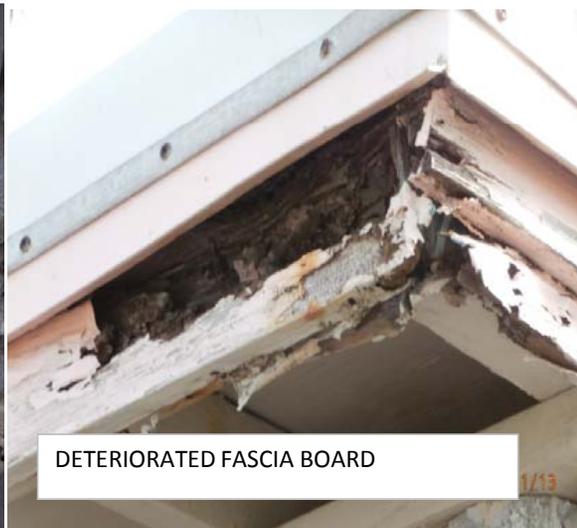
DETERIORATED FASCIA BOARD

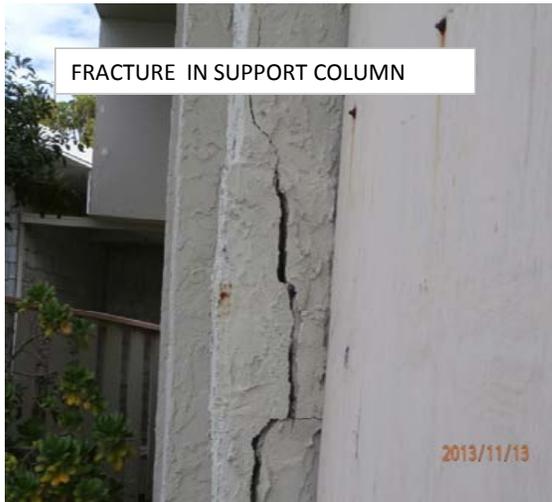
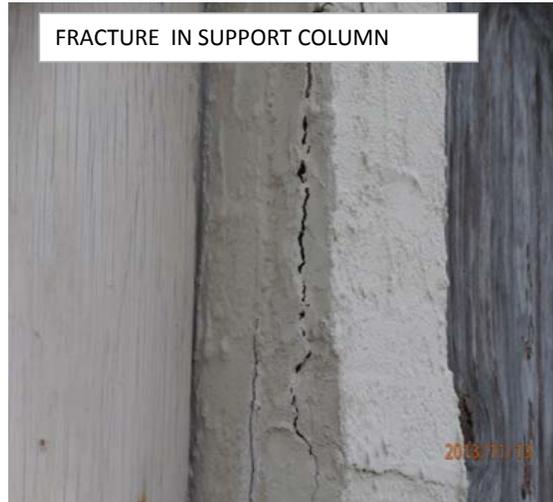
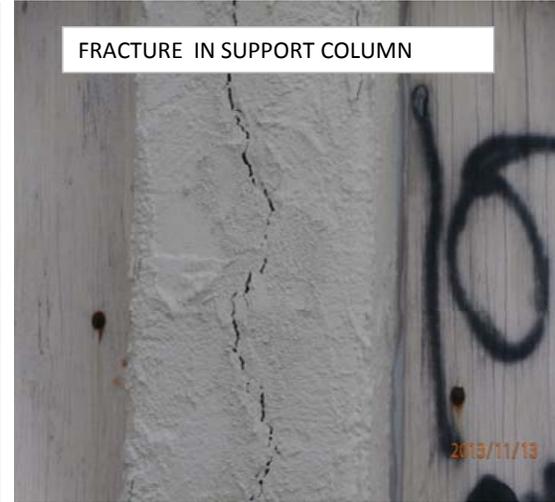
Critical on northwest side. Also found throughout the building
Many locations mainly associated to settlement and some at Northwest especially
At bulged location on northwest side columns of windows

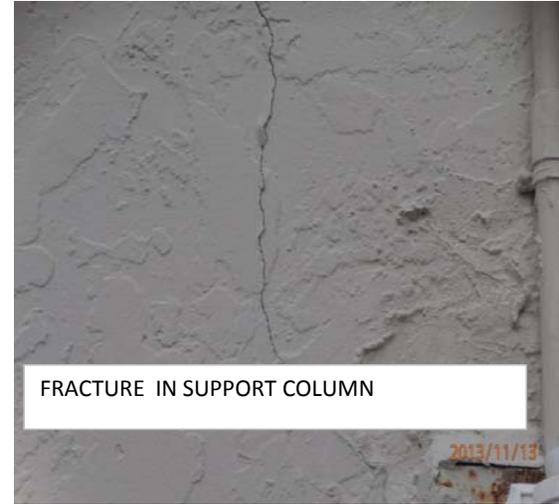
FRACTURE IN SUPPORT COLUMN

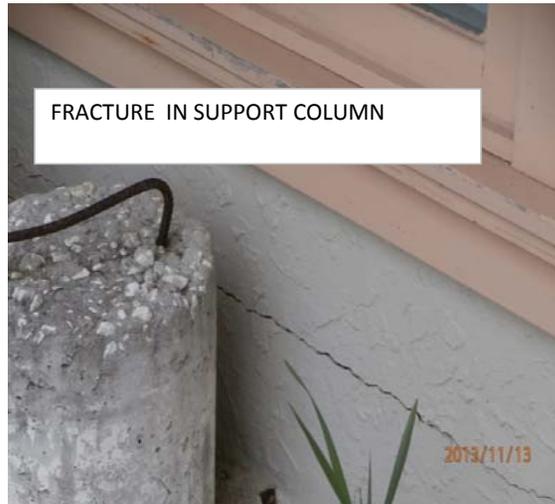
FRACTURE IN SUPPORT COLUMN

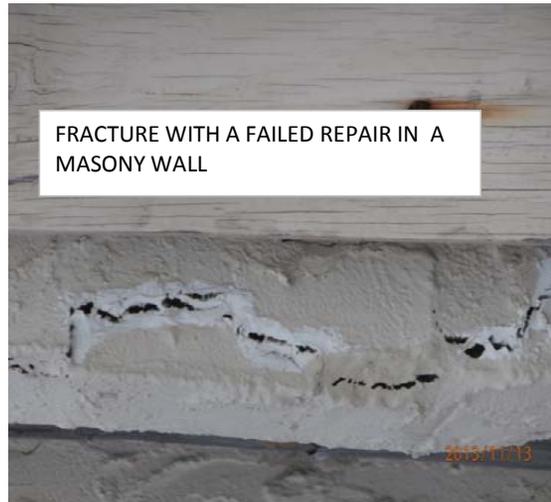
FRACTURE WITH A FAILED REPAIR IN A MASONRY WALL

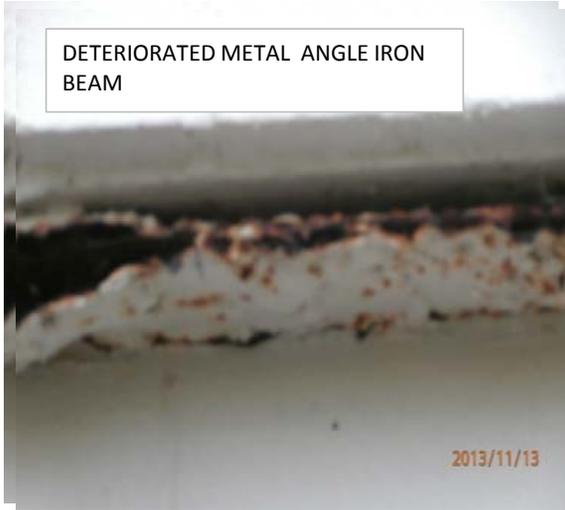
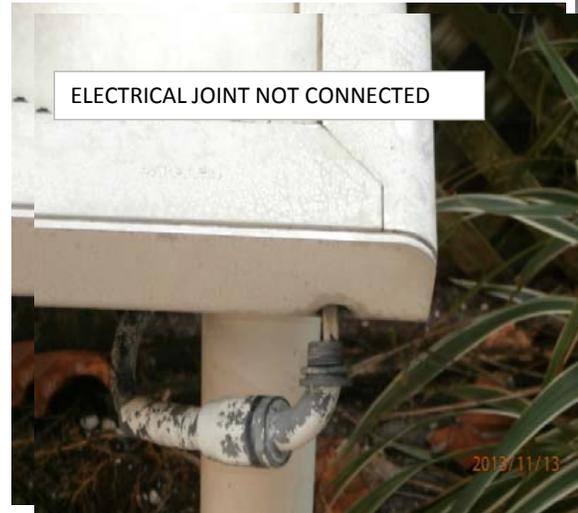
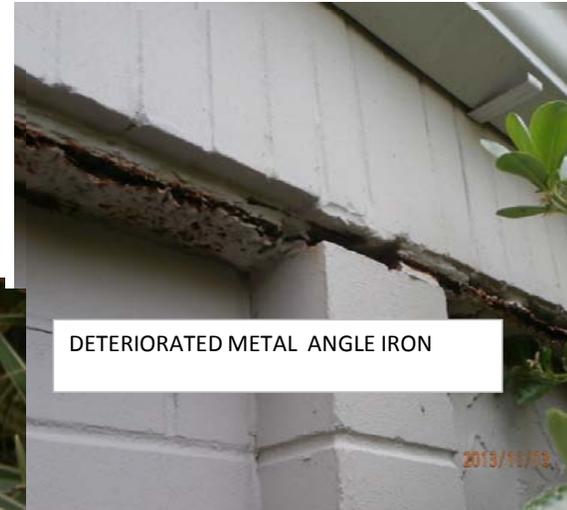
Exposed I beams, canopies. Doors showing signs of failure. Large anaopy area in rear on tube steel and weld joints

Many locations on the canopies.

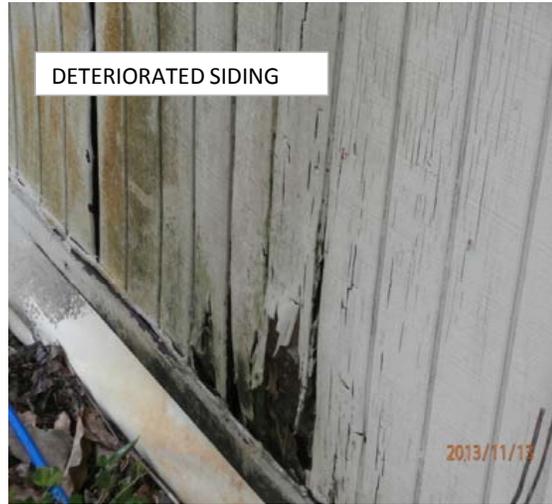
Bee infestation at the rear caused removal of siding

Found vertical separation at on window of realtors office.

Roof over Monkey entry, guard rails, handrails, decking.

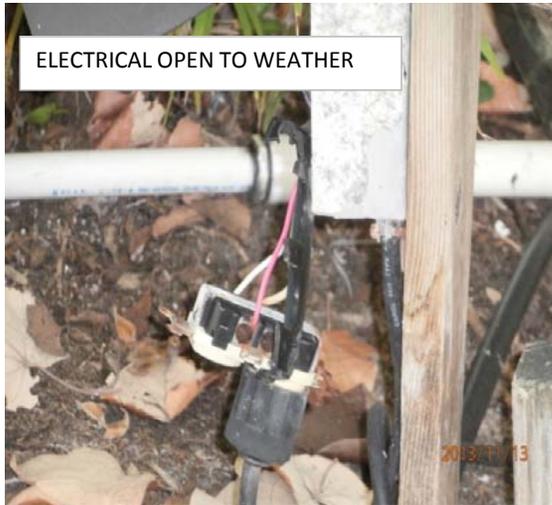
The mechanical equipment on the roof have service panels with open wiring to the weather.

ELECTRICAL OPEN TO WEATHER

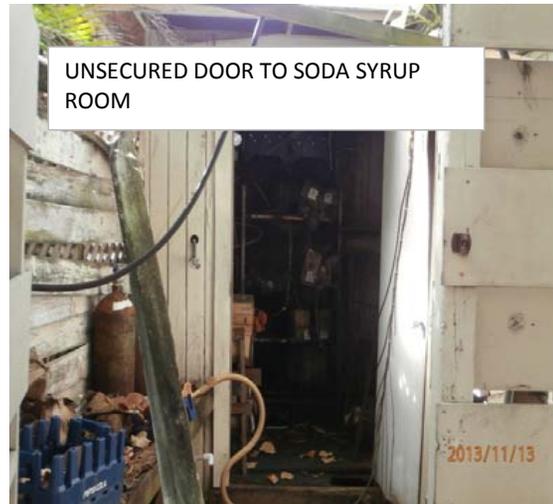
UNSECURED DOOR TO SODA SYRUP ROOM

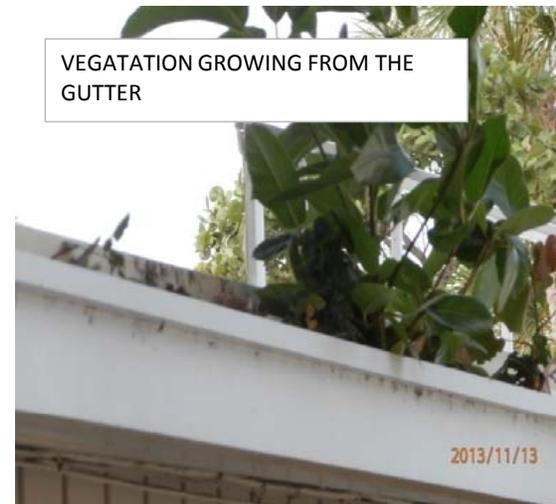
VEGATATION GROWING FROM THE GUTTER

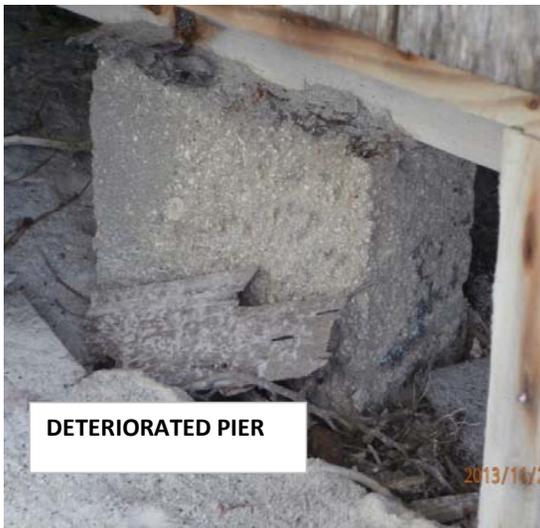
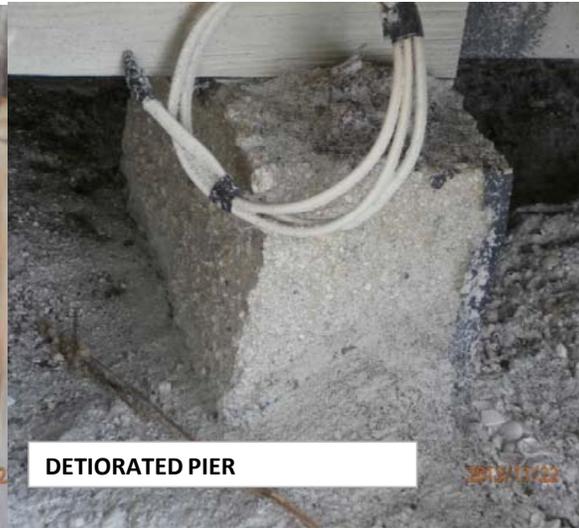
This building is seaward of the coastal construction control line.
Code limitation associated to working on the foundation.
Columns on the north end

- Deterioration
- Ultimate deformation
- Fractures
- Fissures
- Spalling
- Exposed reinforcement
- Detached, dislodged, or failing connections

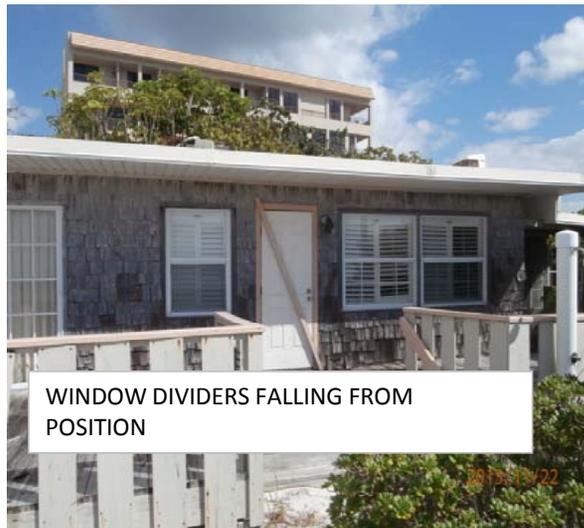
Window and door divider grids breaking away

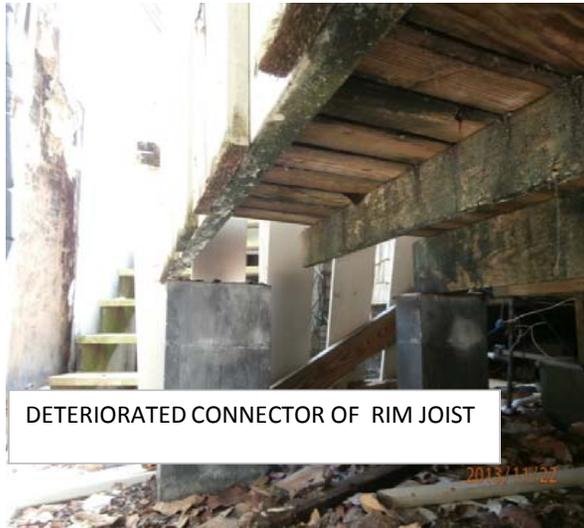
Strap connector rim board to columns

Rim board to columns

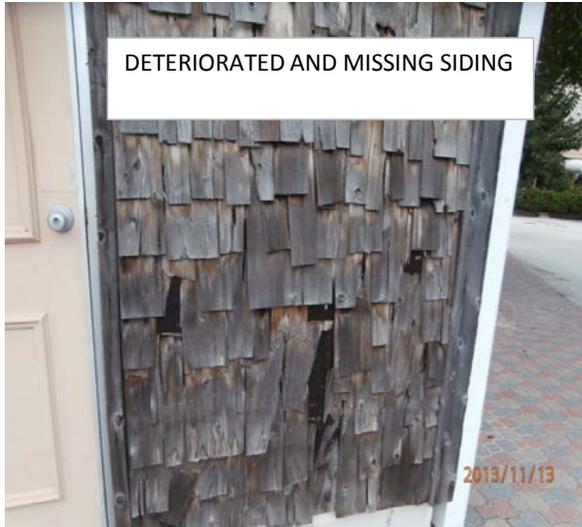
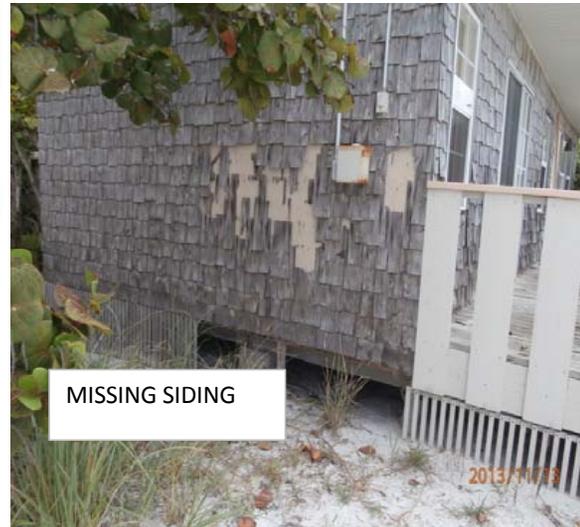
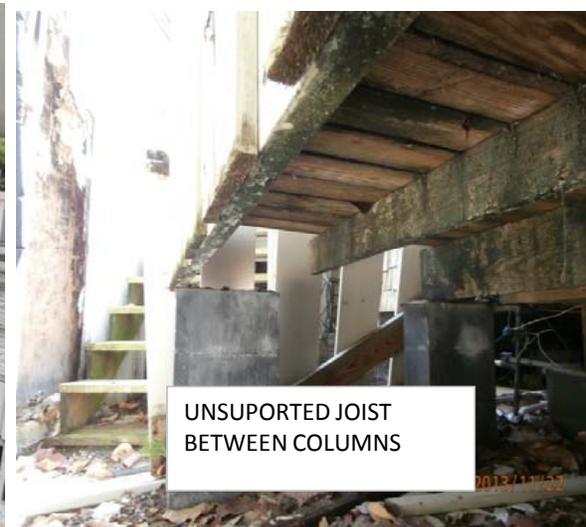
Siding falling from building, exposed sheathing behind. Doors and trims.

Rear deck not properly seated on the columns. Rim board not
Lattice skirting, railings, joists.

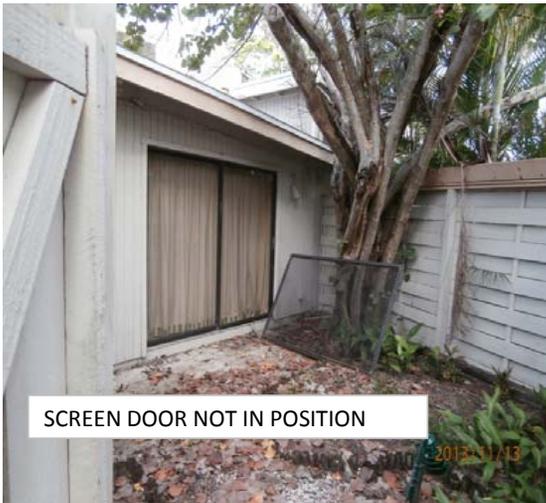
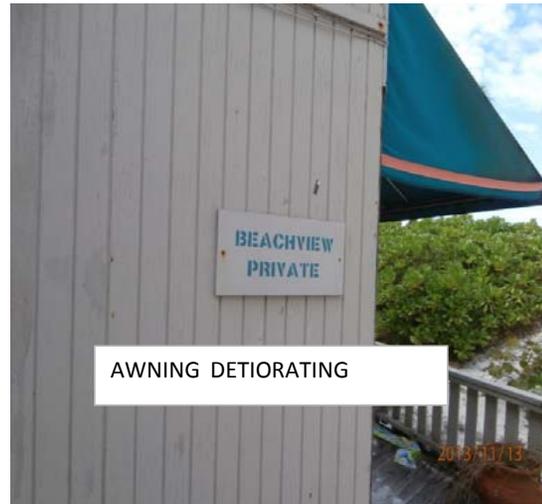
SCREEN DOOR NOT IN POSITION

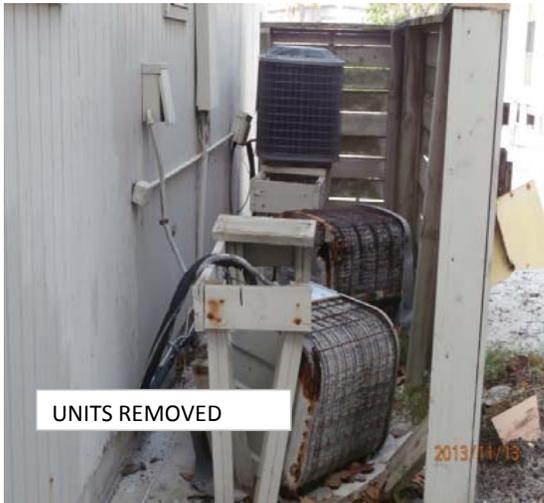
Awnings at all units, air conditioning units

Bottom of air conditioning units
Corroded joints to awnings.

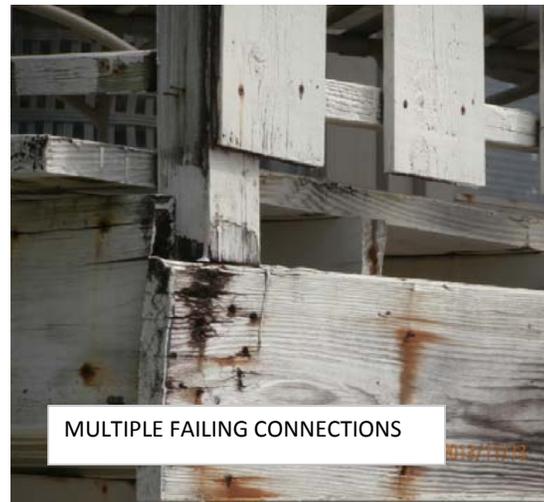
Deck surface warping up
Siding, trims, fascia boards, doors, windows, air conditioning stands, deck joists.

Signs of damage from termite at trims, holes in siding may be from birds and insects. Hole at vagabond a/c once had a dead animal .

Air conditioning stands. Cantilevered balcony to beachview units

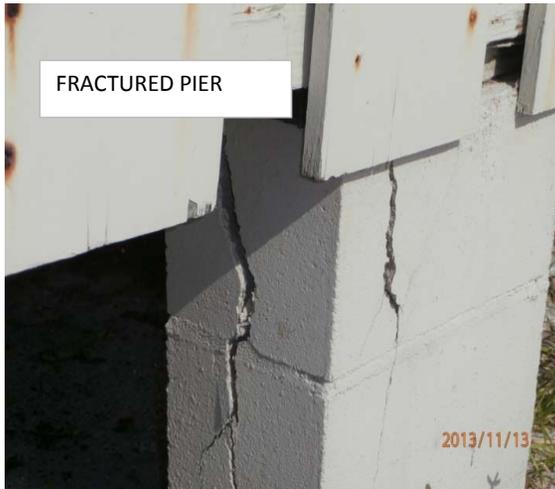
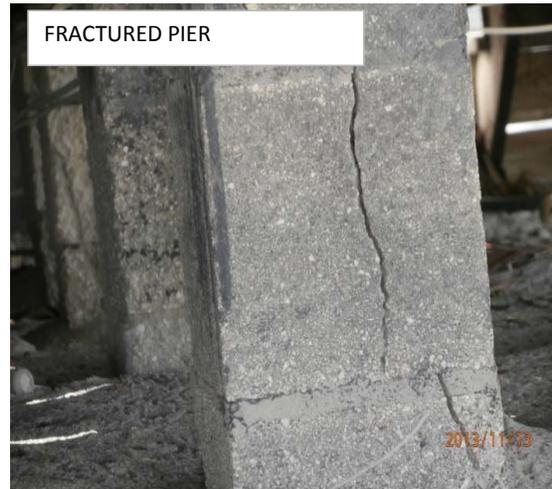
Column supports to deck

Column supports to building and deck.

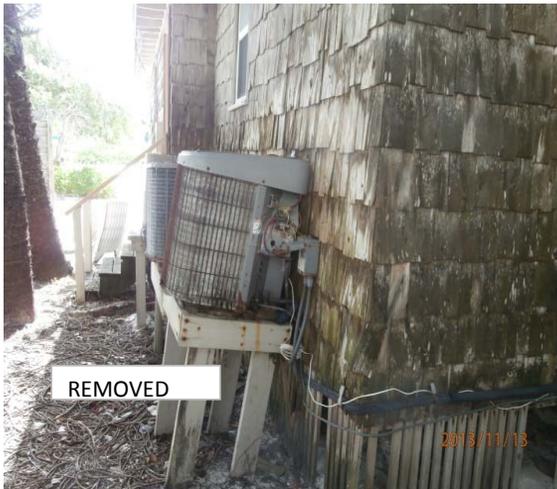
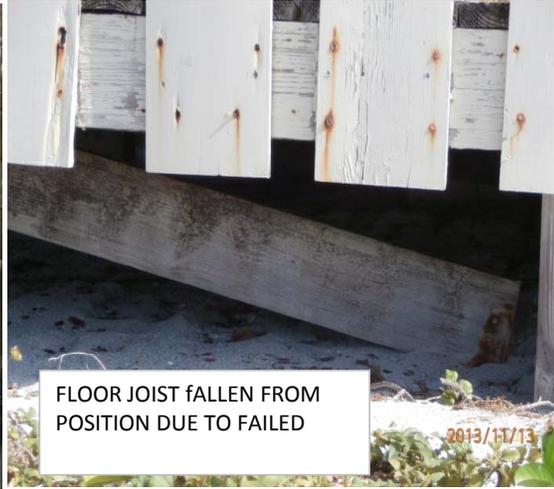
- Deterioration
- Elastic deformation
- Ultimate deformation
- Metal fatigue
- Detached, dislodged, or Joist connectors

Air conditioning units. Air handler unit

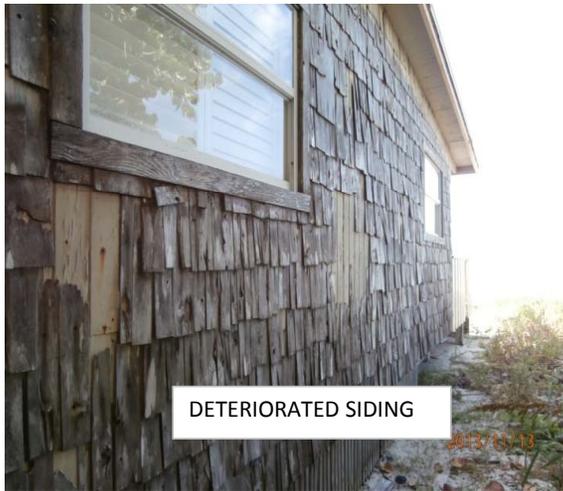
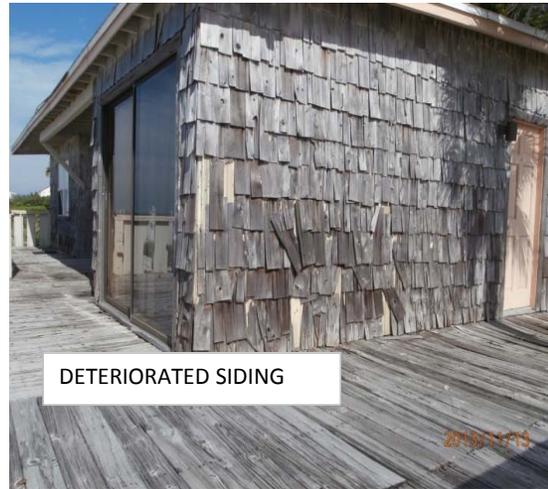
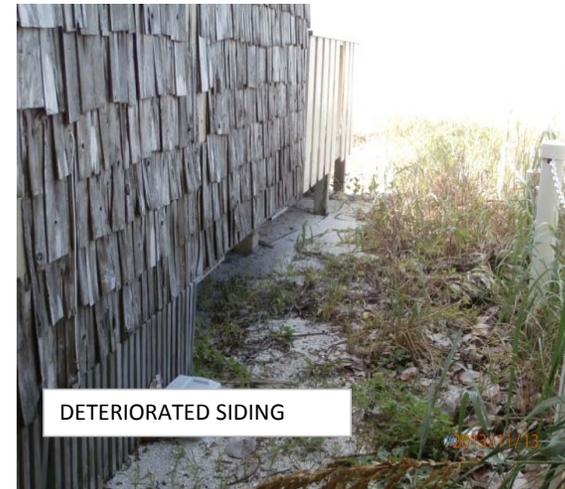
Deck waling surface, sidings, trims, doors, windows, fascia boards, railings.
Signs of insect damage to sheathing behind wood siding.

Fencing falling down, joists have fallen, railing pulling down. Air conditioning stands.

Joists, decking, siding, railings. Lattice skirting falling from structure

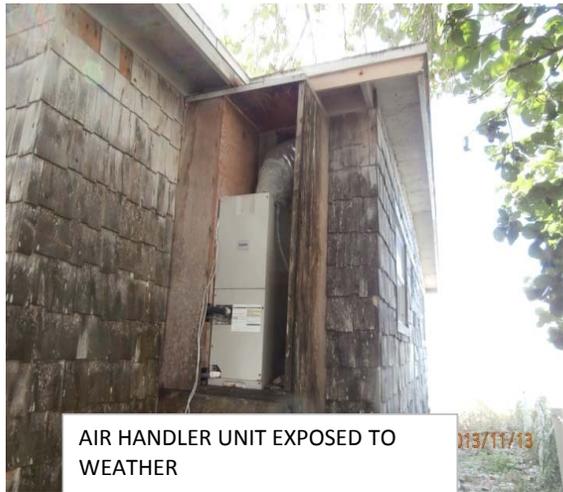
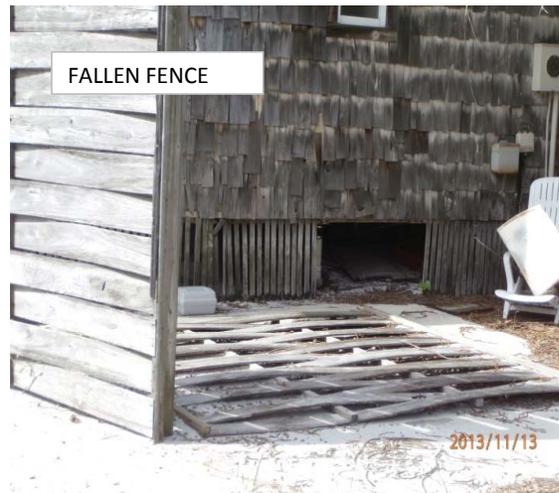
Air handler unit exposed to weather
Fencing falling to ground.

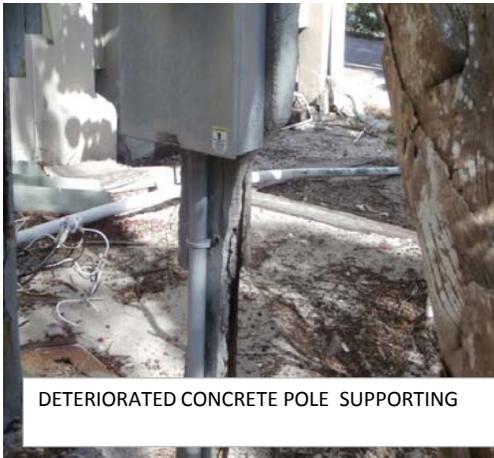
Service meter supports

Upper bond beam south wall at railing

DETERIORATED CONCRETE POLE SUPPORTING

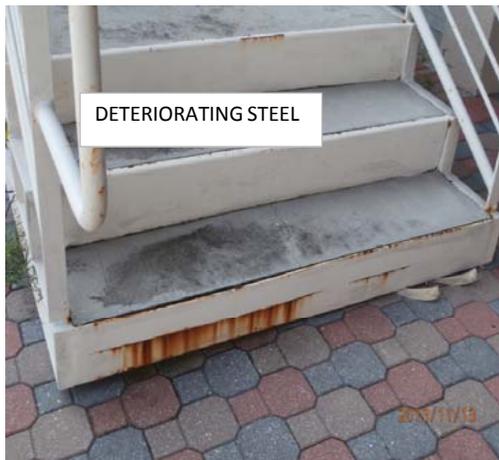
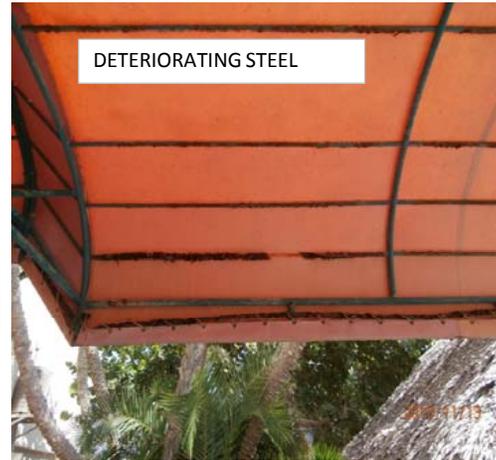
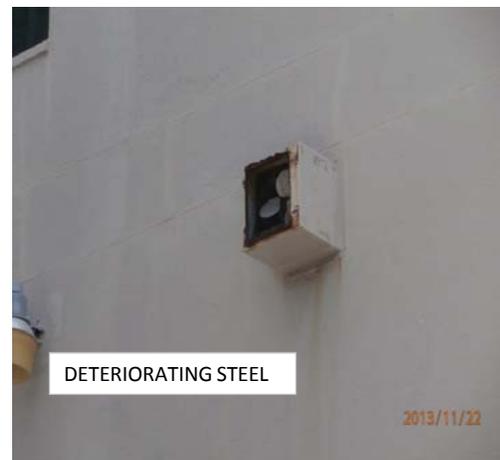
Bracing to parapet walls, fabric canopies

Railing to sixth floor patio, fabric canopies.

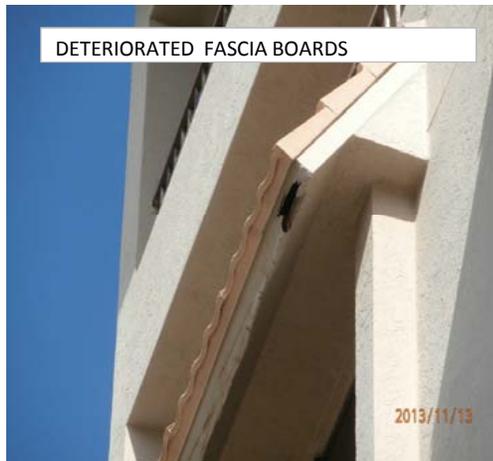
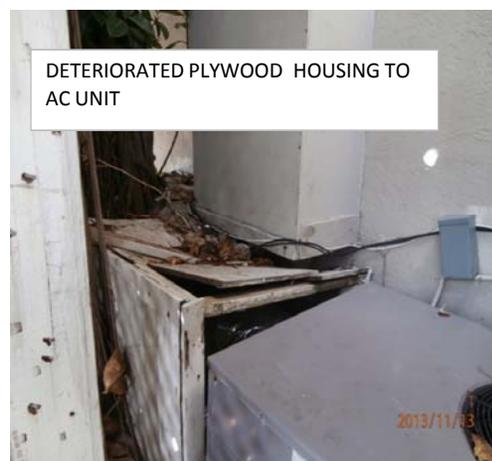
fascia boards and trims

Housing for ductwork. Sign over drive canopy.

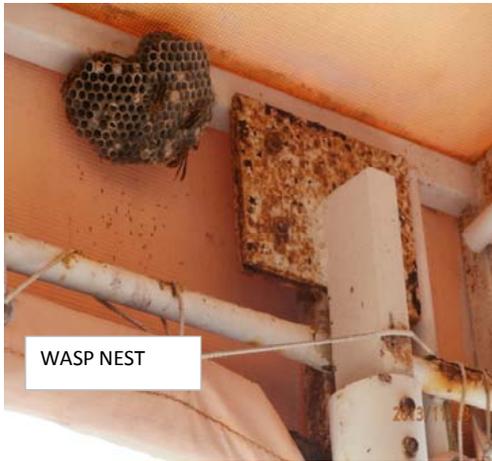
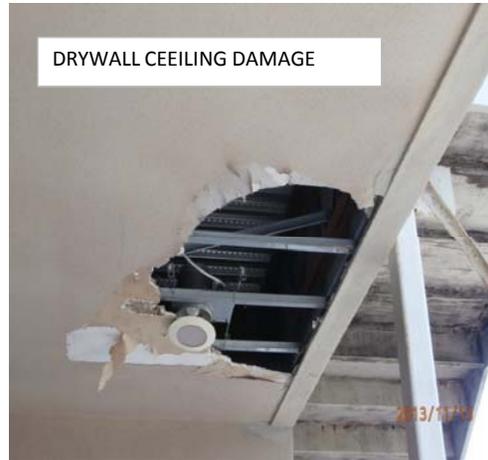
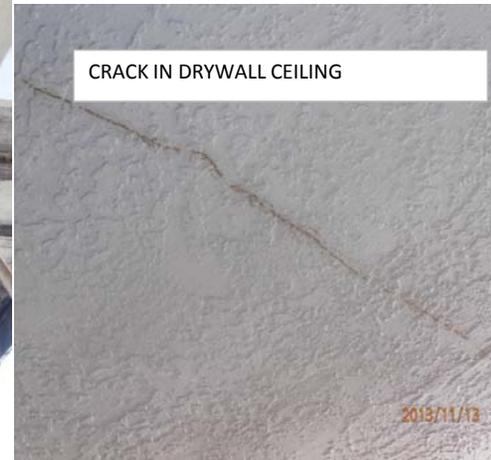
Building has been posted for a non working fire alarm system including the required monitoring. Restricted access.
Building has been posted for failing joists and connection. Temporary shoring in place. No permanent work completed.
The interior of the building has extensive mold. No report indicating that it is a health hazard.
Boarding of opening due to vandalizing.
Drywall soffits and ceilings cracking, damaged and falling.
Found windows propped open. Closed days later.
Wasps nest found.

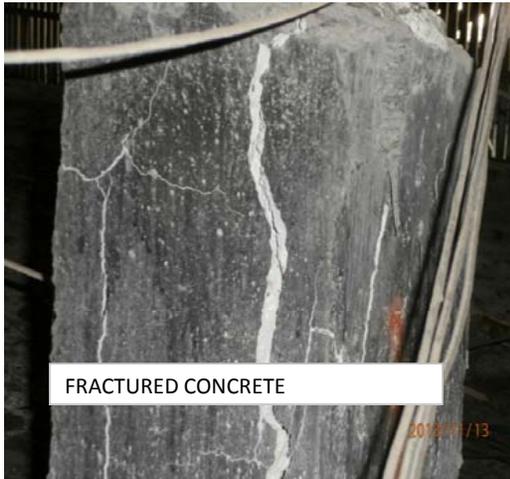
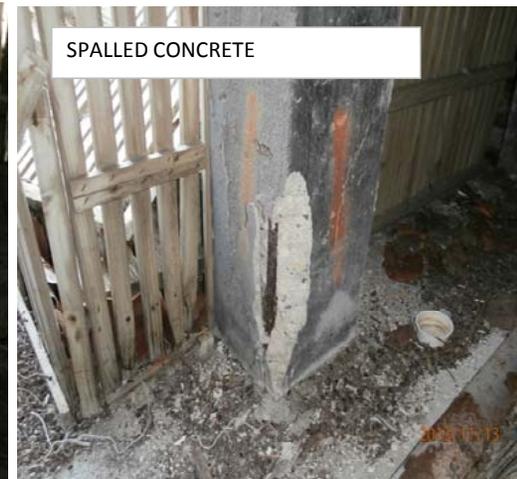
This building is seaward of the coastal construction control line. Code limitation associated to working on the foundation.

Extensive on approximately 75% of the piers
75 % or more of the piers.

Extensive on approximately 75% of the piers
Extensive on approximately 40% of the piers

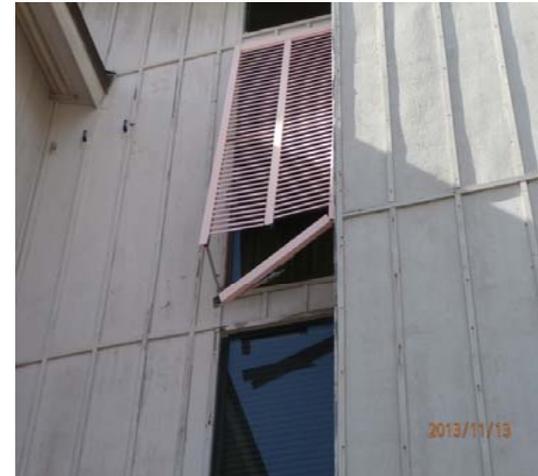
Shutter supports

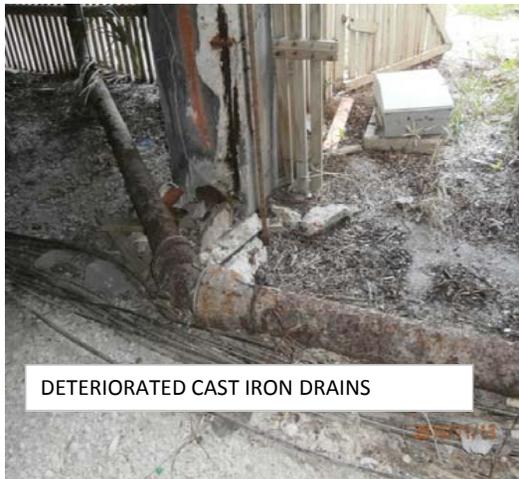
Deterioration Bottom of I- beams. Some joist hangers and visible clips. Many A/C units are showing signs of failure.

Metal fatigue A/C units at the bottom

Detached, dislodged, or Beams to piers.

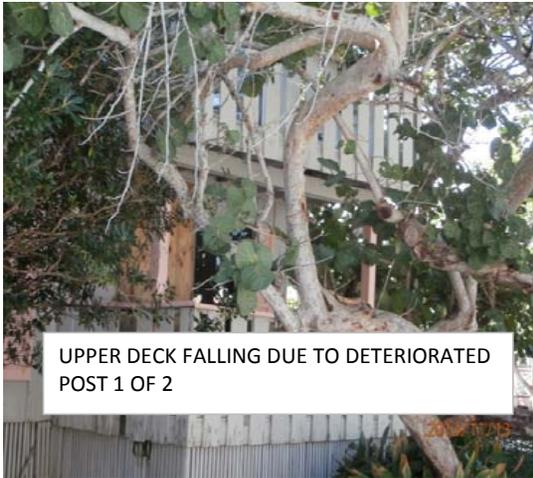
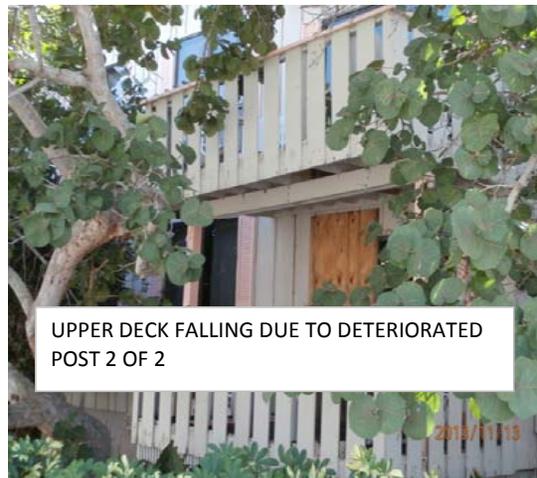
Signs of termite and other insect damage. Extensive on the siding. Currently has wasp nests,
Extensive on holes from birds.

Upper deck of one unit has sunk approximately 4 inches due to rot. A/C unit stands
Siding, trims, floor framing, posts, wood shutters, fascia and soffits. The entry stairs and lower
deck walkway show signs of failing to support. Railings pulling from walls. Railing missing
balusters. Lattice skirting falling from position.

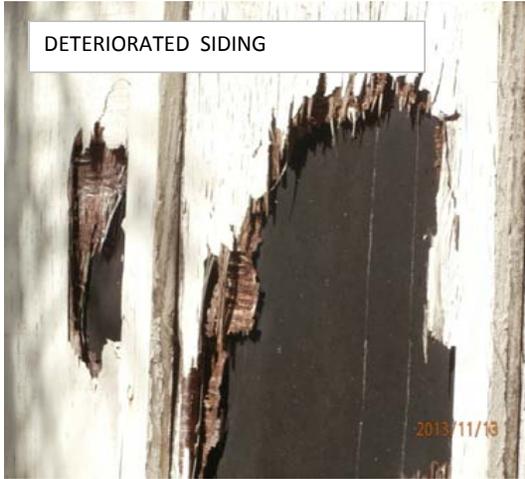
DETERIORATED SIDING

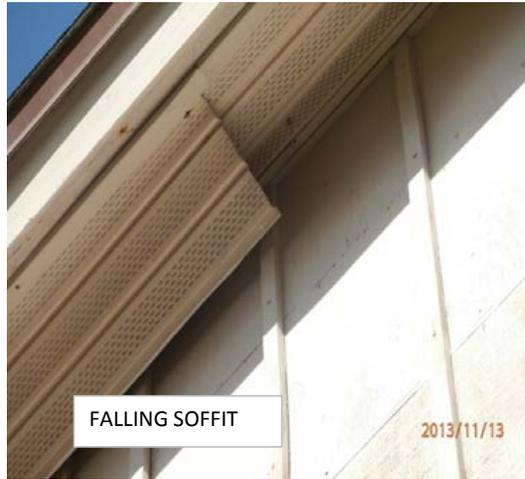
FALLING SOFFIT

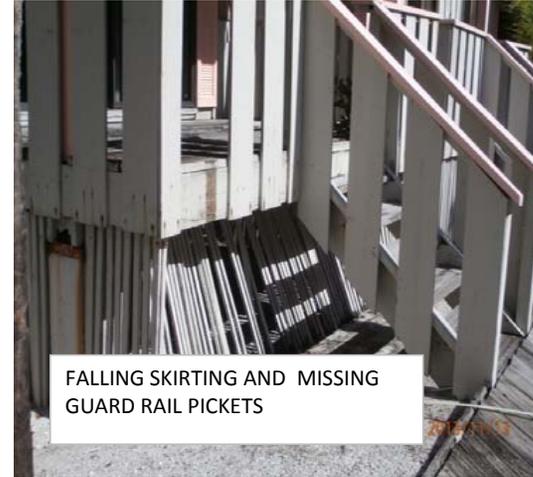
FALLING SKIRTING AND MISSING
GUARD RAIL PICKETS

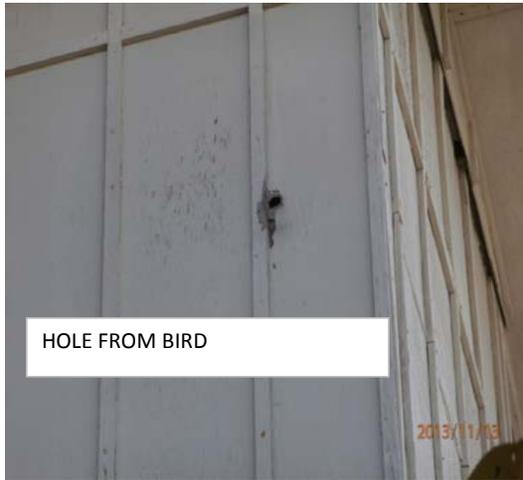
HOLE FROM BIRD

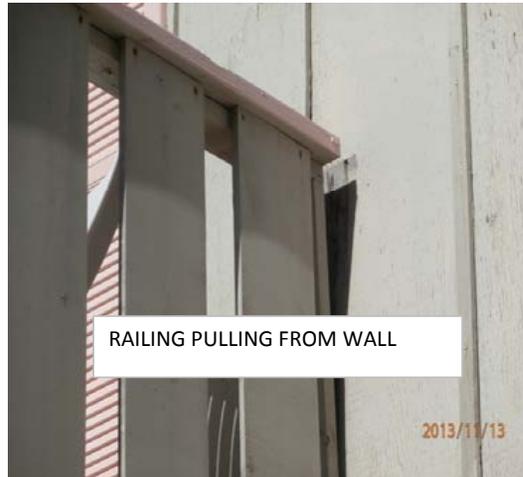
RAILING PULLING FROM WALL

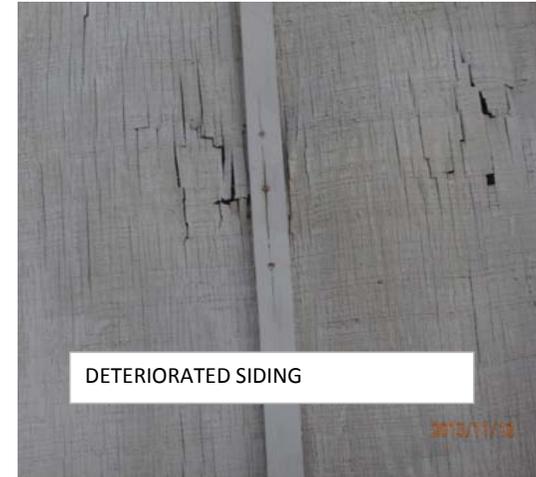
DETERIORATED SIDING

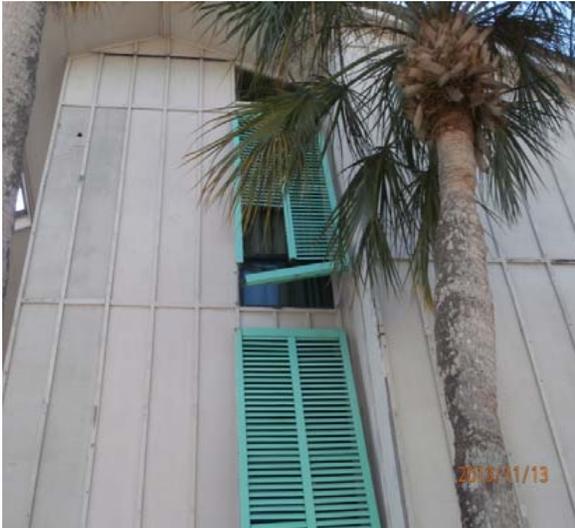
Connection poles to shutters.

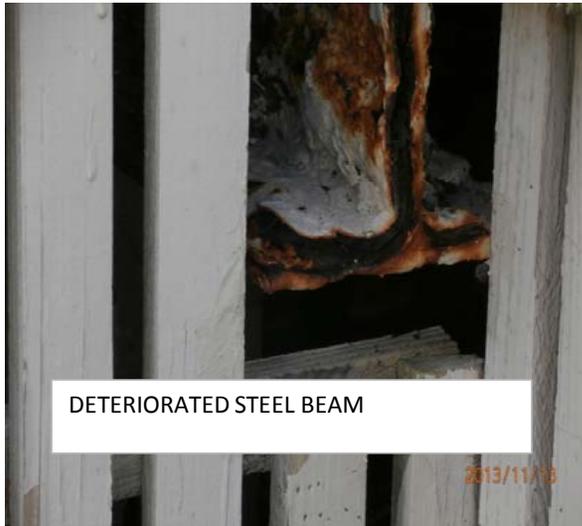
Bottom of I- beams. Some joist hangers and visible clips. Many A/C units are showing signs of failure.

A/C units at the bottom
