ENGINEERING INSPECTION REPORT

THE COLONY BEACH and TENNIS RESORT

Longboat Key, Florida

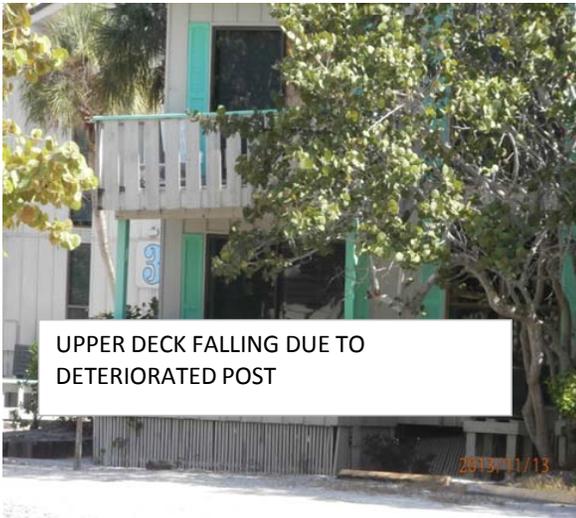
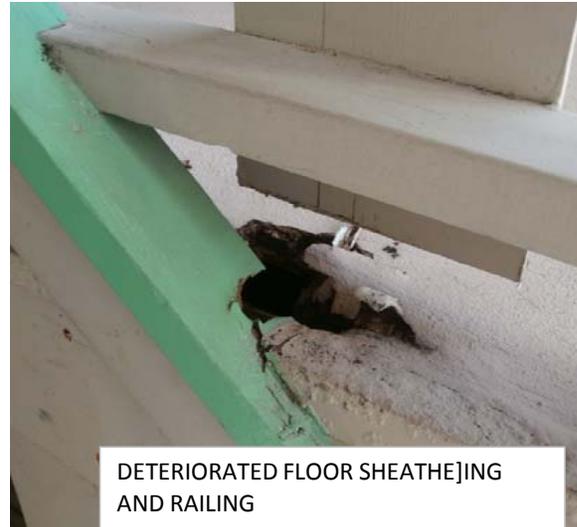
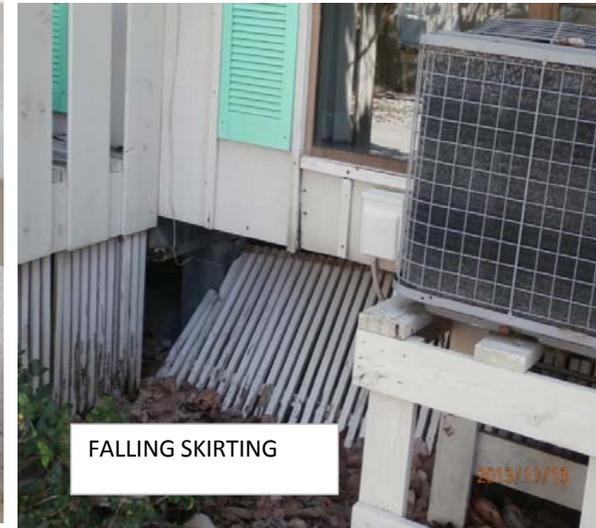
Many porch beams deflected 1/2-inch and more at the center.
Siding, trims, floor framing, upper floor deck, wood shutters,
Signs of termite and other insect damage. Extensive on the siding. Currently has wasp nests.
Holes in siding from birds.

One upper level deck has rotted post and has dropped approximately 4 inches. A/C unit stands.

Siding, trims, floor framing, wood shutters, fascia and soffits. The entry stairs and lower walkway show signs of failing to support. Railings pulling from walls. Railing missing balusters.

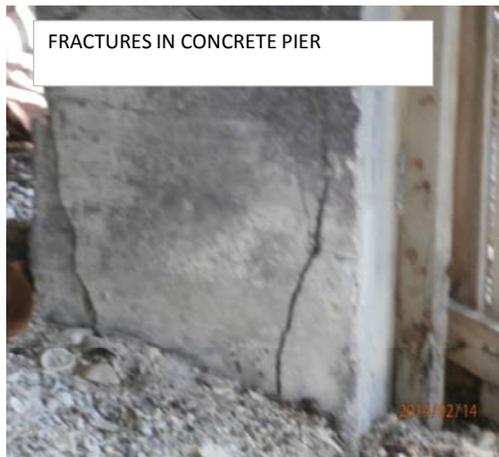
This building is seaward of the coastal construction control line. Code limitation associated to working on the foundation.

Approximately 40% of the piers, some extensive
70 % or more of the piers.
Approximately 25% of the piers
Extensive on approximately 20% of the piers

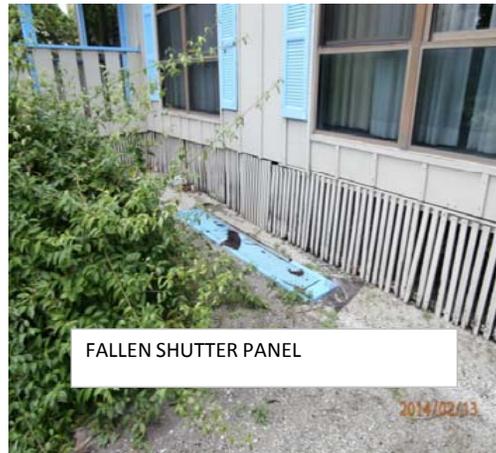
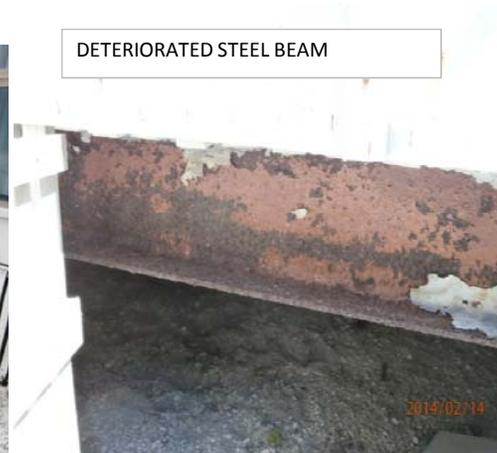
Villa 3
Building Official Report (Cont.)

Deterioration
Elastic deformation
Ultimate deformation
Metal fatigue
Detached, dislodged, or failing connections

Bottom of I- beams. Some joist hangers and visible clips. Many A/C units are showing signs of failure.

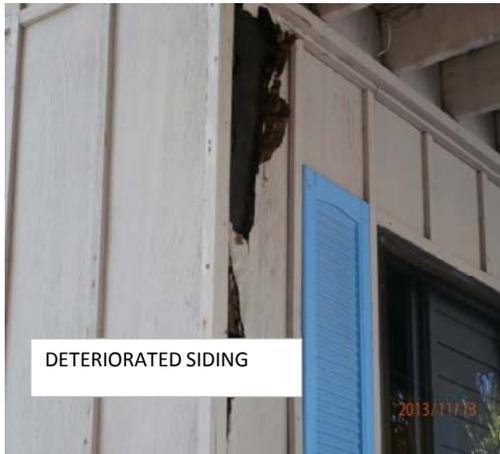
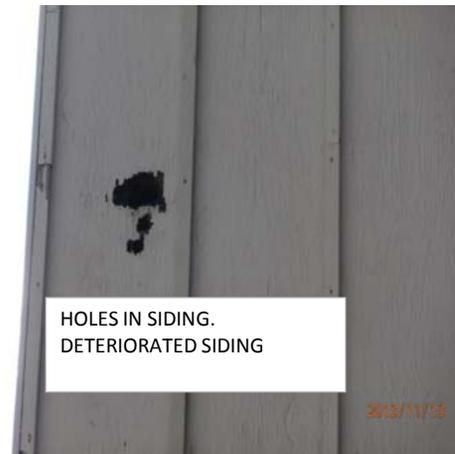
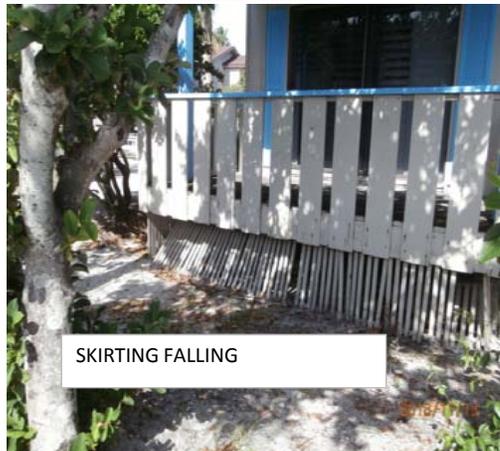
Villa 3

Many porch beams deflected 1/2-inch and more at the center.
Siding, trims, floor framing, posts, wood shutters.
Signs of termite and other insect damage. Extensive on the siding. Holes in siding from birds.

Post not supporting living space floor. A/C unit stands.
Siding, trims, floor framing, wood shutters, fascia and soffits. The entry stairs and lower walkway show signs of failing to support. Railings pulling from walls. Railing missing balusters.

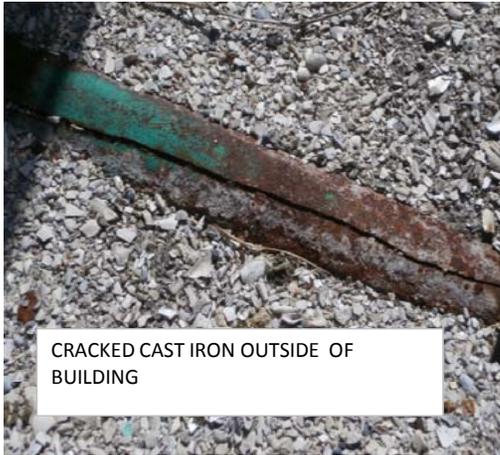
CRACKED CAST IRON OUTSIDE OF BUILDING

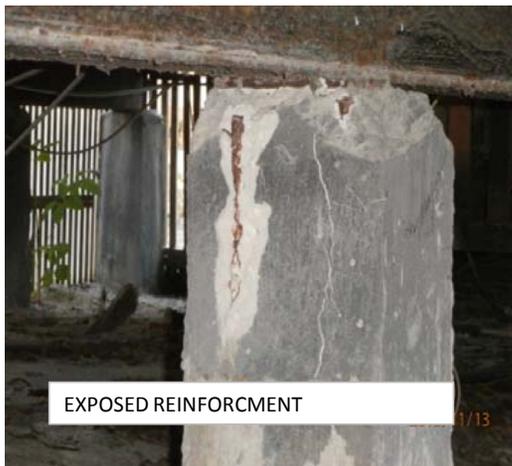
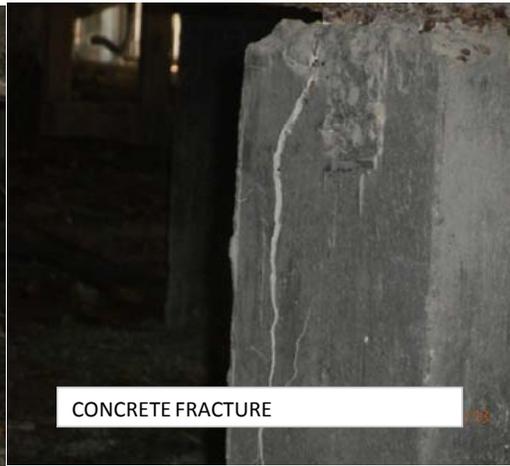
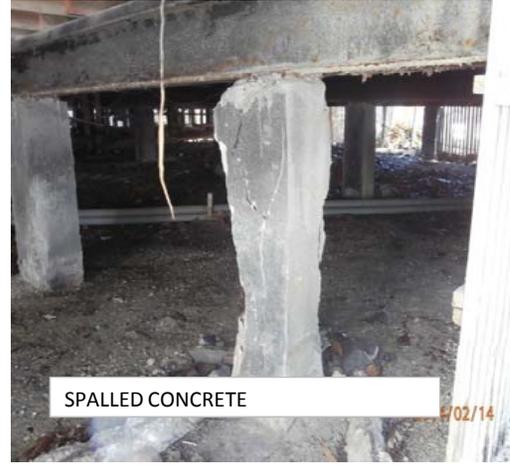
**Villa 4
Building Official Report (Cont.)**

Approximately 35% of the piers

Extensive on approximately 20% of the piers

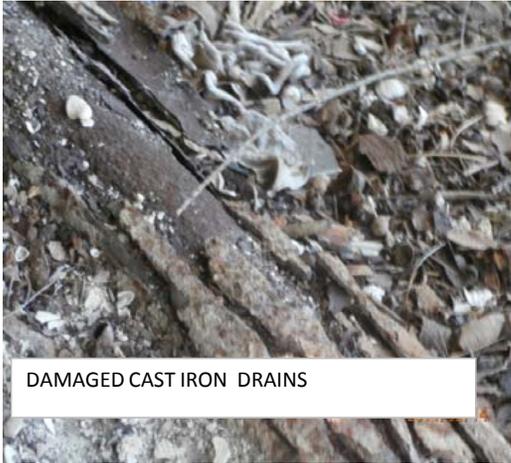
Villa 4

Bottom of I- beams. Some joist hangers and visible clips. Many A/C units are showing signs of failure.

A/C units at the bottom

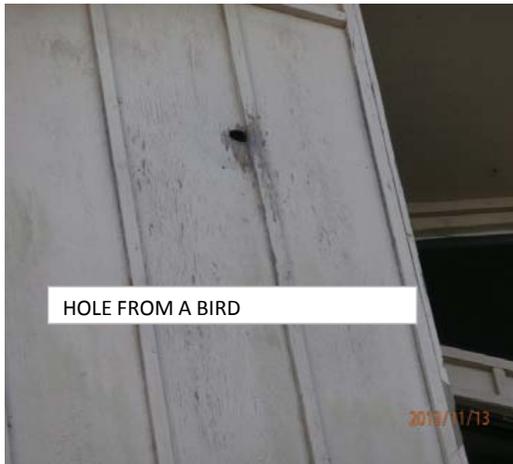
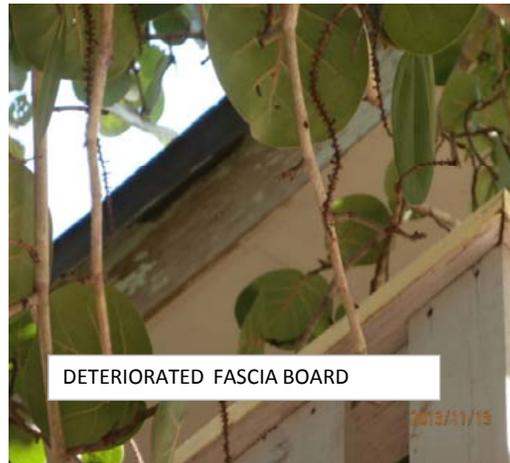
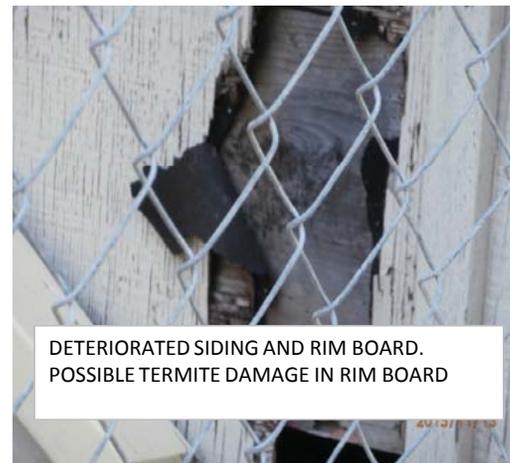
Villa 4
Building Official Report (Cont.)

Signs of termite and other insect damage. Extensive on the siding. Holes in siding from birds.

Column failing to support upper walkway deck and living roof above. A/C unit stands.

Siding, trims, floor framing, wood shutters, fascia and soffits. The entry stairs and lower walkway show signs of failing to support. Railings pulling from walls. Railing missing balusters.

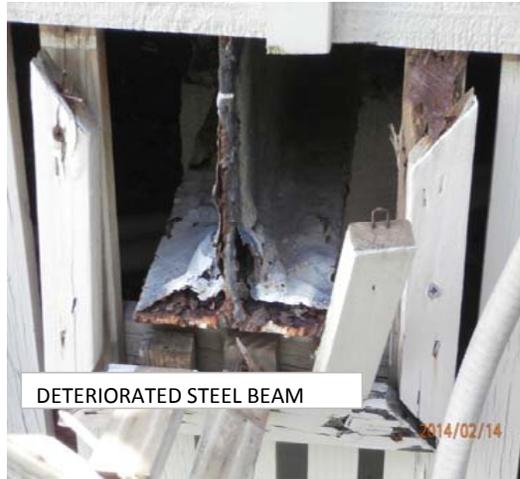
DETERIORATED STEEL BEAM

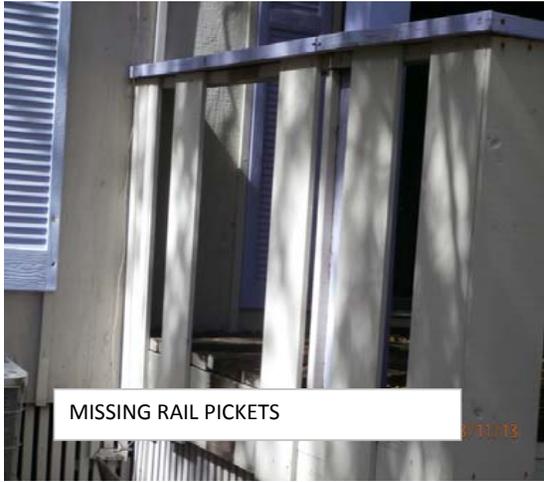
MISSING RAIL PICKETS

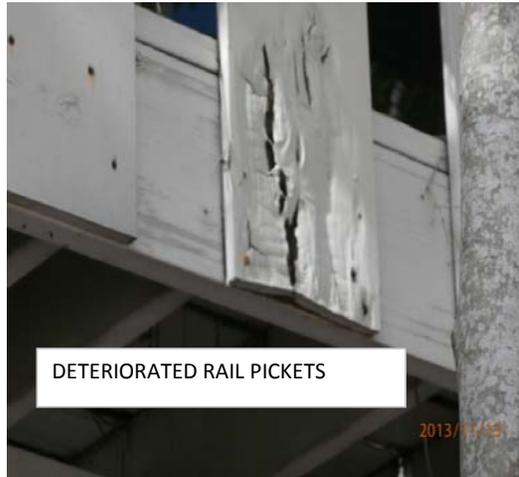
DETERIORATED RAIL PICKETS

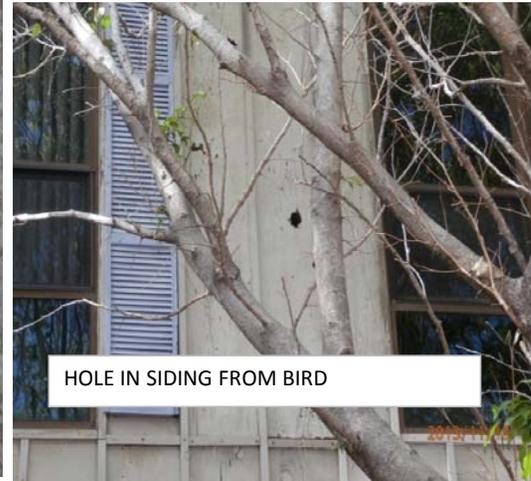
HOLE IN SIDING FROM BIRD

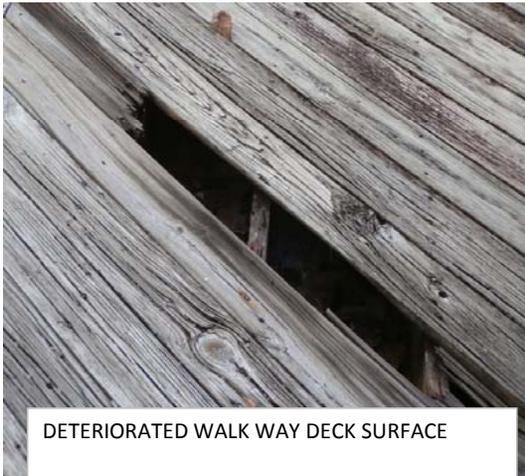
DETERIORATED WALK WAY DECK SURFACE

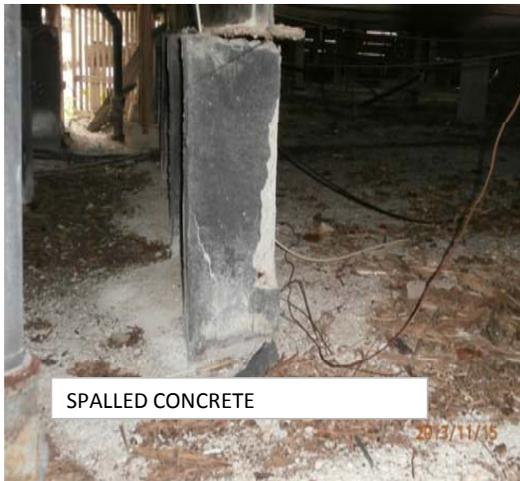
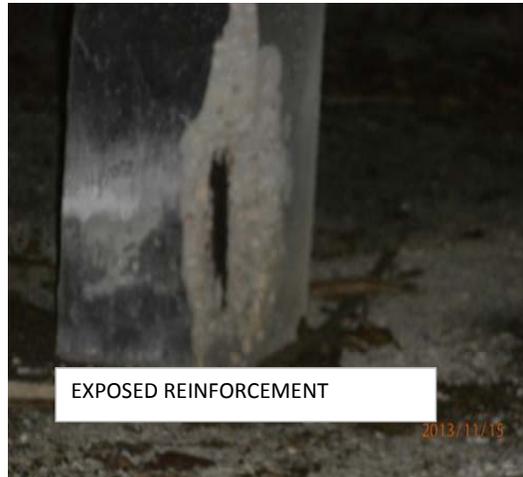
Villa 6

Approximately 20% of the piers

Extensive on approximately 20% of the piers

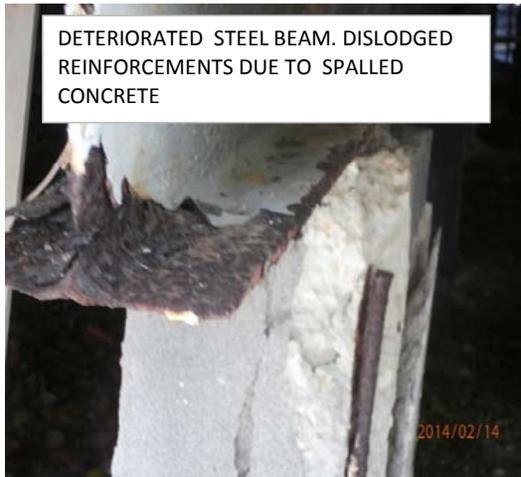
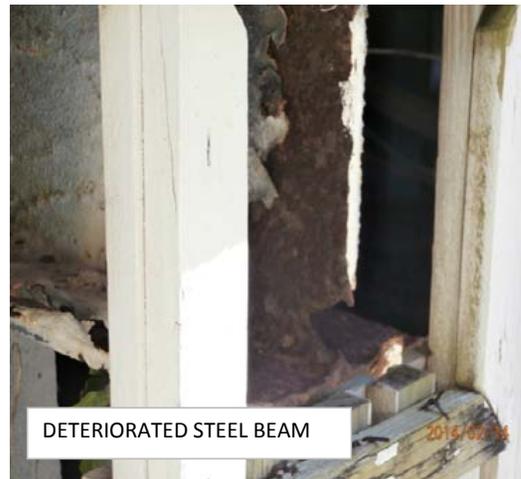
Villa 6

Bottom of I- beams. Some joist hangers and visible clips. Many A/C units are showing signs of failure.

A/C units at the bottom

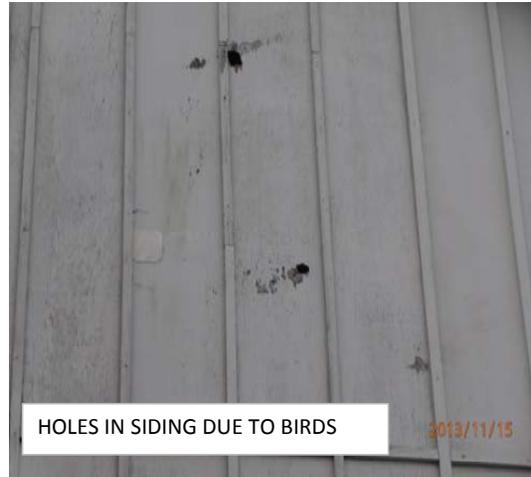
HOLES IN SIDING DUE TO BIRDS

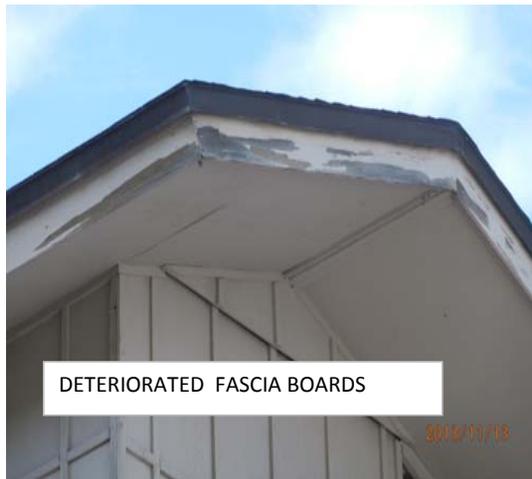
DETERIORATED FASCIA BOARDS

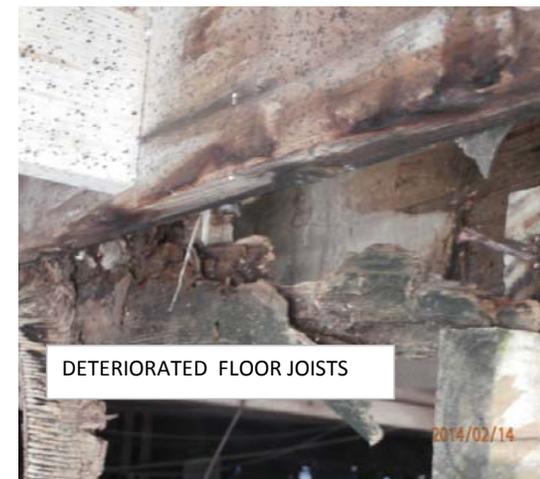
DETERIORATED FLOOR JOISTS

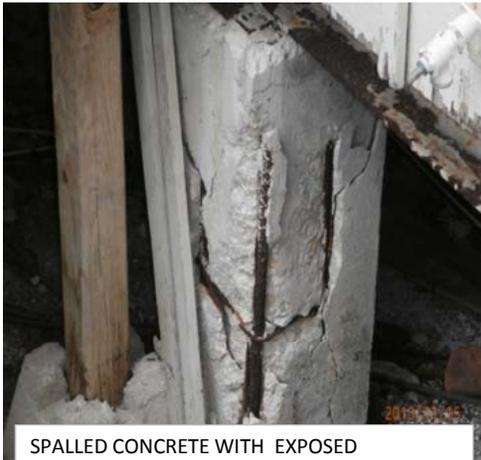
SPALLED CONCRETE WITH EXPOSED REINFORCEMENT .

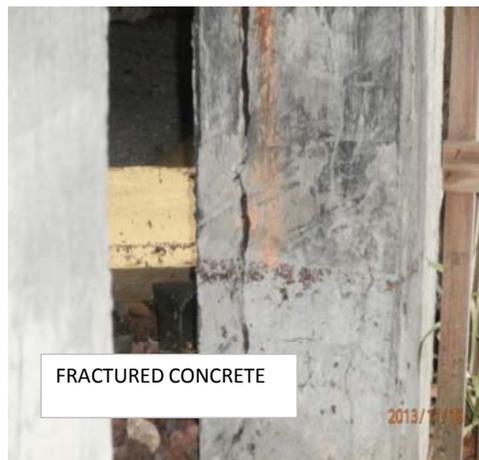
FRACTURED CONCRETE

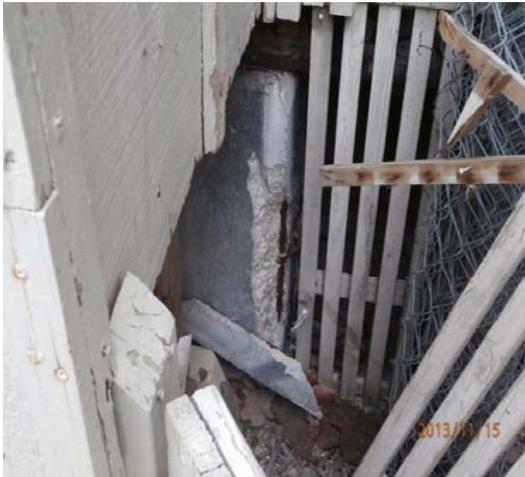
Villa 9

- Deterioration
- Ultimate deformation
- Fractures
- Fissures
- Spalling
- Exposed reinforcement
- Detached, dislodged, or failing connections

Approximately 40% of the piers

Extensive on approximately 40% of the piers

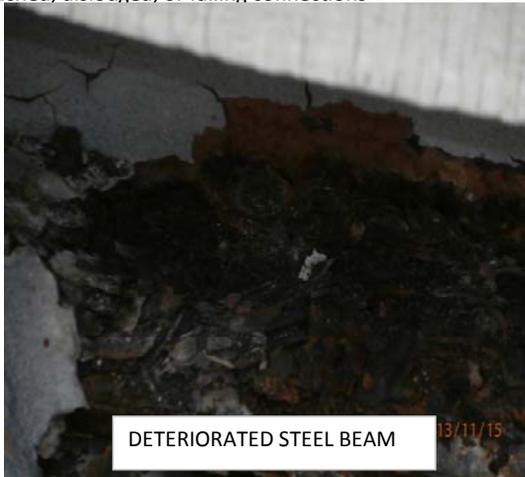
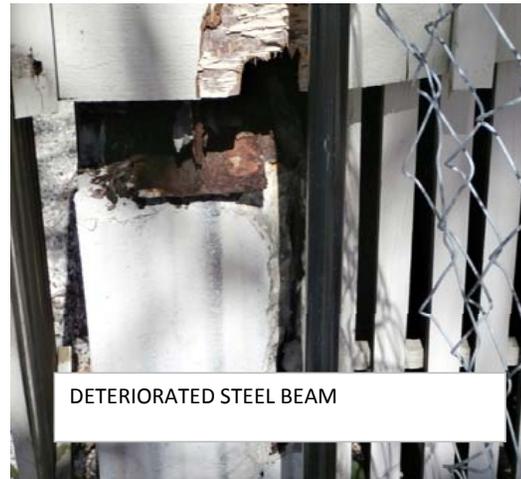
Villa 9

Bottom of I- beams. Some joist hangers and visible clips. Many A/C units are showing signs of failure.

A/C units at the bottom

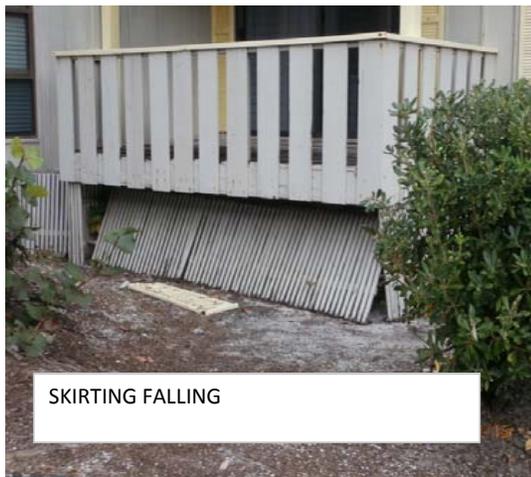
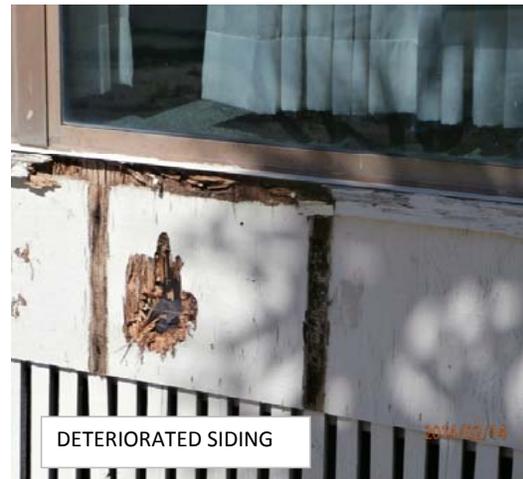
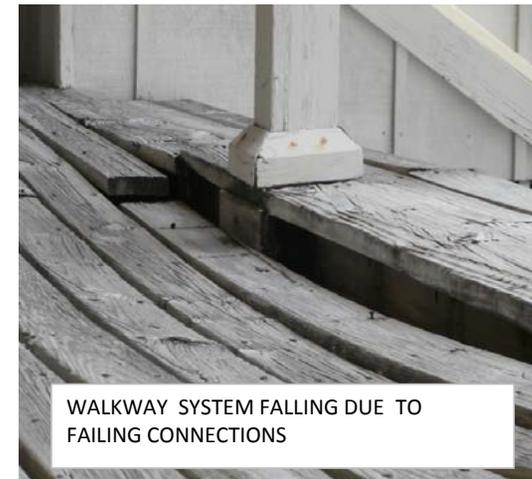
Villa 9

Many porch beams deflected 1/2-inch and more at the center.
Siding, trims, floor framing, upper floor deck , wood shutters, .
Signs of termite and other insect damage. Extensive on the siding. Holes in siding from birds.

Post not supporting walkway. This building has extensive failure of the lower deck walkway.
A/C unit stands.

Siding, trims, floor framing, wood shutters, fascia and soffits. The entry stairs and lower walkway show signs of failing to support. Railings pulling from walls. Railing missing balusters.

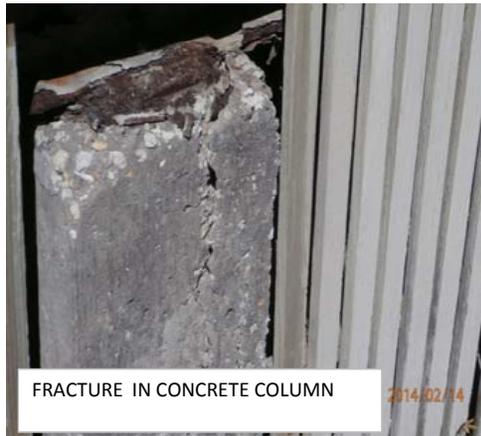
Villa 10

- Deterioration
- Ultimate deformation
- Fractures
- Fissures
- Spalling
- Exposed reinforcement
- Detached, dislodged, or failing connections

Approximately 40% of the piers

Extensive on approximately 20% of the piers

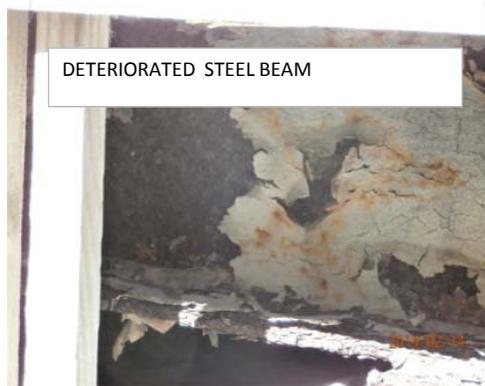
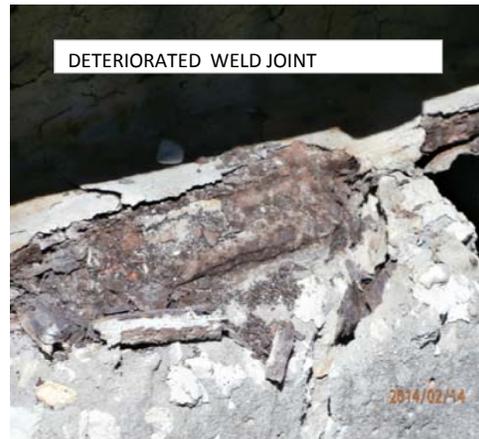
Bottom of I- beams. Some joist hangers and visible clips. Many A/C units are showing signs of failure.

A/C units at the bottom

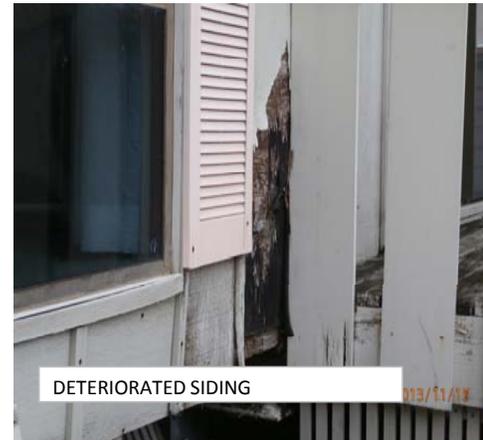
Many porch beams deflected 1/2-inch and more at the center.
Siding, trims, floor framing, upper floor deck, wood shutters, .
Signs of termite and other insect damage. Extensive on the siding. Holes in siding from birds.

A/C unit stands.
Siding, trims, floor framing, wood shutters, fascia and soffits. The entry stairs and lower walkway show signs of failing to support. Railings pulling from walls. Railing missing balusters.

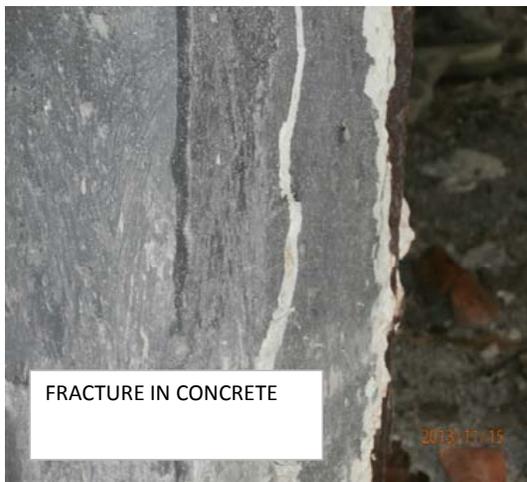
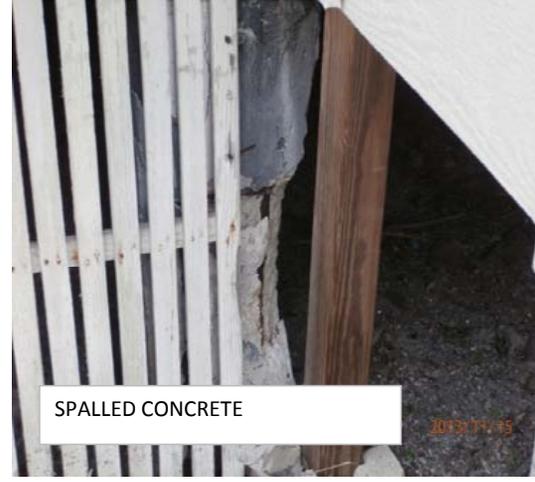
Villa 11

- Deterioration
- Ultimate deformation
- Fractures
- Fissures
- Spalling
- Exposed reinforcement
- Detached, dislodged, or failing connections

Approximately 35% of the piers, some extensive
60 % or more of the piers.

Approximately 20% of the piers
Extensive on approximately 20% of the piers

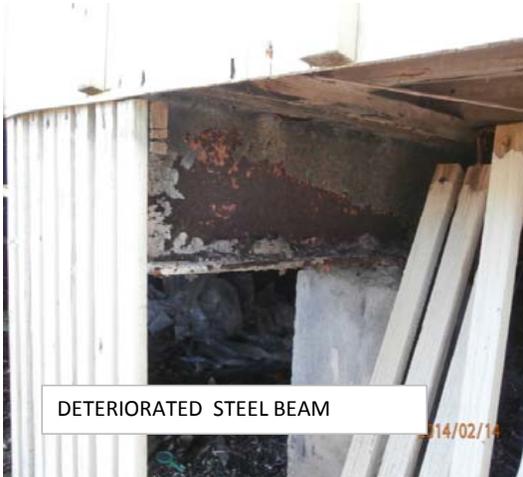
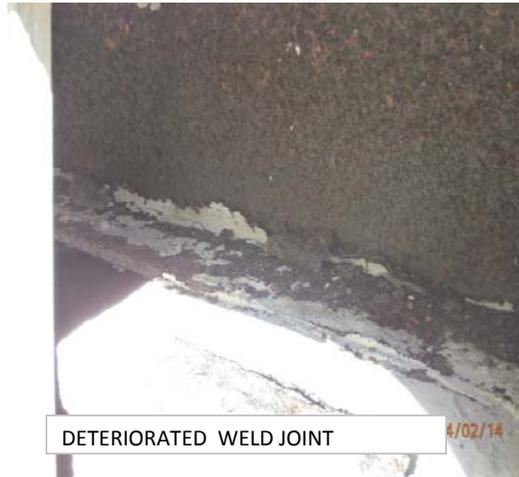
Villa 11

Bottom of I- beams. Some joist hangers and visible clips. Many A/C units are showing signs of failure.

A/C units at the bottom

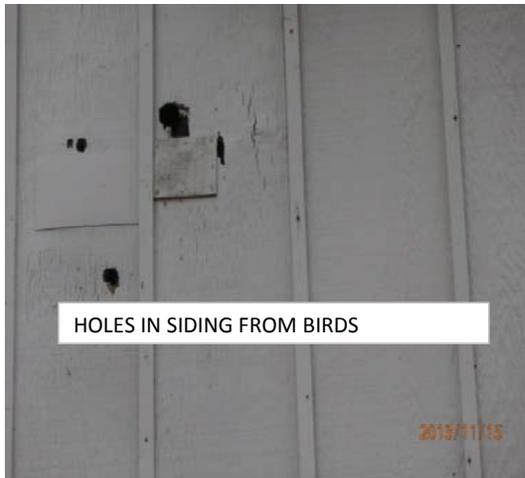
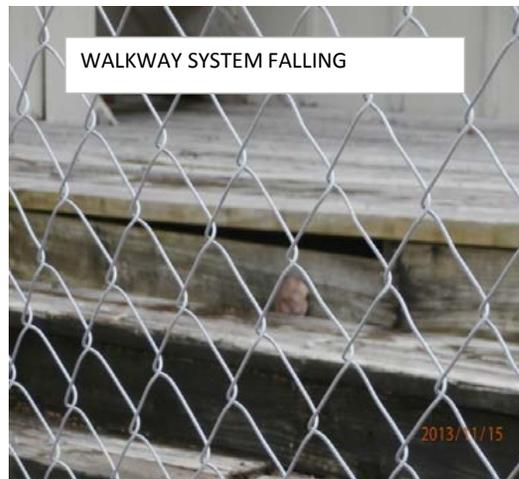
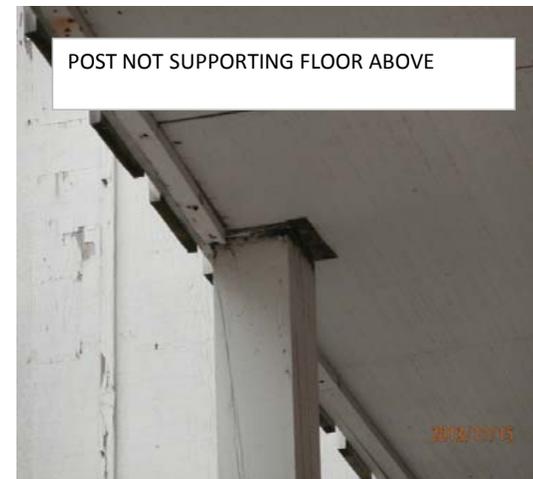
Villa 11

Many porch beams deflected 1/2-inch and more at the center.
Siding, trims, floor framing, upper floor deck, wood shutters, .
Signs of termite and other insect damage. Extensive on the siding. Currently has wasp nests.
Holes in siding from birds.

A/C unit stands
Siding, trims, floor framing, wood shutters, fascia and soffits. The entry stairs and lower walkway show signs of failing to support. Railings pulling from walls. Railing missing balusters.

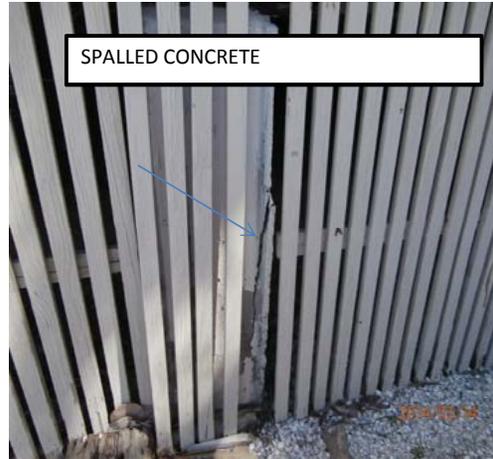
Villa 12

- Deterioration
- Ultimate deformation
- Fractures
- Fissures
- Spalling
- Exposed reinforcement
- Detached, dislodged, or failing connections

Approximately 50% of the piers, some extensive
75 % or more of the piers.
Approximately 40% of the piers
Extensive on approximately 40% of the piers

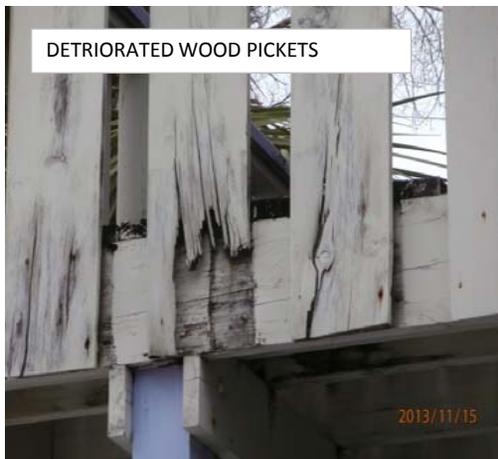
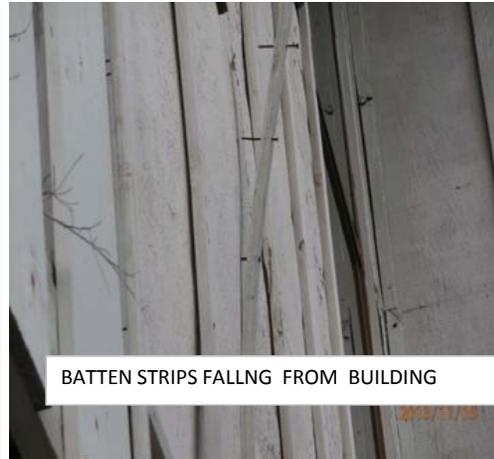
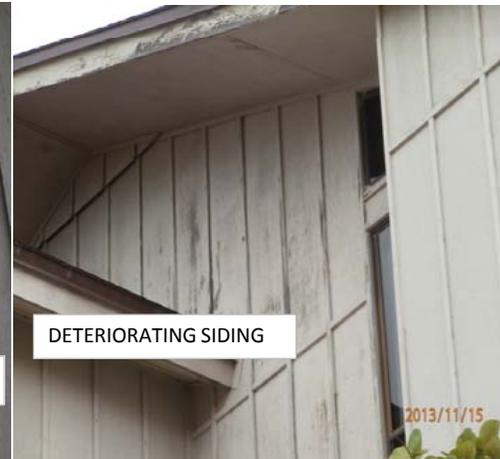
Villa 12

Many porch beams deflected 1/2-inch and more at the center.
Siding, trims, floor framing, upper floor deck, wood shutters, .
Signs of termite and other insect damage. Extensive on the siding. Holes in siding from birds.

A/C unit stands.
Siding, trims, floor framing, wood shutters, fascia and soffits. The entry stairs and lower walkway show signs of failing to support. Railings pulling from walls. Railing missing balusters.

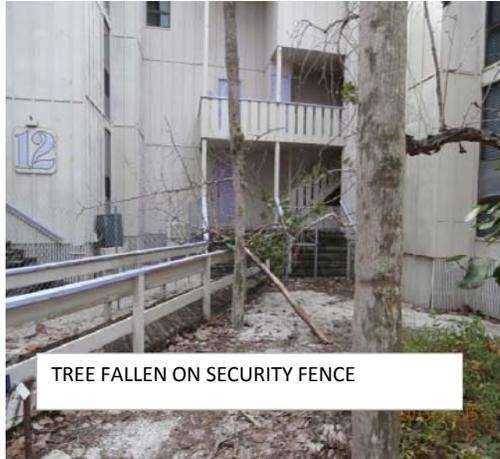
TREE FALLEN ON SECURITY FENCE

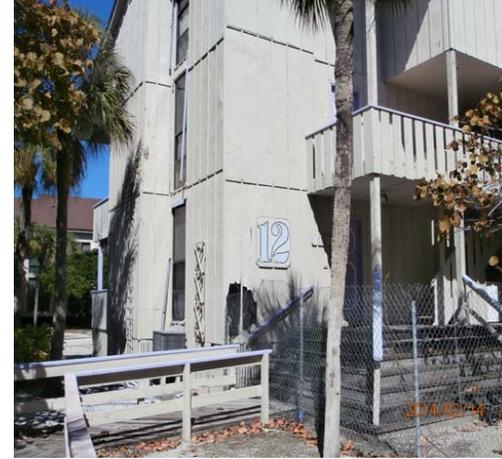
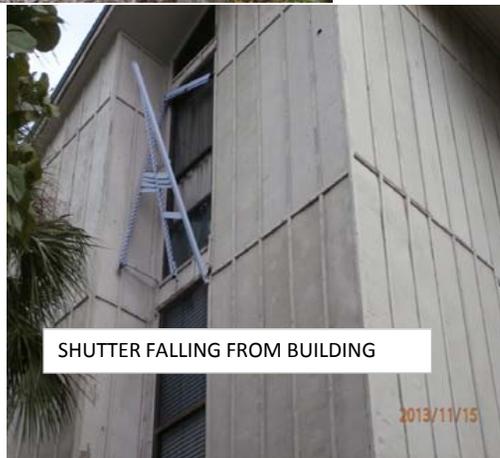
SHUTTER FALLING FROM BUILDING

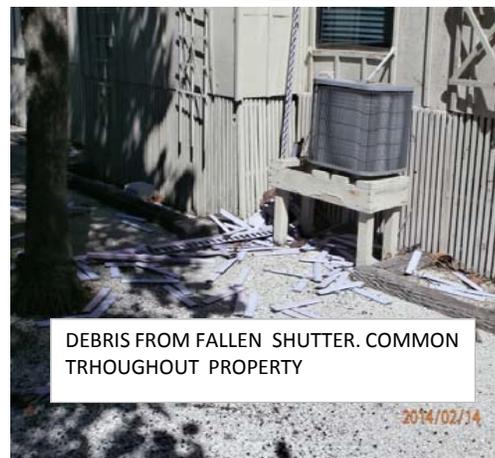
DEBRIS FROM FALLEN SHUTTER. COMMON THROUGHOUT PROPERTY

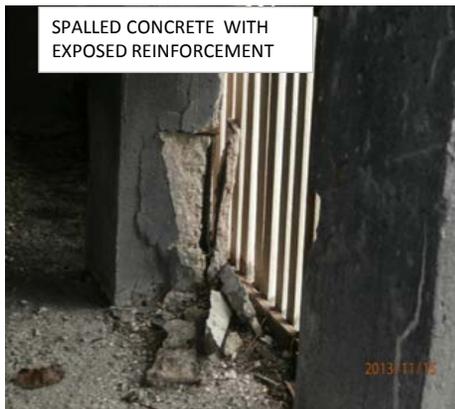
Villa 13

Approximately 15% of the piers

Extensive on approximately 10% of the piers

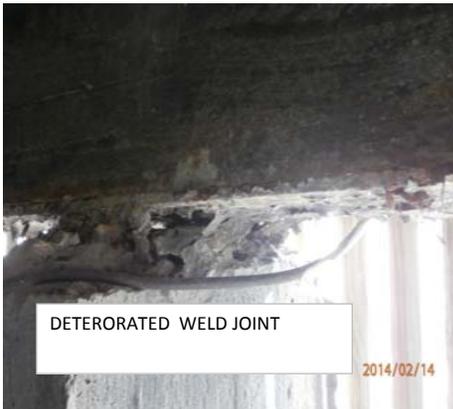
Villa 13
Building Official Report (Cont.)

Bottom of I- beams. Some joist hangers and visible clips. Many A/C units are showing signs of failure.

A/C units at the bottom

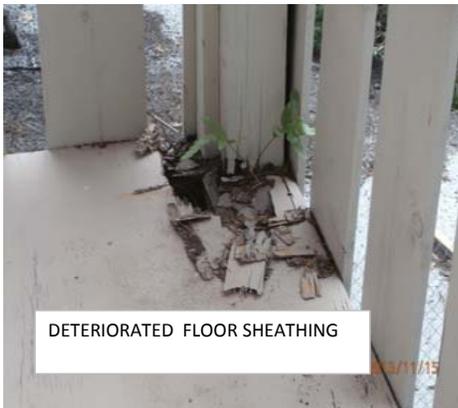
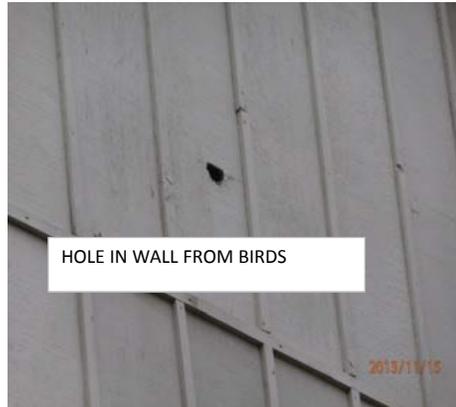
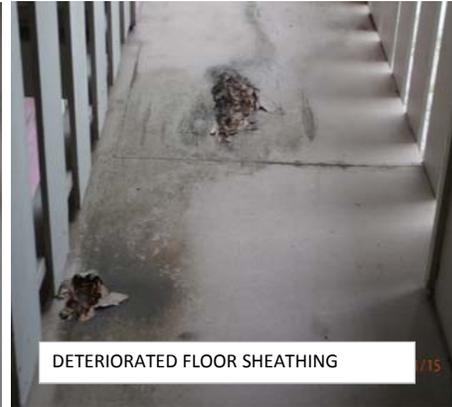
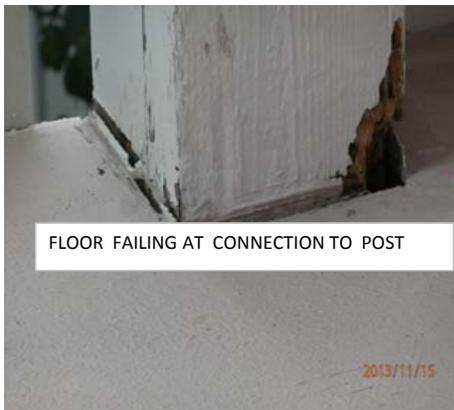
Many porch beams deflected 1/2-inch and more at the center.
Siding, trims, floor framing, upper floor deck, wood shutters, .
Signs of termite and other insect damage. Extensive on the siding. Holes in siding from birds.

Upper walkway deck showing extensive rot and is showing signs of drooping. A/C unit stands.

Siding, trims, floor framing, wood shutters, fascia and soffits. The entry stairs and lower walkway show signs of failing to support. Railings pulling from walls. Railing missing balusters.

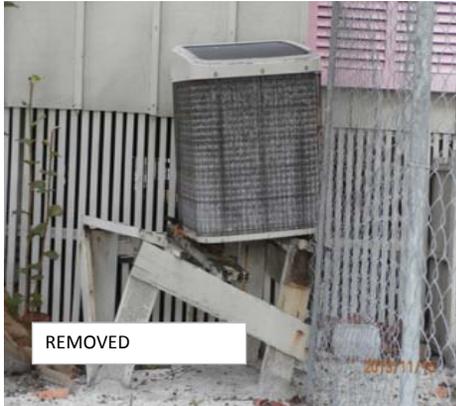
Cast iron building drains corroded and broken

Boarded up windows and doors due to vandalizing.

Air conditioning unit are beginning to fail. A/C unit may fall and have potential to have electrical issues as well as possible leaking of the refrigerant.

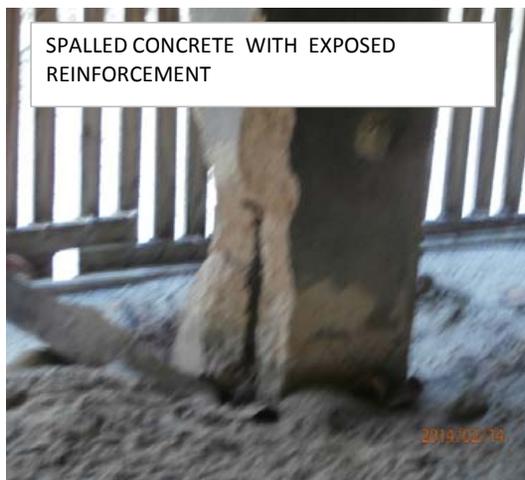
Approximately 15% of the piers

Extensive on approximately 10% of the piers

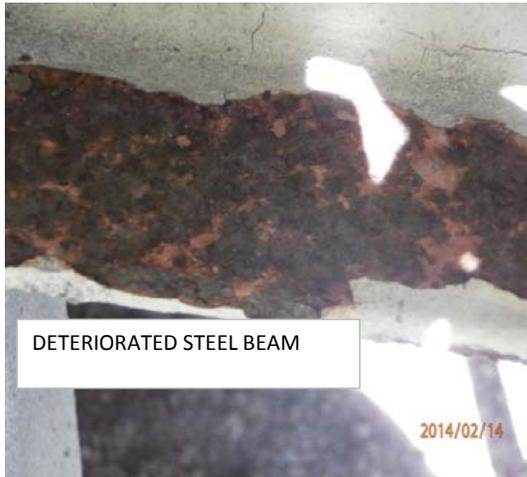
Bottom of I- beams. Some joist hangers and visible clips. Many A/C units are showing signs of failure.

A/C units at the bottom

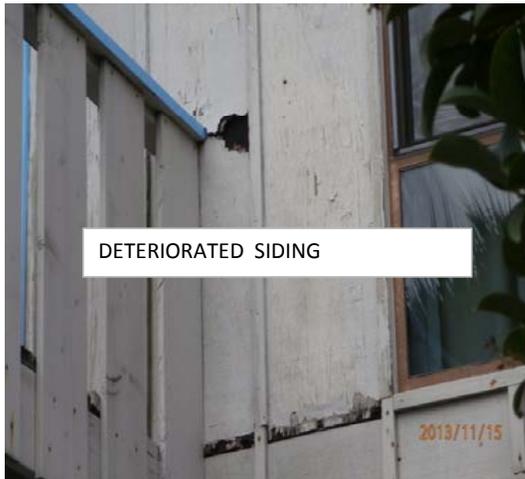
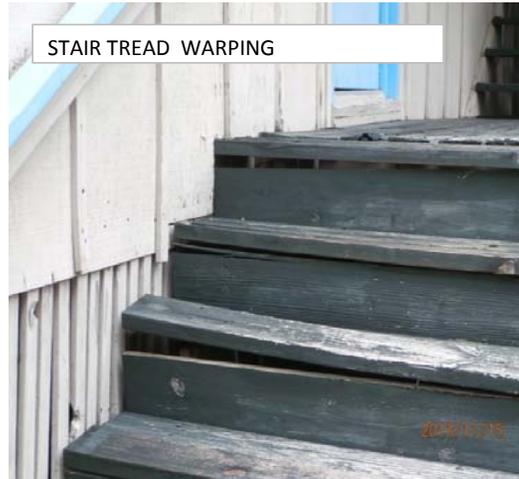
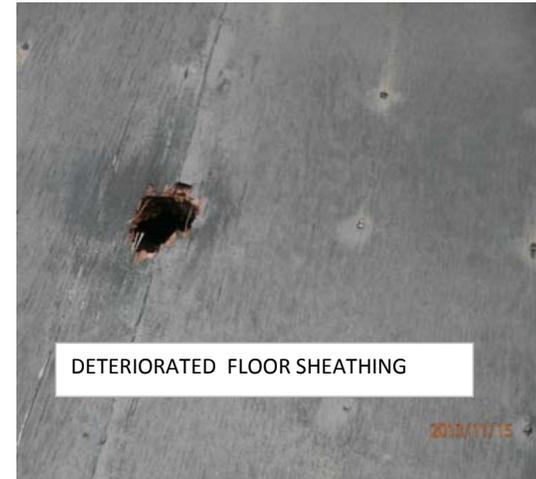
Many porch beams deflected 1/2-inch and more at the center.
Siding, trims, floor framing, upper floor deck, wood shutters, .
Signs of termite and other insect damage. Extensive on the siding. Sign of an animal digging into the upper deck sheathing. Holes in siding from birds.

Some deck joists

A/C unit stands.
Siding, trims, floor framing, wood shutters, fascia and soffits. The entry stairs and lower walkway show signs of failing to support. Railings pulling from walls. Railing missing balusters.

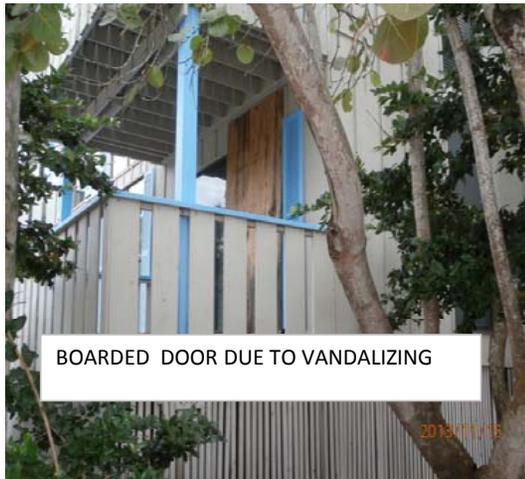
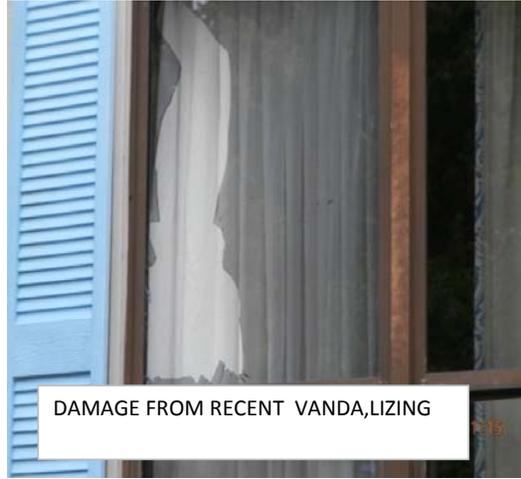
Cast iron building drains corroded and broken

Broken window from recent vandalizing.

Air conditioning unit are beginning to fail. A/C unit may fall and have potential to have electrical issues as well as possible leaking for the refrigerant.

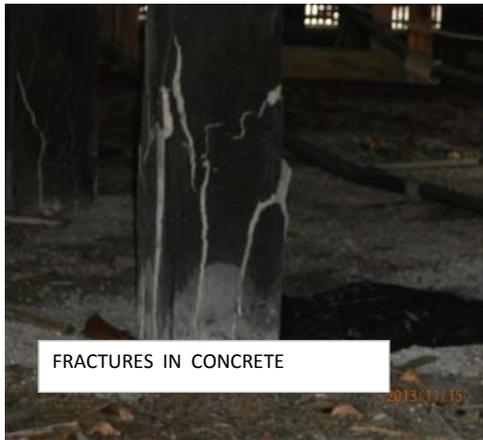
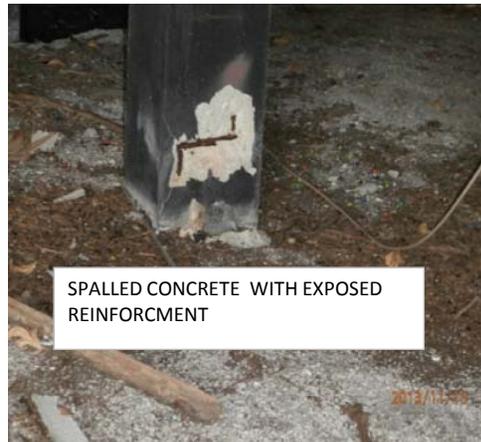
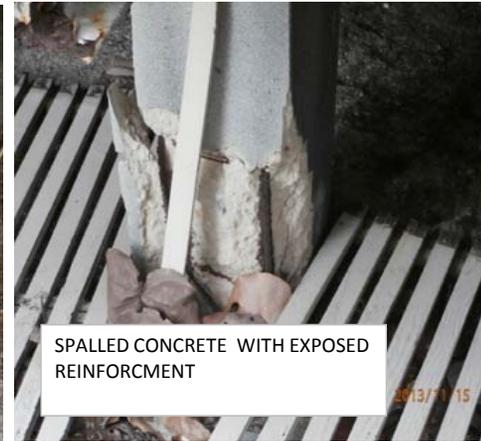
Approximately 15% of the piers

Extensive on approximately 15% of the piers

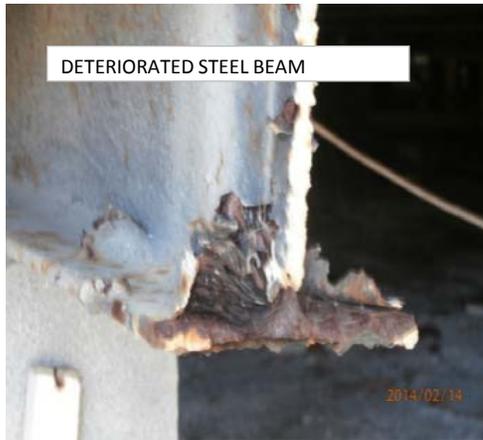
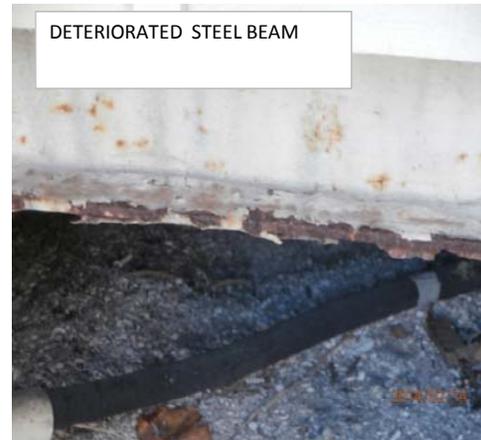
Bottom of I- beams. Some joist hangers and visible clips. Many A/C units are showing signs of failure.

A/C units at the bottom

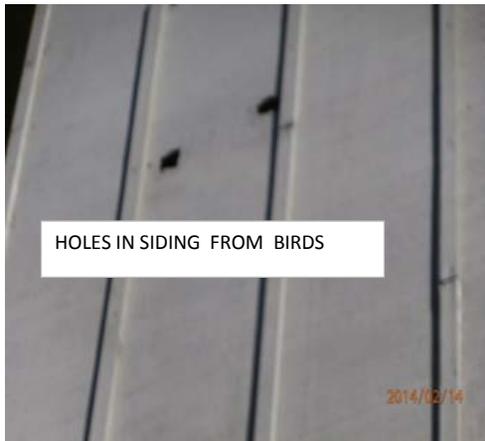
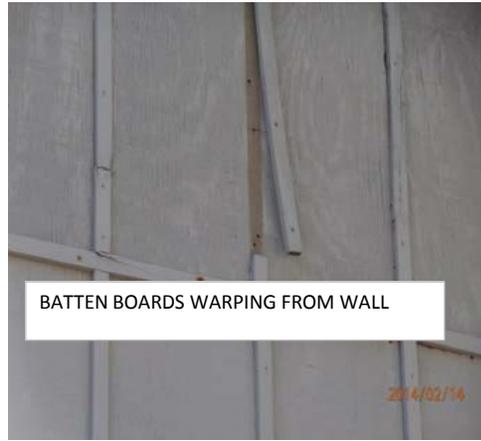
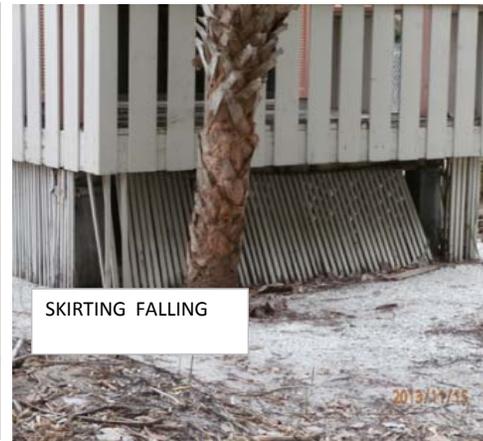
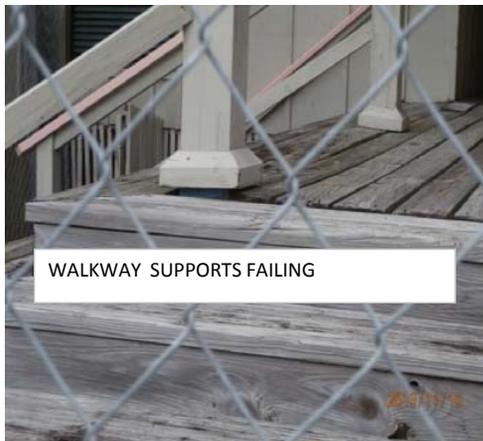
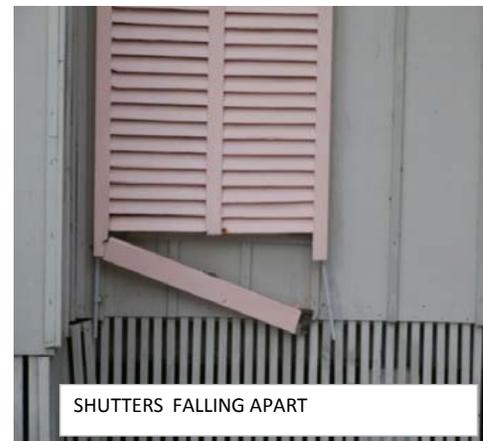
Many porch beams deflected 1/2-inch and more at the center.
Siding, trims, floor framing, upper floor deck, wood shutters, .
Signs of termite and other insect damage. Extensive on the siding. Holes in siding from birds.

Some deck joists

A/C unit stands
Siding, trims, floor framing, wood shutters, fascia and soffits. The entry stairs and lower walkway show signs of failing to support. Railings pulling from walls. Railing missing balusters.

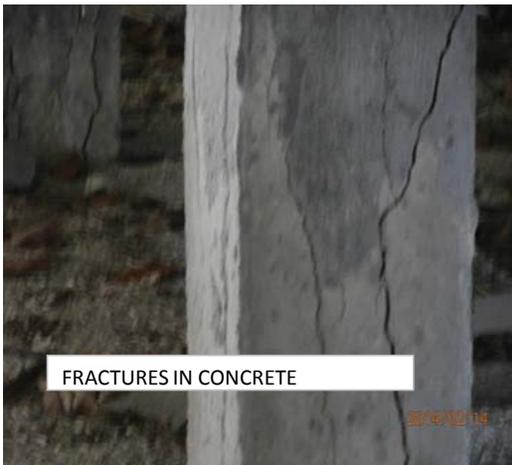
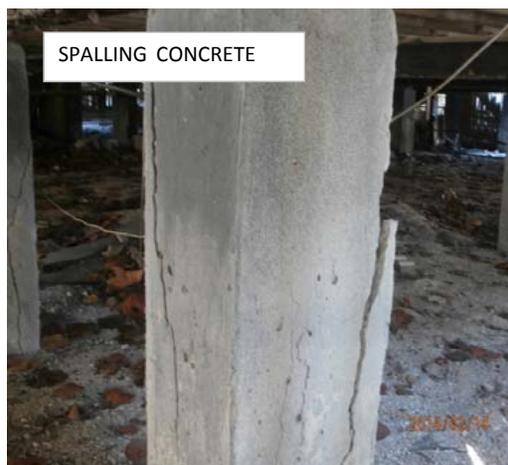
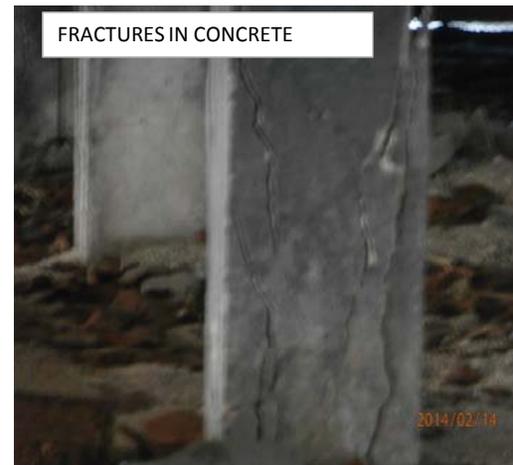
This building appears seaward of the coastal construction control line. Code limitation associated to working on the foundation.

Approximately 30% of the piers, some extensive
50 % or more of the piers.
Approximately 15% of the piers
Extensive on approximately 10% of the piers

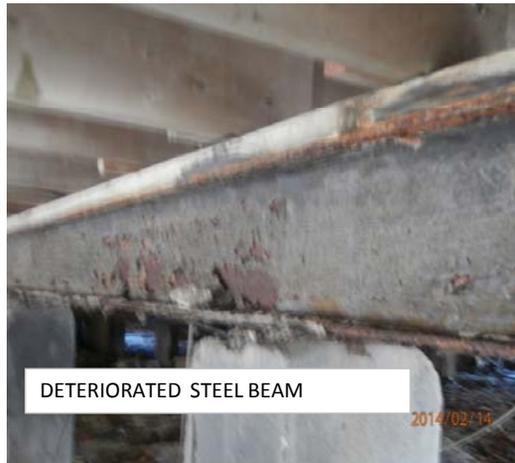
Bottom of I- beams. Some joist hangers and visible clips. Many A/C units are showing signs of failure.

A/C units at the bottom

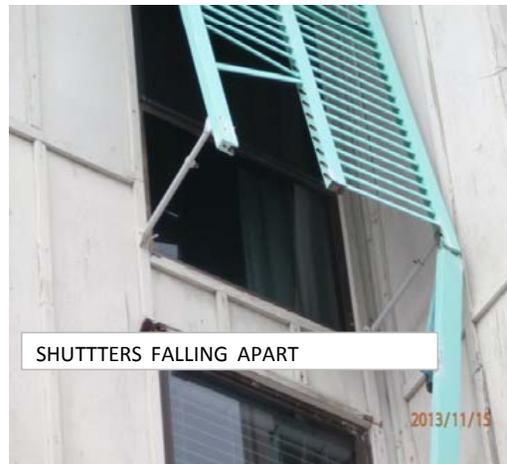
Many porch beams deflected 1/2-inch and more at the center.
Siding, trims, floor framing, upper floor deck , wood shutters, .
Signs of termite and other insect damage. Extensive on the siding. Holes in siding from birds.

Some deck joists

A/C unit stands.
Siding, trims, floor framing, wood shutters, fascia and soffits. The entry stairs and lower walkway show signs of failing to support. Railings pulling from walls. Railing missing balusters.
