ENGINEERING INSPECTION REPORT

THE COLONY BEACH and TENNIS RESORT

Longboat Key, Florida

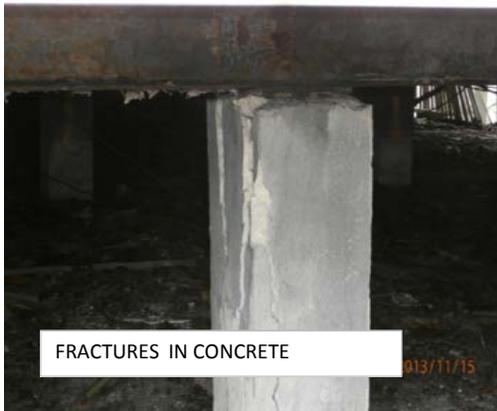
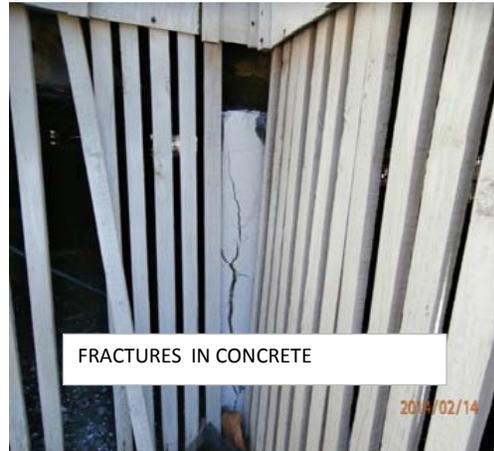
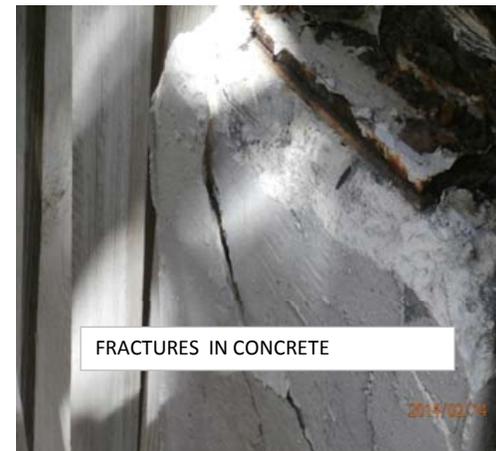
Villa 17

Approximately 20% of the piers

Extensive on approximately 10% of the piers

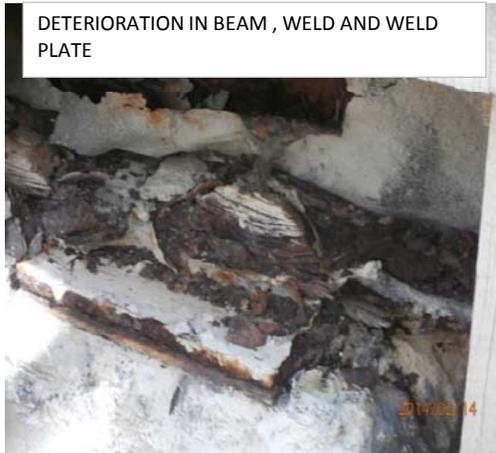
Bottom of I- beams. Some joist hangers and visible clips. Many A/C units are showing signs of failure.

A/C units at the bottom

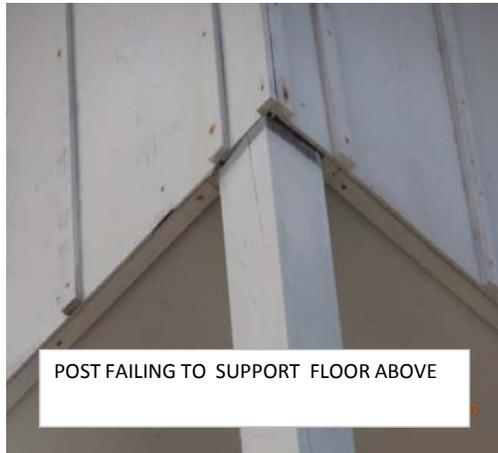
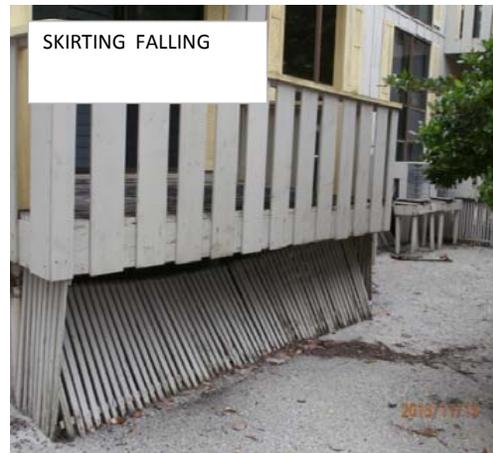
Many porch beams deflected 1/2-inch and more at the center.
Siding, trims, floor framing, upper floor deck, wood shutters, .
Signs of termite and other insect damage. Extensive on the siding. Holes in siding from birds.

A/C unit stands.
Siding, trims, floor framing, wood shutters, fascia and soffits. The entry stairs and lower walkway show signs of failing to support. Railings pulling from walls. Railing missing balusters.

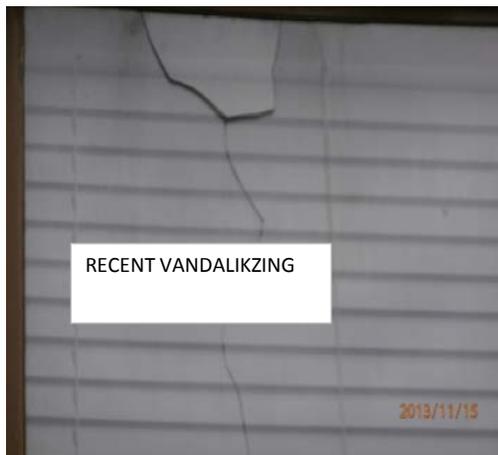
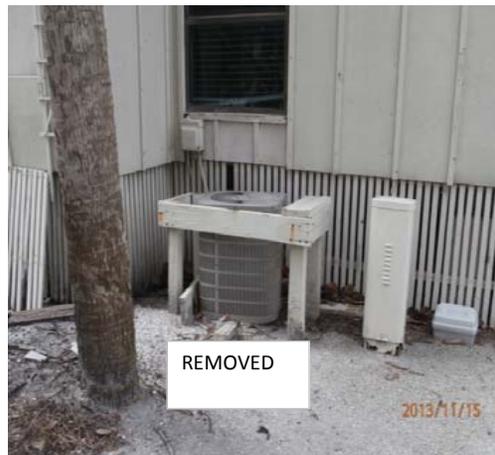
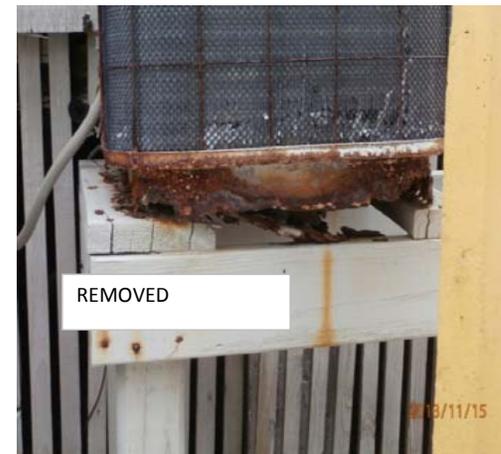
Cast iron building drains corroded and broken

Boarded up windows and doors due to vandalizing. Broken window due to recent vandalizing.

Air conditioning unit are beginning to fail. A/C unit may fall and have potential to have electrical issues as well as possible leaking for the refrigerant. One unit has dropped to the ground.

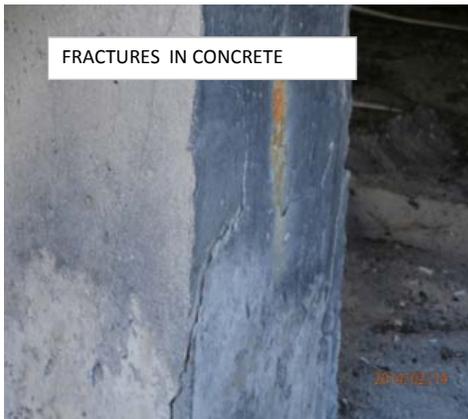
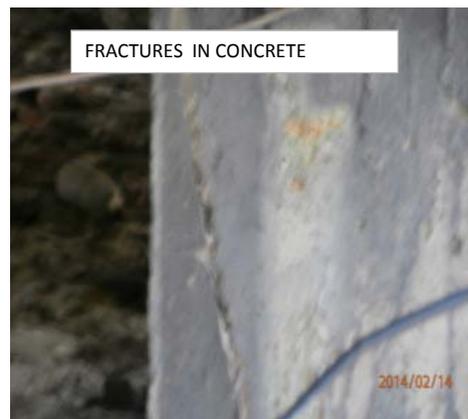
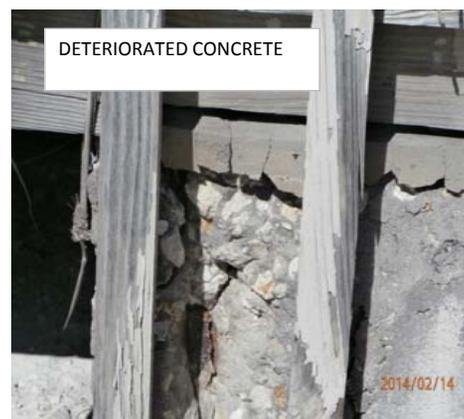
This building is seaward of the coastal construction control line. Code limitation associated to working on the foundation.

Approximately 40% of the piers

Extensive on approximately 40% of the piers

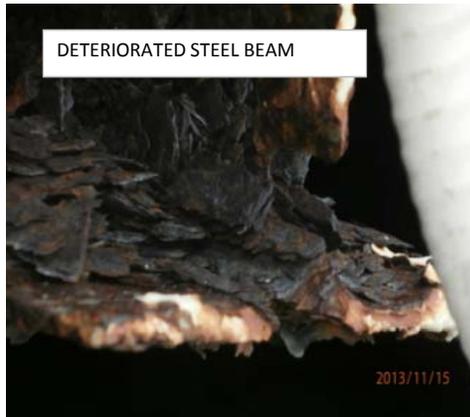
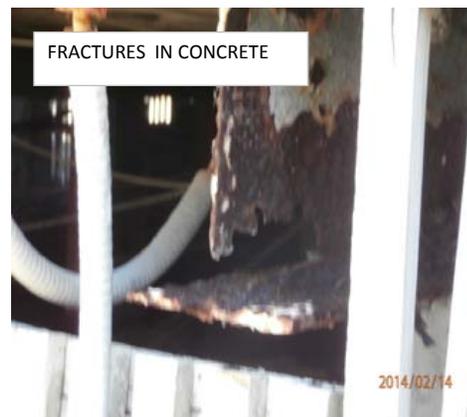
Bottom of I- beams. Some joist hangers and visible clips. Many A/C units are showing signs of failure.

A/C units at the bottom

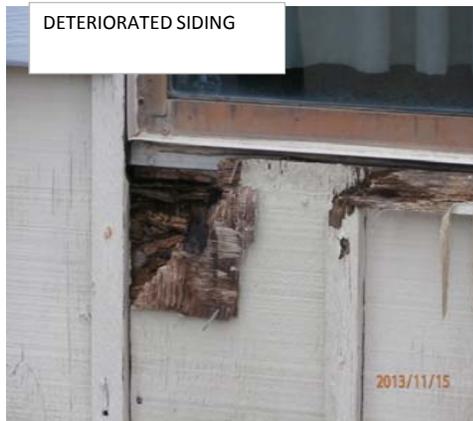
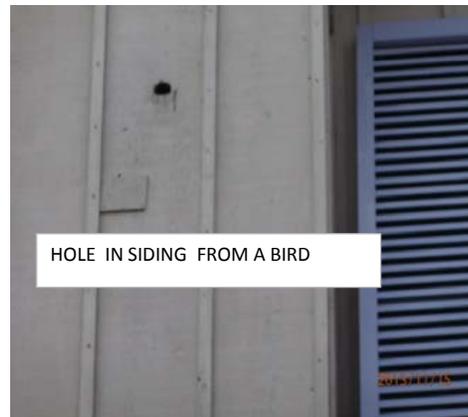
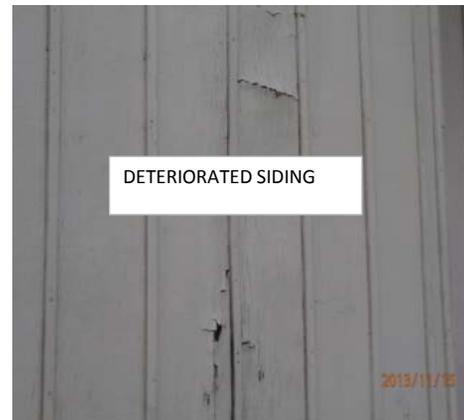
Many porch beams deflected 1/2-inch and more at the center.
Siding, trims, floor framing, upper floor deck, wood shutters, .
Signs of termite and other insect damage. Extensive on the siding. Currently has wasp nests.
Holes in siding from birds.

Post appears to not be supporting upper walkway. A/C unit stands
Siding, trims, floor framing, wood shutters, fascia and soffits. The entry stairs and lower
walkway show signs of failing to support. Railings pulling from walls. Railing missing balusters.

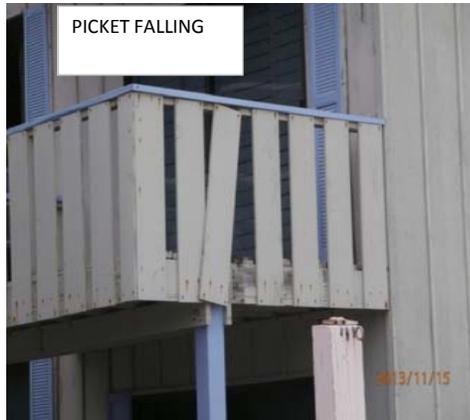
PICKET FALLING

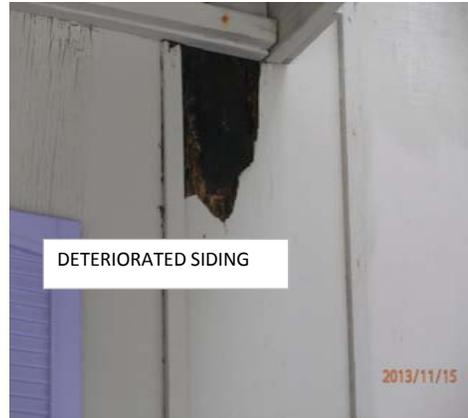
DETERIORATED SIDING

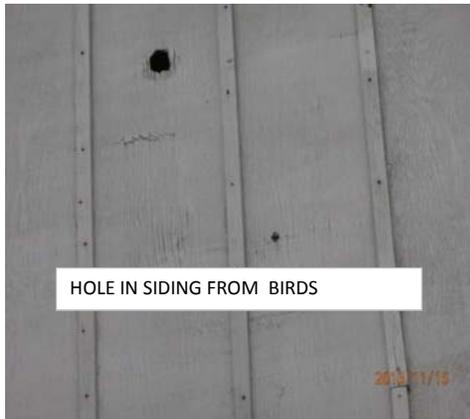
HOLE IN SIDING FROM BIRDS

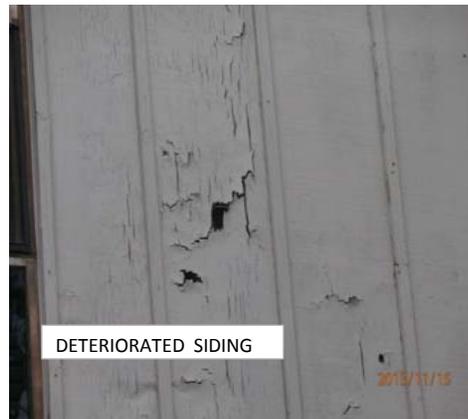
DETERIORATED SIDING

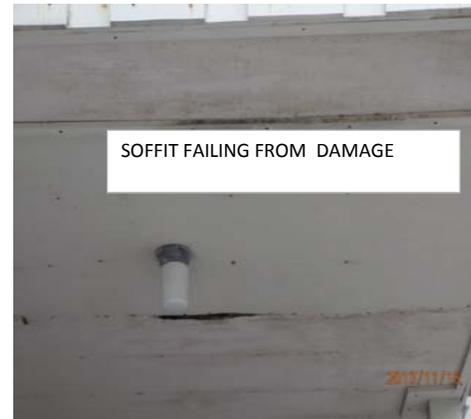
SOFFIT FAILING FROM DAMAGE

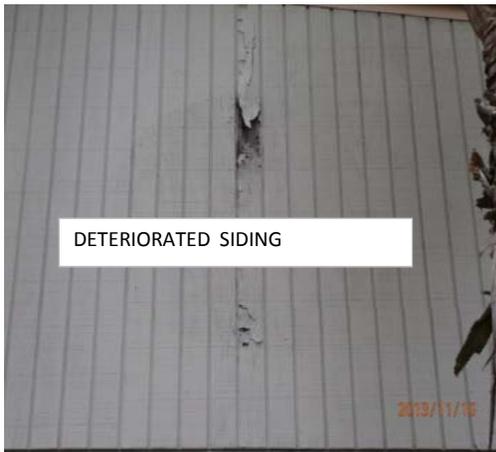
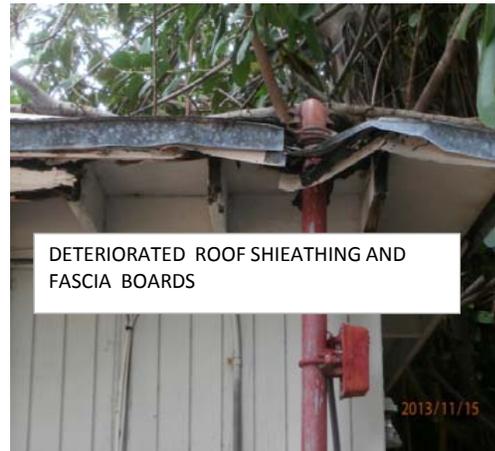
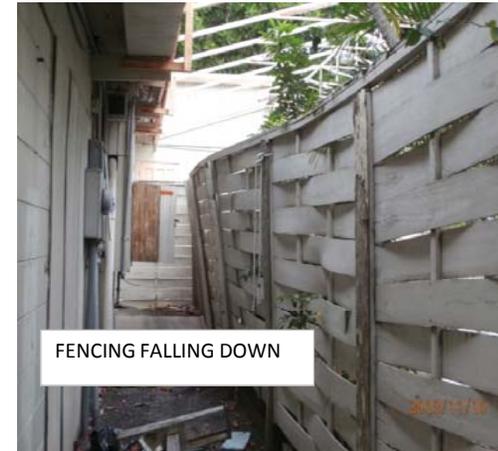
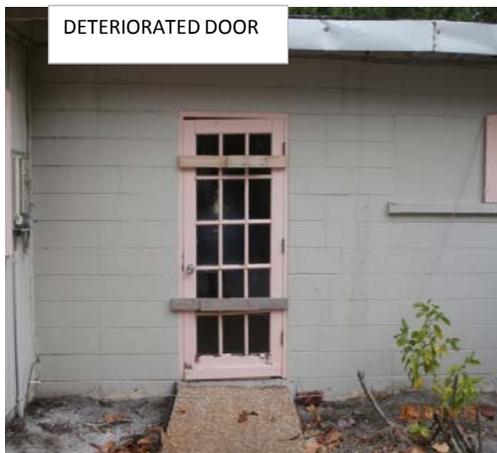
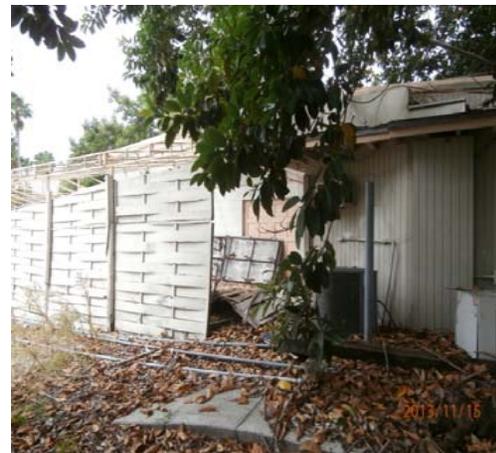
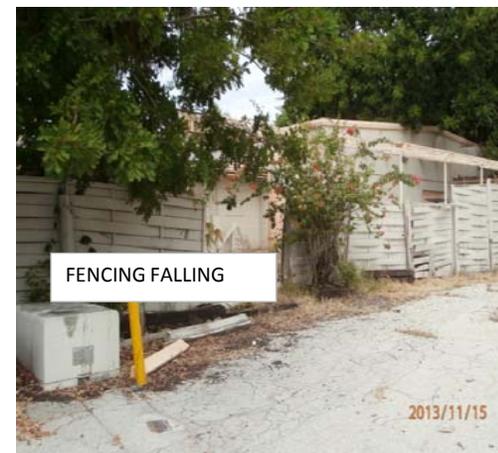
Roof sheathing. Siding, fascia boards, trims, doors, windows.
Signs of termite damage

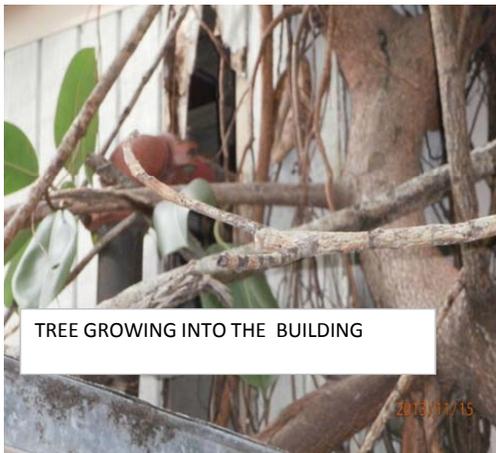
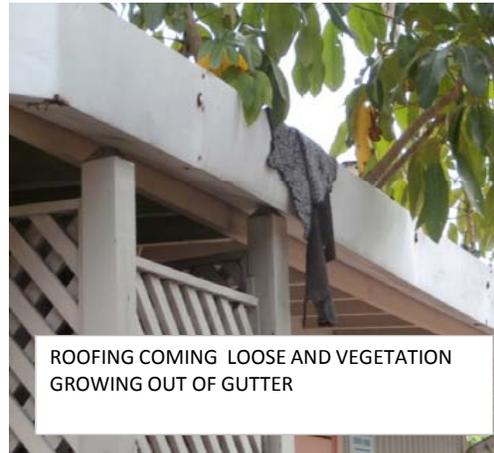
Roofing appears to be failing.

Boarding due to vandalizing and condition of doors.

Broken conduit exposing electrical conductors not

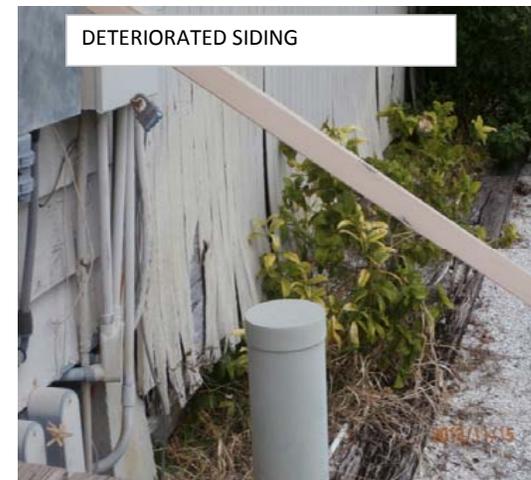
Signs of termite damage.

One shed roof is collapsing. Siding damage due to vandalizing.

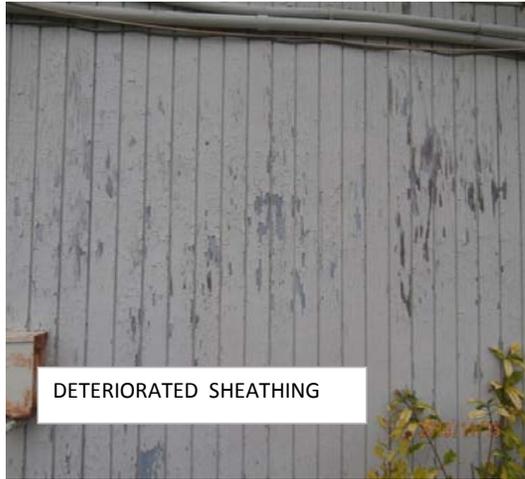
DETERIORATED SHEATHING

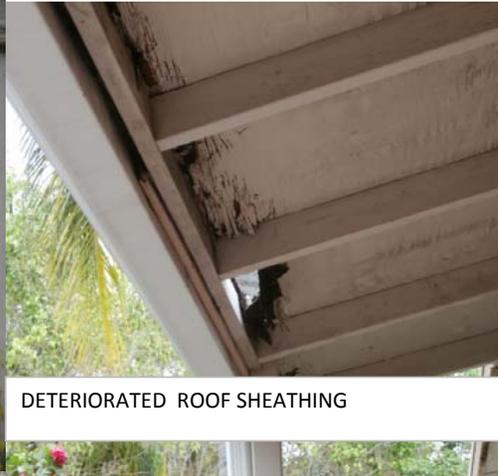
DETERIORATED ROOF SHEATHING

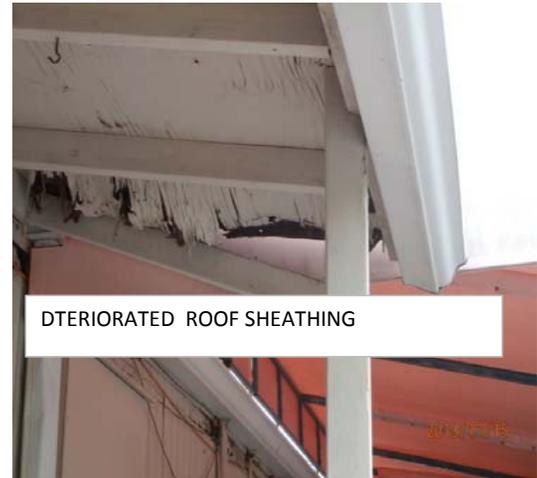
DETERIORATED ROOF SHEATHING

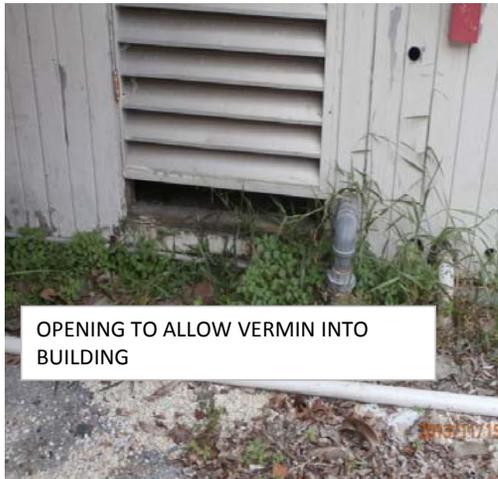
OPENING TO ALLOW VERMIN INTO BUILDING

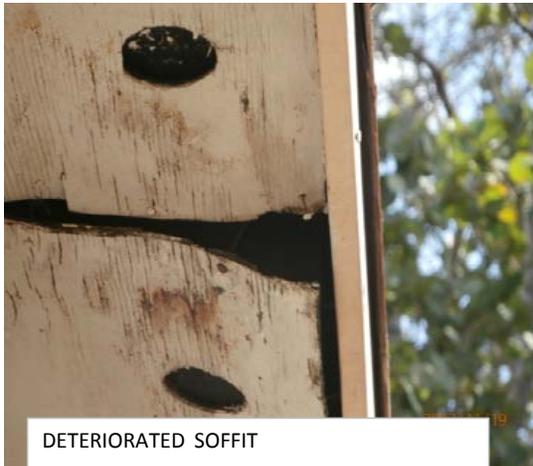
DETERIORATED SOFFIT

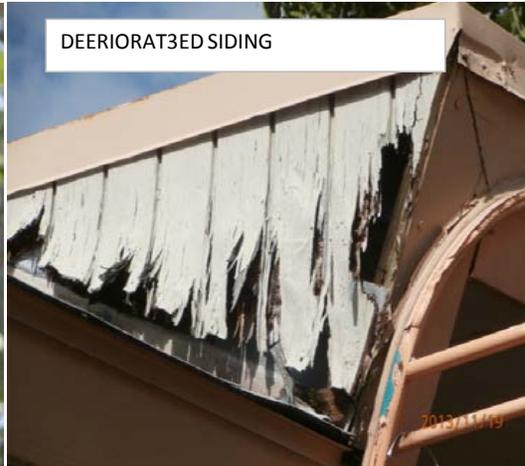
DEERIORATED SIDING

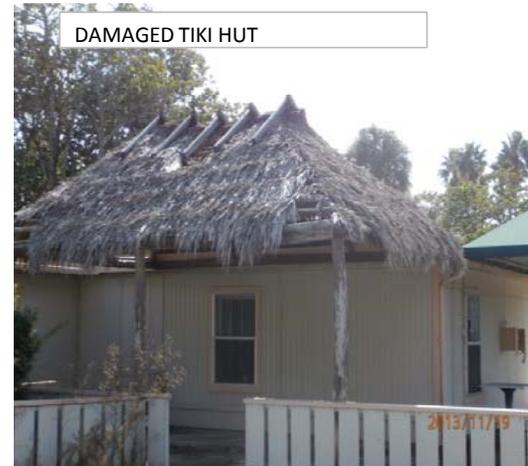
DAMAGED TIKI HUT

Tiki structure at rear is deteriorating and the roof thatch are falling off.

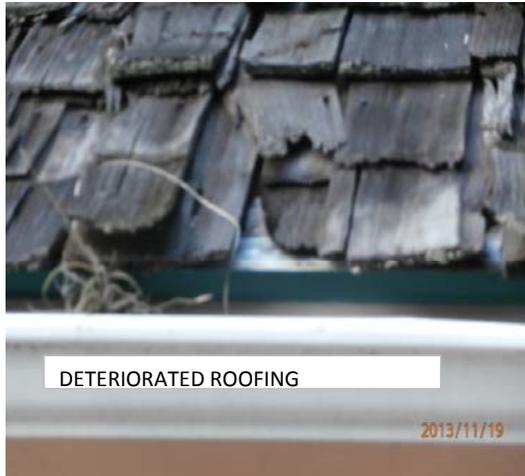
Siding, fascia boards, roof shakes.
Signs of termite damage

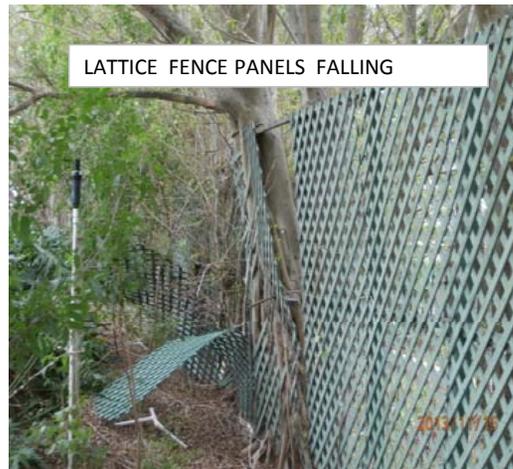
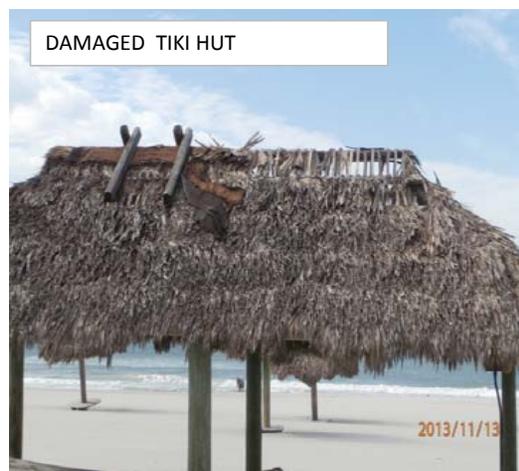
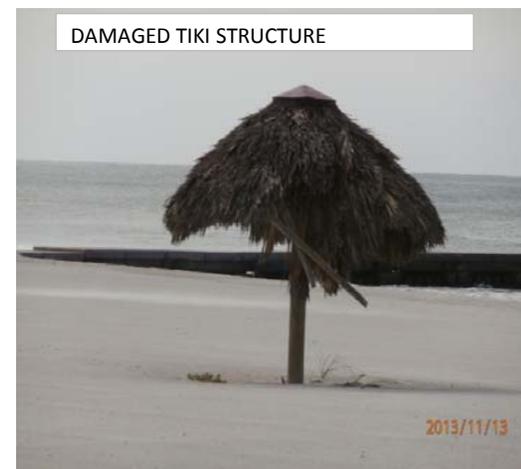
Loose trash and debris throughout property.

Tiki huts starting to fall and thatch coming loose. This is out on the beach as well as within the site.

Fencing falling down in various locations on the site. Loose lattice fence panel falling down. Fallen branches throughout property. One in the front right of way.

Tennis courts showing signs of deterioration and has vegetation growing throughout them.

All ground level walkways and ramps have rotted wood, warp deck boards, rotted deck boards, and broken railings

Security fencing incomplete at some building. At first inspection appeared complete until an up close inspection was made. Some locations have had vandalizing requiring repair and or reset.
