**PUBLIC NUISANCE HEARING
1620 GULF OF MEXICO DRIVE
RESTAURANT/BAR COMPLEX**

**TOWN COMMISSION SPECIAL MEETING
MARCH 4, 2014**

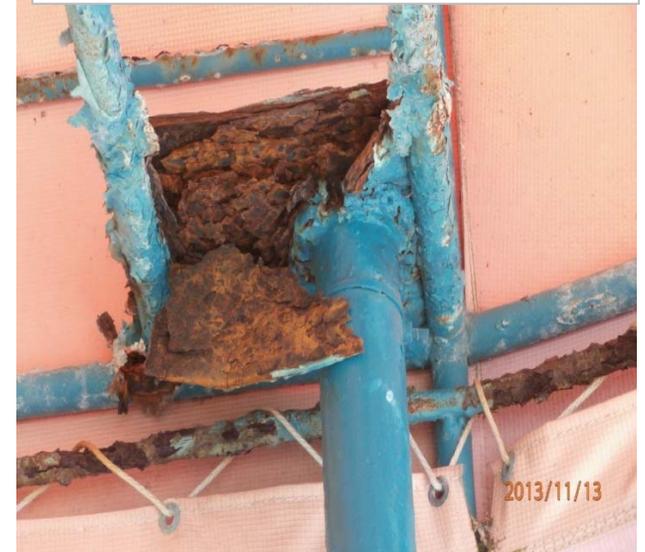
- **Deterioration**
- **Metal fatigue**
- **Detached, dislodged, or failing connections**

DETERIORATING STEEL AND FAILED CONNECTION

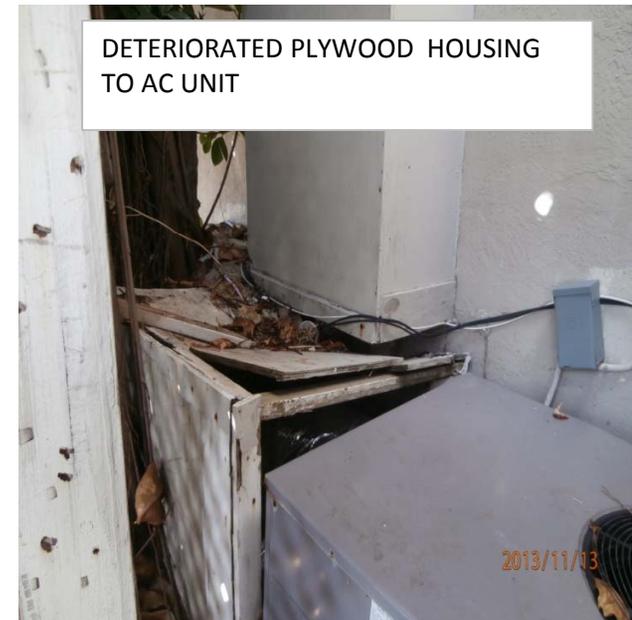
- **Deterioration**
- **Detached, dislodged, or failing connections**

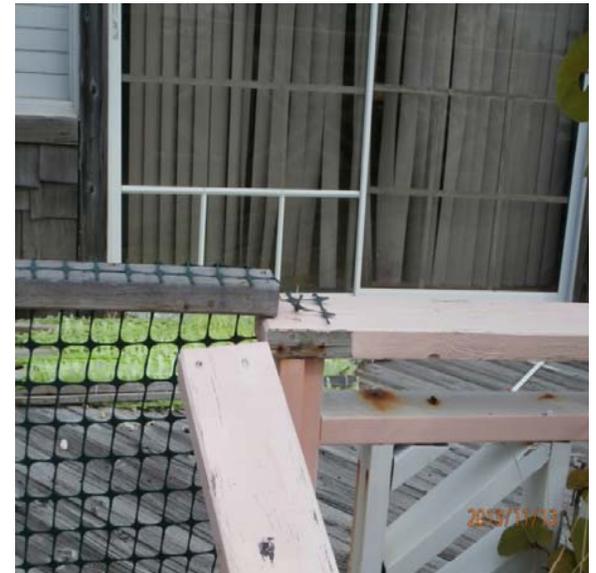
- **Detached, dislodged, or failing connections**

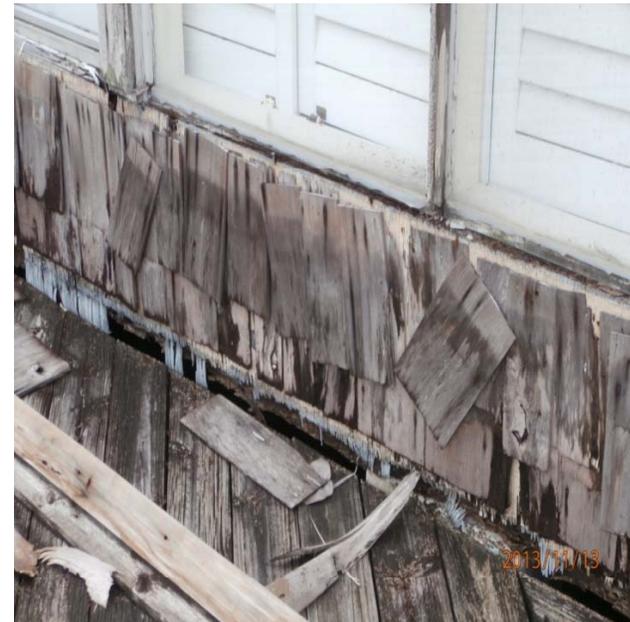
- **Deterioration**
- **Damage from insects, rodents and other vermin**
- **Detached, dislodged, or failing connections**

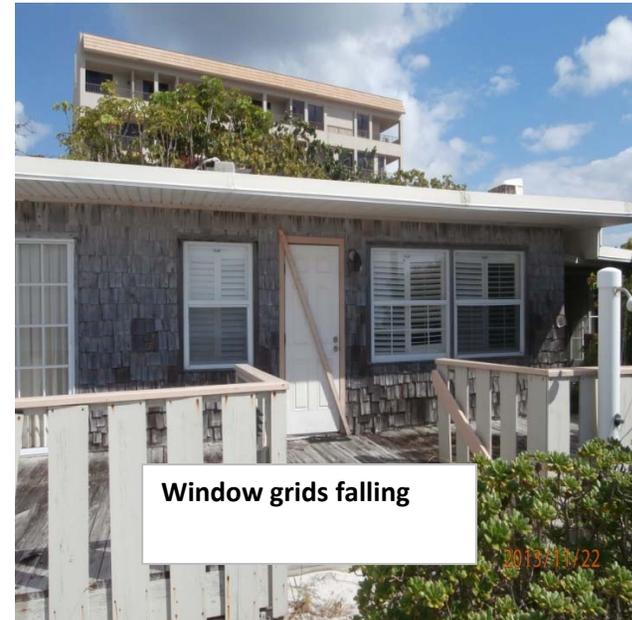
- **Detached, Dislodged or Failing Connections**

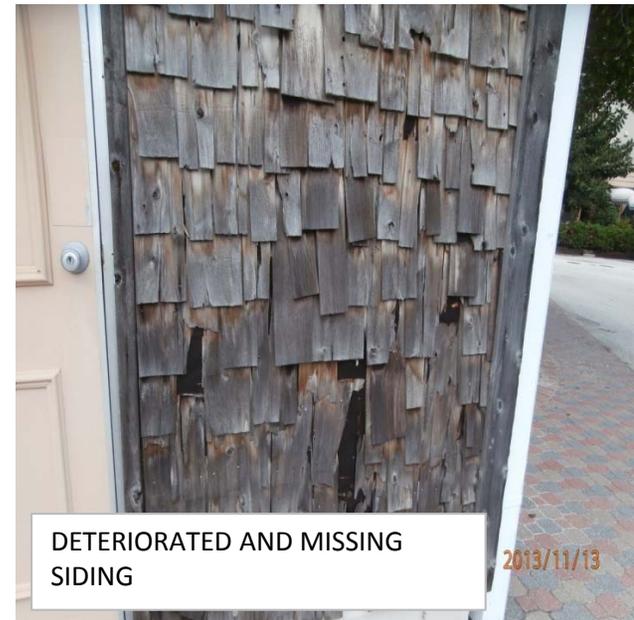
- Deterioration
- Inadequate support
- Detached, dislodged,
or failing connections.

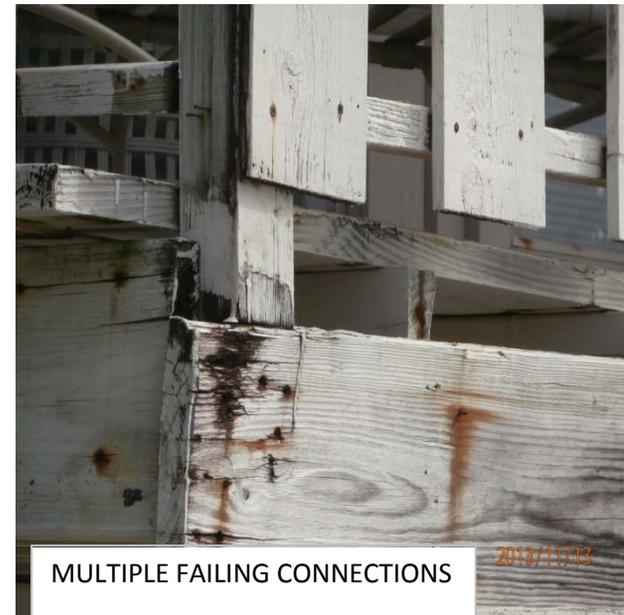
- Ultimate deformation
- Deterioration
- Damage from insects, rodents and other vermin
- Detached , dislodged, or failing connections

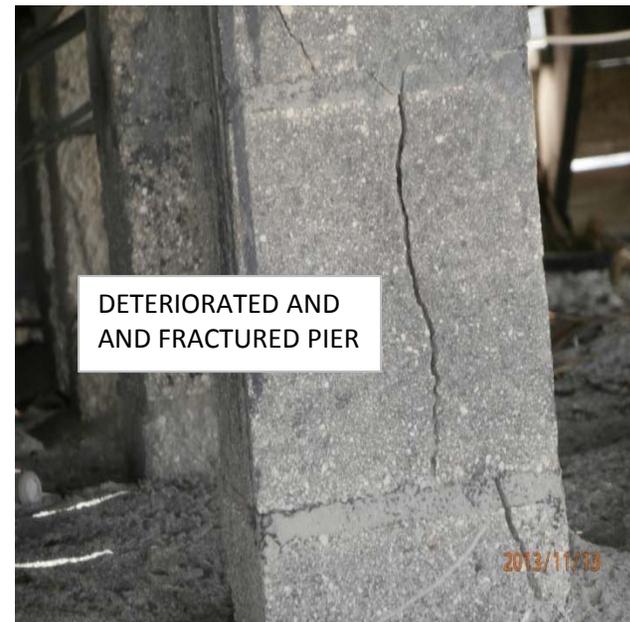
- Deterioration
- Fractures
- Fissures

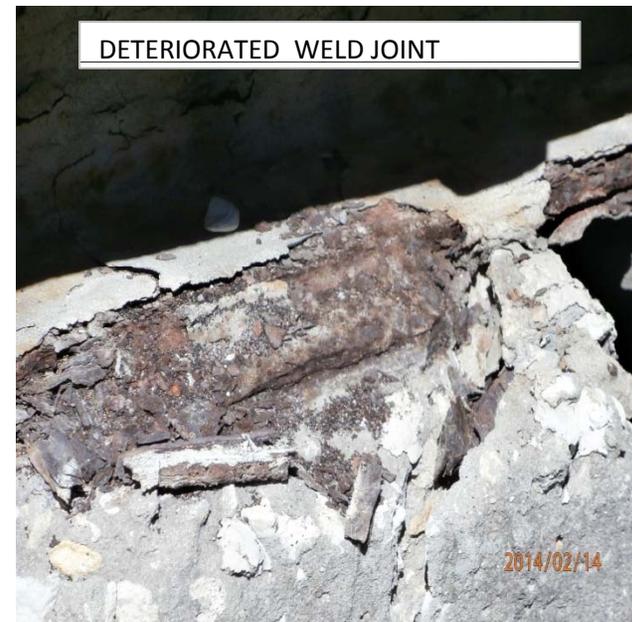
- Deterioration
- Metal fatigue
- Detached, dislodged, or failing connections

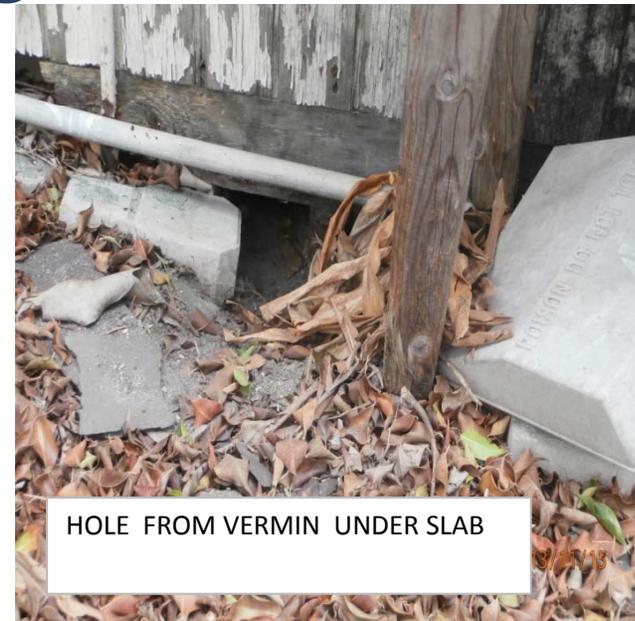
MAINTENANCE BUILDING – CONCRETE

- This building is slab at grade.
Unable to inspect.

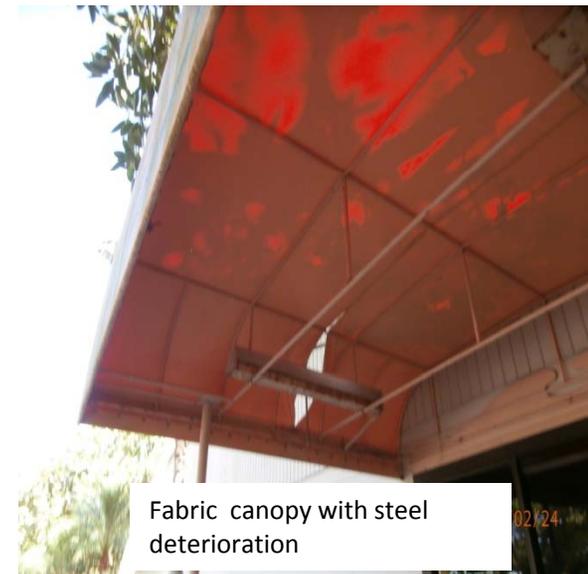
CONFERENCE CENTER/AEROBICS CENTER BUILDING STEEL

- **Deterioration**
- **Metal fatigue**
- **Detached, dislodged,
or failing connections**
