ENGINEERING INSPECTION REPORT

THE COLONY BEACH and TENNIS RESORT

Longboat Key, Florida

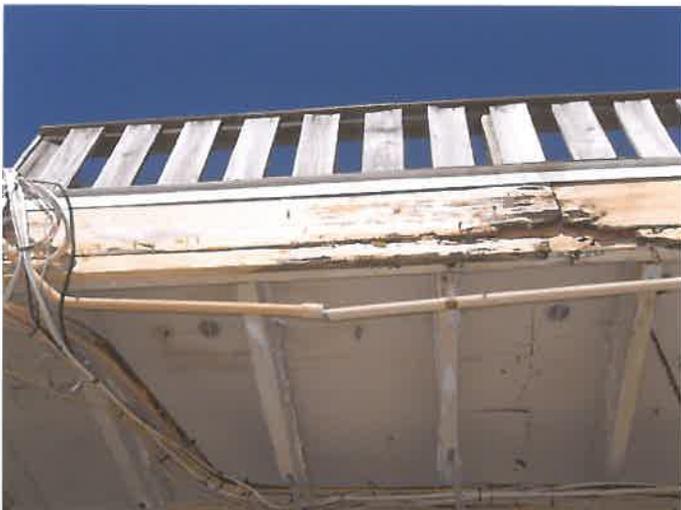
| 66 | Restaurant Complex – siding rot, south side | 1910 | Restaurant Complex |

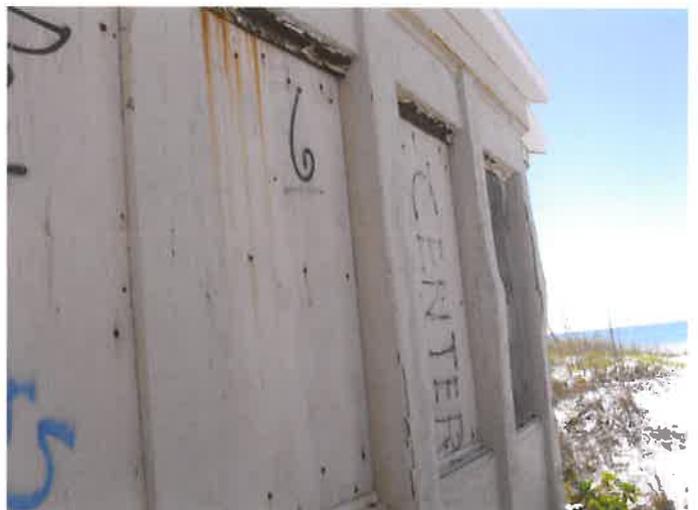
| 67 | Restaurant Complex – roof rot, south side | 1914 | Restaurant Complex |

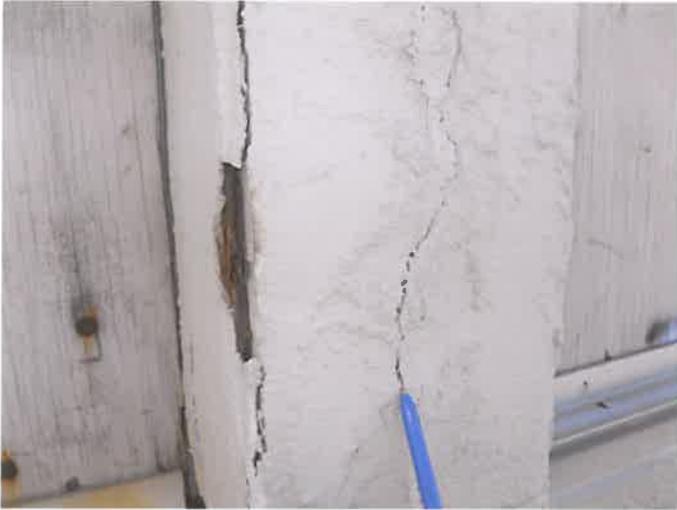
| 68 | Restaurant Complex – cracked CMU columns, north side | 1958 | Restaurant Complex |

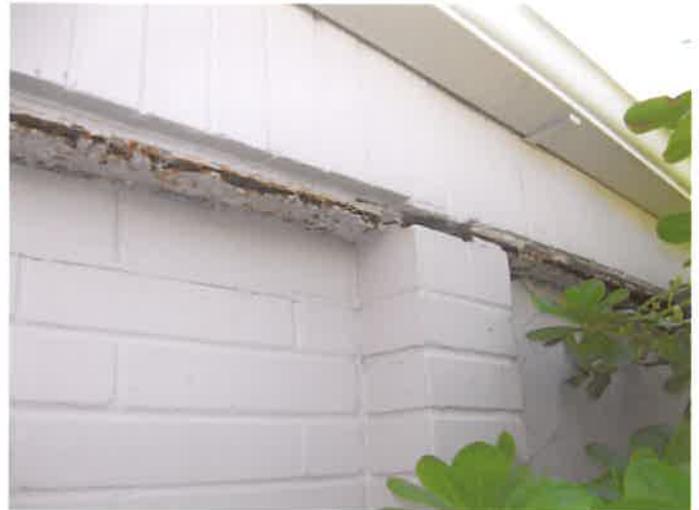
| 69 | Restaurant Complex – cracked CMU columns, north side | 1963 | Restaurant Complex |

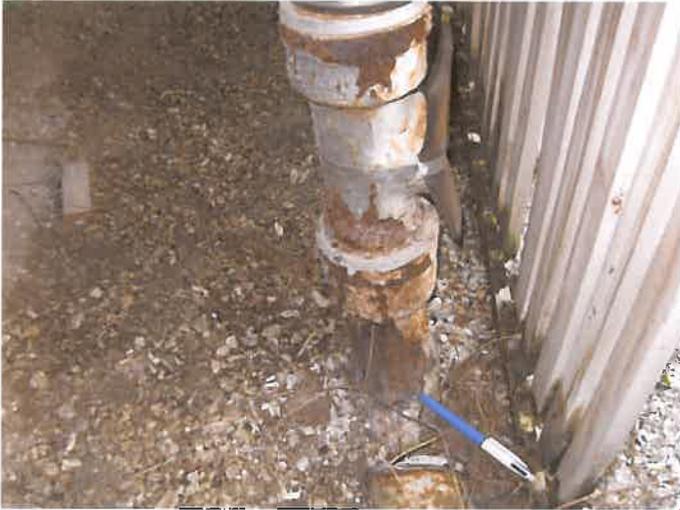
| 77 | Villa - Corroded cast iron drain | 1700 | Villa 14 |
